# Conditions Assessment

## Gould Memorial Library & Hall of Fame

FINAL REPORT | 15 MARCH 2018

**BRONX**  
**COMMUNITY**  
COLLEGE

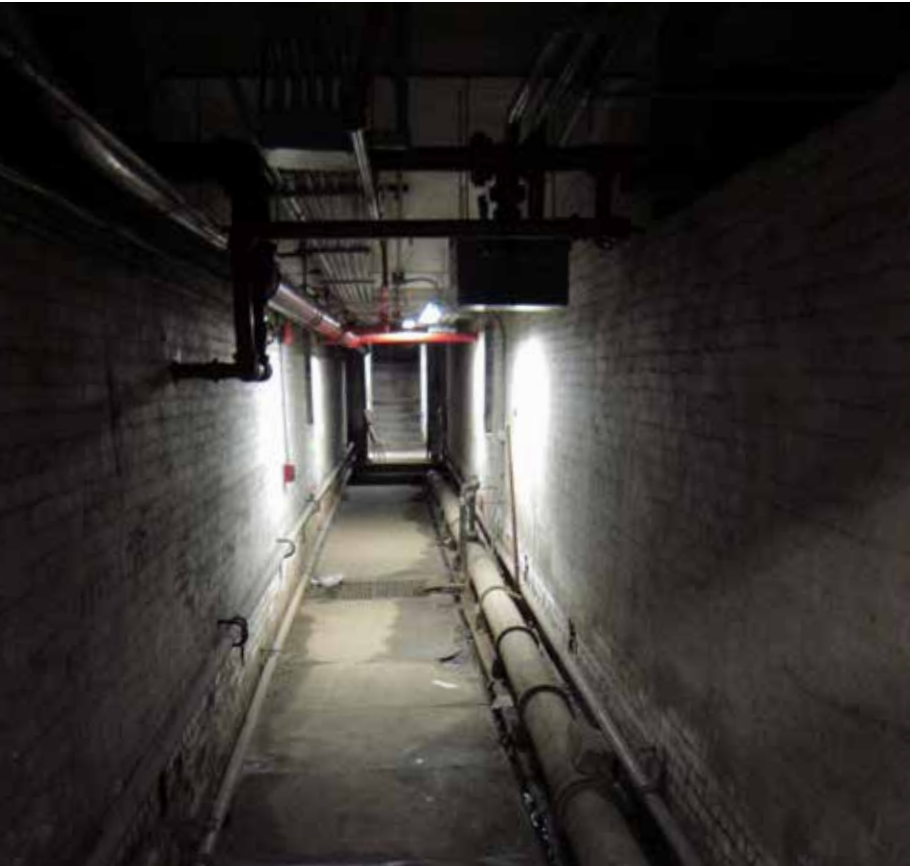
Combined sanitary / storm main runs north-south through the level oB cellar corridor, and sprinkler piping is suspended from the ceiling.

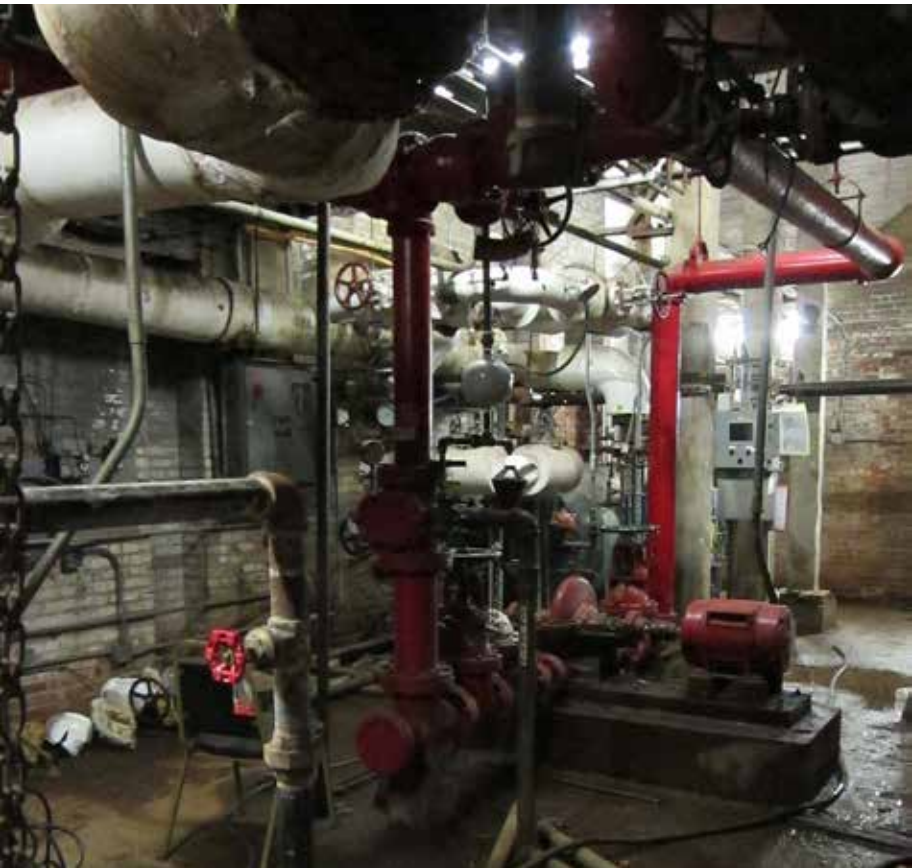
Space for services is ample in cellar level oB. The red sprinkler pump in the foreground at 208V, different than the campus system, and the steam generator behind is supplied by the network.

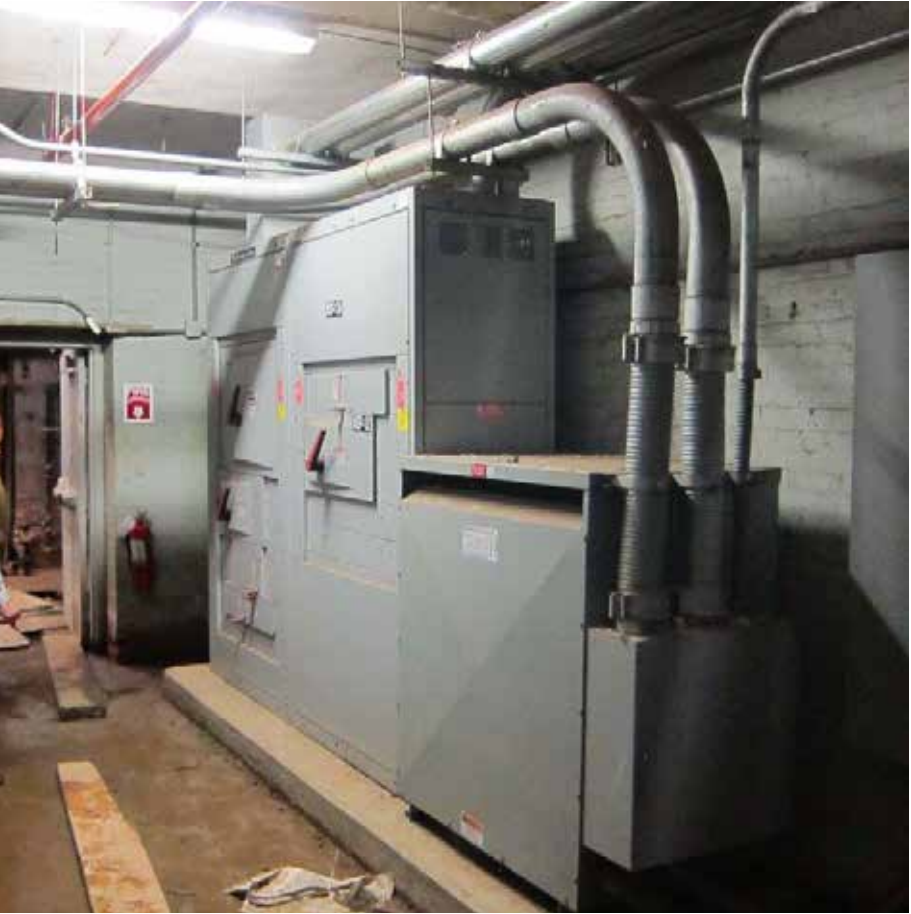
208V main switchgear and transformer in cellar level oB would need upgrade to match the 480V campus system.

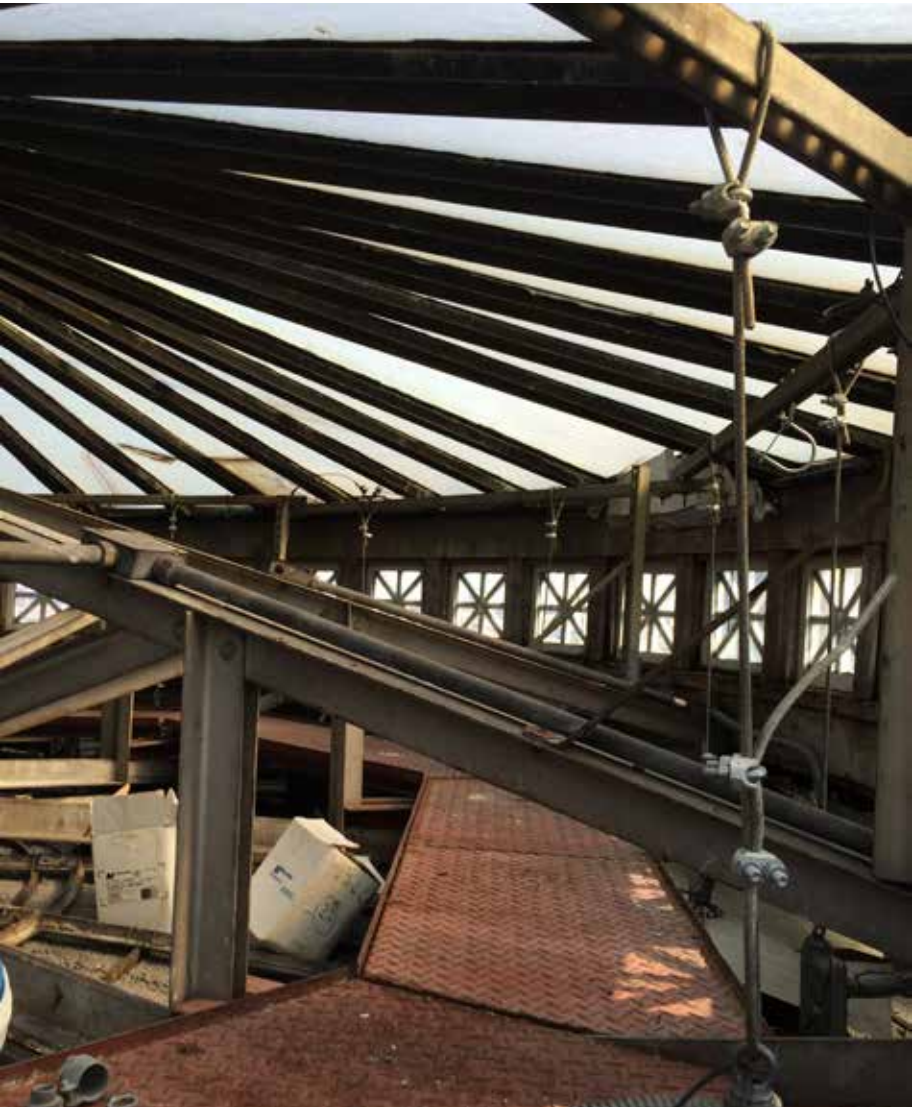
Project for the replacement of the cupola skylight awaits funding. New windows below the rafters would be operable to allow future smoke purge.

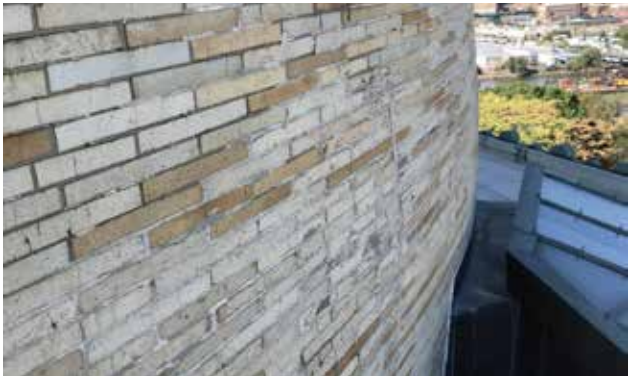
DS  GML Dome Drum	<b>Displacement</b> Units bulging out of plane. This movement is typically caused by long-term water infiltration that has weakened internal collar joints bonding outer and inner wythes of brick.	<b>Masonry Reconstruction</b> Remove entire wythe of face brick. Replace portion of interior wythe where deteriorated. Provide replica brick, mortar joints, collar joint and stainless steel reinforcement with ties. Replace 100% of drum brick for best performance and appearance.	Level 3

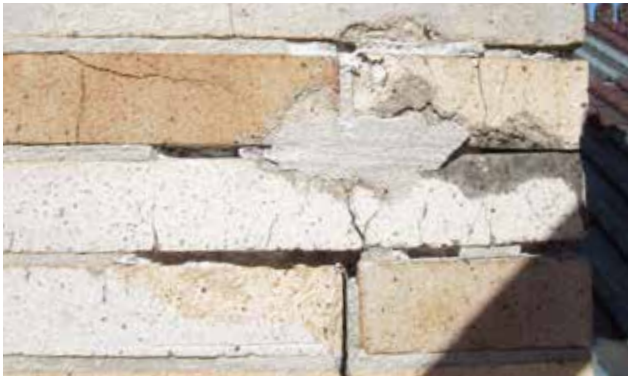
IR  GML Facades (Attic Level)	<b>Inappropriate Repair</b> Earlier patch of brick or cementitious material at probe or area of failure.	<b>Masonry Replacement</b> Remove temporary patch & provide brick to match original.	Level 4

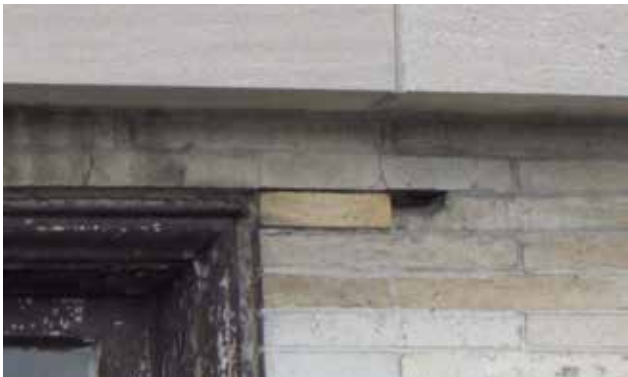
IS  GML Facades	<b>Incipient Spall</b> Detachment (but not loss) of unit fragments, often related to the infiltration of water beneath the surface, expansion of steel reinforcement or manufacturing defects.	<b>Masonry Replacement</b> Fully expose the bearing leg of the corroding lintel causing the spall. Prepare, prime, and waterproof the steel to prevent further reactions. Replace face brick in kind.	Level 3

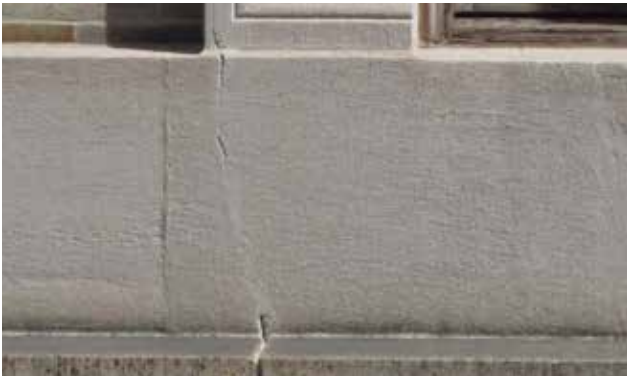
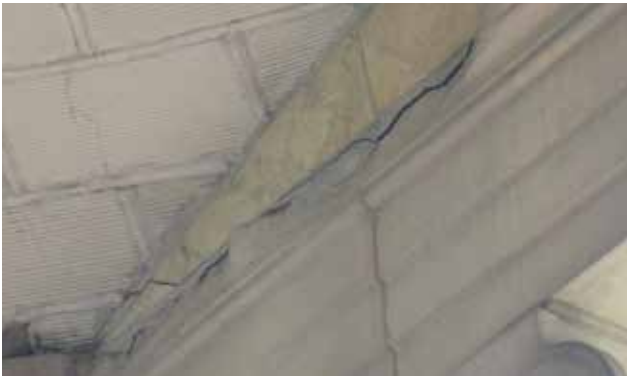
CJ  GML Limestone  HOF Limestone	<b>Crack through Unit and Joint</b> Cracks through multiple units are due to stresses within the wall system from differential movement stresses within the building envelope.	<b>Option 1: Singular Cracks</b> Provide limited repairs at crack and provide an appropriate fill to limit water infiltration.  <b>Option 2 Pervasive Cracking</b> Partially rebuild the cracked area with replacement stone to match existing.	GML & HOF Limestone Level 3

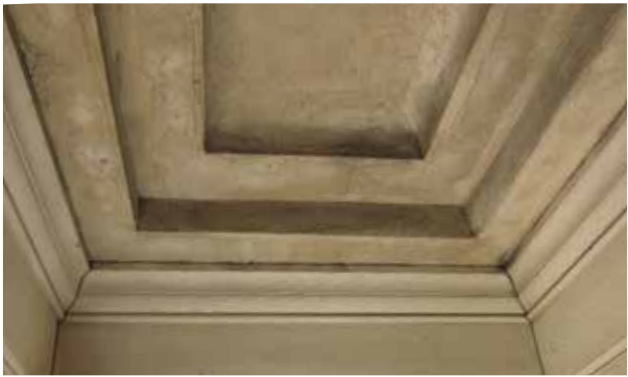
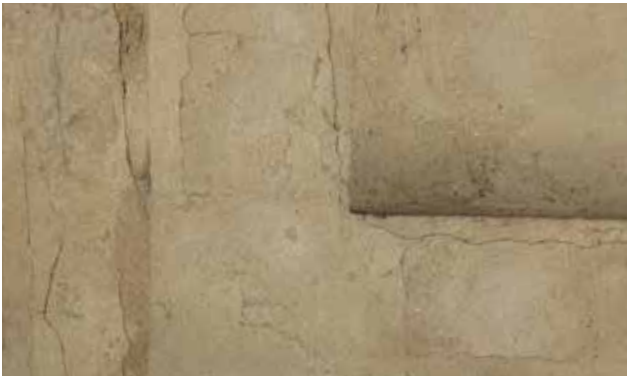
CN  GML Portico	<b>Cracking: Network</b> A pattern of intersecting fissures in stucco accelerated by water infiltration above. Loose material flakes may dislodge from the ceiling.	<b>Stucco Replacement</b> Remove stucco ceiling and lathe support. Repair or replace metal framing substructure. Fasten stainless steel metal lathe and finish with 3-coat stucco system to match original profile and color.	Level 2

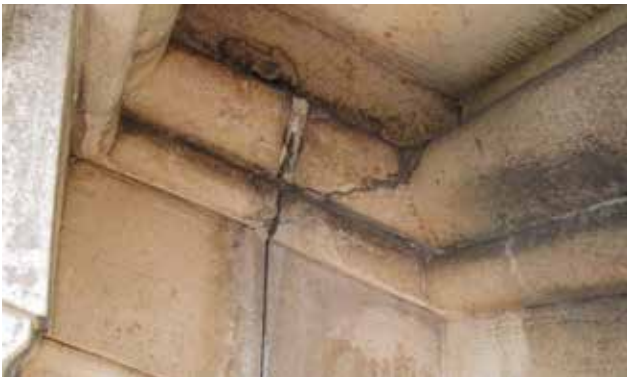
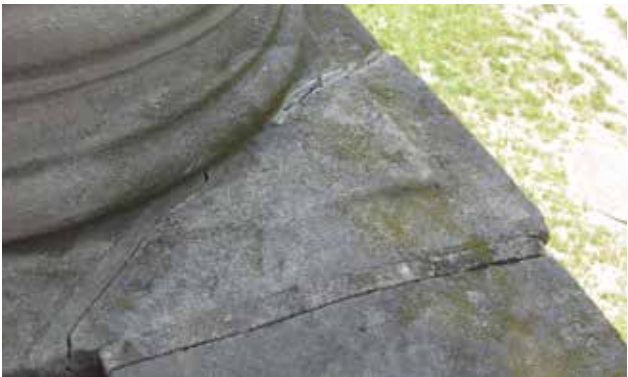
CR  GML Limestone  HOF Limestone	<b>Crack: Limestone</b> A fracture or fissure in the masonry of minimum 1/16” width that could indicate movement of adjacent parts.  Cracks open due to age, weathering, or differential stresses from movement within the building envelope. Opening of cracks within a single stone unit may indicate differential movement between sections of the building.	<b>Option 1: Short &amp; Obscured Cracks</b> Stabilize unit and provide fill or patch repair at crack.  <b>Option 2: Wide Cracks in Primary View</b> Provide stone Dutchman at crack location.	GML & HOF Limestone Level 3

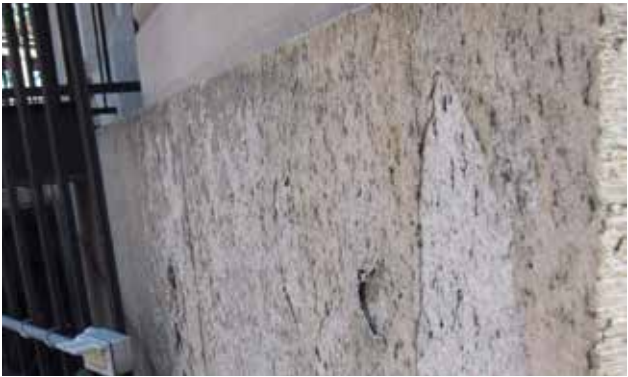
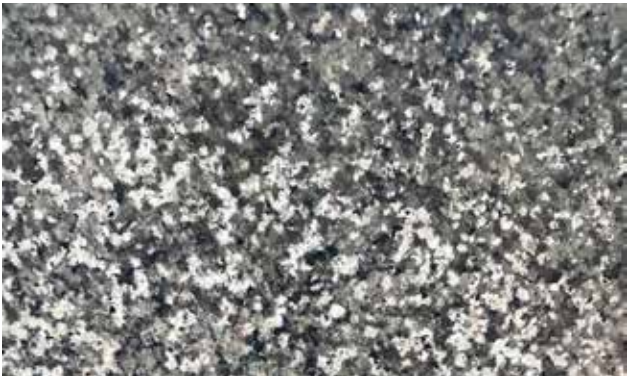
IC  GML Granite Plinth  HOF Granite Statue Pedestals	<b>Inappropriate Coating</b> Clear, non-breathable sealer on the plinth course has trapped moisture and resulted in surface spalls in some locations.	<b>GML: Chemical Cleaning</b> Remove with paint stripper. Apply chemical, dwell and pressure rinse.  <b>HOF: Chemical Cleaning &amp; Additional Testing:</b> Remove coating with paint stripper. Apply chemical, dwell and pressure rinse. Where coating is not fully removed, conservator to analyze with Fourier Transform Infrared (FTIR) Spectroscopy to confirm composition of the coating and test cleaning methods.	GML Granite Level 3  HOF Granite Level 3

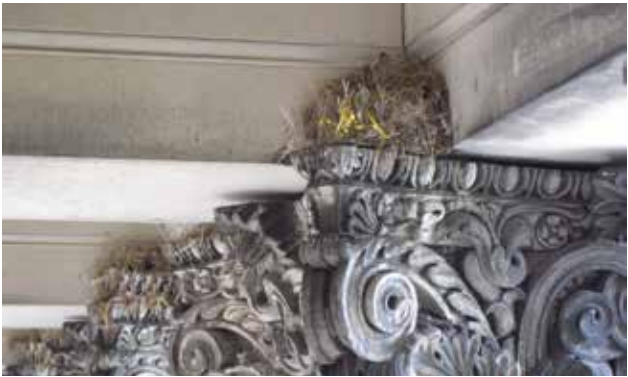
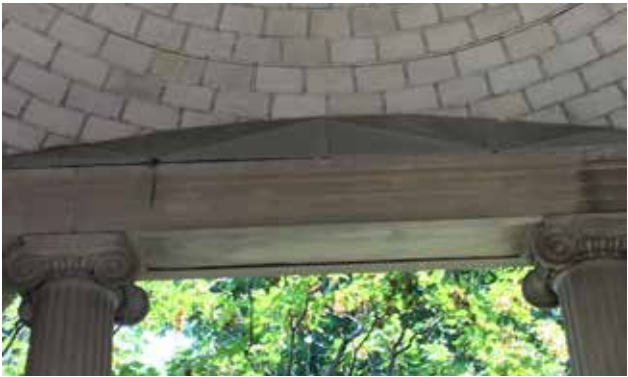
IE  GML Limestone  HOF Limestone	<b>Inappropriate Element</b> Objects attached to facades that are not in keeping with the historic character of the building including: <ul style="list-style-type: none"><li>• Bird Protection</li><li>• Bird Nest</li><li>• Metal cover</li></ul>	<b>Remove Element &amp; Add Protection</b> Carefully detach object or element, repair damage to base material.  Provide minimally-visible bird-proofing wire to prevent future roosting.	Level 4

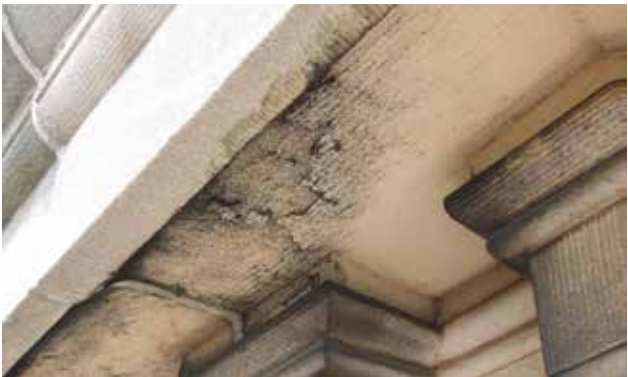
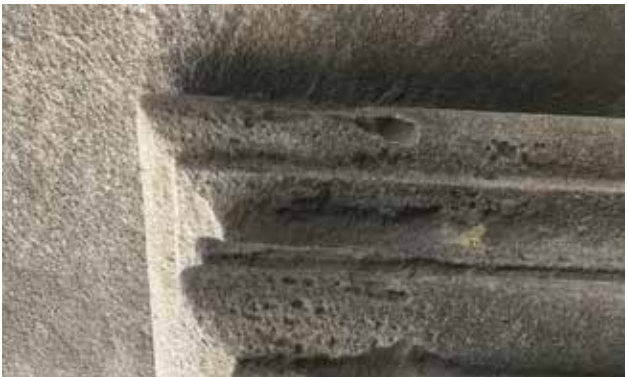
LS  GML Limestone  HOF Limestone	<b>Loss of Surface</b> The absence of masonry surface as evidenced by incompleteness of form, profile or decoration.	<b>Patch Repair</b> Provide composite patch repair in material to match aesthetic and physical characteristics of the existing stone.	GML & HOF Limestone Level 3

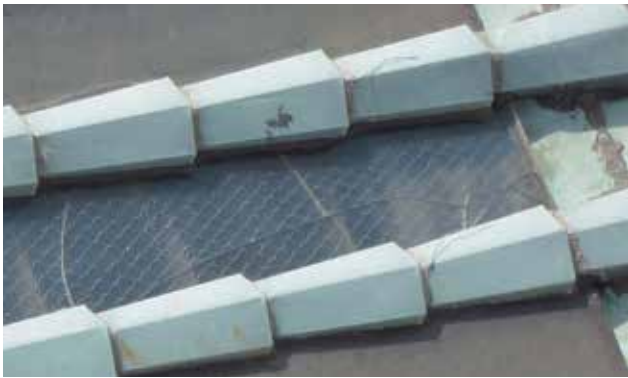
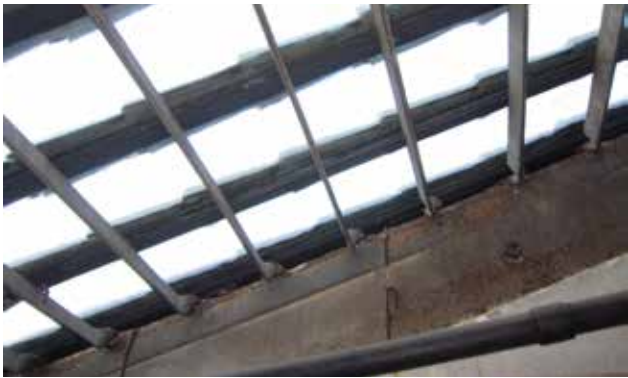
DU1 GML Gable Roof Skylights	<b>Deteriorated Unit</b> Original glazing cracked and steel framing corroded due to previous water infiltration.	<b>Replace Glazing Pane</b> <b>GML Skylights:</b> Carefully remove skylight muntins and framing to expose glass. Remove glass pane, repair, prime and paint steel framing. Provide glass matching historic original. Set in glazing, and replace framing.	GML Skylights Level 3

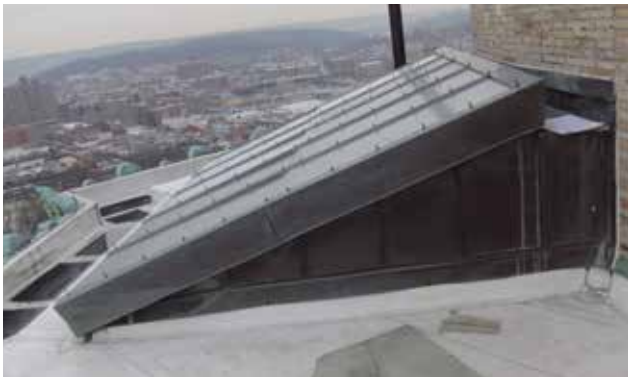
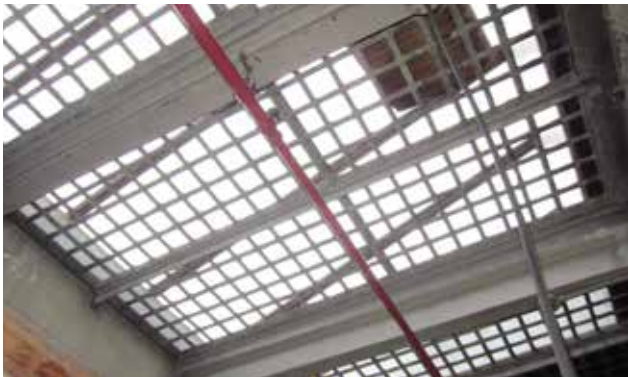
DU2 GML Drum Roof Skylights & Laylights	<b>Deteriorated Unit</b> Angled skylights replacement units are detrimental to GML. Skylights are not insulated, have deteriorated glazing and flashings, and alter the original appearance as they are visible from the ground.  Cast iron and glass vault laylights are sources of past leaks and have been damaged by water infiltration and installation of previous roof coverings.	<b>Replace Skylight</b> Fully remove angled skylights and provide flat (1/2" per foot pitch) insulated units in the same footprints.  <b>Restore Laylight</b> Salvage unit to be repaired offsite by conservation studio. Replace all glass lites in kind, restore cast iron frame, clean glass and metal, reset in original location. Include allowance for upgrade for back-lighting with LED fixtures.	GML Skylights & Laylights Level 4

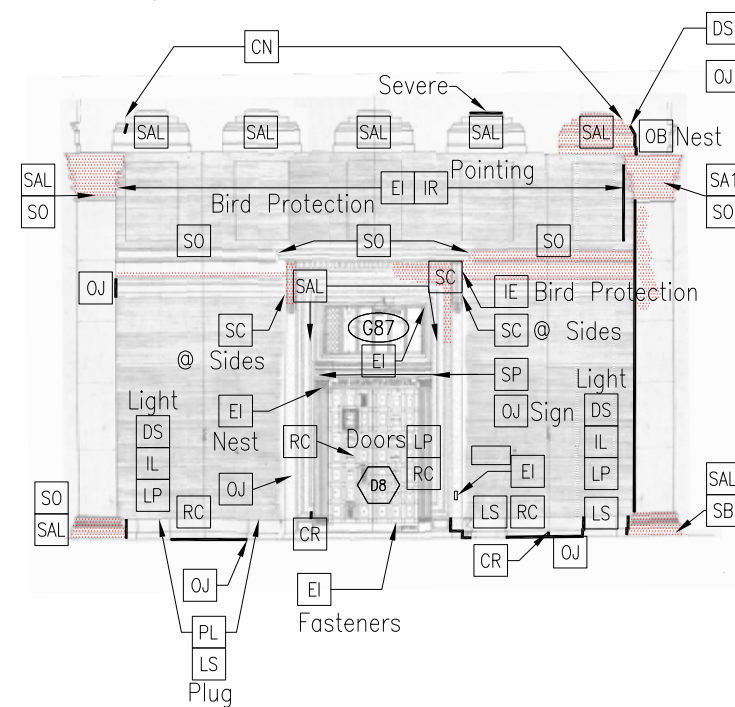
- Severe staining below modillions
- Open joints @ cornice units
- Water staining below open joints
- Staining @ capitals

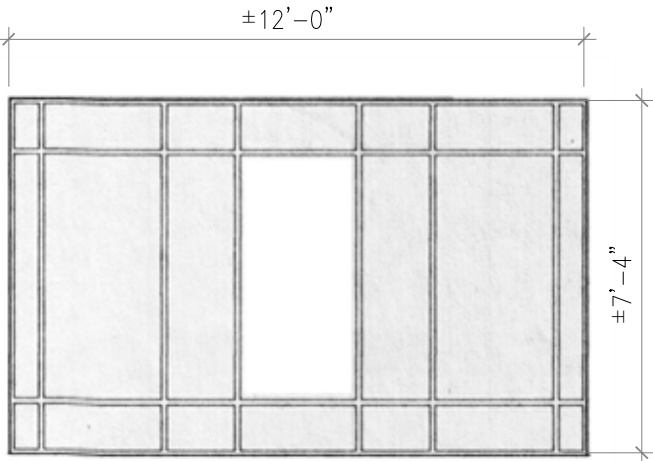
Facades at N, S, W  
Divided light windows generally exist in good condition.  
As a character-defining element windows may be repaired except 3 severely deteriorated units at the south facade.

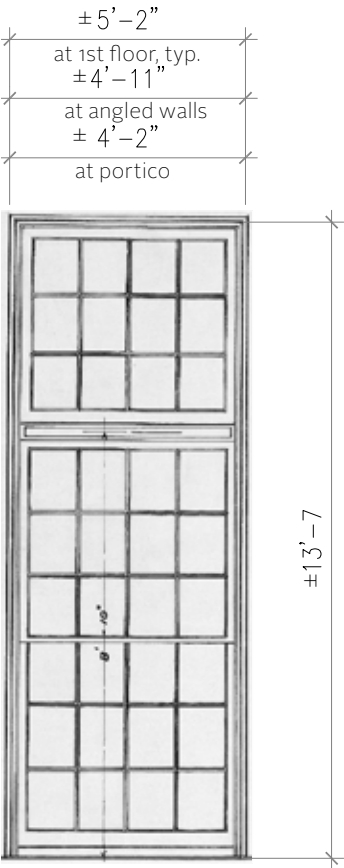
E  
fixed

Non-original unit;  
Replacement included in egress stair project scope

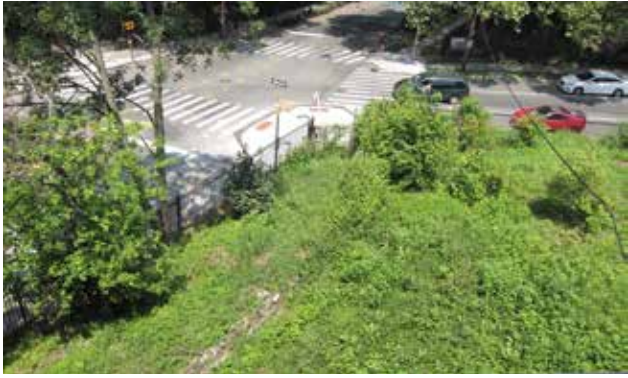
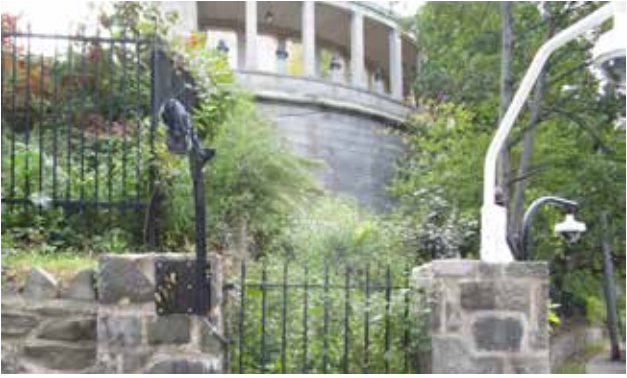
LA5	<p><b>Southwest Pedestrian Walk Access</b></p> <p>The historic steps and walk from the White complex to the corner of Sedgwick Drive and University Terrace is deteriorated, unmaintained and out of service.</p>	<p><b>Removal</b></p> <p>The pedestrian connection at this location is no longer viable. The failed steps and walk should be removed.</p>	Level 5

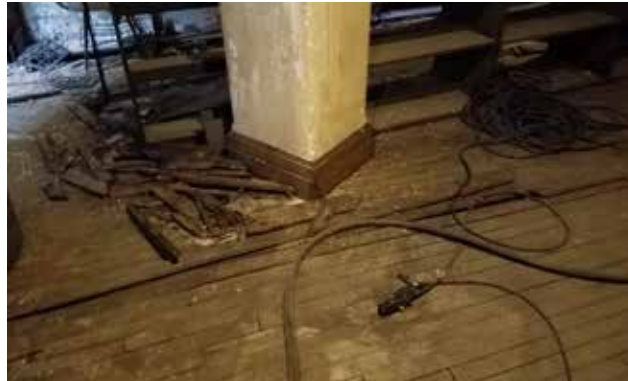
<b>F2-SD</b>  Wood Floor System	<b>Scratches / Dents</b> <ul style="list-style-type: none"><li>Damage to material caused by mechanical components or equipment</li></ul>	<b>Material Repair or Replacement</b> <ul style="list-style-type: none"><li>Patch areas of missing or damaged material, if feasible; remove and replace material, as required.</li></ul>	Level 3

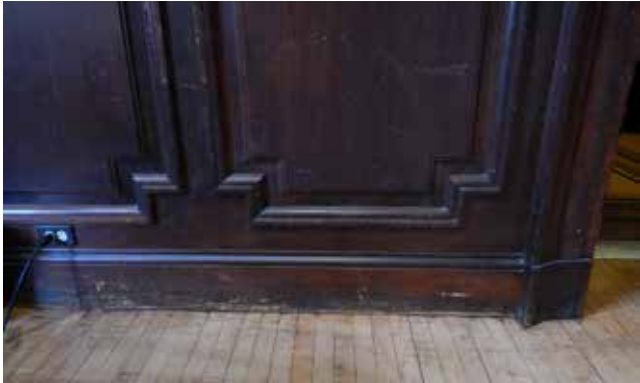
<b>W6-SB</b>  Wood Panel Wall System	<b>Biological Growth</b> <ul style="list-style-type: none"><li>Surface growth having biological origins, typically found in damp locations.</li></ul>	<b>Develop Cleaning Program</b> <ul style="list-style-type: none"><li>Clean, identify source of water infiltration and remedy cause. If severe, replace deteriorated material.</li></ul>	Level 3

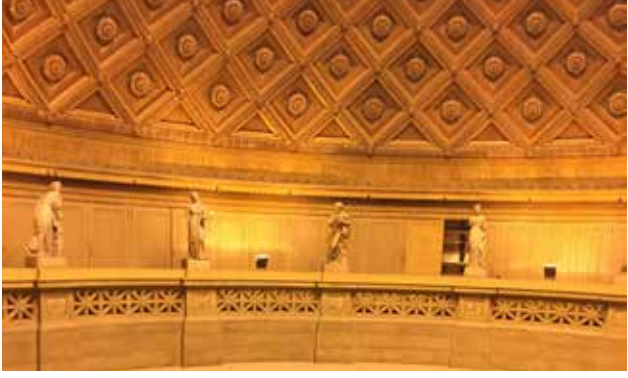
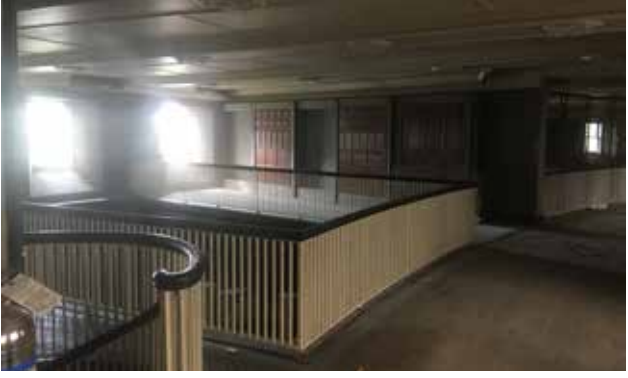
Air Conditioning	<b>Thermal Comfort</b> Much of the building does not have air conditioning, including GML Rotunda & stacks, & HOF rooms.	<b>Provide Cooling</b> Design units and distribution system to suit existing spaces & minimize the effect on the historic fabric.	Level 5

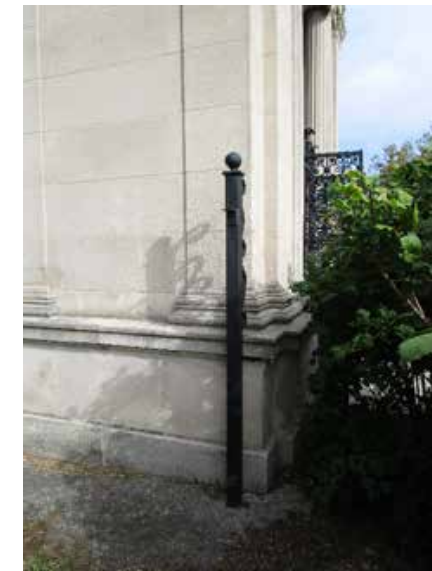
- LE6 The pair of three-inch square metal post between the Hall of Philosophy and HOF are not functioning.

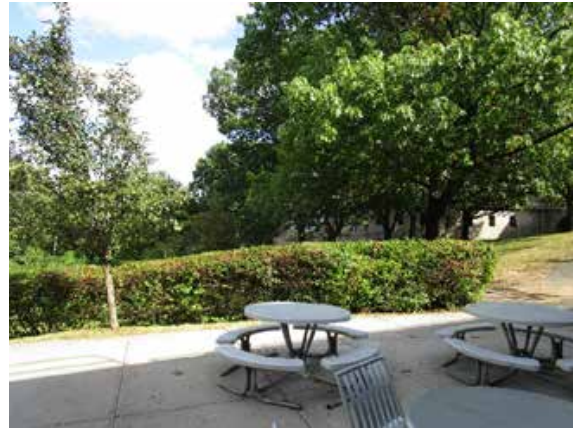
- LP3 Privet hedge is overgrown and impedes pedestrian passage on the adjacent walk. Hedge forms a physical and visual barrier separating the Colston Hall and Community Hall space from the adjacent west lawn of GML & HOF.
