# Conditions Assessment

## Gould Memorial Library & Hall of Fame

FINAL REPORT | 15 MARCH 2018

**BRONX**  
**COMMUNITY**  
COLLEGE

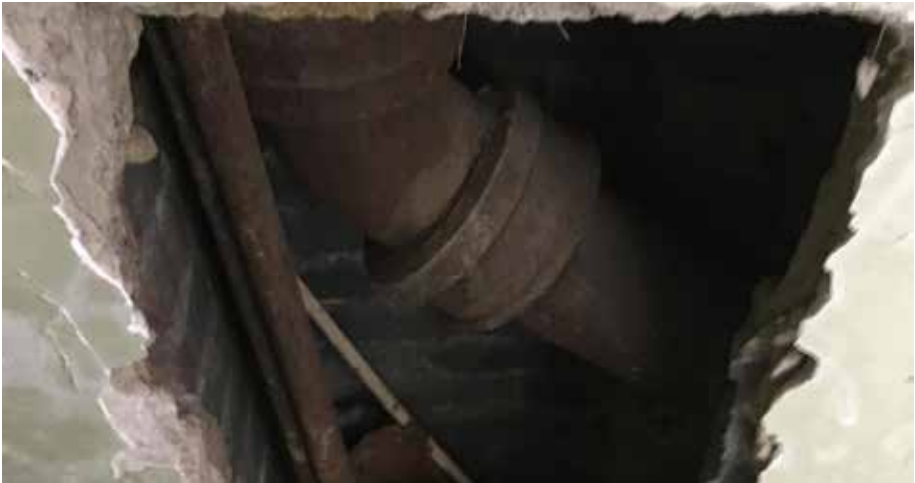
Existing stormwater drain exposed in Attic Level.

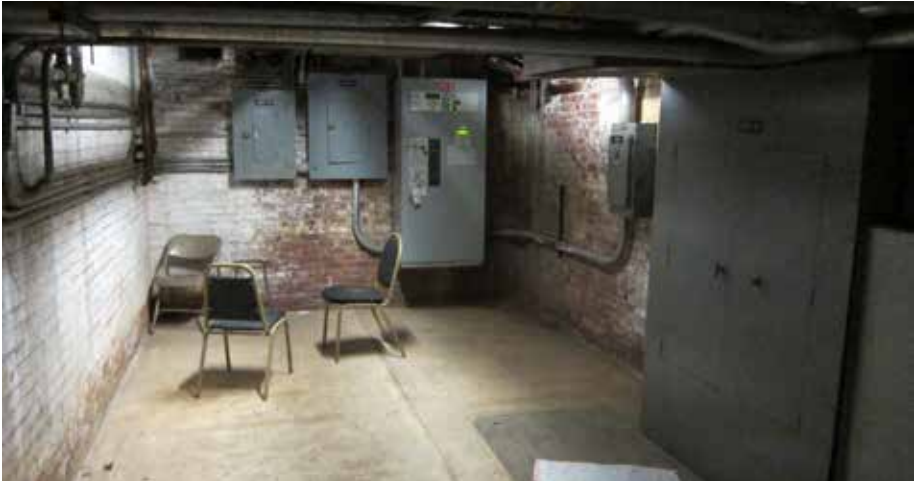
Emergency Lighting Panel, Emergency Power Panel & Automatic Transfer Switch in Basement.

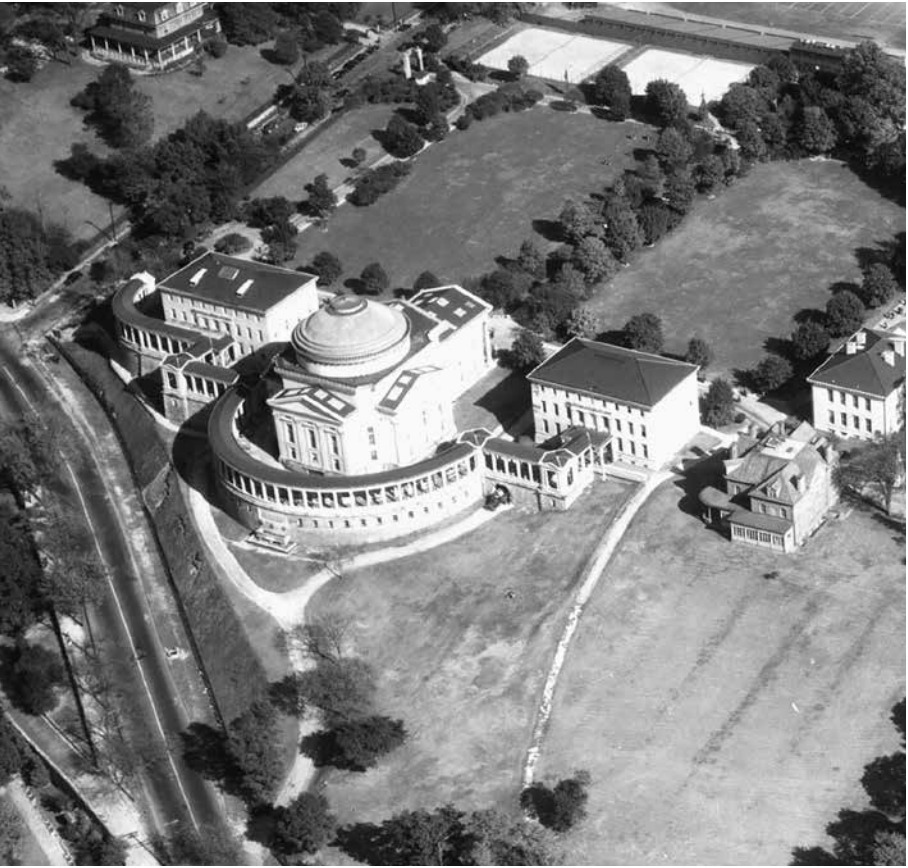
Landscape with low vegetation, open views and access to the western HOF terrace in 1937.

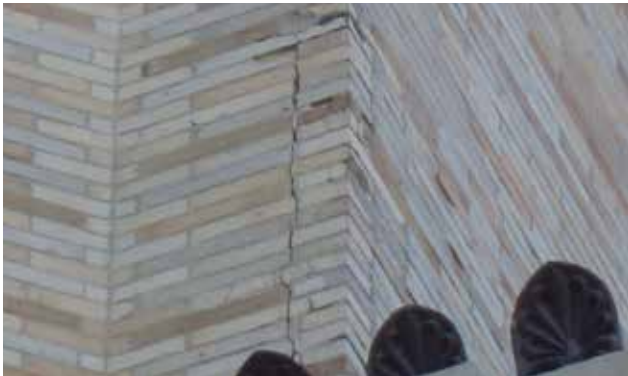
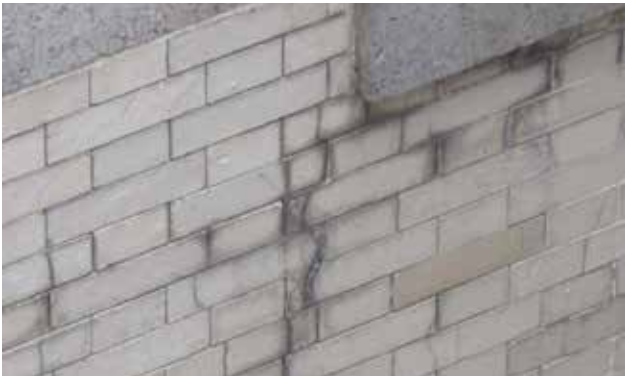
COMPONENT	CONDITION	TREATMENT	PRIORITY	REPRESENTATIVE PHOTO	
CJ  GML Facades  GML Areaways	<b>Crack through Unit and Joint</b> Cracks through multiple units are due to stresses within the wall system from differential movement in the building envelope, or differing expansion and contraction rates between the mortar and the brick. This is sometimes an indication that the mortar is too hard for the substrate.	<b>Option 1:</b> GML Dome Drum - Rebuild the cracked area with replacement brick to match existing and provide expansion joints in reconstructed masonry.  <b>Option 2:</b> GML Areaways - Rebuild the cracked area with replacement brick to match existing.	Facades Level 2  Areaways Level 3

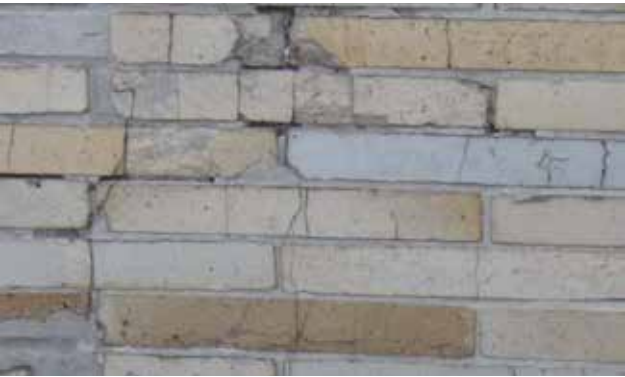
DS  GML Dome Drum	<b>Displacement</b> Units bulging out of plane. This movement is typically caused by long-term water infiltration that has weakened internal collar joints bonding outer and inner wythes of brick.	<b>Masonry Reconstruction</b> Remove entire wythe of face brick. Replace portion of interior wythe where deteriorated. Provide replica brick, mortar joints, collar joint and stainless steel reinforcement with ties. Replace 100% of drum brick for best performance and appearance.	Level 3

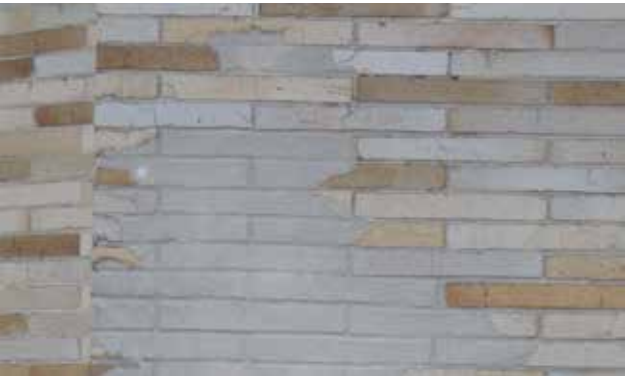
IR  GML Facades (Attic Level)	<b>Inappropriate Repair</b> Earlier patch of brick or cementitious material at probe or area of failure.	<b>Masonry Replacement</b> Remove temporary patch & provide brick to match original.	Level 4

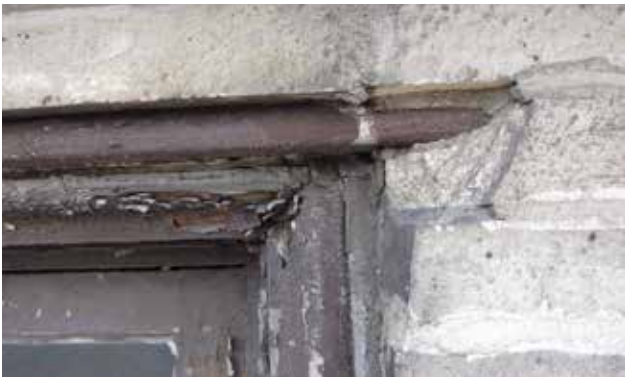
IS  GML Facades	<b>Incipient Spall</b> Detachment (but not loss) of unit fragments, often related to the infiltration of water beneath the surface, expansion of steel reinforcement or manufacturing defects.	<b>Masonry Replacement</b> Fully expose the bearing leg of the corroding lintel causing the spall. Prepare, prime, and waterproof the steel to prevent further reactions. Replace face brick in kind.	Level 3

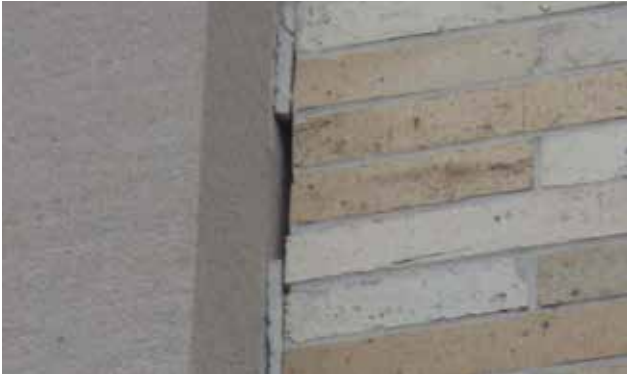
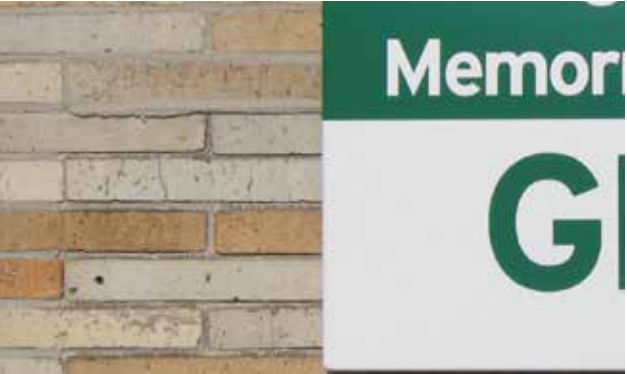
COMPONENT	CONDITION	TREATMENT	PRIORITY	REPRESENTATIVE PHOTO	
<div>OJ</div> <div>GML Facades</div>	<p><b>Open Joint</b> Complete or partial loss of pointing mortar. This provides access for moisture migration into the masonry substrate and may also result in potential structural instability.</p> <p>Joints open due to age, weathering, or differential stresses from movement within the building envelope. The mortar can be further damaged with salts and moisture migration.</p>	<p><b>Cut and Point</b> Rake out and repoint joints 100%. Rake out and repoint open and damaged joints to limit water infiltration into the exterior masonry walls. Mortar must be an appropriate mix to match the physical and aesthetic characteristics of the original mortar and building materials. Brick and mortar analysis should be conducted to determine compressive strength of the brick and chemical composition of the mortar.</p>	Facades Level 3

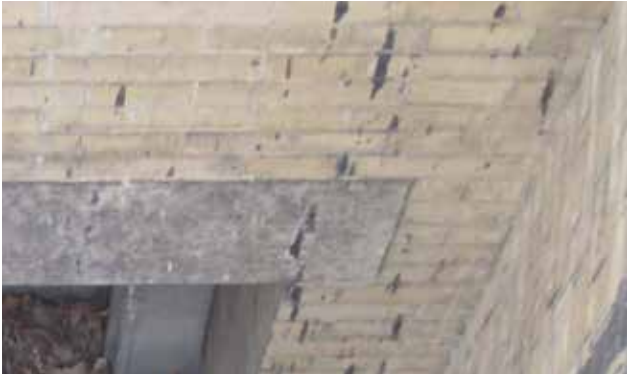
<div>RC</div> <div>GML Areaways</div>	<p><b>Residual Coating</b> Paint coating or splatters on brick walls.</p>	<p><b>Chemical Cleaning</b> Apply paint stripper, dwell and pressure rinse.</p>	Level 4

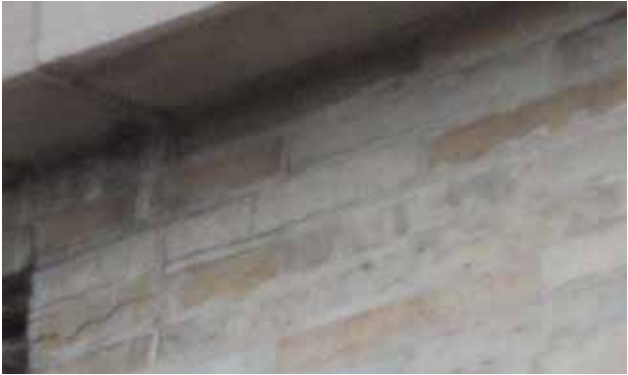
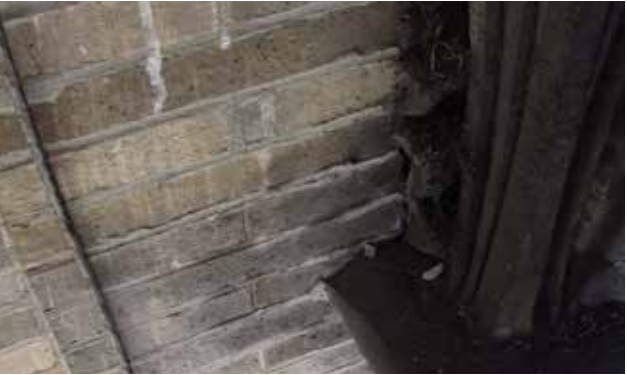
<div>SA</div> <div>GML Facades</div>	<p><b>Soiling: Atmospheric</b> Buildup of atmospheric pollutants over time, generally in areas not washed (in the shadow of precipitation).</p>	<p><b>Pressure Washing</b> Clean with fresh water and power sprayer.</p>	Level 4

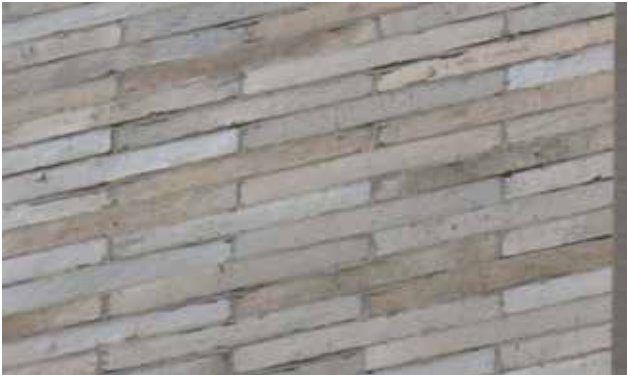
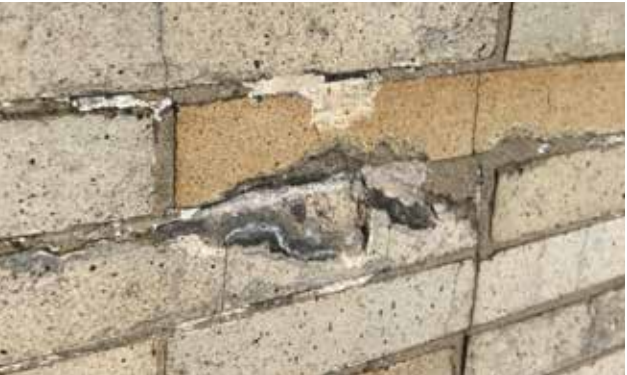
<div>SP</div> <div>GML Facades</div>	<p><b>Surface Spall</b> Fragment or chip in the material may result from impact damage and/or material weakness. Moisture and salts penetrate the material due to the weathering process and can deteriorate the stone. Susceptibility of stone to weathering ranges with different quality of brick.</p>	<p><b>Option 1:</b> GML Facades: Monitor areas of minor loss for performance and retain in place unless condition worsens.</p> <p><b>Option 2:</b> GML Facades: Patch minor spall locations with restoration mortar custom-matched to brick color.</p> <p><b>Option 3: Dome Drum:</b> Replace spalled brick with new to match existing.</p>	Facades Level 4  Dome Drum Level 2

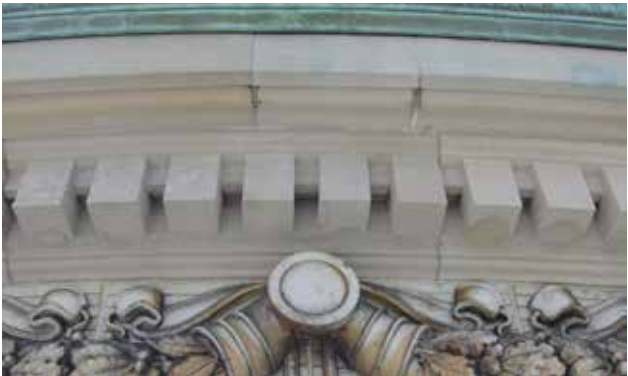
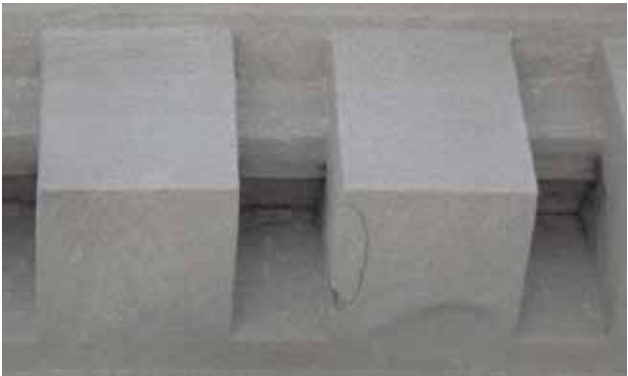
COMPONENT	CONDITION	TREATMENT	PRIORITY	REPRESENTATIVE PHOTO	
CH  GML Limestone  HOF Limestone	<b>Crack: Hairline</b> A minor fracture or fissure in the masonry of 1/16” or less in width and length that could indicate movement of adjacent parts.	<b>Crack Repair</b> Provide patch with restoration mortar in a custom-matched color, with the process including: <ul style="list-style-type: none"><li>• Cut out crack</li><li>• Drill &amp; inject repair epoxy</li><li>• Applying patching material to match finish stone</li></ul>	GML & HOF Limestone Level 3

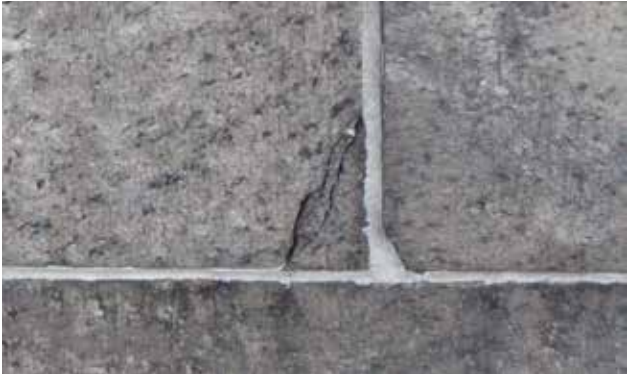
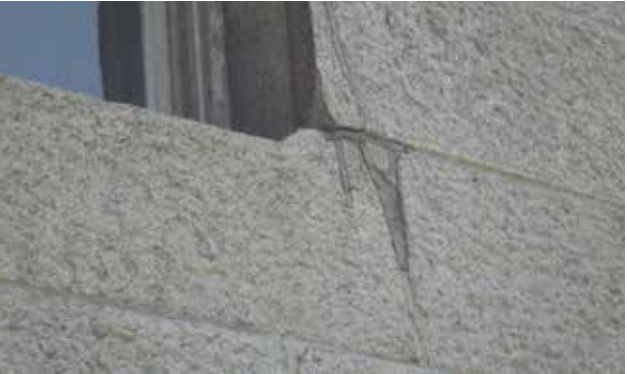
COMPONENT	CONDITION	TREATMENT	PRIORITY	REPRESENTATIVE PHOTO	
CR  GML Granite  HOF Granite	<b>Crack: Granite</b> A fracture or fissure in the masonry of minimum 1/16" width that could indicate movement of adjacent parts.  Cracks open due to age, weathering, or differential stresses from movement within the building envelope. Opening of cracks within the single stone unit may indicate differential movement between sections of the building.	<b>Option 1: Small Cracks &amp; Obscured Locations:</b> Stabilize unit and provide fill or patch repair at crack.  <b>Option 2: Large Cracks</b> Provide stone Dutchman at crack location.	GML Granite Level 4  HOF Granite Level 4

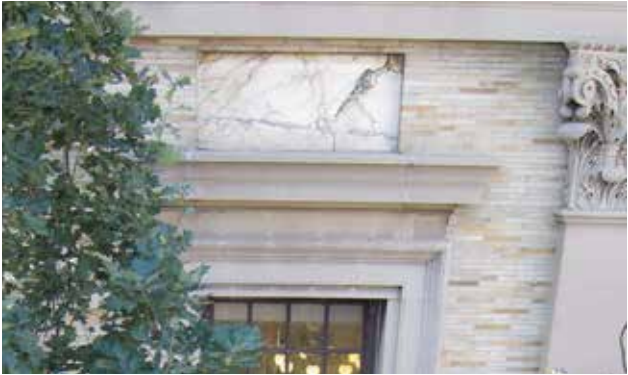
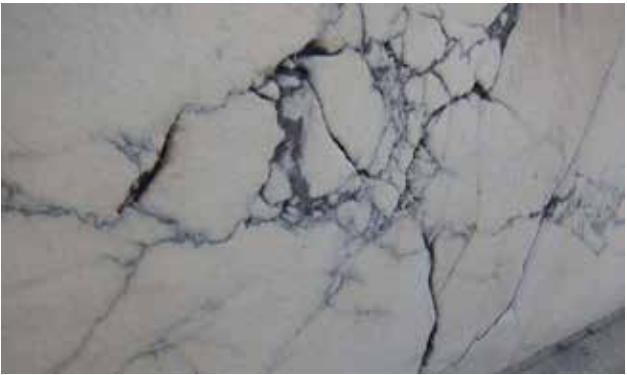
DI  GML Marble	<b>Disaggregation</b> Loss of surface material in powder or granular form, by deterioration and erosion of the binding material, caused by rain with acidic pollutants.	<b>Consolidation with Multi-step Coating</b> Clean with water spray, scrub with brush, dry. Apply chemical treatment 3 coats, rinse & cure. Apply sealer 6 coats.	Level 3

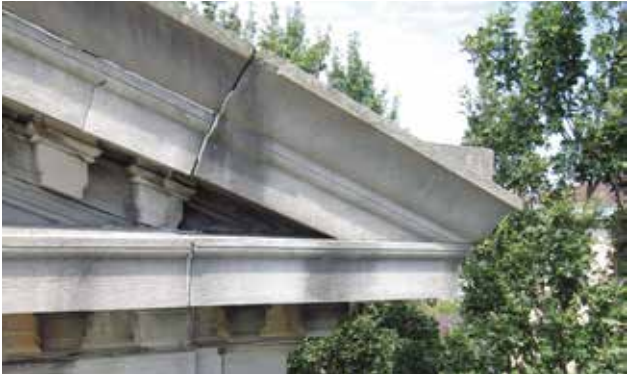
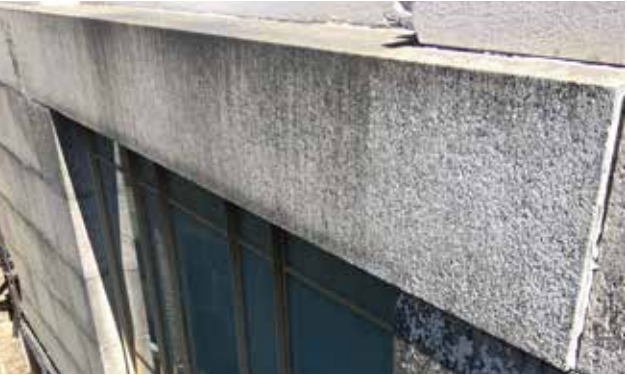
DS  GML Limestone  GML Granite	<b>Displaced Unit</b> Movement over time out of normal plane, typically caused by prolonged cycles of freeze-thaw jacking.	<b>Structural Remediation: Pediment</b> Monitor movement throughout the year. Structural engineer to review data and determine if movement will continue. Corrective action includes shoring, resetting stones, pinning in place, and restoring original joints and cracked stones.  <b>Structural Remediation: Plinth</b> Removal, structure repair, and resetting of stone in scope of egress stair project.	GML Limestone Level 2  GML Granite Level 2

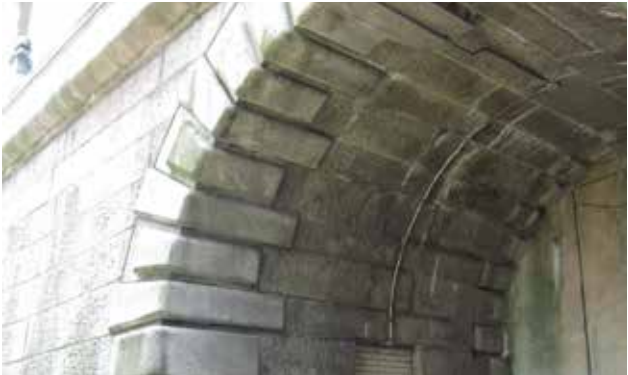
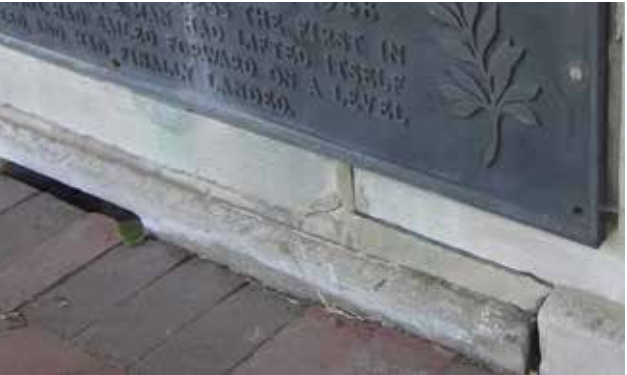
EF  HOF Granite  GML & HOF Limestone	<b>Gypsum Crusts &amp; Efflorescence</b> The formation of surface deposits, often white in color, crystalline in form, powdery to the touch, and composed of soluble salts, originating from substances applied to the material or from constituents within or behind the material itself, or from external, environmental sources.	<b>Gypsum Crusts: Tooling</b> Employ masonry chisels and hammers to physically remove large crystal formations.  <b>Efflorescence: Clean with Poultice</b> Mix poultice, trowel apply, cover for dwell, fully dry, remove with a scrub-rinse. Repeat on persistent stains.	HOF Limestone Level 3  HOF Granite Level 4

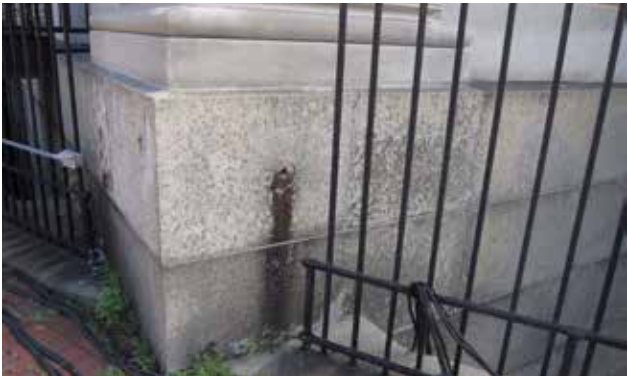
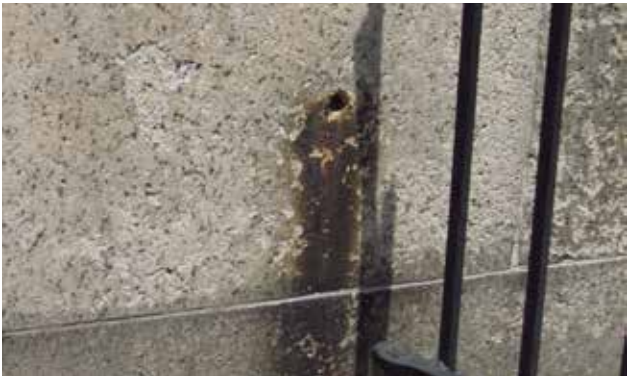
COMPONENT	CONDITION	TREATMENT	PRIORITY	REPRESENTATIVE PHOTO	
HL  GML Granite  HOF Granite	<b>Hole in Unit</b> Missing original material resulting from previously drilled anchor or support.	<b>Patch Repair</b> Provide composite patch repair in material to match aesthetic and physical characteristics of the existing stone.	GML & HOF Granite Level 4

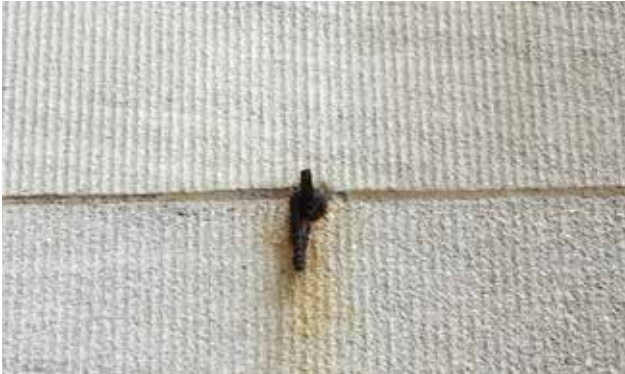
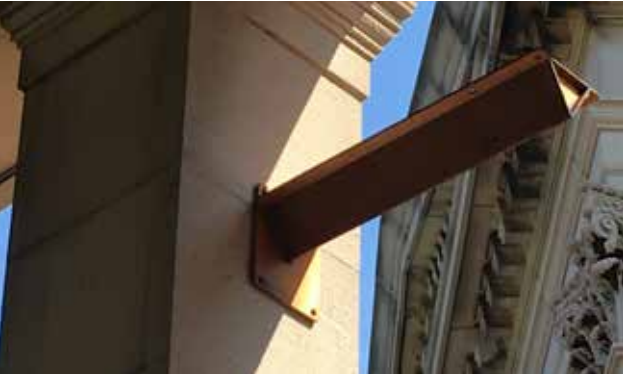
COMPONENT	CONDITION	TREATMENT	PRIORITY	REPRESENTATIVE PHOTO	
OB  GML Limestone  HOF Limestone	<b>Foreign Object</b> Elements that penetrate the facades for an earlier functional purpose are unsightly, deteriorating, and may cause long term damage to the substrate, such as anchors and braces.	<b>Mechanically Remove &amp; Patch</b> Provide composite patch repair in material to match aesthetic and physical characteristics of the existing stone.	GML & HOF Limestone Level 3

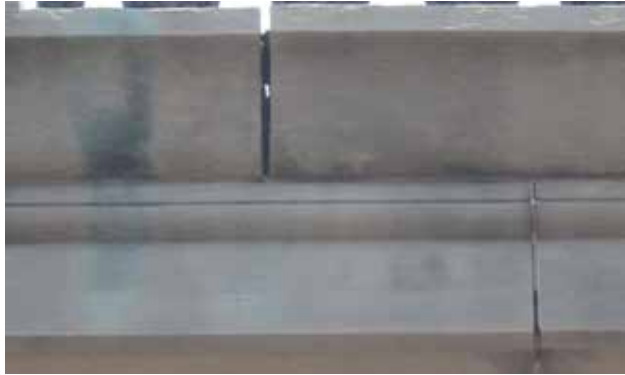
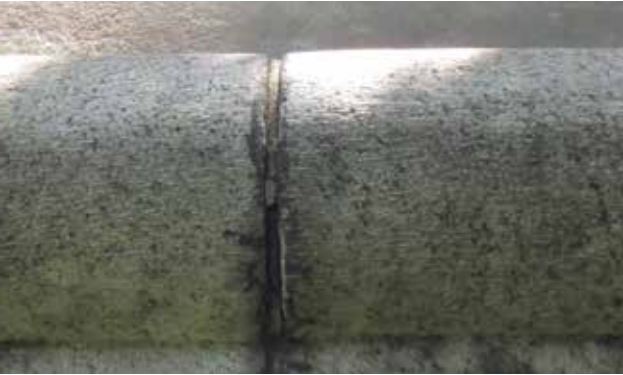
OJ  GML Granite & Limestone  HOF Granite & Limestone	<b>Open Joint</b> Complete or partial loss of pointing mortar. This provides access for moisture migration into the masonry substrate and may also result in potential structural instability.  Joints open due to age, weathering, or differential stresses from movement within the building envelope. The mortar can be further damaged with salts and moisture migration.	<b>Cut and Point</b> Rake out and repoint open and damaged joints to limit water infiltration into the exterior masonry walls. Restoration mortar must be an appropriate mix to match the physical and aesthetic characteristics of the original mortar and building materials. Mortar analysis should be conducted to determine the color and chemical composition of the mortar.	GML Granite & Limestone Level 3  HOF Granite & Limestone Level 3

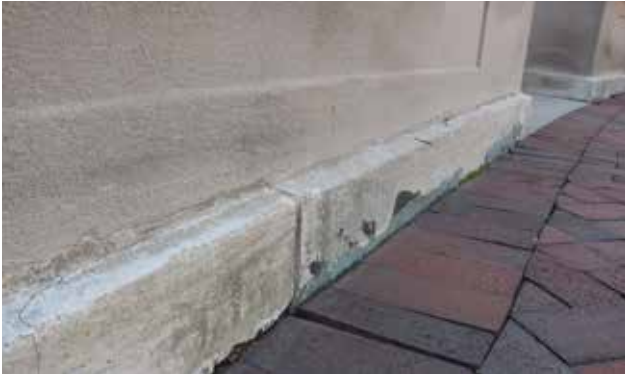
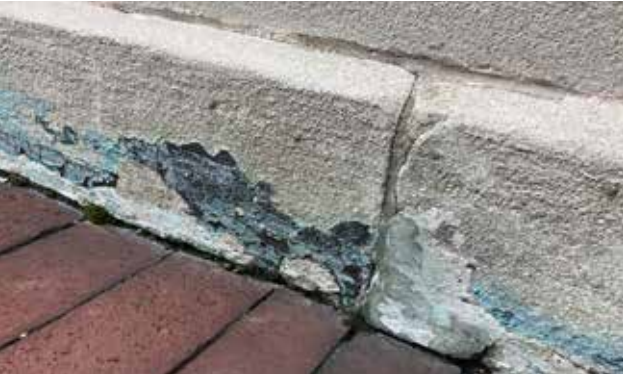
RC  GML Granite  HOF Limestone	<b>Residual Coating</b> Old paint or tar remnants remaining on the stone.	<b>Paint Stripper &amp; Chemical Cleaner</b> Remove coating with paint stripper. Apply chemical cleaner, dwell, scrub & rinse.	Level 3  GML Granite Level 4  HOF Limestone Level 4

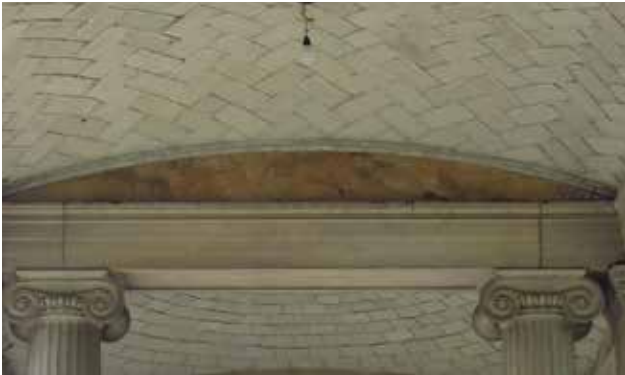
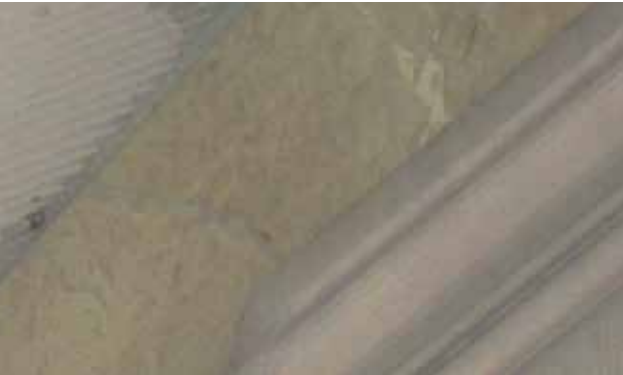
SAM  HOF Marble	<b>Soiling: Atmospheric - Marble</b> Buildup of atmospheric pollutants over time, generally in areas not washed (in the shadow of precipitation).	<b>Water Scrub</b> Gently scrub and rinse, without pressure washer.	Level 4

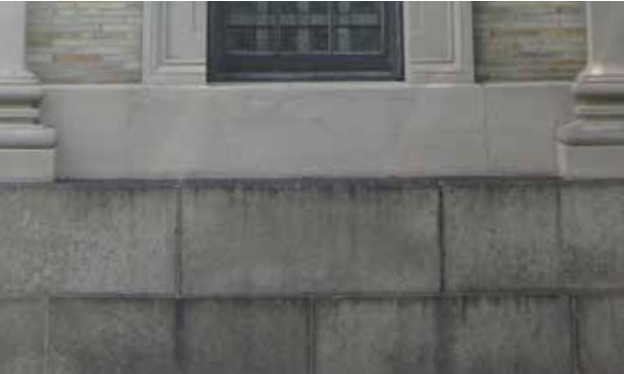
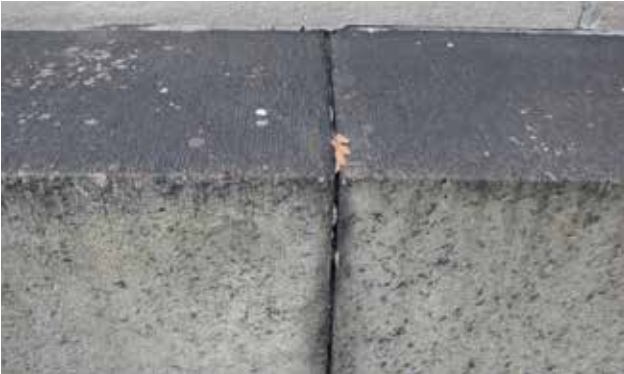
COMPONENT	CONDITION	TREATMENT	PRIORITY	REPRESENTATIVE PHOTO	
SA1  GML Granite	<b>Soiling: Atmospheric &amp; Coating</b> Clear, non-breathable sealer with atmospheric pollutants trapped beneath.	<b>Chemical Cleaning &amp; Blasting</b> Remove sealer with paint stripper. Treat stains with low pressure microabrasive cleaning.	Level 3

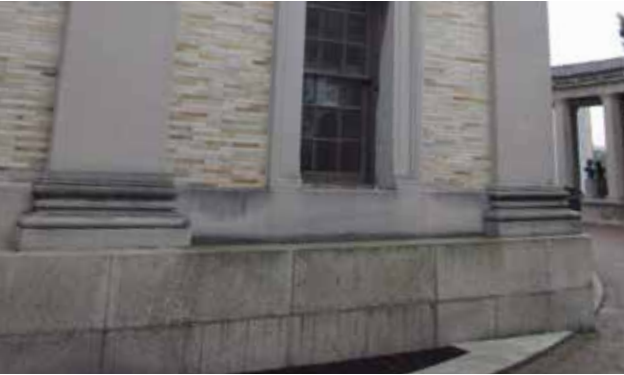
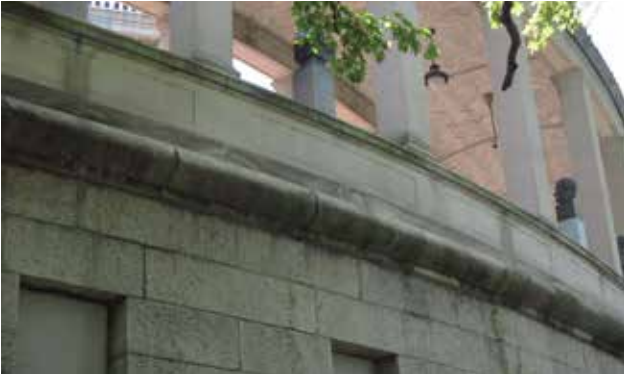
SAG  GML Granite HOF Granite	<b>Soiling: Atmospheric - Granite</b> Buildup of atmospheric pollutants over time, generally in areas not washed (in the shadow of precipitation).	<b>Wash-away Cleaner</b> Spray apply chemical, dwell, rinse with pressure washer.	GML & HOF Granite  Level 3

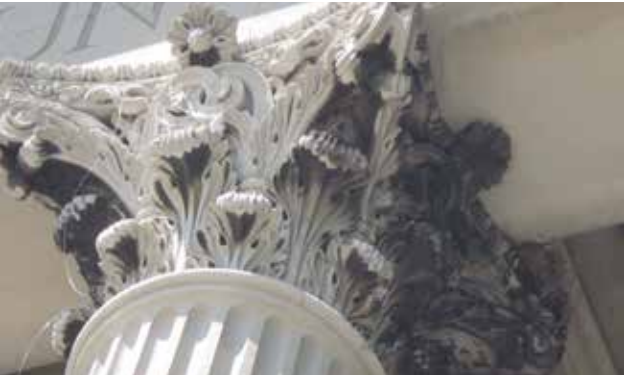
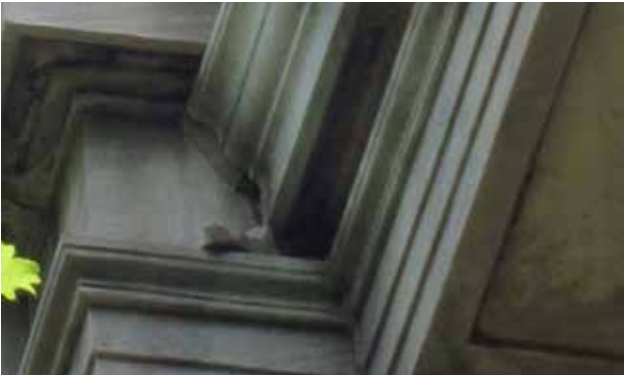
SAL  GML Limestone HOF Limestone	<b>Soiling: Atmospheric - Limestone</b> Long-term deterioration is caused by acidic precipitation that dissolves the stone. Surfaces that are not readily washed by rain build up black gypsum crusts from trapped pollutant particles. Crusts that peel off reveal crumbling stone beneath.	<b>Microabrasive</b> Carefully blast with low-pressure abrasive.	GML & HOF Limestone  Level 3

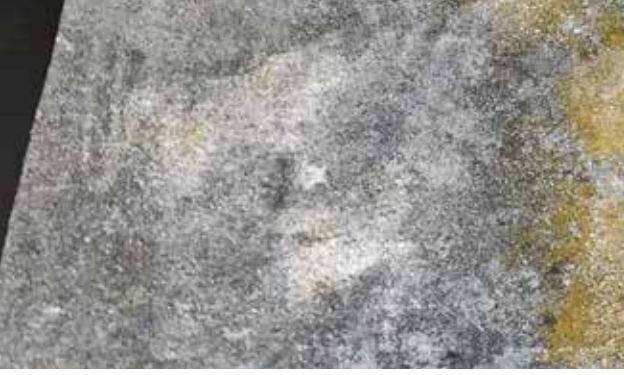
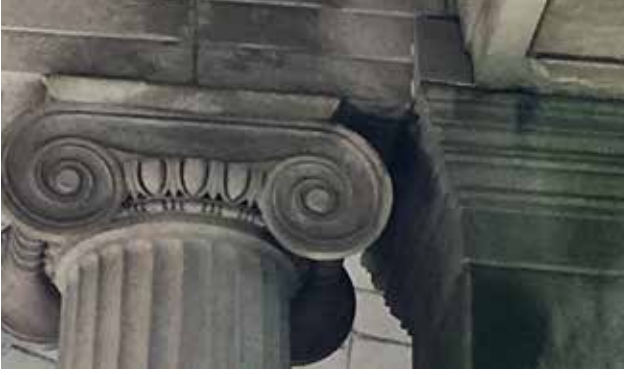
SB  GML Granite GML Limestone  HOF Granite HOF Limestone	<b>Staining: Biological - Green &amp; Grey</b> Surface growth or coloration indicative of biological colonization. May be of varying thicknesses, colors (generally green, grey, or black), and biological origin (micro-flora such as fungi, lichen, algae, bacteria). Biogrowth is typically found in damp locations, shady elevations, or in the presence of water.	<b>Wash-away Cleaner</b> Spray apply chemical, dwell, rinse with pressure washer.	GML & HOF Granite & Limestone  Level 3

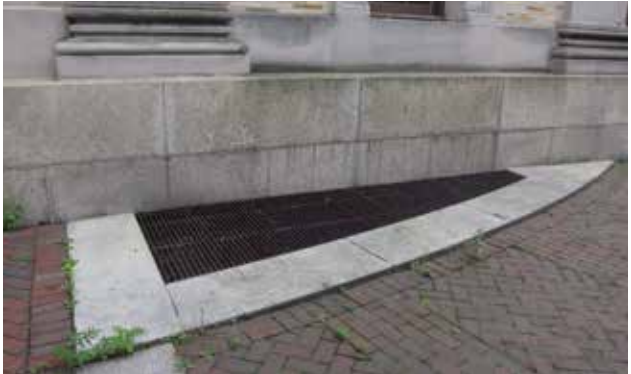
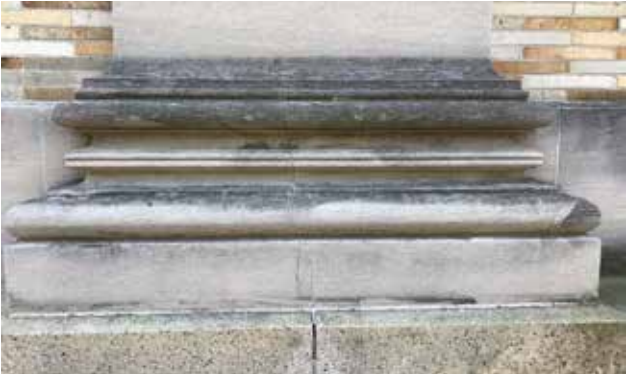
COMPONENT	CONDITION	TREATMENT	PRIORITY	REPRESENTATIVE PHOTO	
SB1  GML Limestone North Facade	<b>Staining: Biological - Black</b> Biological colonization that is more tenacious than the typical growth.	<b>Chemical Cleaning with Dwell</b> Mix cleaner, brush apply, dwell, scrub, rinse, apply afterwash, & rinse with pressure wash.	Level 3

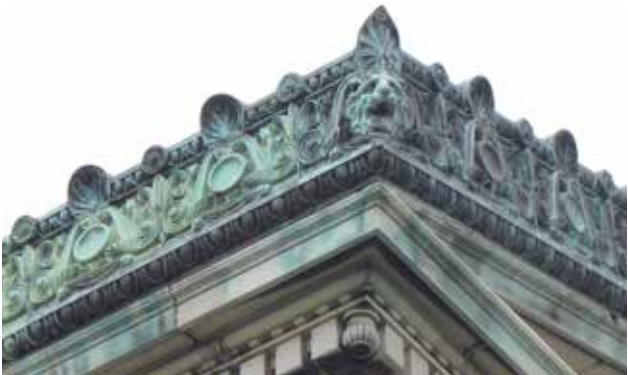
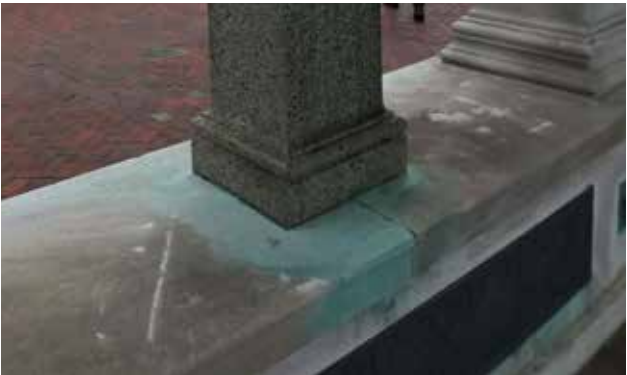
SC  GML Limestone  HOF Limestone	<b>Staining: Copper</b> Discoloration caused copper ions in water run-off from a copper-containing element. Stains pervade deep into the stone but are not cause of long-term deterioration.	<b>Cleaning with Poultice</b> Mix poultice, trowel apply, cover for dwell, fully dry, remove with a scrub-rinse. Repeat on persistent stains.  Maintenance program is required for copper & bronze or stains will re-emerge.	GML Limestone Level 4  HOF Limestone Level 4

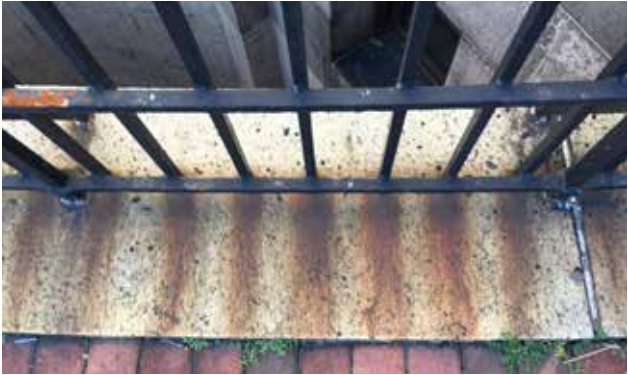
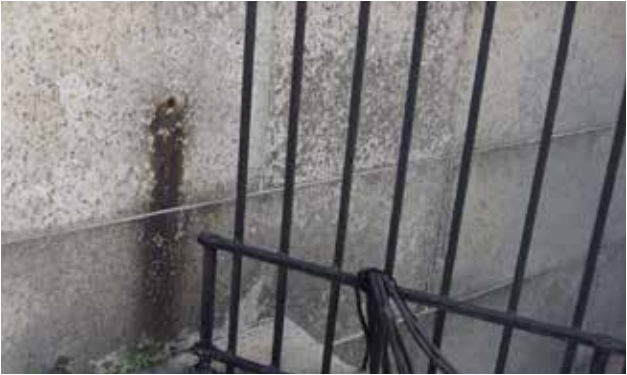
SF  GML Granite	<b>Staining: Ferrous</b> Discoloration caused by water running off of a corroding ferrous element. If left untreated, increasing oxidation of embedded ferrous elements may result in rust jacking and damage to adjacent masonry.	<b>Multi-step Chemical Cleaning</b> Remove sealer with paint stripper. Apply chemical cleaner, dwell, scrub & rinse.	Level 4

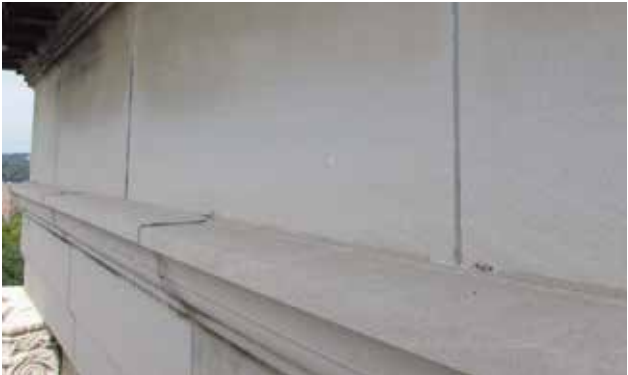
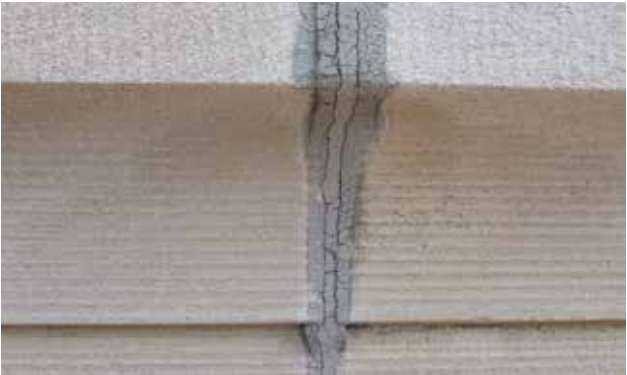
SJ  GML Limestone	<b>Sealant Joint</b> Previous repair of deteriorated mortar joint was finished with elastomeric sealant. The sealant has dried, cracked and failed. Water is allowed into the joint and will accelerate deterioration of adjacent stone. Application of the sealant was not historically appropriate for the building, the sealant had only short term durability, and will leave stains on stone in some locations.	<b>Replace Joint</b> Rake out and repoint joints 100% to limit water infiltration. Repair mortar must be an appropriate mix to match the physical and aesthetic characteristics of the original mortar and building materials. Mortar analysis should be conducted to determine color and chemical composition.	Level 3

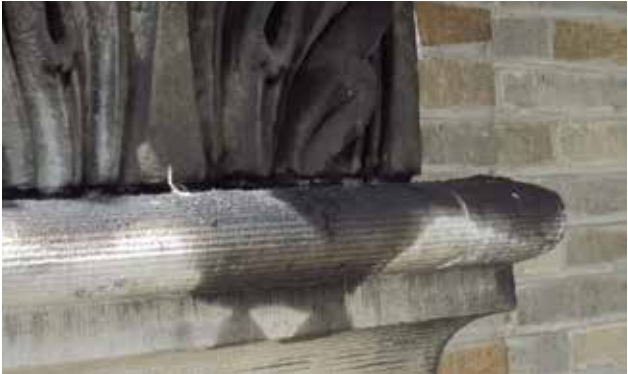
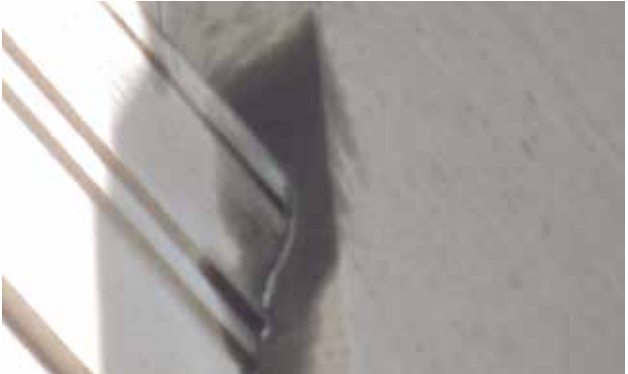
COMPONENT	CONDITION	TREATMENT	PRIORITY	REPRESENTATIVE PHOTO	
SO  GML Limestone HOF Limestone	<b>Staining: Chemical - Oil</b> Residue left behind from installation of bird protection.	<b>Chemical Cleaning &amp; Protection</b> Apply fast acting stripper only to oil stain, dwell, rinse & scrub.  Install minimally-visible bird-proofing wire to prevent future roosting.	GML & HOF Limestone Level 4

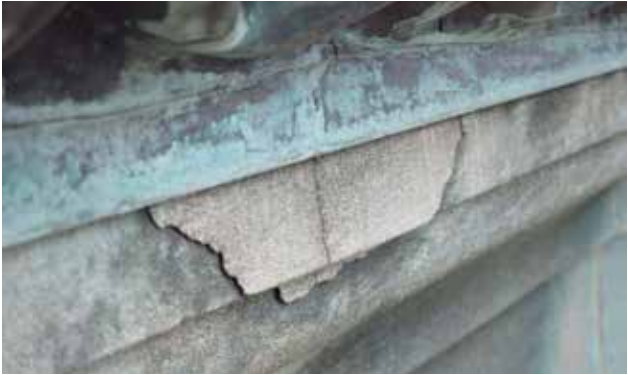
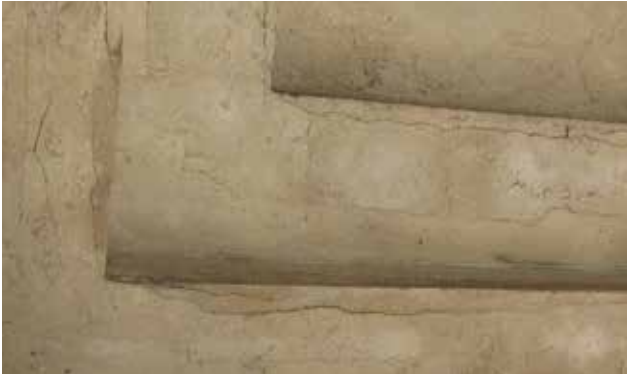
SP  GML Limestone Portico  HOF Limestone	<b>Spall</b> Fragment or chip in the material may result from impact damage and/or material weakness. Moisture and salts penetrate the material due to the weathering process and can deteriorate the masonry. Susceptibility to weathering varies with exposure.	<b>Option 1: Minor Spalls</b> Patch with restoration mortar custom-matched to the stone color.  <b>Option 2: Pervasive Spalls</b> Replace spalled stone with new to match existing.  <b>Option 3: Stucco Failure</b> Remove stucco, repair support framing, provide stainless steel lath and 3-coat stucco system	GML & HOF Limestone Level 3  GML Portico Stucco Level 2

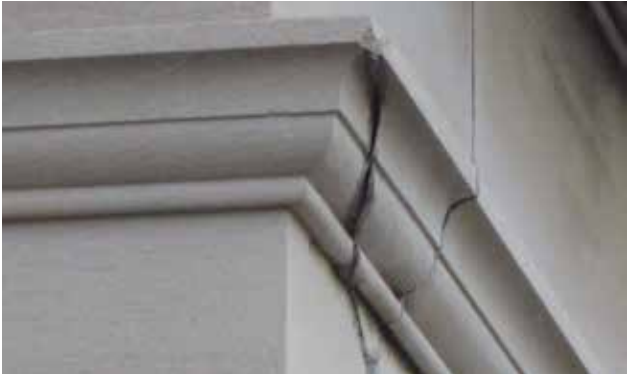
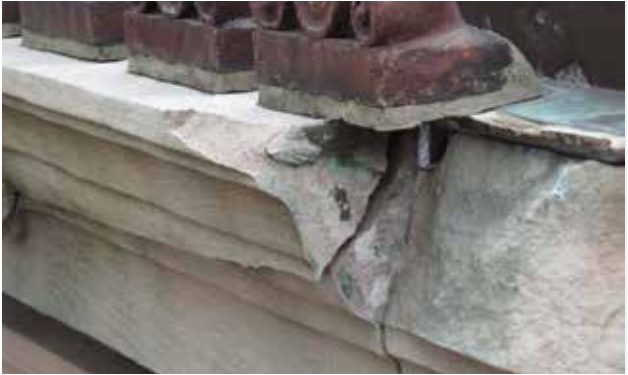
SS  GML Limestone  HOF Limestone	<b>Severe Spall</b> Fragment or chip in the material caused by movement or expansive forces within the stone.  Separation of stone at GML is the result of loading from displaced cornice/eave units above. Spalling of HOF gutters is caused by inappropriate expansion anchors that were installed to secure terra cotta antefixes when its roof was replaced.	<b>Option 1: GML Cornice</b> Remove stone to sound substrate. Replace spalled stone with stone identical in type and profile. Secure stone in place with epoxy adhesive and stainless steel pins.  <b>Option 2: HOF Gutter</b> Remove and install deteriorated stone as option 1, and provide replica of cast stone in lieu of matching stone type.	GML Limestone Level 1  HOF Limestone Level 1

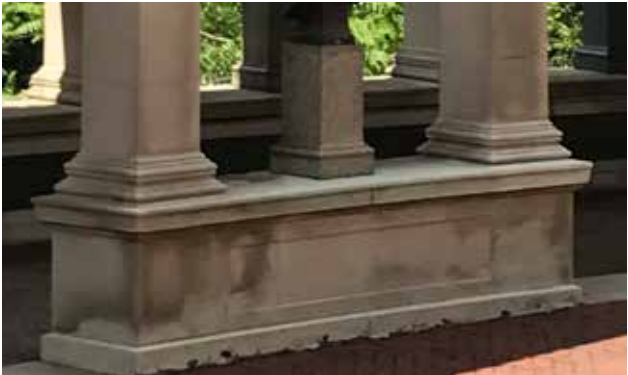
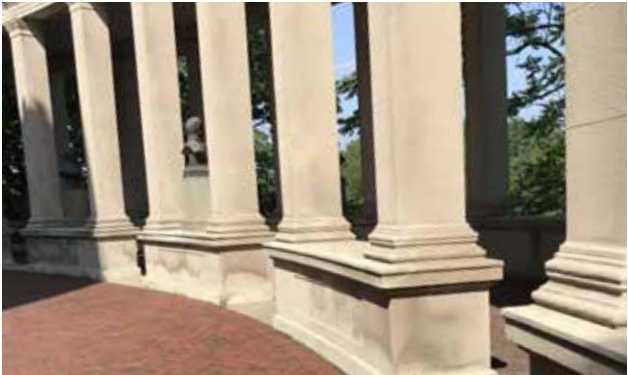
SW  HOF Limestone	<b>Staining: Moisture</b> Discoloration of stone resulting from prolonged infiltration of water from open joints above.	<b>Masonry Repairs</b> Rake out all horizontal joints and repoint with historically matching mortar mix.  Cleaning treatment was not consistently effective for removing water stains, and cleaning is not recommended. Normal stone coloration may return after it dries over time.	Level 3

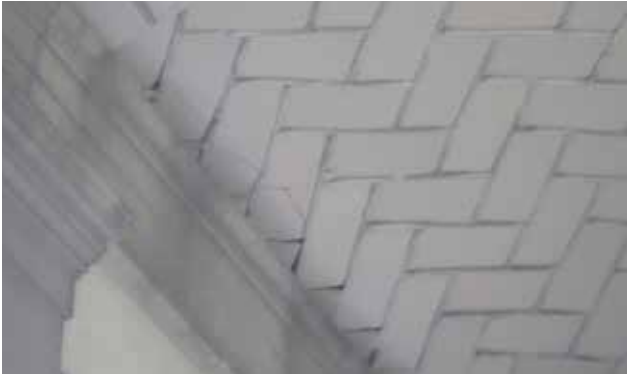
COMPONENT	CONDITION	TREATMENT	PRIORITY	REPRESENTATIVE PHOTO	
CR  HOF Ambulatory	<b>Cracked Unit</b> Distress of exposed Guastavino Tiles. Cracked tiles are only evident at refurbished vaults.	<b>Replace Unit</b> Remove cracked tiles & stitch in replica units.	Level 3

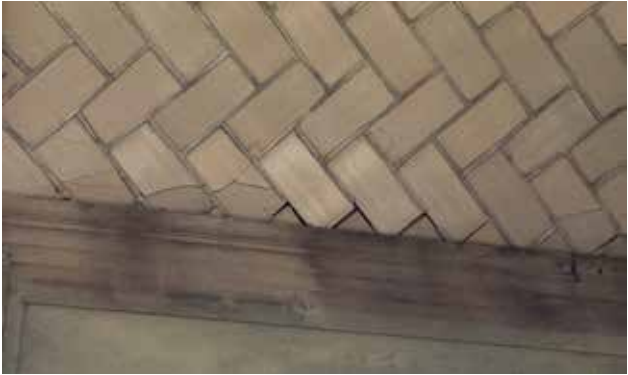
DS  HOF Ambulatory	<b>Displacement</b> Longitudinal cracks at ribs and vaults indicating distress, possibly due to deterioration of metal beam concealed above Guastavino tiles.	<b>Reconstruct Vault</b> Replace affected bay with new tile vault.  Additional investigation is required to understand assembly of roof and ceiling structure. Steel beam has been confirmed above rib at another location. Probe will be required to verify presence and condition of steel beam to determine extents of repair.	Level 2

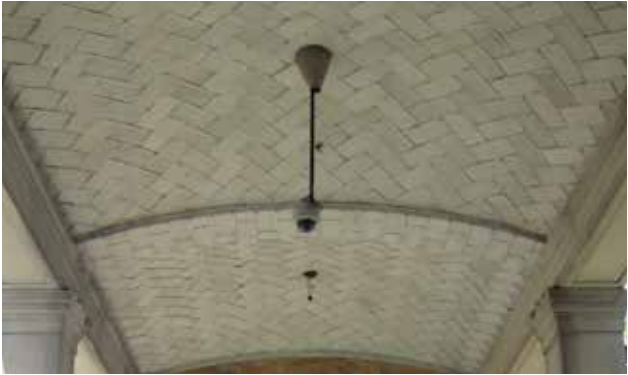
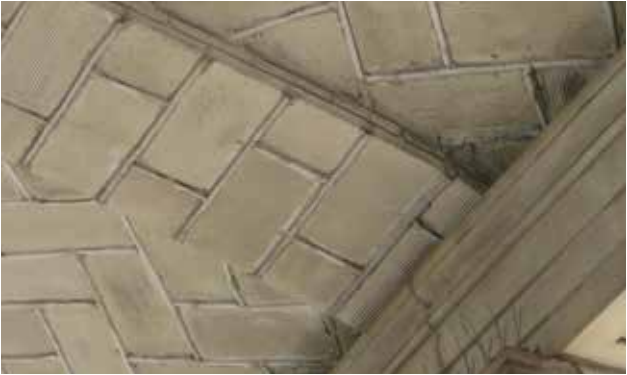
GL  HOF Ambulatory	<b>Loss of Glazed Finish</b> Wear of original ceramic glaze resulting from prolonged weathering.	<b>Reglaze</b> After cleaning, brush-apply breathable glaze coating over entire tile.	Level 3

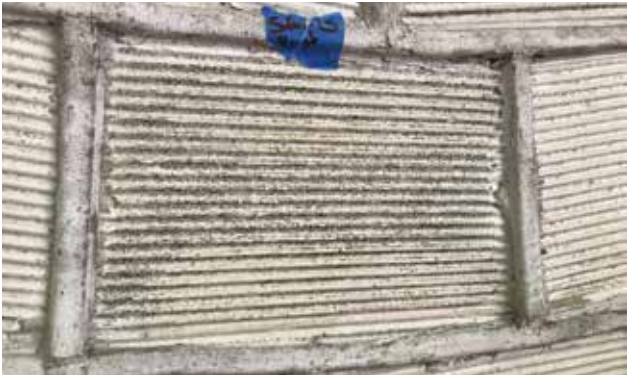
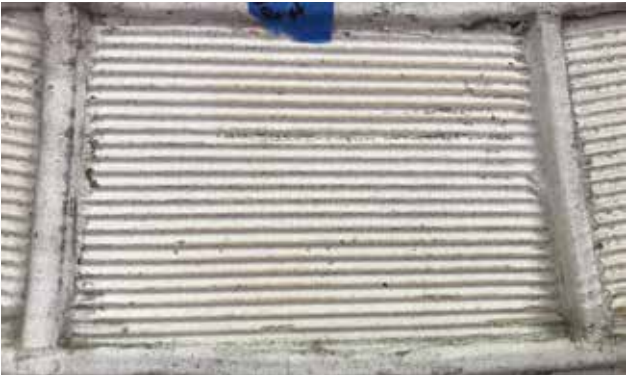
SA  HOF Ambulatory	<b>Soiling: Atmospheric</b> Buildup of atmospheric pollutants over time, generally in areas not washed (in the shadow of precipitation).	<b>Chemical Cleaning</b> Apply chemical until dried, dwell 10 minutes, scrub & rinse	Level 3

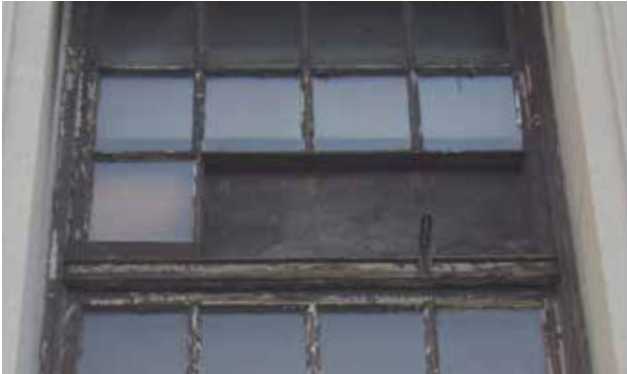
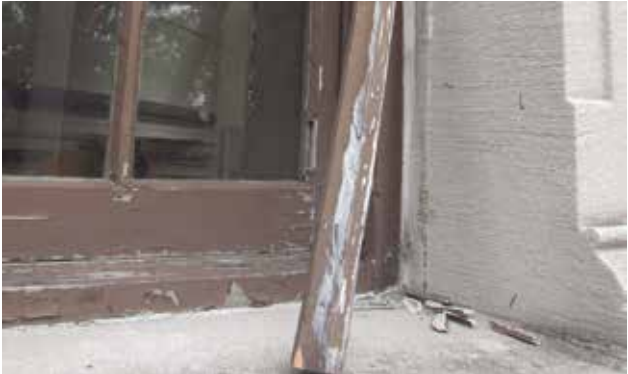
COMPONENT	CONDITION	TREATMENT	PRIORITY	REPRESENTATIVE PHOTO	
<div>W1</div> <div>(BU shown on Survey Notes)</div> <div>GML Windows</div>	<div>Broken Unit</div> <div>Glass pane previously removed from muntin and not replaced in kind. Filler panel of wood or other object present.</div> <div>Glass pane split or shattered by impact or movement.</div>	<div>GML: Window Restoration</div> <div>Replace Glazing</div> <div>Option 1: Replace glass in existing muntins with type to match original. Re-putty, prime and finish paint in historical color.</div> <div>Option 2: Provide dutchman repair of missing muntins with glass infill.</div>	Level 3

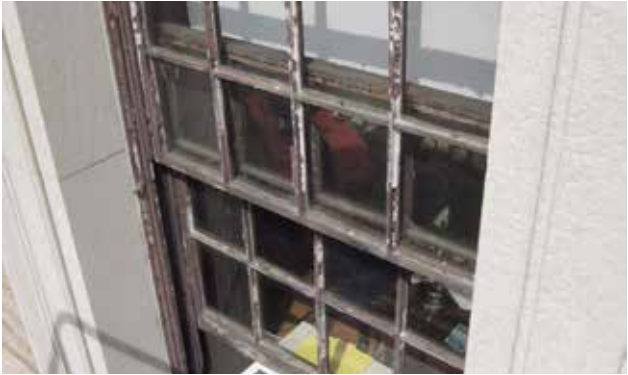
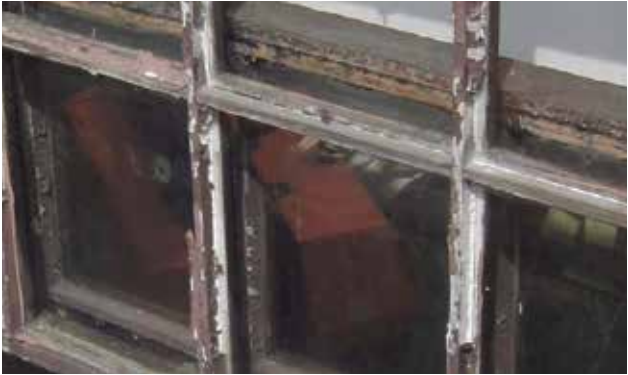
<div>W1</div> <div>(GC shown on Survey Notes)</div> <div>GML Windows</div>	<div>Failed Glazing Compound</div> <div>Loss of window putty resulting age, weather, and delayed maintenance.</div>	<div>GML: Window Restoration</div> <div>Re-putty</div> <div>Salvage historic glass for re-installation. Remove existing compound to bare wood, and clean by sanding. Tack glass into muntins and apply putty to match original. Apply primer and (2) coats of finish paint, match original historic color.</div>	Level 2

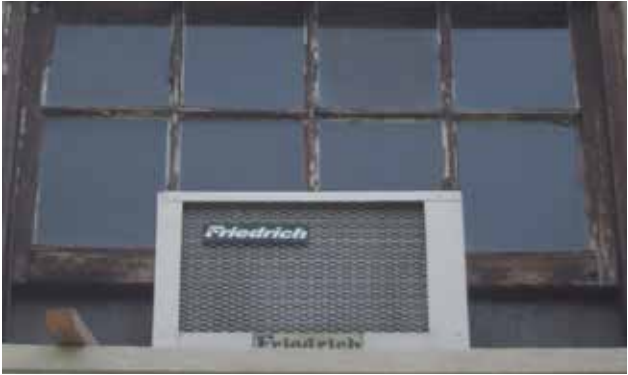
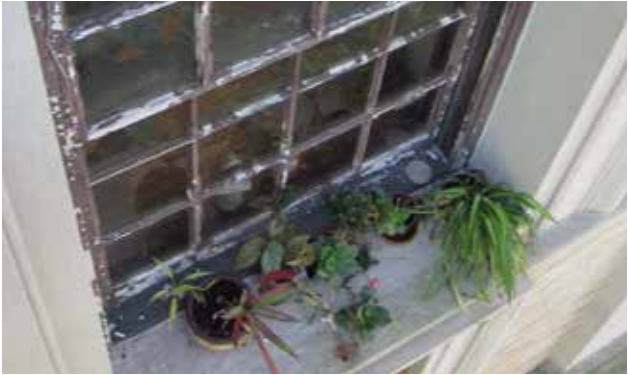
<div>W1</div> <div>(EI shown on Survey Notes)</div> <div>GML Windows</div>	<div>Inappropriate Element</div> <div>Objects deleterious to original building fabric are in place, including through-wall air conditioner units, plants, fasteners, and animal nests.</div>	<div>GML: Window Restoration</div> <div>Remove Elements</div> <div>Return windows and surrounding elements to their original conditions. Institute semi-yearly maintenance to prevent condition from re-occurring.</div>	Level 3
