# Conditions Assessment

## Gould Memorial Library & Hall of Fame

FINAL REPORT | 15 MARCH 2018

**BRONX**  
**COMMUNITY**  
COLLEGE

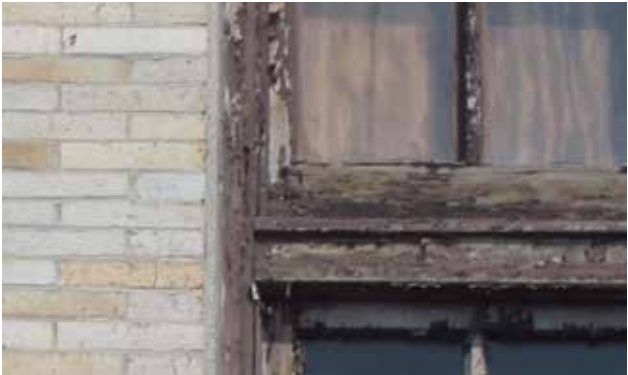
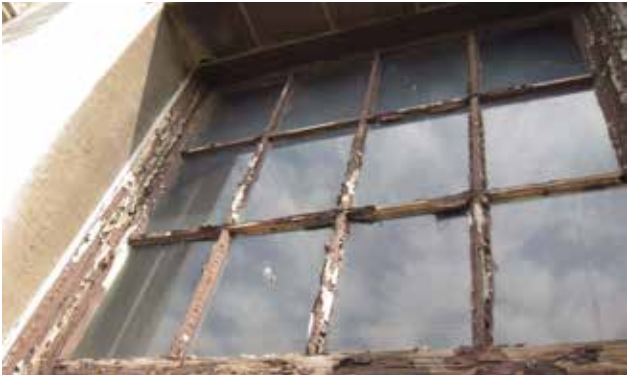
<div>W1</div> <div>(FL shown on Survey Notes)</div> <div>GML Windows</div>	<div>Loss of Coating</div> <div>Natural wear of applied finish caused by age, weather, and delayed maintenance.</div>	<div>GML: Window Restoration</div> <div>Refinish Unit</div> <div>Remove coating by chemical or mechanical means to original wood. Fill any defects in surface to return to original profile, and treat dried wood with boiled linseed oil, as required. Apply primer and (2) coats of finish paint, match original historic color.</div>	Level 3

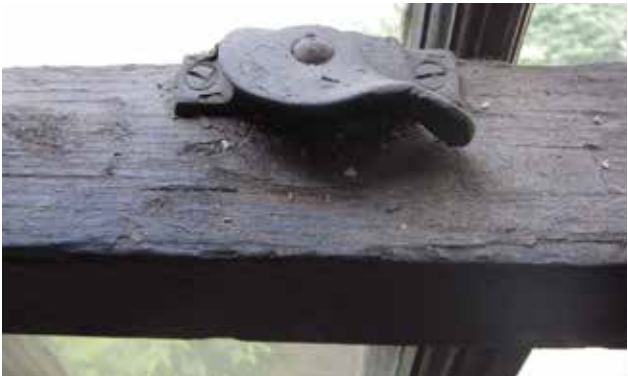
COMPONENT	CONDITION	TREATMENT	PRIORITY	REPRESENTATIVE PHOTO	
<div>W1 (EM shown on Survey Notes)</div> <div>GML Windows</div>	<div>Missing Element</div> <div>Original hardware or trim lost or removed over time.</div>	<div>GML: Window Restoration</div> <div>Provide Replica Hardware</div> <div>Install hardware following window restoration. Ensure smooth operation.</div>	Level 3

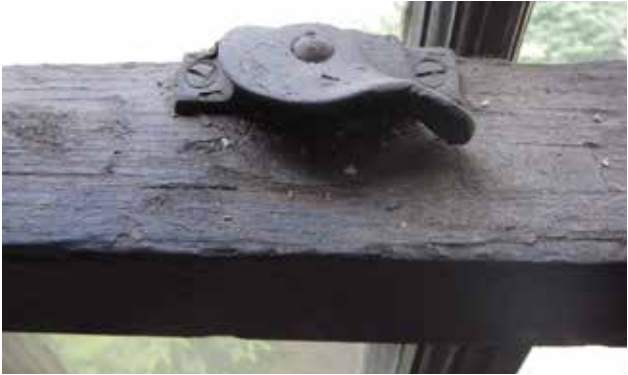
<div>W1 (OP shown on Survey Notes)</div> <div>GML Windows</div>	<div>Non-Operational</div> <div>Movable sashes are stuck in place, caused by missing hardware, swelling, or deferred maintenance.</div>	<div>GML: Window Restoration</div> <div>Repair Unit</div> <div>Salvage unit to shop, restore elements &amp; reinstall.</div>	Level 3

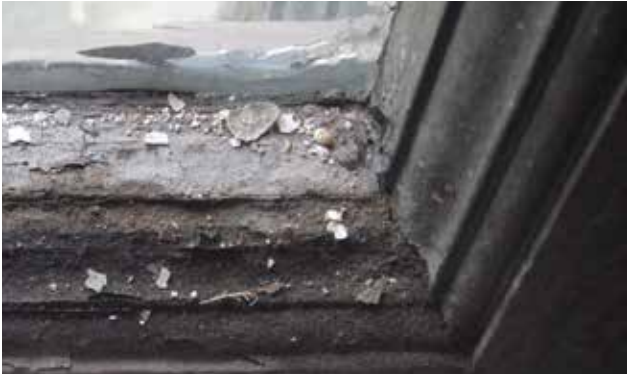
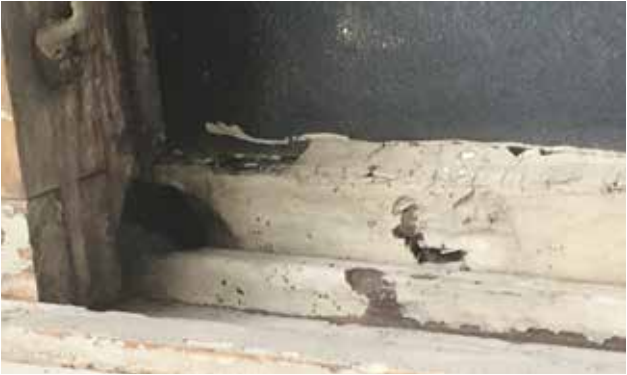
<div>W1 (RT shown on Survey Notes)</div> <div>GML &amp; HOF Windows</div>	<div>Rotted Element</div> <div>Element of sash compromised by prolonged exposure to moisture, characterized by softness or flaking of wood.</div>	<div>GML: Window Restoration</div> <div>Dutchman Repair</div> <div>Clean wood to original finish by stripping and sanding. Fill defects in surface to return to original profile. Apply primer and (2) coats of finish paint, match original historic color.</div>	Level 3

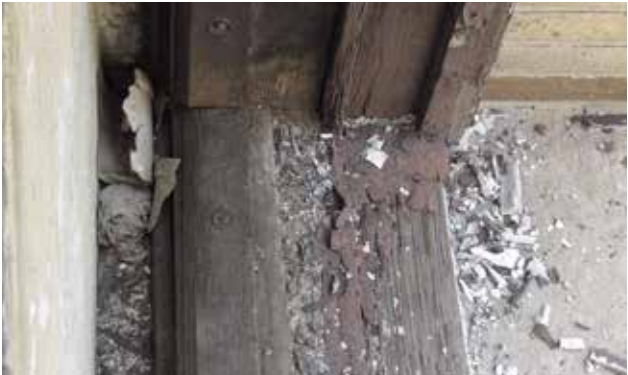
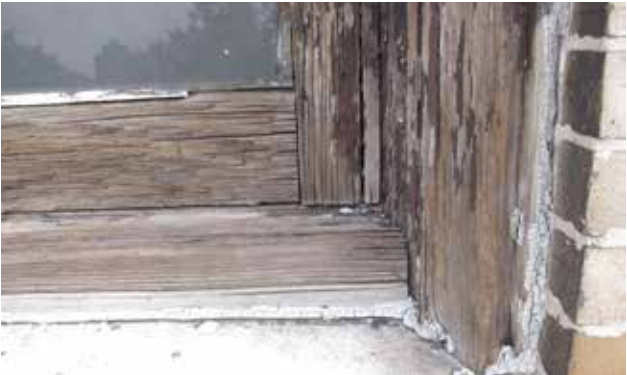
<div>W1 (CH1 shown on Survey Notes)</div> <div>GML Windows</div> <div>W2 GML Windows South Facade</div>	<div>Severe Checking</div> <div>Opening of wide gaps in the surfaces of sashes, muntins or frames typically larger than hairlines.</div>	<div>W1: Window Restoration</div> <div>Dutchman Repair</div> <div>Replace severely checked element(s) of sash, frame or sill with new wood dutchman in matching or compatible specials. Finish to match window.</div> <div>W2: Replace Window</div> <div>Install replica window sashes &amp; frame where severe checking is pervasive.</div>	Level 3

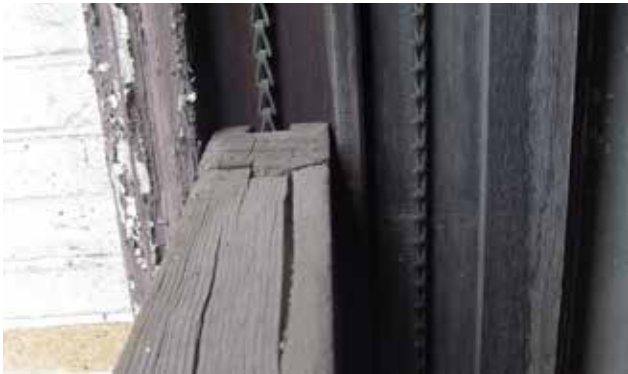
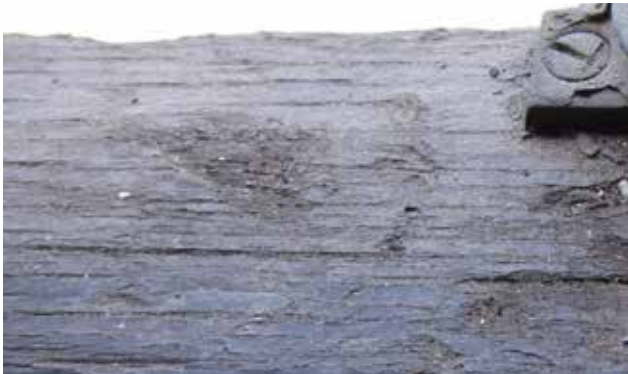
COMPONENT	CONDITION	TREATMENT	PRIORITY	REPRESENTATIVE PHOTO	
<div>W1</div> <div>(CH shown on Survey Notes)</div> <div>GML Windows</div>	<div>Wood Checking</div> <div>Opening of parallel striations or gaps in the surfaces of sashes, muntins or frames resulting from excessive drying and swelling of wood. Primarily caused by lack of paint or primer.</div>	<div>GML: Window Restoration</div> <div>Recondition Wood</div> <div>Clean wood to original finish by sanding, apply boiled linseed oil, prime and apply (2) coats of finish paint.</div>	Level 3

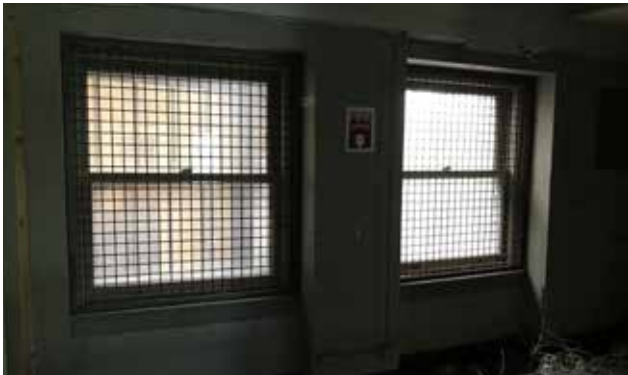
<div>W2</div> <div>(GR shown on Survey Notes)</div> <div>HOF Windows</div>	<div>Missing Grate</div> <div>Original protective grille removed or lost over time.</div>	<div>HOF: Replace Grating</div> <div>Provide replica grate where required by new use.</div>	Level 4

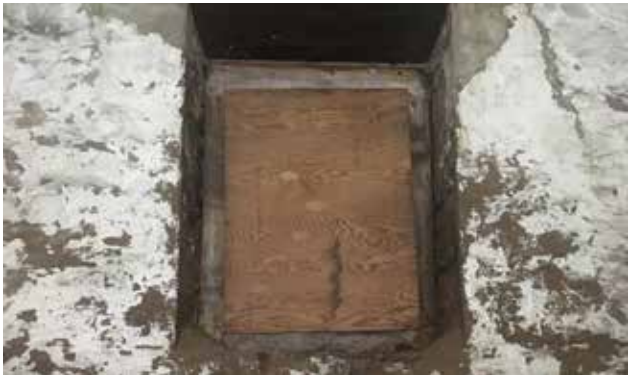
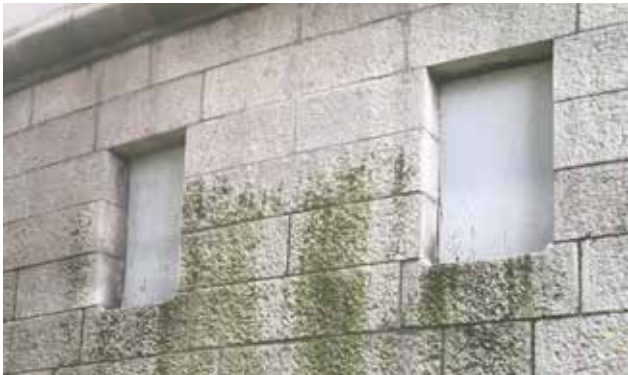
<div>W2</div> <div>(BU, FL, EI, GC, CH, CH1, RT, MU, EM, OP, GR shown on Survey Notes)</div> <div>GML Windows</div> <div>South Facade</div> <div>HOF Windows</div>	<div>Severely Deteriorated or Missing Unit</div> <div>Broken Unit</div> <div>Wood Checking</div> <div>Severe Checking</div> <div>Inappropriate Element</div> <div>Loss of Coating</div> <div>Missing Glazing</div> <div>Missing Element</div> <div>Non-Operational</div> <div>Missing Grate</div>	<div>GML &amp; HOF: Replace Window</div> <div>Install historically accurate replica with double-glazing. Assume condition of window is poor due to deferred maintenance.</div>	Level 3

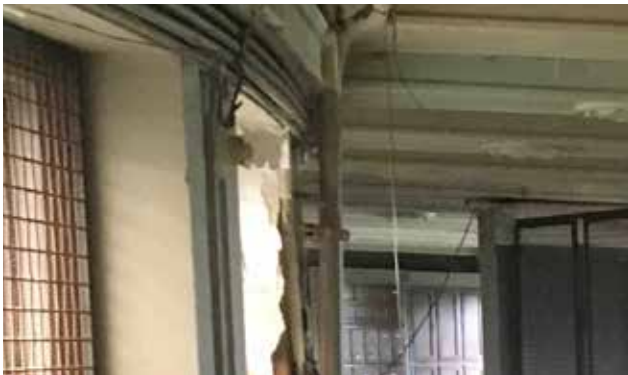
<div>W2-DS</div> <div>HOF Windows</div>	<div>Displaced Window</div> <div>Unit compromised by adjacent deterioration.</div>	<div>HOF: Repair Wall</div> <div>Provide structural and waterproofing repairs at perimeter of window.</div> <div>Replace Window Unit</div> <div>Install historically accurate replica with double-glazing.</div>	Level 2

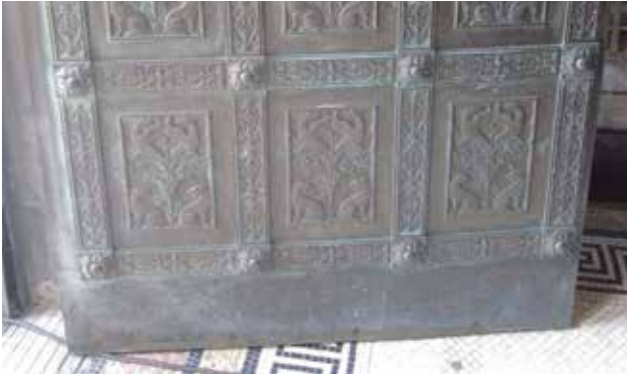
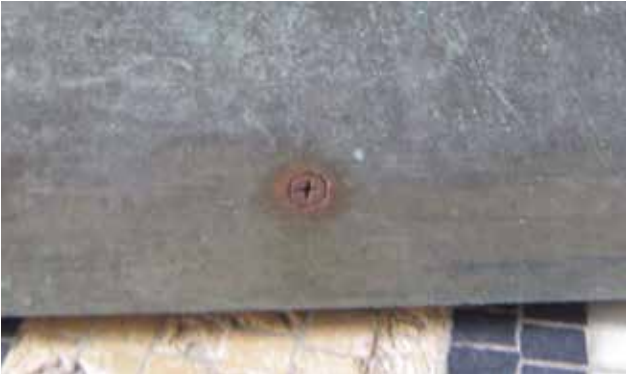
COMPONENT	CONDITION	TREATMENT	PRIORITY	REPRESENTATIVE PHOTO	
IR  GML Portico  HOF Entrances	<b>Inappropriate Repair</b> GML: Ferrous fasteners were installed to repair commemorative bronze doors.  HOF: Original wood doors/transoms are not extant and were replaced with hollow metal units.	<b>GML Portico: Provide Replica Elements</b> Remove fasteners, install copper replica element with copper nails.  <b>HOF Entrances: Provide Wood Doors</b> Remove door & wall infill within original masonry opening, Replace door to match original.	Level 3

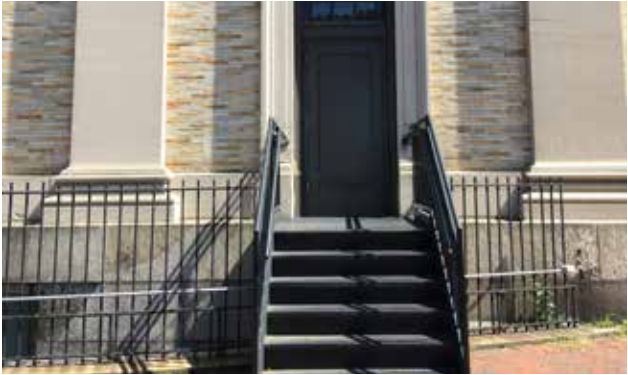
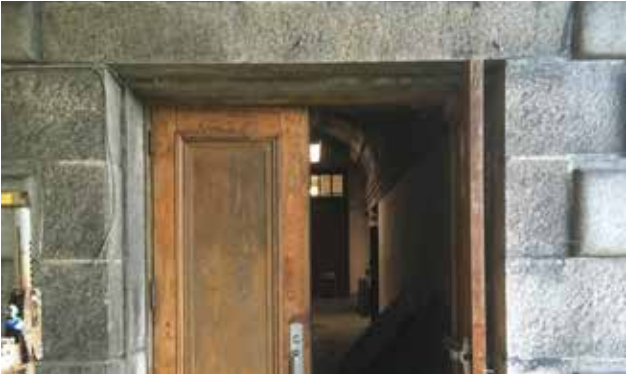
LC  GML West Exit Stairs  HOF West Doors	<b>Loss of Coating or Finish</b> Failure of finish paint or stain, which acts as a protective sacrificial layer against weathering. When these coatings fail, the substrate is vulnerable to moisture penetration and deterioration, eventually leading to loss of section/profile.	<b>Refinish</b> Prepare, prime & paint with coating to match original color and sheen.	GML & HOF Level 3

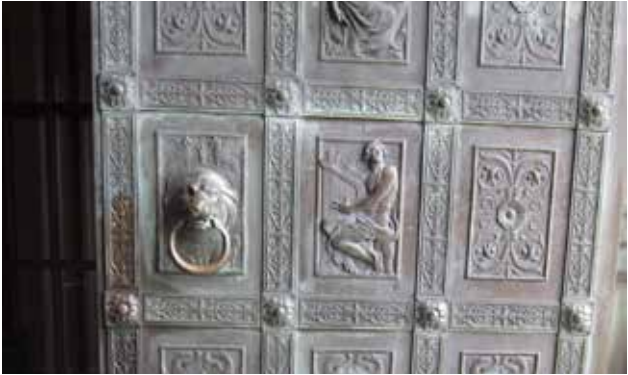
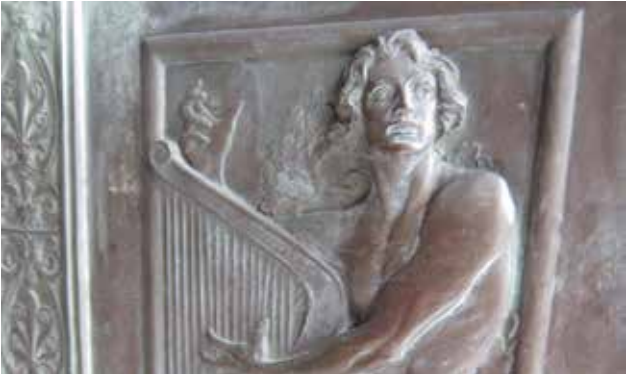
LP  GML Portico	<b>Loss of Patination</b> Wear of protective copper finish is compromising the weather resistance of historic doors.	<b>Clean &amp; Refinish</b> Dilute chemical, hand-apply & scrub, rinse.  Spray-apply corrosion-inhibiting coating, apply, dry and re-apply.	Level 3

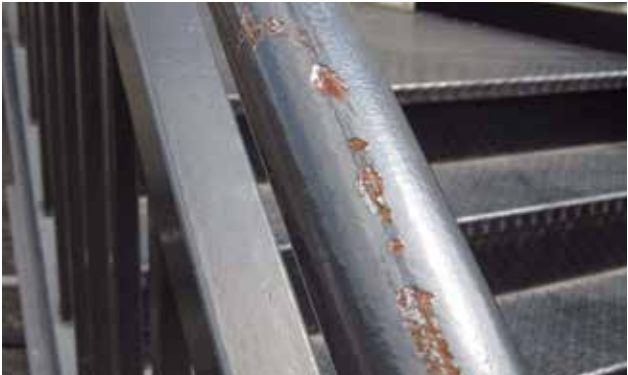
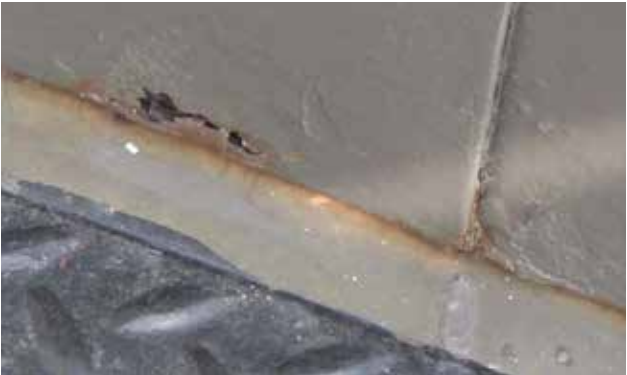
MC  GML West Exit Stairs	<b>Metallic Corrosion</b> Formation of rust resulting from failure of original finish. Corrosion at base of doors formed holes through thin sheet metal.	<b>Doors:</b> Remove corrosion to sound substrate, Rebuild metal profile with synthetic filler, prime & paint.  <b>Railings:</b> Remove corrosion to sound substrate, prime & paint.	Level 3

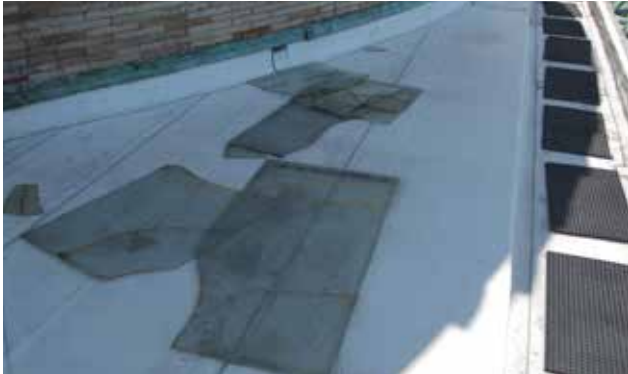
COMPONENT	CONDITION	TREATMENT	PRIORITY	REPRESENTATIVE PHOTO	
IE  GML Dome Drum Roof	<b>Inappropriate Element</b> Elements and debris not properly secured to the roof may cause damage or compromise the performance of the membrane.	<b>Remove Element</b> Discard glass shards (from prior skylight repair) and ensure no punctures were made through membrane.  <b>Support Object</b> Remove satellite dish or mount of soft blocks adequately ballasted or secured to the deck.	Level 2

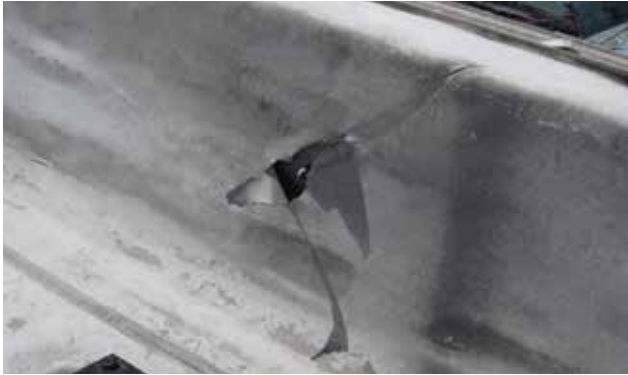
HL  GML Dome Drum Roof	<b>Hole</b> Puncture through membrane.	<b>Temporary Patch</b> Install new waterproofing membrane over defect.  <b>Replace Roof</b> Remove membrane roof in its entirety from dome drum gutters to expose original masonry. Repair extant defects in masonry resulting from water damage to receive new roofing. Install multi-ply built up roofing system or liquid roofing. Work is included in the scheduled roof restoration project.	Level 2

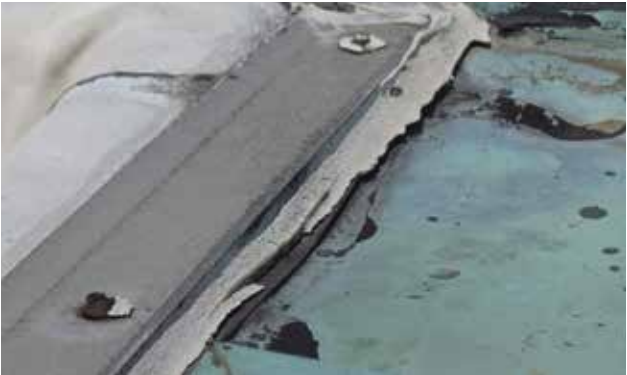
OJ  GML Dome Drum Roof	<b>Open Joint</b> Gap between membrane sheets allowing water to enter and affect the interior.	<b>Temporary Repair</b> Install new waterproofing membrane over defect.  <b>Replace Roof</b> Removal of existing membrane and replacement with liquid roof system is included in the scheduled roof repair project.	Dome Drum Gutters Level 1  Dome Drum Cornice Level 3

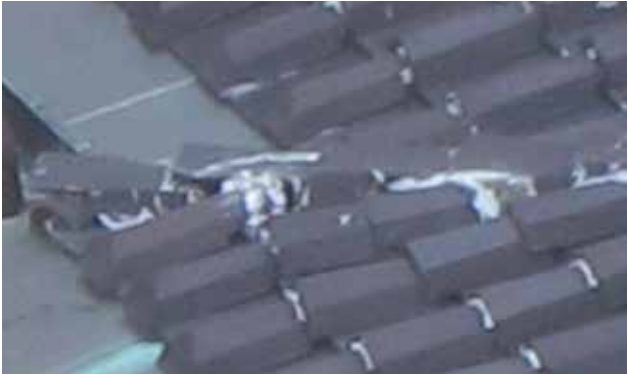
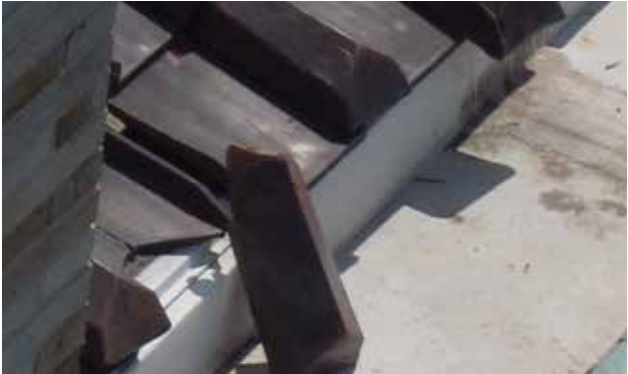
COMPONENT	CONDITION	TREATMENT	PRIORITY	REPRESENTATIVE PHOTO	
BU  GML Gable Roof  HOF Roof	<b>Broken Unit</b> Tile broken or sheared, with fragment subject to fall from roof to ground below.	<b>Remove Loose Unit</b> Sound adjacent units for defects and remove all fragments. Install temporary patching or waterproofing to prevent short-term water infiltration.	GML & HOF Roofs Level 1

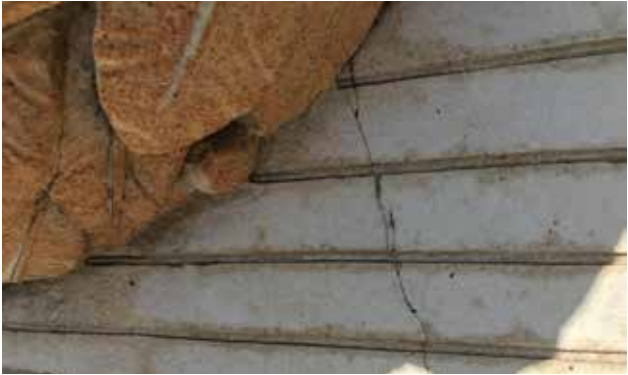
CR  GML Dome Drum	<b>Crack</b> A fracture or fissure in the masonry of minimum 1/16" width Cracks open due to age, weathering, or differential stresses from movement within the unit.	<b>Crack Repair</b> Provide fill or patch repair at crack.	Level 3

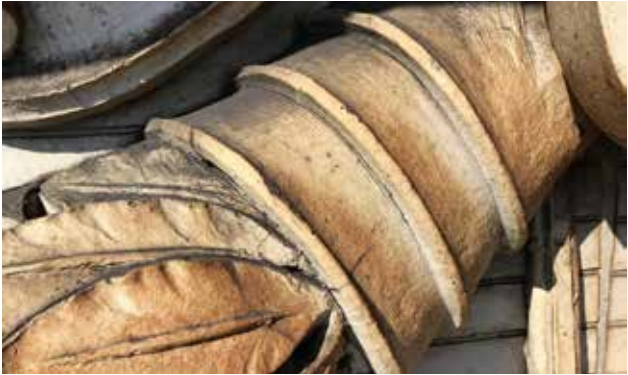
CRH  GML Dome Drum	<b>Crack: Hairline</b> A minor fracture or fissure in the masonry of 1/16" or less in width and length that could indicate movement of adjacent parts.	<b>Crack Repair</b> Drill & inject repair epoxy. Applying patching material to match finish stone.	Level 3

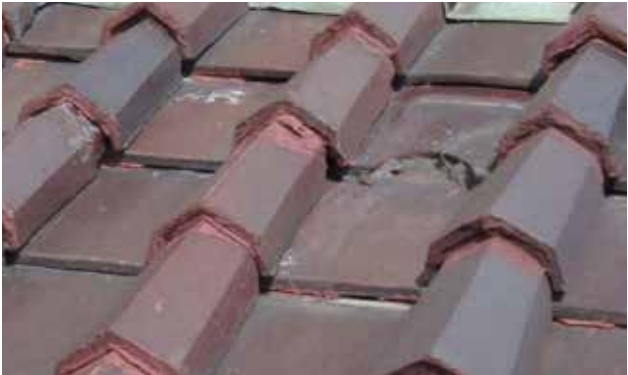
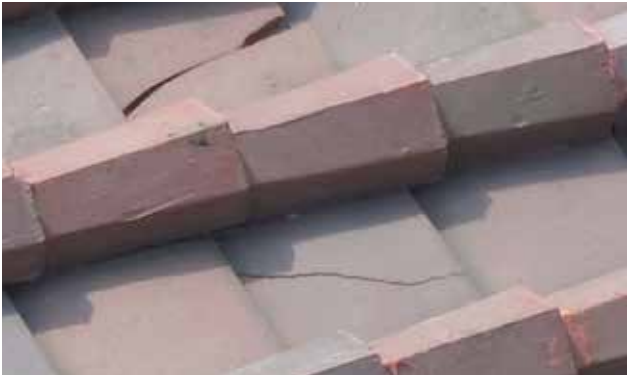
CT  GML Gable Roof  HOF Roof	<b>Cracked Tile</b> Tile broken or sheared, resulting from differential movement in the roofing or masonry substrate, freeze-thaw action, or impact by objects.	<b>Replace Roof in Kind</b> Salvage all original tile at GML and HOF for re-installation. Recreate any tile that cannot be salvaged or was installed as part of a prior repair campaign.  Prior to installation of tile, properly prepare substrate. At GML and HOF roofs, replace entire roofing membrane and tile fastening system. At GML and HOF gutters/cornices, repair or replace masonry substrates to provide sound connections.	GML & HOF Roofs Level 3

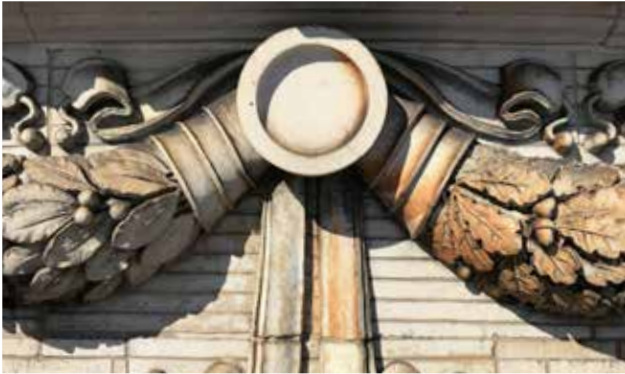
COMPONENT	CONDITION	TREATMENT	PRIORITY	REPRESENTATIVE PHOTO	
GL  GML Dome Drum	<b>Loss of Glazed Finish</b> Wear of original ceramic finish resulting from prolonged weathering.	<b>Reglaze</b> Clean with chemical, brush-apply breathable glaze coating over entire tile.	Level 3

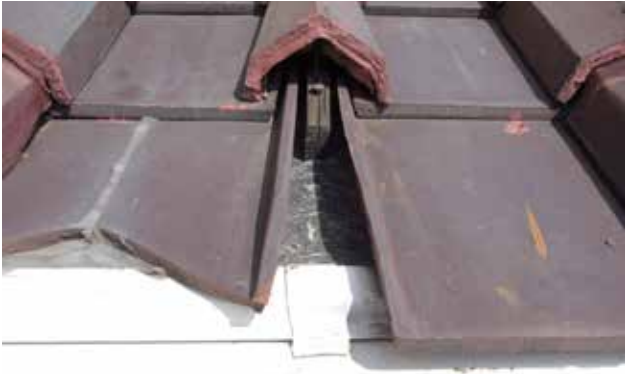
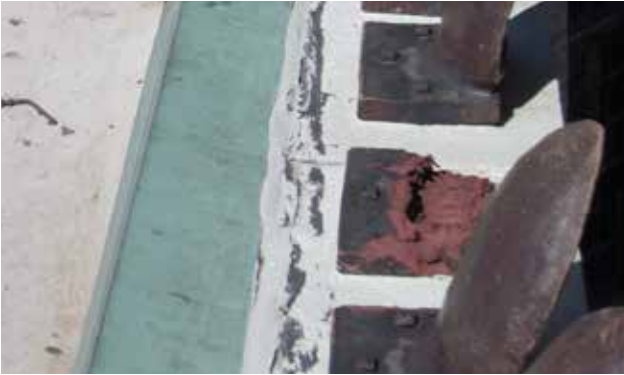
MU  GML Gable Roof  HOF Roof	<b>Missing Unit</b> Tile broken or sheared, resulting from differential movement in the roofing or masonry substrate, freeze-thaw action, or impact by objects.	<b>Replace Unit in Kind</b> Salvage all original tile at GML and HOF for re-installation. Recreate any tile that cannot be salvaged or was installed as part of a prior repair campaign.  Prior to installation of tile, properly prepare substrate. At GML and HOF gutters/cornices, repair or replace masonry substrates to provide sound connections.	GML & HOF Roofs Level 3

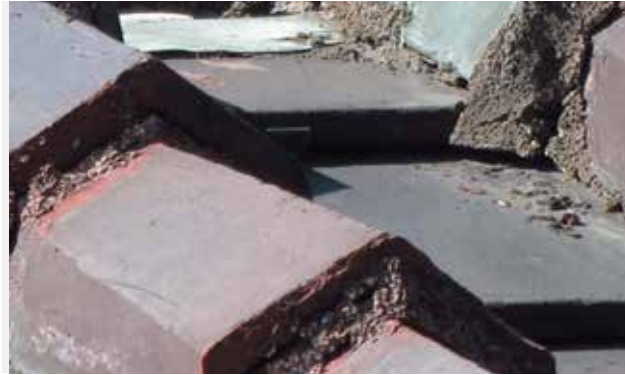
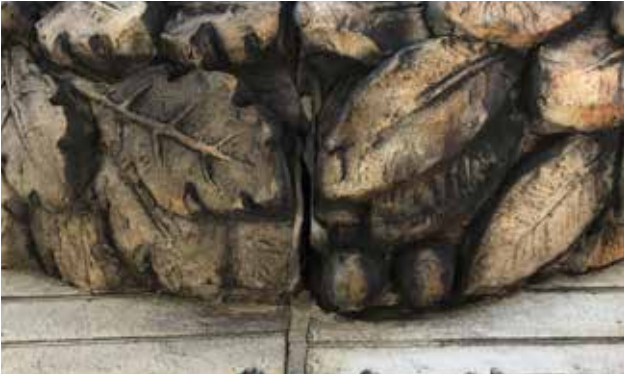
OJ  GML Gable Roof  HOF Roof	<b>Open Joint</b> Complete or partial loss of setting mortar. Open joints may lead to accelerated ingress of water, or compromise the stability of units in place.  Masonry filler was applied to GML gable tiles.	<b>Replace Joints</b> Provide masonry setting joints and secure tile in accordance with industry standards during roof replacement.	GML & HOF Roofs Level 3  GML Dome Drum Level 3

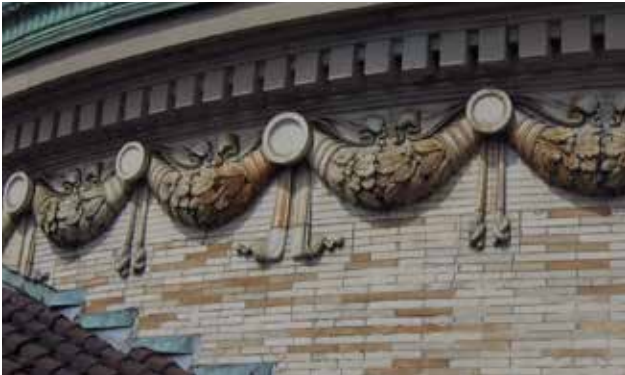
SA  GML Dome Drum	<b>Soiling: Atmospheric</b> Buildup of atmospheric pollutants over time, generally in areas not washed (in the shadow of precipitation).	<b>Restoration Cleaner</b> Mix chemical, pre-wet terra cotta, brush apply, dwell, rinse with pressure washer.	Level 4

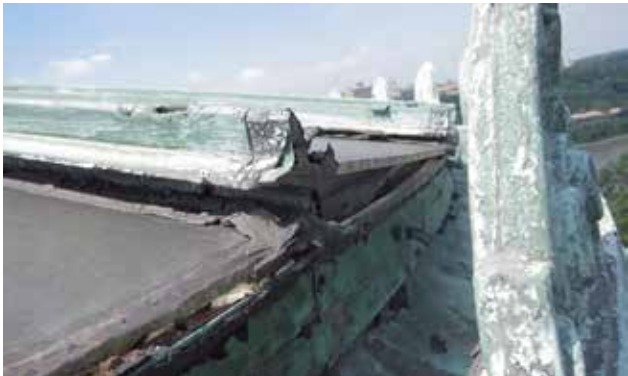
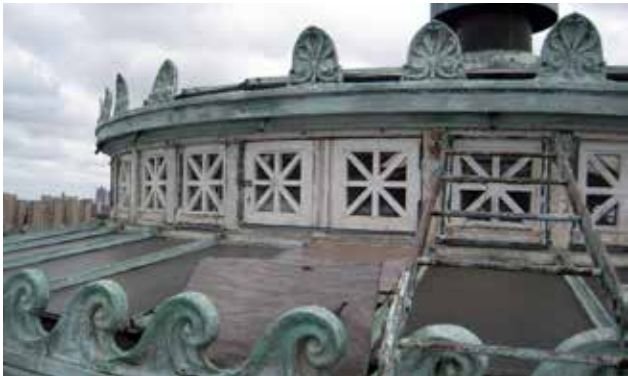
COMPONENT	CONDITION	TREATMENT	PRIORITY	REPRESENTATIVE PHOTO	
DS GML Cupola	<b>Displaced Unit</b> Movement over time out of normal plane, typically caused by prolonged cycles of thermal expansion and contraction or freeze-thaw jacking.	<b>Temporary Repair</b> Provide temporary waterproofing membrane.  <b>Replace Skylight</b> Replace Cupola skylight as part of previously designed "Critical Roof Repair" project.	Temporary Repair Level 1  Skylight Level 3

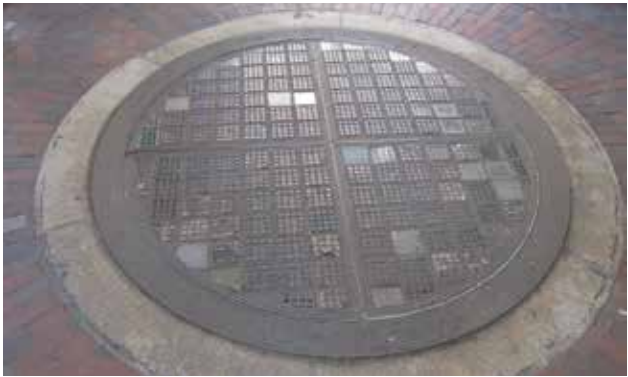
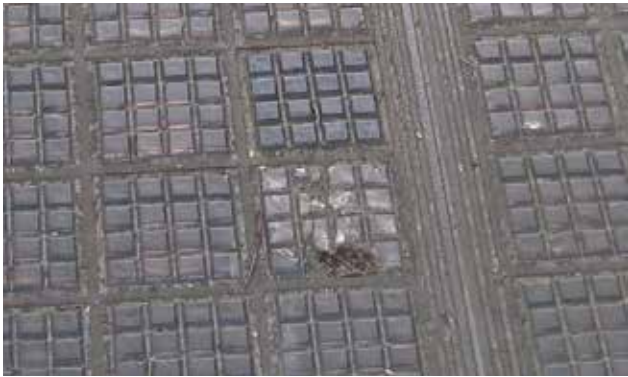
DU3 HOF Vault Lights	<b>Deteriorated Unit</b> Cracked piece of original glazing.	<b>Restore Laylight</b> <b>HOF Vault Lights:</b> Salvage unit to be repaired offsite by conservation studio. Replace cracked and broken lites in kind, restore cast iron frame, clean glass and metal, reset in original location.	HOF Vault Light Level 3

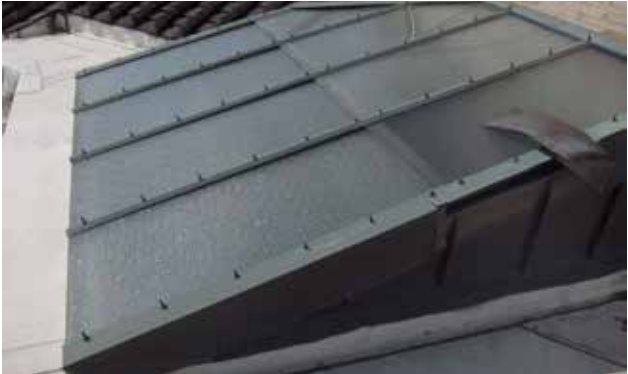
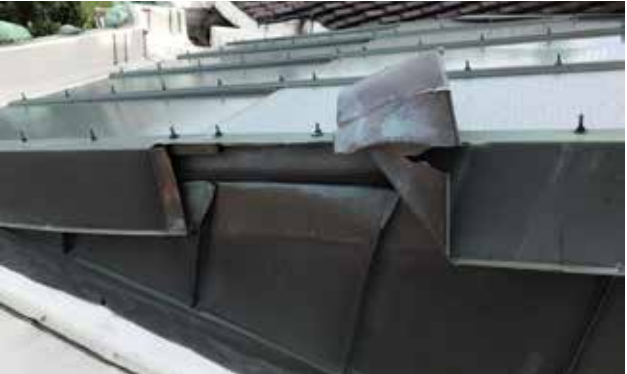
COMPONENT	CONDITION	TREATMENT	PRIORITY	REPRESENTATIVE PHOTO	
EL GML Dome Drum Roof	<b>Loose Element</b> Flashing physically displaced due to repetitive stress and insecure fastening.	<b>Temporary Repair</b> Remove loose element and repair flashing.	Level 1 Repair

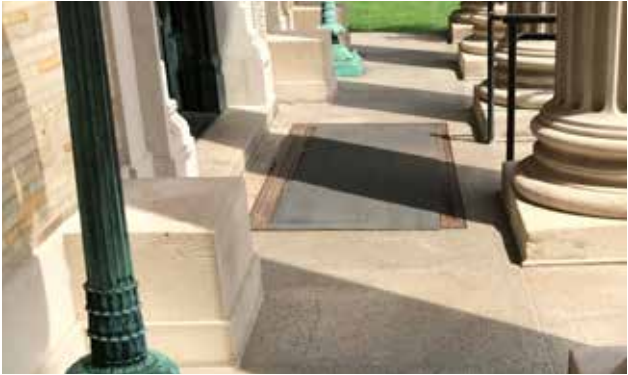
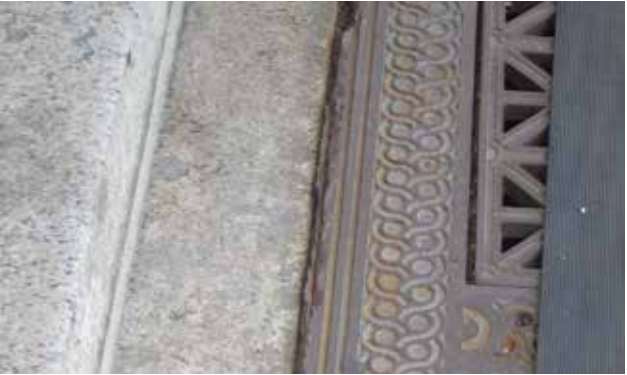
MC  GML Vault Light	<b>Corroded Metal</b> Loss of original profile from ferrous-corrosion of cast iron element. Cause is from oxidation likely exacerbated to prolonged exposure to water and de-icing salts.	<b>Clean &amp; Refinish</b> Clean with micro-abrasive applied by a conservator. Apply corrosion-inhibiting primer and finish coats in color to match original.	Level 3

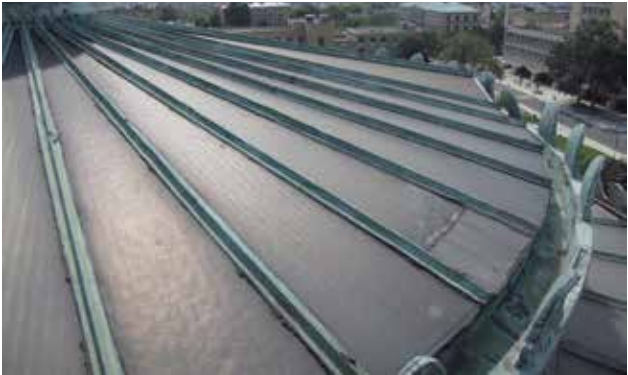
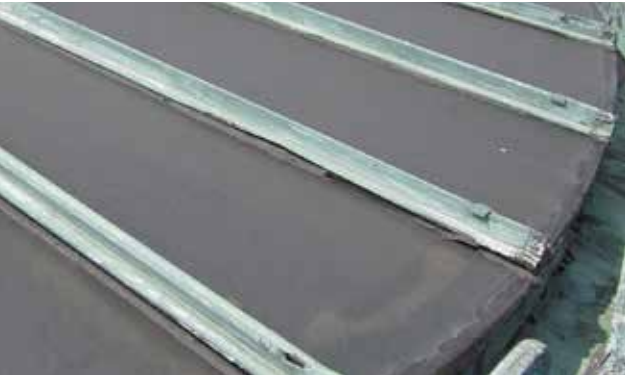
SJ GML Cupola	<b>Sealant Joint</b> Loose, dried, or missing compound resulting from age and deferred maintenance.	<b>Replace Skylight</b> Replace cupola skylight as part of previously designed “Critical Roof Repair” project.	Level 2

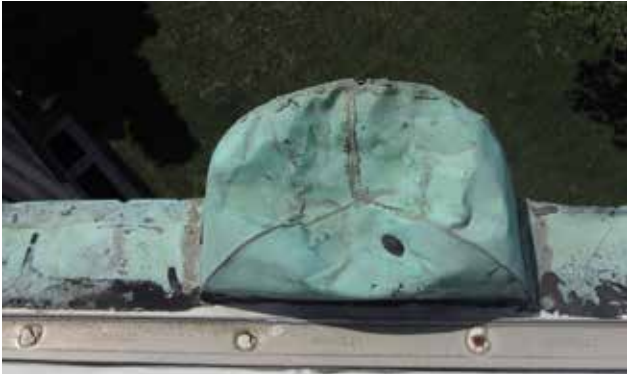
COMPONENT	CONDITION	TREATMENT	PRIORITY	REPRESENTATIVE PHOTO	
ED  GML Cornice	<b>Deformed Element</b> Malformation of decorative element resulting from prior impact.	<b>Restore Cornice</b> Remove and salvage section for repair in a shop. Remove deformed repousse and fabricate replica. Carefully cut seams and remove horizontal coping. Re-solder and stitch in copper sheets and repousse into original.  <b>Alternate: Replace in Kind</b> Salvage entire cornice and install replica on stainless steel armature.	GML Cornices Level 4

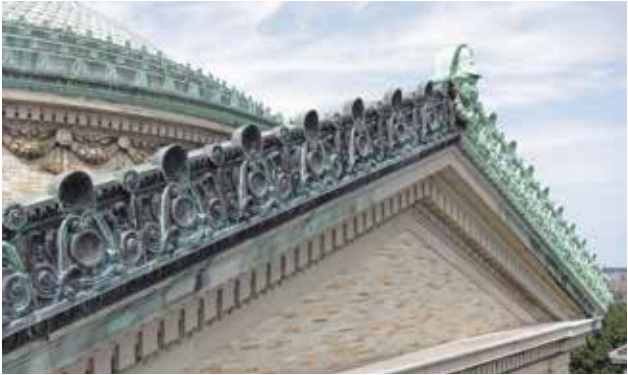
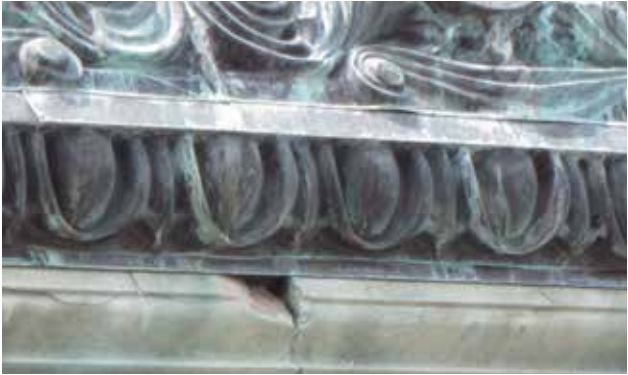
IR  GML Cornice East Facade	<b>Inappropriate Repair</b> Previously repaired section of cornice held in place with expansion anchor fasteners.	<b>Remove &amp; Re-secure</b> Remove and salvage section of cornice. Repair masonry substrate. Review condition of existing support structure and repair or supplement to create a sound connection.	Level 3

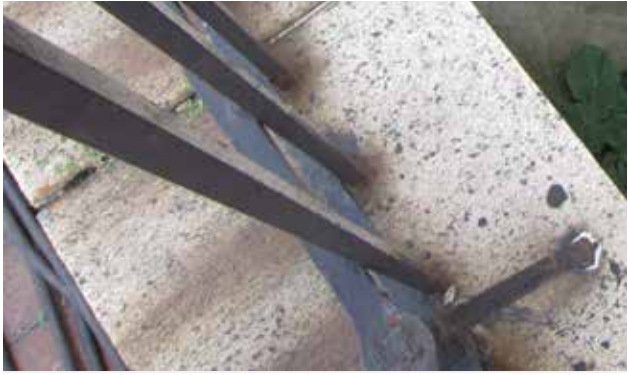
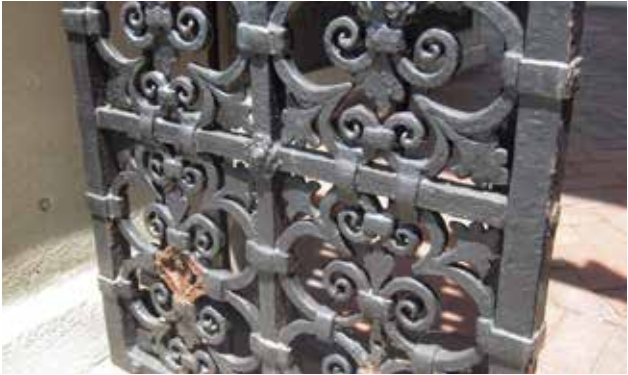
MC  HOF Terrace  HOF Ambulatory	<b>Metallic Corrosion</b> Failure of paint coating, which acts as a protective sacrificial layer against weathering. When these coatings fail, the substrate is vulnerable to moisture penetration and deterioration, eventually leading to loss of section/profile. Rusting of metal may result in damage to adjacent materials.	<b>Refinish</b> Remove corrosion, prepare, prime & paint.	HOF Terrace & Ambulatory Level 3

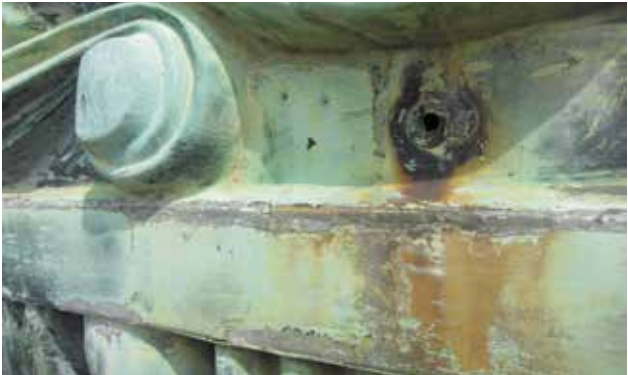
ME  GML Cornice	<b>Missing Element (Fastener)</b> Loss of original element resulting from mechanical failure, removal, or movement.	<b>Restore Cornice</b> Conduct probe to review condition of existing supporting structure. Repair or supplement support if necessary, and refasten.  <b>Alternate: Replace in Kind</b> Remove and salvage entire cornice, fabricate stamped copper replica, install on new stainless steel armature. Assume 3' sections composed of multiple custom-stamped units soldered together.	GML Cornices Level 3

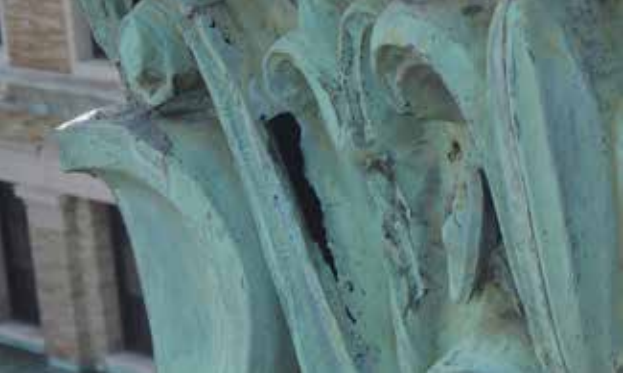
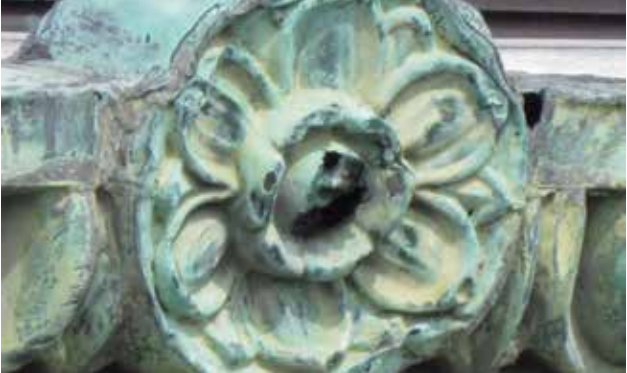
COMPONENT	CONDITION	TREATMENT	PRIORITY	REPRESENTATIVE PHOTO	
MP  GML Cornice	<b>Pitted Metal</b> Corrosion through entire thickness of sheet metal. Opening is a path for accelerated water infiltration, that may affect back-up masonry.	<b>Restore Cornice</b> Repair in place (assume 75% of cornice). Clean and prepare metal, form copper sheet to match missing profile, solder into place. Repair offsite (assume 25%): Remove and salvage section for repair in a shop. Review condition of existing support structure and repair or supplement. Secure repaired cornice segment in original location.  <b>Alternate: Replace in Kind</b> Salvage entire cornice and install replica on stainless steel armature.	GML Cornices Level 3

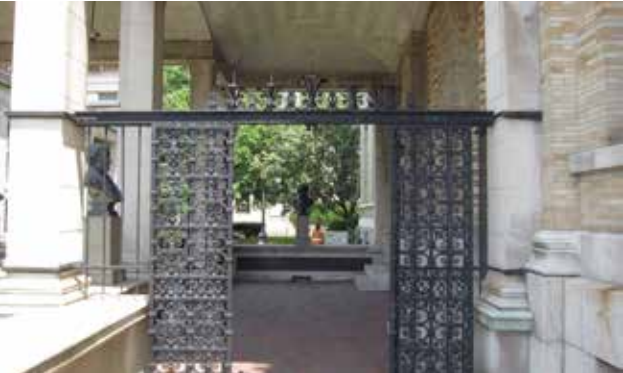
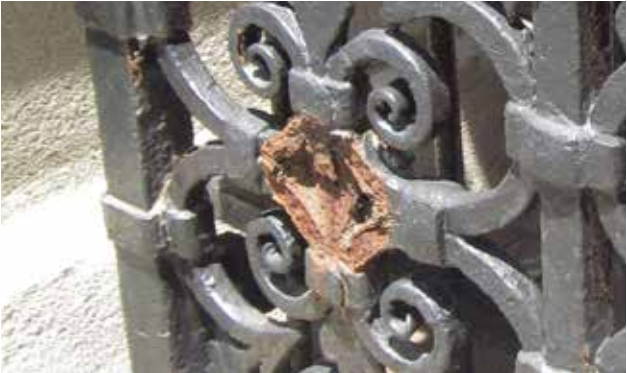
MU  HOF Ambulatory	<b>Missing Unit</b> Decorative element lost, resulting from impact or weakening due to corrosion.	<b>Replace Unit in Kind</b> Create custom-cast replica matching in material composition (metallurgy) and secure in place. Prime and finish to match the decorative grille.	Level 3

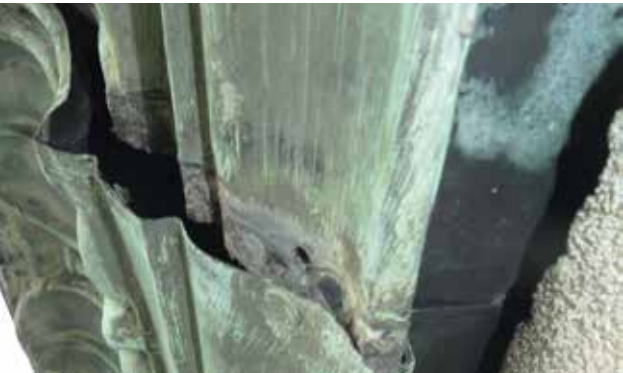
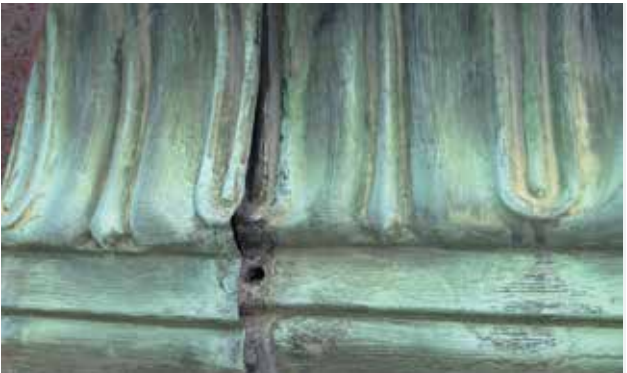
OJ  GML Cornice	<b>Open Joint</b> Gap in seam between sections of sheet metal. Opening may be a result of differential movement between sections caused by deterioration of the masonry substrate or corrosion of the supporting structure.	<b>Remove &amp; Re-secure</b> Remove and salvage section of cornice. Review condition of existing support structure and repair or supplement to create a sound connection. Clean metal and secure in original location.	Level 3

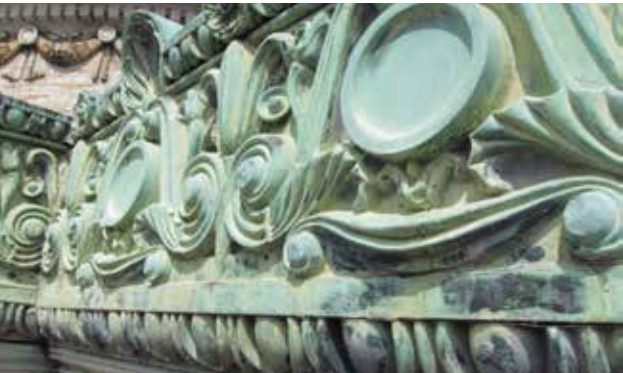
SA  GML Cornice	<b>Soiling: Atmospheric</b> Buildup of atmospheric pollutants over time, generally in areas not washed (in the shadow of) precipitation.	<b>Restore Cornice: Clean &amp; Coat</b> Dilute chemical, hand-apply & scrub, rinse Spray apply, dry and re-apply.  <b>Alternate: Replace in Kind</b> Salvage entire cornice and install replica on stainless steel armature.	GML Cornices Level 4

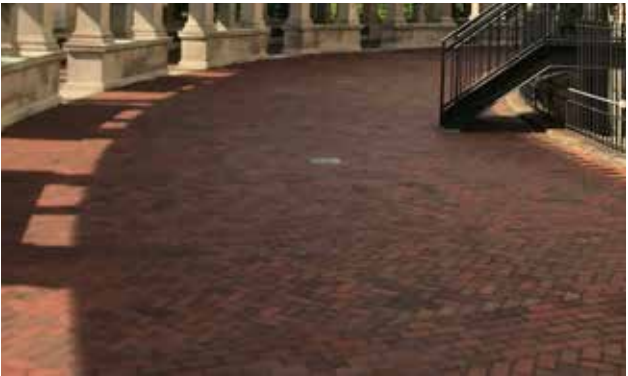
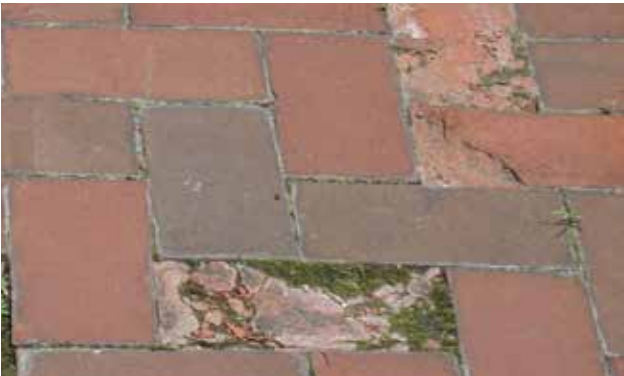
COMPONENT	CONDITION	TREATMENT	PRIORITY	REPRESENTATIVE PHOTO	
BU  HOF Terrace	<b>Broken Unit</b> Brick Paver broken or severely deteriorated by mechanical abrasion, impact, or prolonged weathering. Durable outer surface has been compromised to expose softer inner clay.	<b>Remove Loose Unit</b> Provide replacements for broken and missing pavers.  <b>Alternate: Replace Terrace Roof</b> Remove all terrace pavers (installed during a prior repair project). Review condition of waterproofing and deck below. Provide new pavers and setting bed.	Broken Pavers Level 2  Terrace Paving Level 5

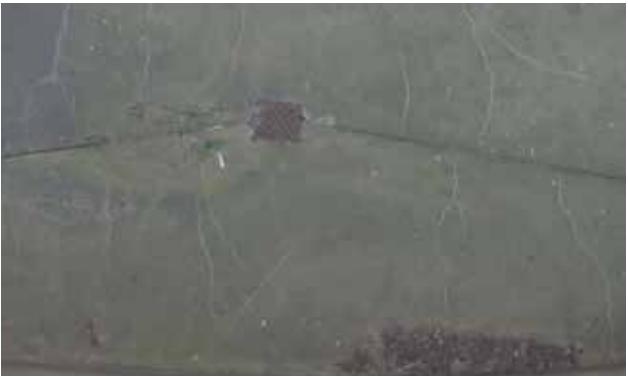
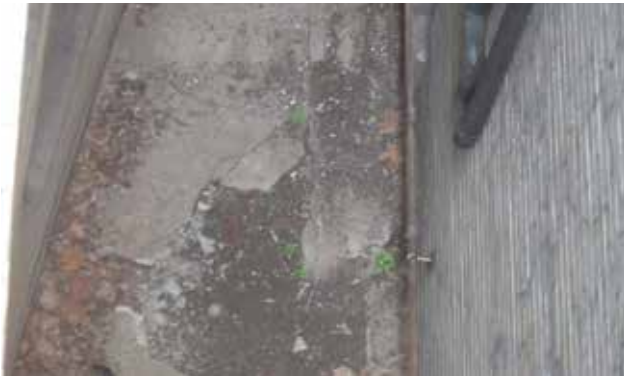
CN  GML Areaways	<b>Crack: Network</b> A patterned network of intersecting fissures.	<b>Replace Paving</b> Remove deteriorated concrete & replace in kind. Include replacement of all drains and leader lines into building.	Level 3

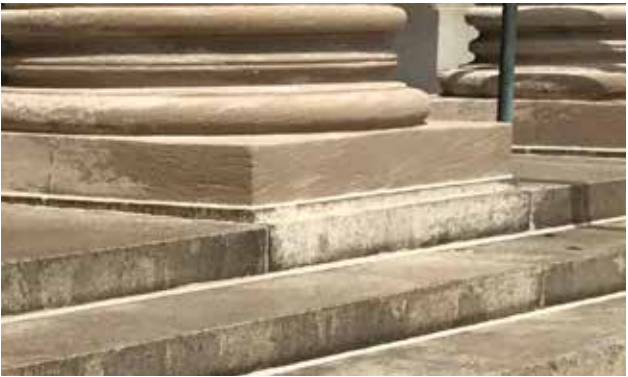
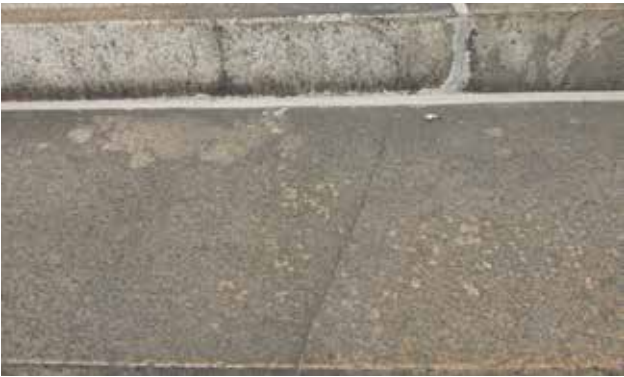
CR  GML Portico	<b>Cracked Stone</b> A fracture or fissure in the masonry of minimum 1/16" width and length that could indicate movement of adjacent parts.  Cracks open due to age, weathering, or differential stresses from movement within the building envelope. Opening of cracks within the single stone unit may indicate differential movement between sections of the building.	<b>Partial Replacement</b> Provide stone Dutchman at crack location.	Level 3

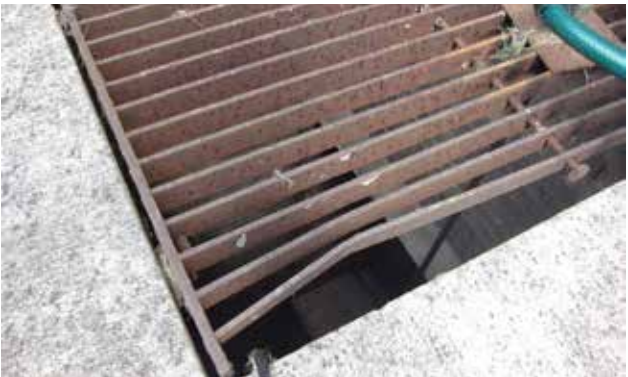
ED  GML Areaways	<b>Deformed Element</b> Malformation of areaway grating resulting from prior impact or movement.	<b>Repair &amp; Refinish</b> Salvage grating, bend into place or weld replacement units for those misshaped. Prepare, prime & paint.	Level 3

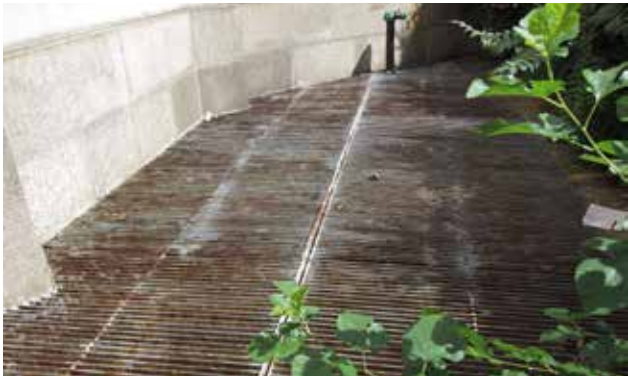
COMPONENT	CONDITION	TREATMENT	PRIORITY	REPRESENTATIVE PHOTO	
MC  GML Areaways	<b>Metallic Corrosion</b> Failure of paint coating, which acts as a protective sacrificial layer against weathering. When these coatings fail, the steel substrate is vulnerable to moisture penetration and oxidation, eventually leading to loss of section/profile.	<b>Refinish</b> Prepare, prime & paint.	Level 3

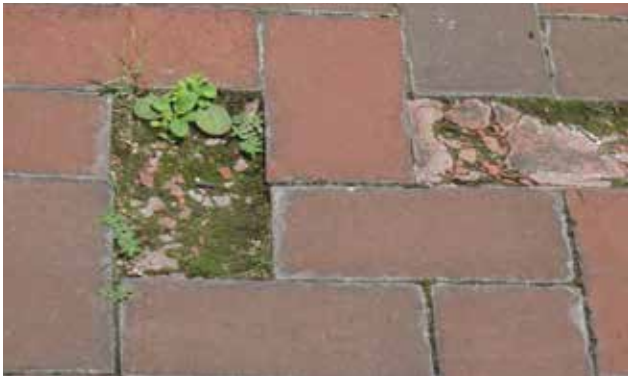
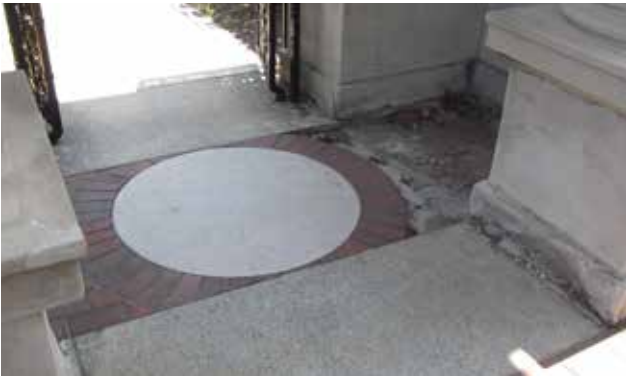
MU  HOF Terrace	<b>Missing Unit</b> Brick Paver broken or sheared, resulting from differential movement in the roofing or masonry substrate, freeze-thaw action, or impact by objects.	<b>Replace Unit in Kind</b> Provide replacements for broken and missing pavers.  <b>Alternate: Replace Terrace Roof</b> Remove all terrace pavers (installed during a prior repair project). Review condition of waterproofing and deck below. Provide new pavers and setting bed.	Level 2

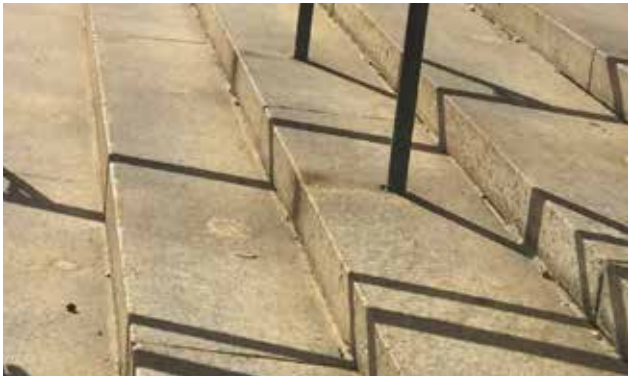
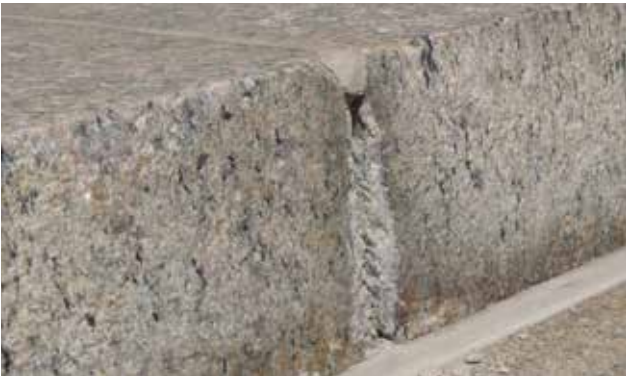
OJ  GML Portico Stairs  GML Areaways	<b>Open Joint</b> Complete or partial loss of pointing mortar provides access for moisture migration into the masonry substrate.  Joints open due to age, weathering, or differential stresses from movement within the stone or its foundation. The mortar can be further damaged with salts and moisture migration.	<b>Cut and Point</b> Rake out and repoint joints 100%. Rake out and repoint open and damaged joints to limit water infiltration into the exterior masonry walls. Mortar must be an appropriate mix to match the physical and aesthetic characteristics of the original mortar and building materials. Mortar analysis should be conducted to determine color and chemical composition of the mortar.	Portico Stairs Level 3  GML Areaways Level 3

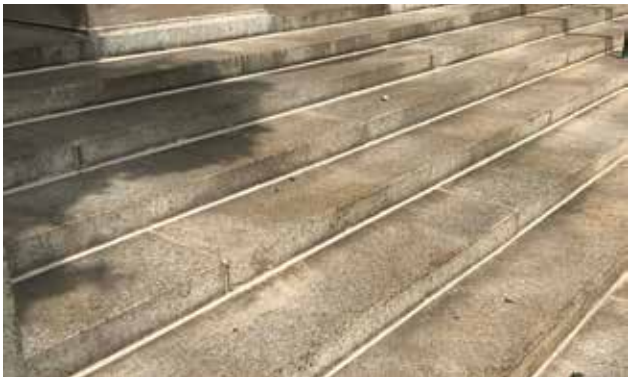
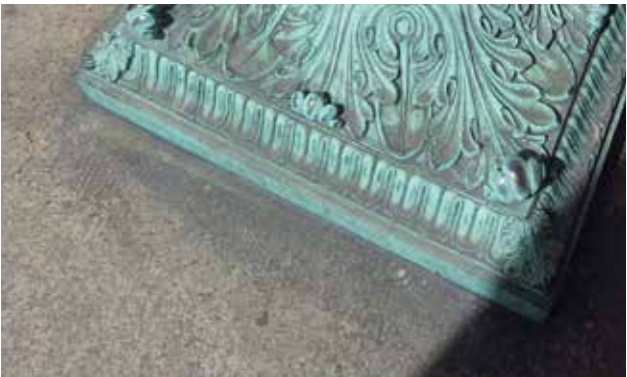
SA SB SC  GML Portico Stairs  GML Areaways	<b>Soiling: Atmospheric</b> <b>Staining: Biological</b> <b>Staining: Copper</b>  Soiling and staining of the base material are described by Components above including Atmospheric Soiling, Biological Growth, Copper Staining.  Copper staining at GML granite is limited in area and effect, while the removal process is labor intensive.	<b>Cleaning</b> Perform procedures described in the Stone Masonry Treatments.	Portico Stairs Level 5  GML Areaways Level 3
