# Conditions Assessment

## Gould Memorial Library & Hall of Fame

FINAL REPORT | 15 MARCH 2018

**BRONX**  
**COMMUNITY**  
COLLEGE

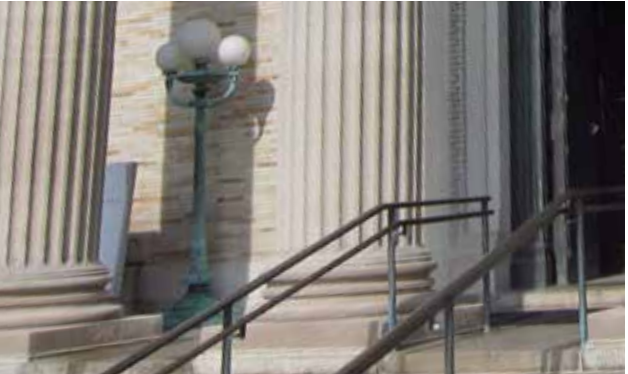
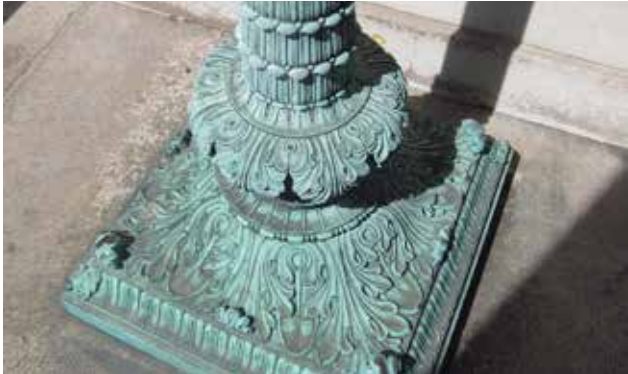
COMPONENT	CONDITION	TREATMENT	PRIORITY	REPRESENTATIVE PHOTO	
DS  GML Portico	<b>Displacement</b> Fixture out of plumb.	<b>Restoration</b> Perform full repair of light fixture by disassembling, cleaning, re-wiring, re-assembling, and tightening all connections.  Secure fixture in place with new epoxy anchors and removable nuts.	Level 4

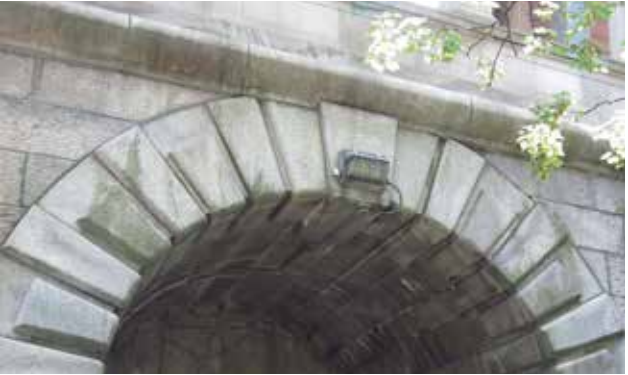
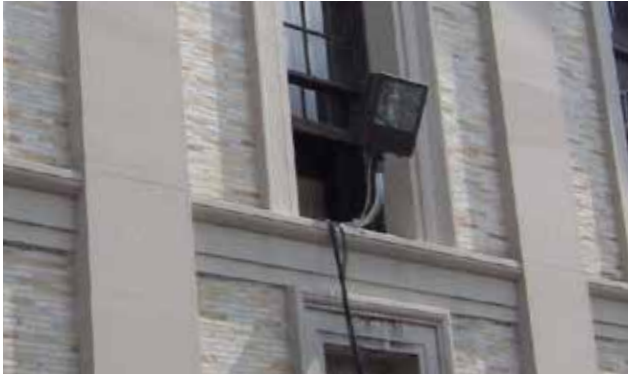
EI  GML Facade  HOF Granite	<b>Inappropriate Element</b> Security lighting not historically appropriate.	<b>Provide Historically Appropriate Lighting</b> Perform analysis of light levels required at exterior areas and implement a system of fixtures that provide suitable illumination and are in keeping with the historic character.	GML & HOF Level 4

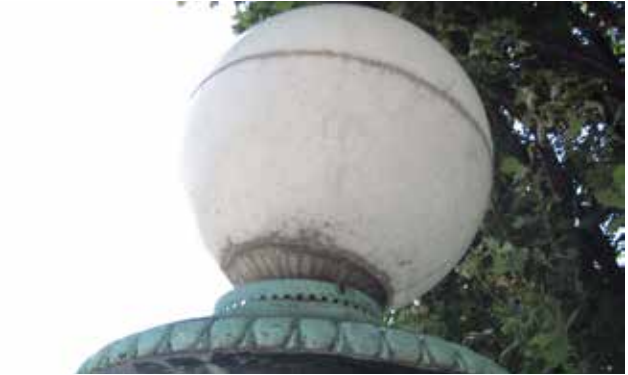
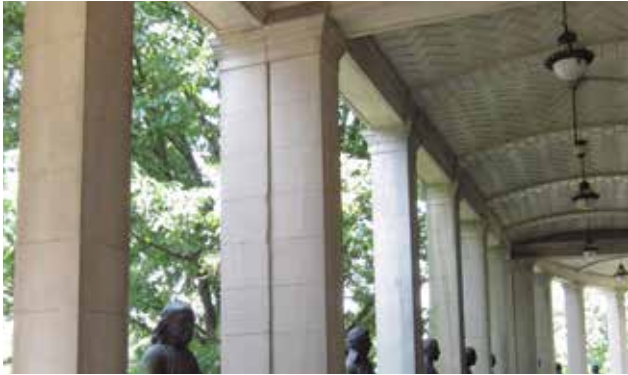
IL  All Exterior Areas	<b>Illumination</b> Fixture does not provide footcandles/lumens required by code for wayfinding or egress.	<b>Relamp Existing Fixture</b> Perform analysis of light levels required at exterior areas to determine whether supplemental illumination is needed.  Perform full repair of light fixture by disassembling, cleaning, re-wiring, re-assembling, and tightening all connections.  Replace bulbs with higher output energy efficient lamps.	Level 4

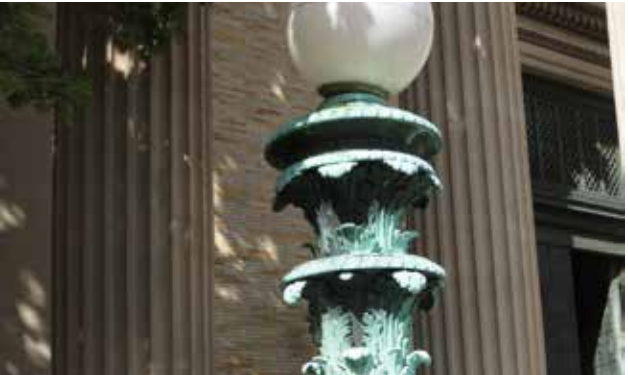
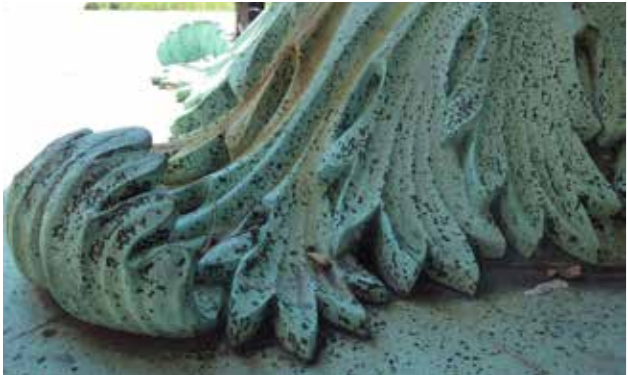
LP  GML Portico	<b>Loss of Patination</b> Wear of protective finish.	<b>Clean &amp; Refinish</b> Clean with micro-abrasive applied by a conservator.  Apply corrosion-inhibiting coating, dry and re-apply.	Level 4

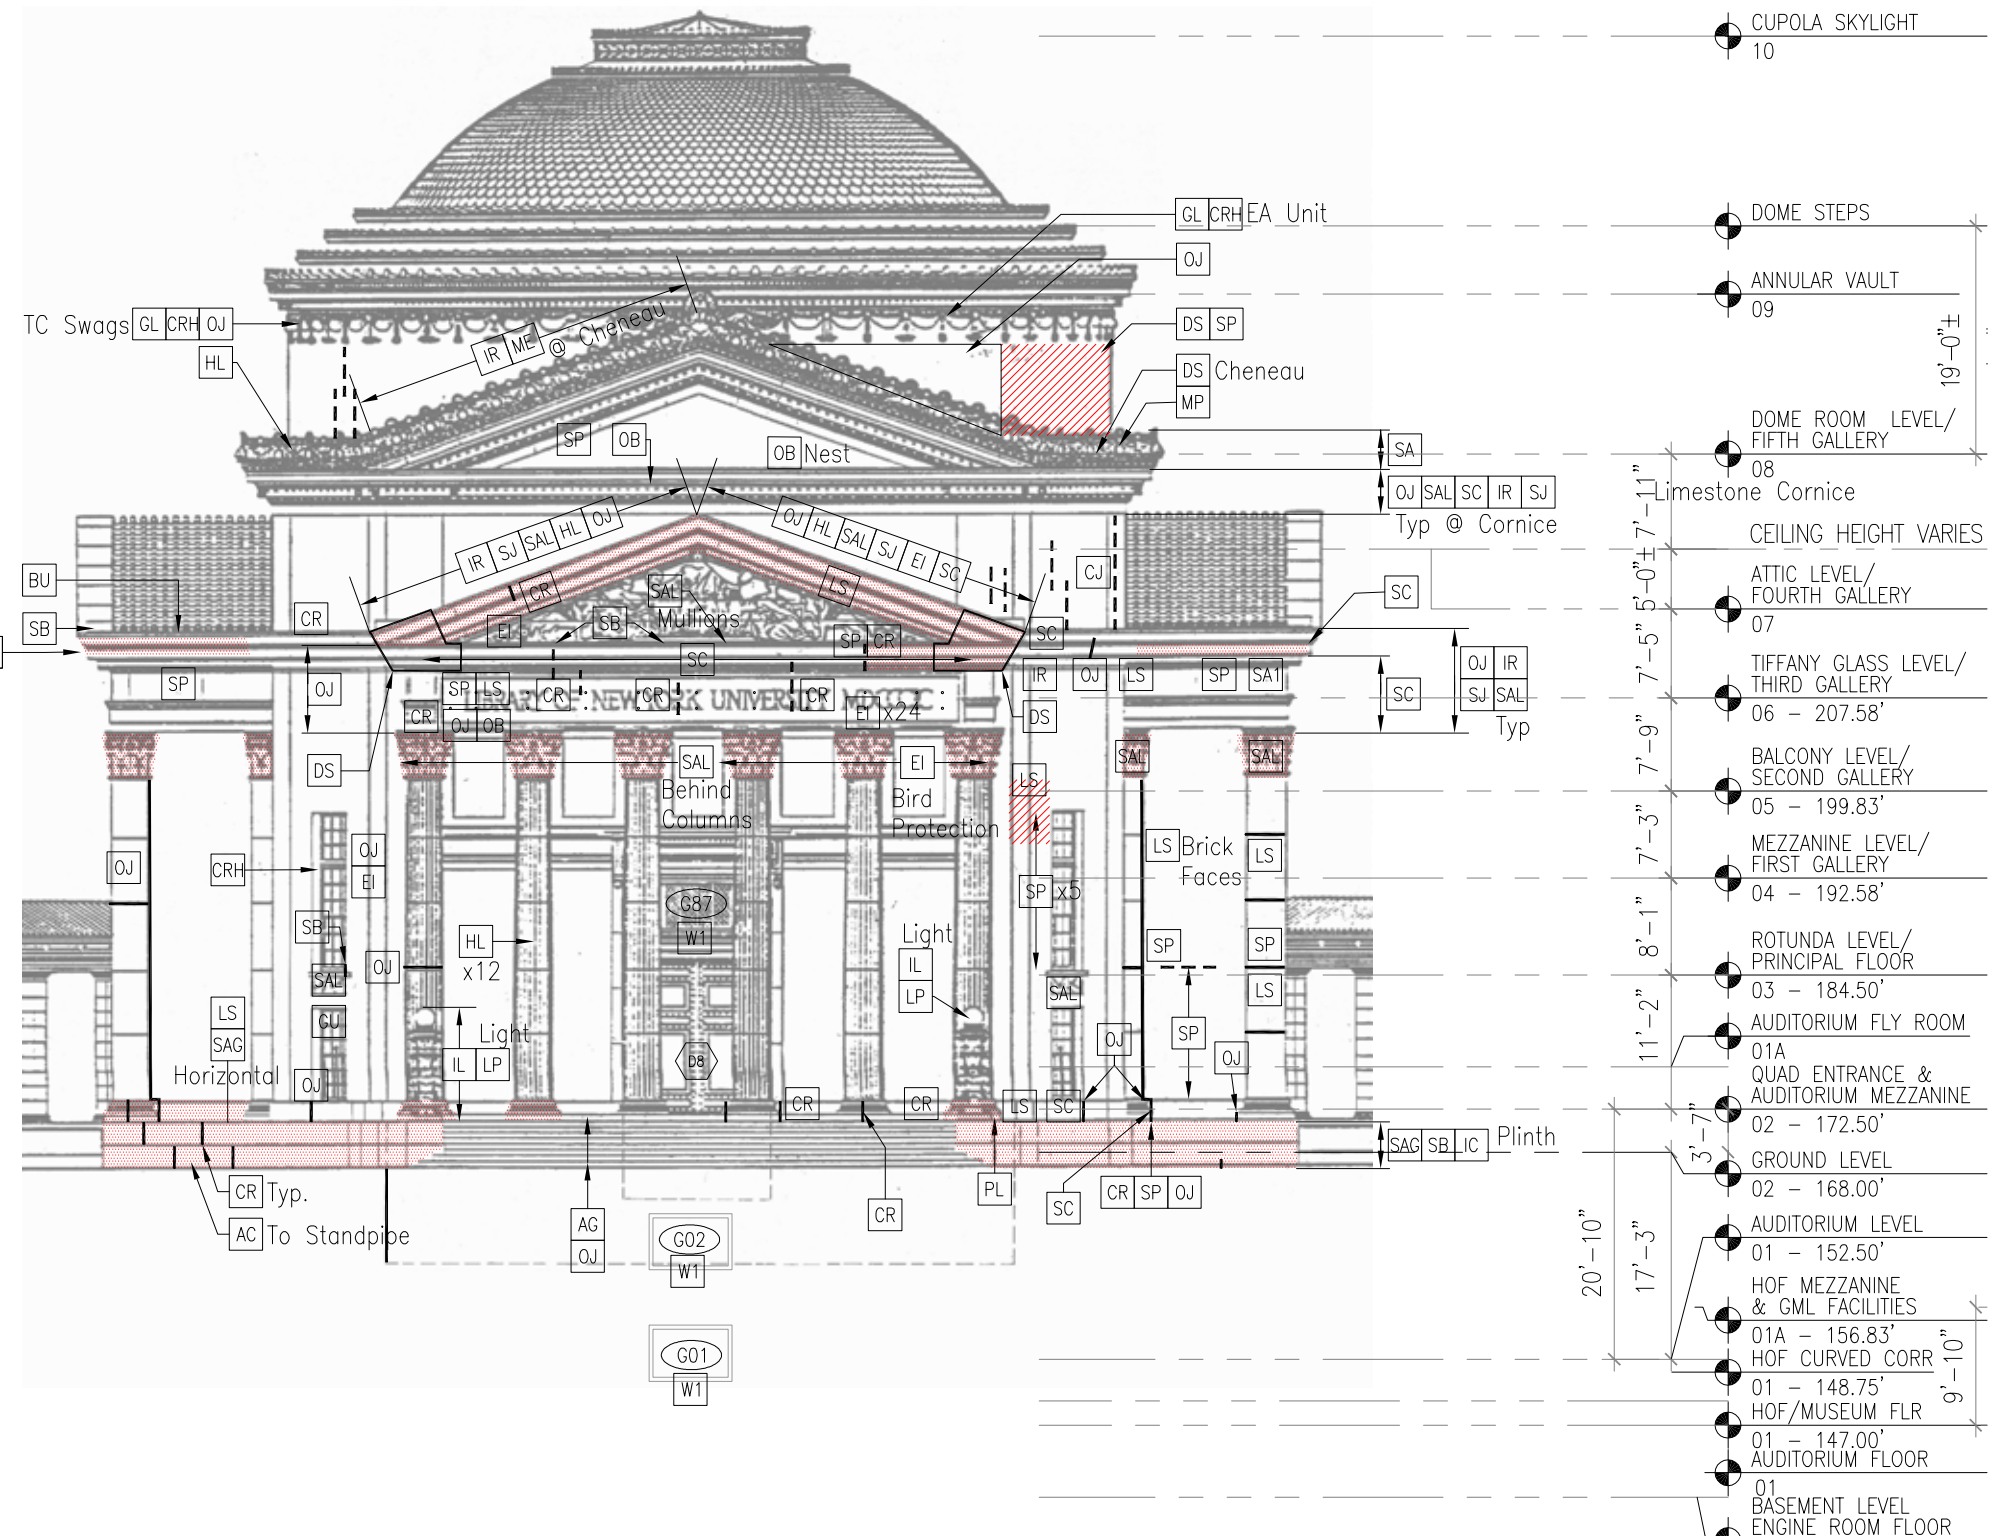
- Severe staining below modillions
- Open joints @ cornice units
- Water staining below open joints
- Staining @ capitals

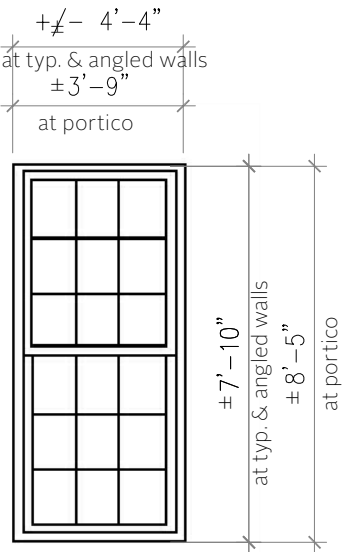
B  
double-hung

Facades at N, S, W  
Divided light windows generally exist in good condition.  
As a character-defining element windows may be repaired except 3 severely deteriorated units at the south facade.

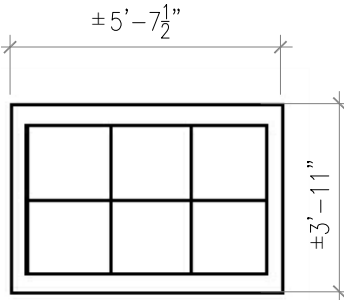
F  
fixed transom

Non-original units;  
Good conditions

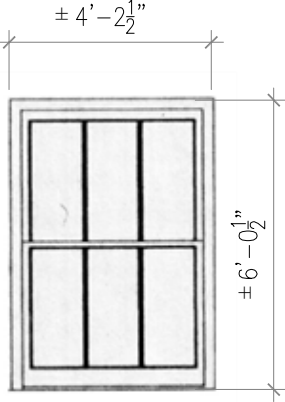
**H**  
casement

North Areaway  
Restore

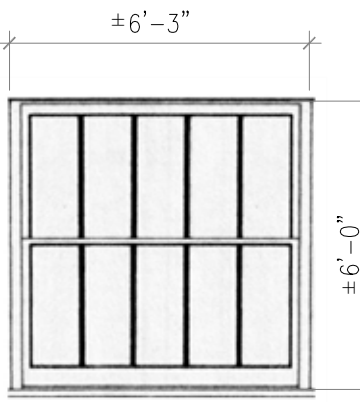
**I**  
double-hung

Areaways  
Restore

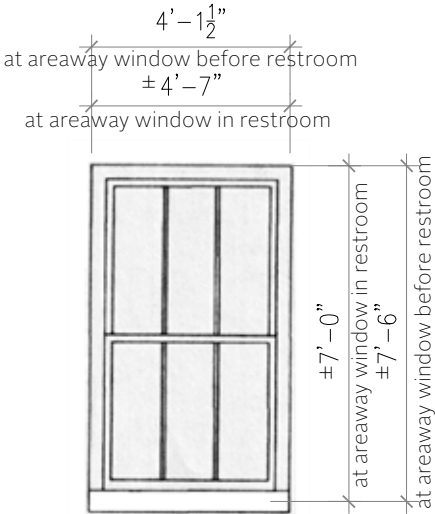
**J**  
double-hung

Areaways  
Restore

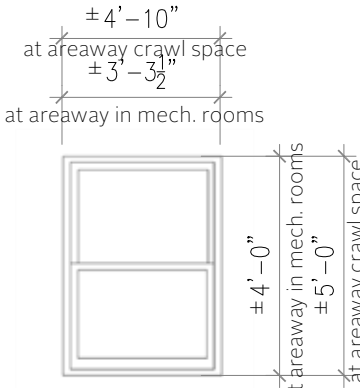
**L**  
double-hung

Basement o1  
Poor condition,  
replacement  
recommended

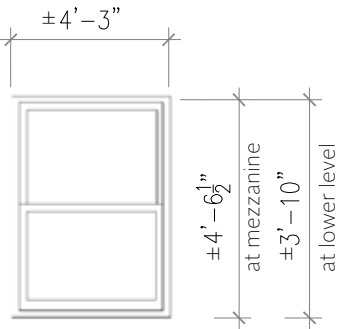
**O**  
fixed

Language & Philosophy Corridors  
Non-original units;  
replacement recommended

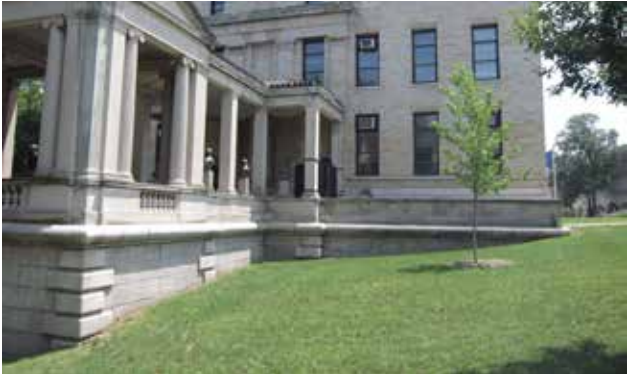
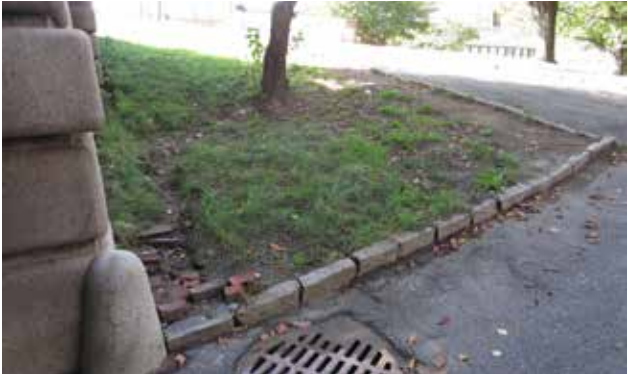
COMPONENT	CONDITION	TREATMENT	PRIORITY	REPRESENTATIVE PHOTO	
LD1 - LD5	<p><b>Poor Drainage</b></p> <p>In locations where water flows toward the building or pathway as a result of settlement or long term erosion activity, the grade may be modified by elevating areas to pitch away from the structure. Where the grade inherently slopes toward the building or walkway a soft swale or drainage gutter can be considered to collect and redirect surface flows.</p>	<p><b>Modify Grade</b></p> <p>In locations where water flows toward the building or pathway as a result of settlement or long term erosion activity, the grade may be modified by elevating areas to pitch away from the structure. Where the grade inherently slopes toward the building or walkway a soft swale or drainage gutter can be considered to collect and redirect surface flows.</p>	Level 4

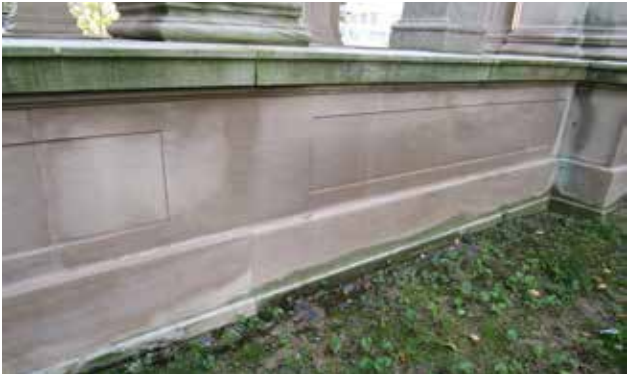
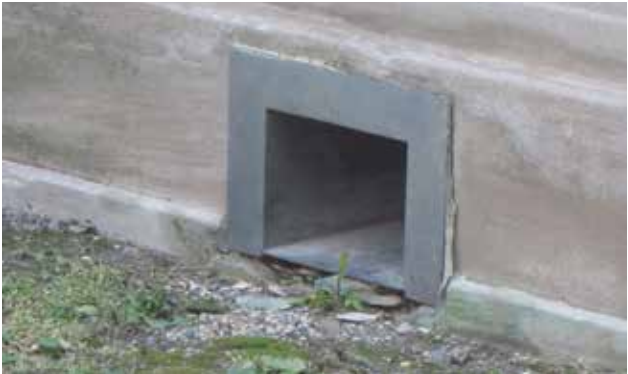
LD6 - LD11	<p><b>Erosion</b></p> <p>Perimeter of HOF has been washed away by run-off from roof scuppers.</p>	<p><b>Provide Maintenance Border</b></p> <p>Install a stone maintenance border at the perimeter of the HOF to absorb the impact of roof run off and direct it away from the building wall sloping toward central lawn drains. Drainage gravel below the maintenance strip will aid in reducing rising damp at the buildings limestone base course.</p>	Level 3

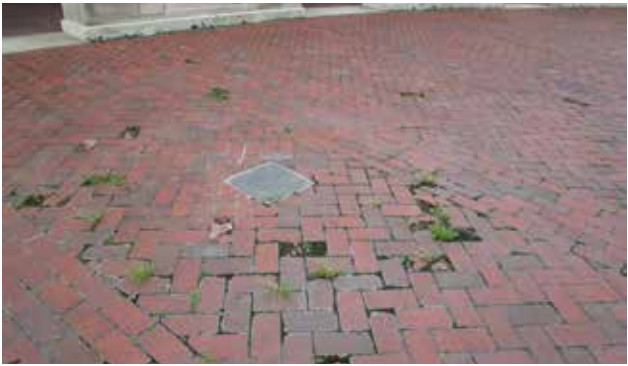
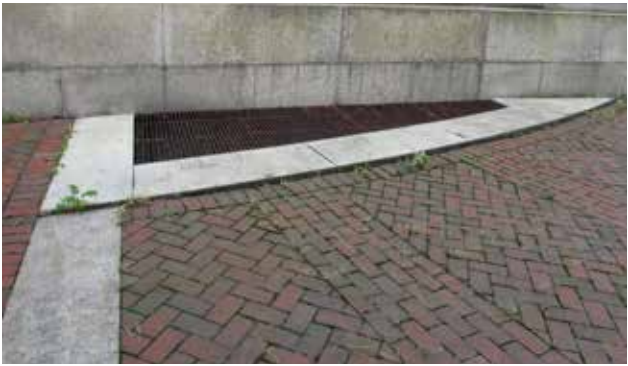
LD12 - LD13	<p><b>Surfaces</b></p> <p>Surface spalling of brick paving is evident and surface vegetation is seeded in the joint work between the paving bricks. Level of spalling is modest less than 10 percent of the overall paved surface.</p> <p>Granite border on areaway grate is two to four inches above the adjacent brick paving.</p>	<p><b>Replace Paving</b></p> <p>Replace brick paving that has begun to spall, remove organic vegetation, point any open joints to arrest deterioration and water infiltration.</p> <p><b>Assess Granite Areaway Borders</b></p> <p>It is not certain if this is the original as-built condition or if the paving has settled. The condition should be looked at as a potential safety concern should the HOF terrace be used for public events.</p>	Level 3

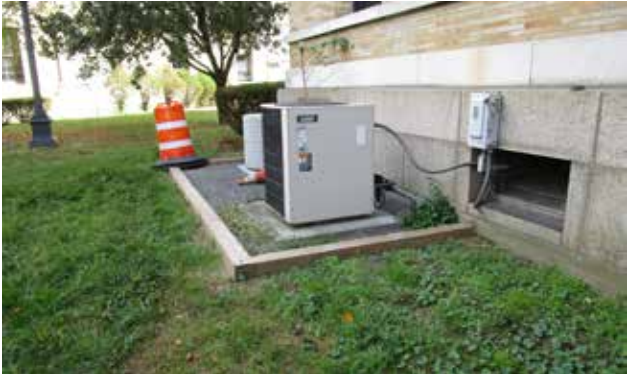
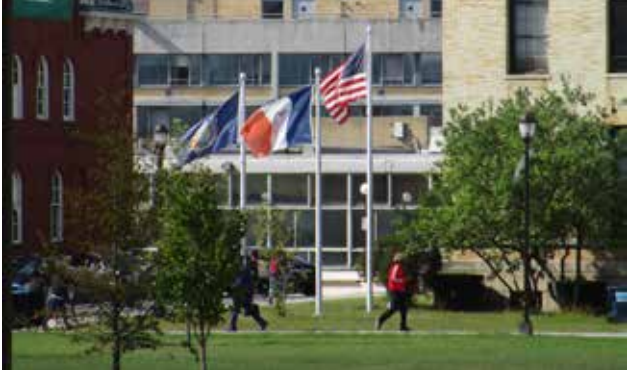
LE1 - LE5	<p><b>Inappropriate Elements</b></p> <p>AC units located west of the Hall of Language within a landscape timber and gravel setting are unsightly, distract from the landscape setting and make noise adjacent to the HOF adversely affecting the experience.</p> <p>The AC condensing units are unsightly and distract from the curved wall of the GML as seen from Sedgwick Avenue.</p> <p>Decorative site elements are not in the character of the historic landscape, including metal posts between Philosophy Hall and HOF, concrete and bronze tree memorial, and flagpoles outside of Language Hall.</p>	<p><b>Improve Mechanical Systems</b></p> <p>Units should be relocated away from important views and public areas. Where units cannot be taken out of the public landscape their positioning and treatment the immediate surrounds should reflect historic character of the White complex.</p> <p><b>Assess Landscape Elements</b></p> <p>Service upgrades (including chilled water, electric, fire alarm, data, etc.) should be installed below grade. Fencing element remaining attached to the historic building will need to be assessed for historic appropriateness and rehabilitated or removed. Memorial marker at the White complex should be treated with the same respect as the markers relocated for improvements of the Quad Landscape Improvements.</p>	Level 5

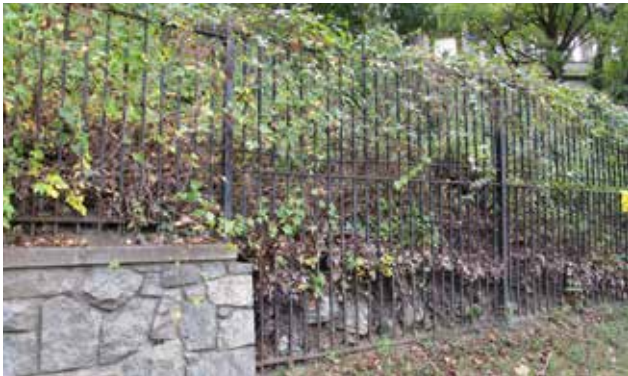
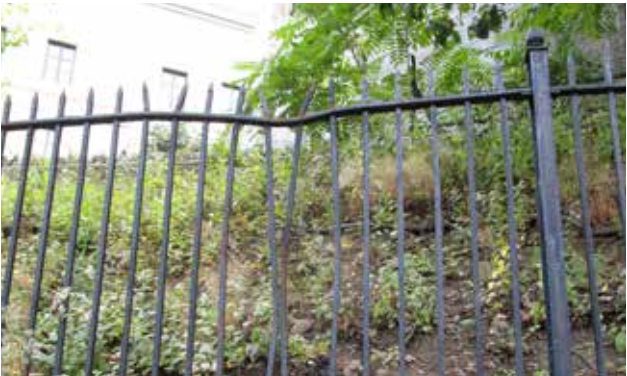
COMPONENT	CONDITION	TREATMENT	PRIORITY	REPRESENTATIVE PHOTO	
LE6 - LE7	<p><b>Site Fences</b></p> <p>Iron fencing along Sedgwick Avenue is in fair to poor condition. Many of the historic acorn finials are missing and the base is rusting from having soil and debris pile up against the post and pickets over several decades. Some minor sections of fence have bent or dislodged pickets.</p>	<p><b>Fence Repair</b></p> <p>Iron fencing along Sedgwick Avenue is a contributing element of the historic landscape. Repair/rehabilitation of the fencing to reflect its historic character. Deteriorated site conditions, collected debris, elevated grades and proposed vegetation renewal, need to be addressed as part of the perimeter fence work.</p>	Level 4

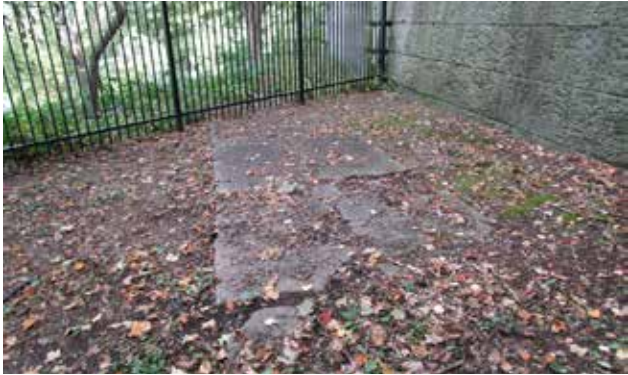
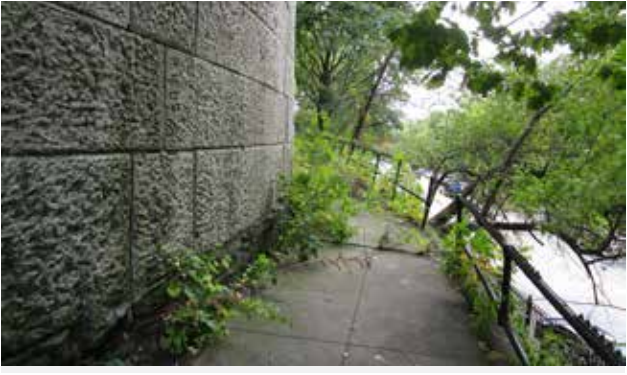
LE8 - LE10	<p><b>Site Walks</b></p> <p>The concrete walk at the northwest auditorium exit is cracked and failing. The walk is blocked off from the corner of Sedgwick Avenue and Hall of Fame Terrace drive by the 8 foot high aluminum fencing.</p> <p>The concrete walk, metal handrail and downslope stone retaining wall are failed along the west perimeter of the HOF.</p>	<p><b>Improve Walkway</b></p> <p>The concrete walk is part of the historic circulation system of the building. Contemporary pedestrian and emergency exit needs for the auditorium will direct the preferred treatment options in this location. The aluminum fencing is a contemporary add addressing security concerns. Its position and relationship to the building needs to reflect the historic setting.</p>	Level 5

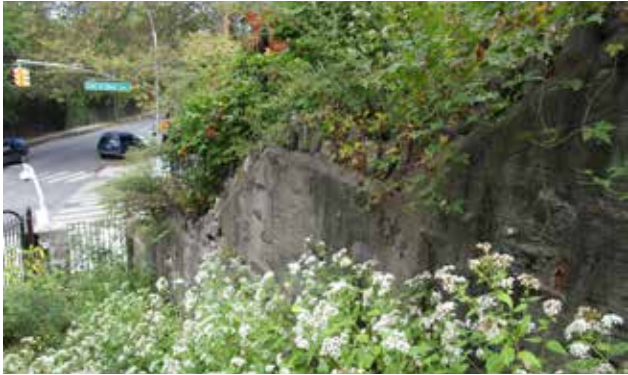
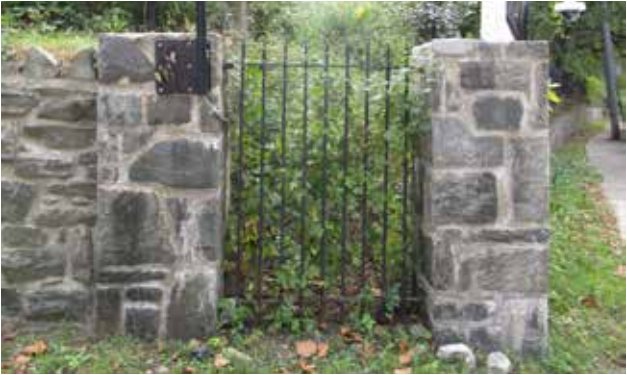
LE11 - LE13	<p><b>Site Walls</b></p> <p>The historic steps to the corner of Sedgwick Ave and Hall of Fame terrace gate are no longer present and the gate in operation.</p> <p>The stepped retaining wall with stone finials upslope of the historic walk and steps is a character feature of the historic landscape and still functions to retain the slope. It is in fair to poor condition.</p>	<p><b>Repair Walls</b></p> <p>The stepped retaining wall is both an historic feature and performs a function in retaining the steep slope. Restoration of the wall to preserve its historic materials and fabric and prevent future failure is the preferred approach. Steps which are no longer present would not be replaced. Re-grading of their location to illustrate the historic circulation pattern and replacement with a secure yet operational gate will serve as a maintenance access for this area.</p>	Level 4

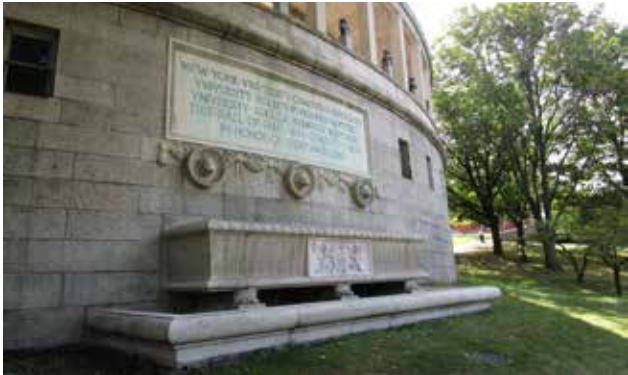
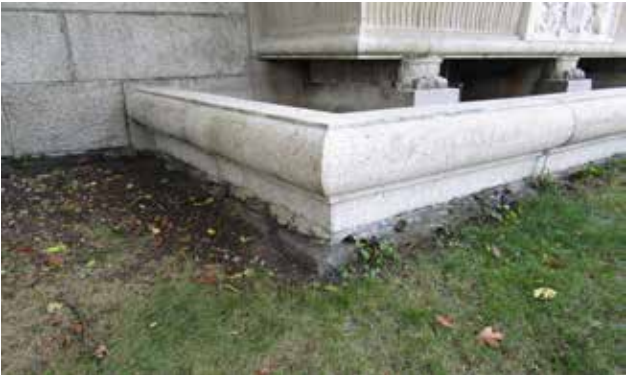
LE14	<p><b>Historic Fountain</b></p> <p>The fountain at the base of the HOF west slope is in fair to good condition, without operational plumbing systems.</p>	<p><b>Restore Fountain</b></p> <p>Repair stone fountain, restore basin and re-energize with flowing water.</p>	Level 5

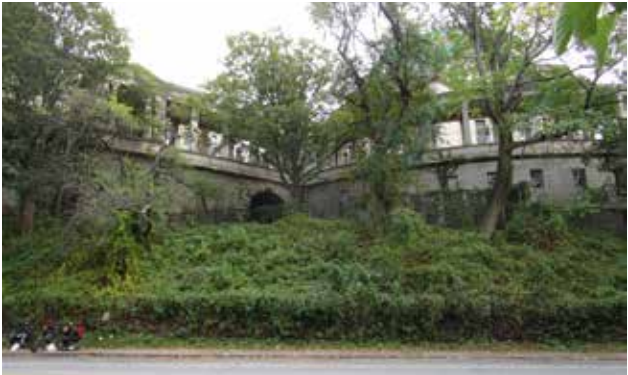
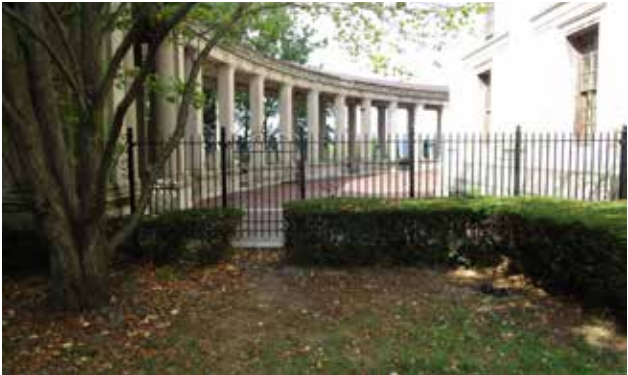
COMPONENT	CONDITION	TREATMENT	PRIORITY	REPRESENTATIVE PHOTO	
LP1 - LP10	<p><b>Plantings</b></p> <p>The west sloping bank is covered with invasive vines, brambles, woody shrubs and tree species.</p> <p>Hedges &amp; invasive vines obstruct and engulf the SW portion of the site.</p> <p>Vegetation at the east facing the Quad has been altered over time by addition of small ornamental plantings, not in keeping with the historic character and setting.</p>	<p><b>New Contextual Plantings</b></p> <p>Vegetation treatment for the White complex will vary with proximity to the buildings and anticipated uses. Planting at the immediate core of the White buildings is to be reduced and restructured to reinforce the historic structures and framework of the landscape. The slightly sloped west lawn between HOF and Community Hall can remain as a tree canopied turf area refined to reflect the historic setting for the Complex. The lower slope requires removal of invasive species and maintenance strategy to retain open views from Sedgwick Ave.</p>	Level 4

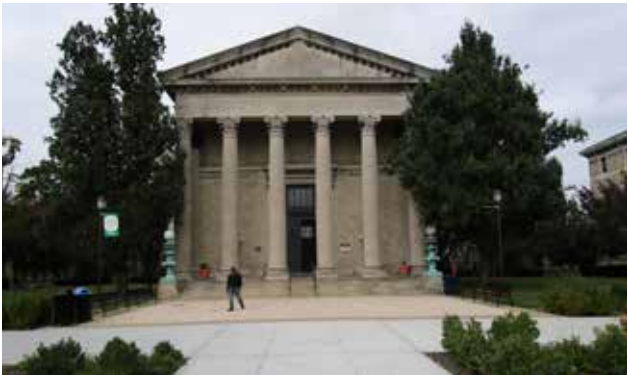
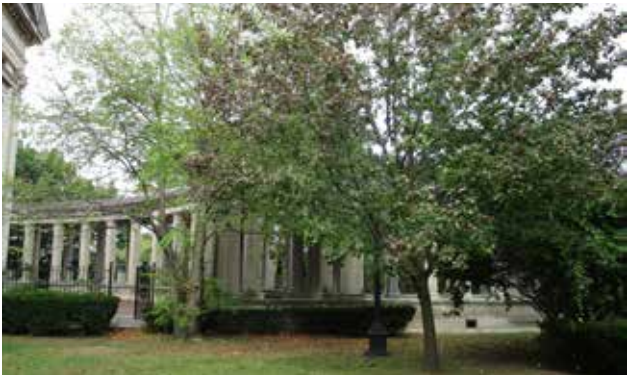
LV1 - LV3	<p><b>Visual Obstruction of Buildings</b></p> <p>The east façade of GML is partially covered by flanking columnar English oak trees to either side. The view of the GML front façade and pediment is partially blocked from the central and crossing walkways.</p> <p>Trees are planted that will block the view of the HOF colonnade and GML south facing end wall and dome structure from the campus walks and drive.</p>	<p><b>Remove Existing &amp; Provide Contextual Plantings</b></p> <p>Restructure tree and shrub planting to reinforce the historic setting of the White complex while addressing contemporary uses of the immediate buildings surrounds. The process will involve review of historic images, selective removal and appropriate replacement materials.</p>	Level 4

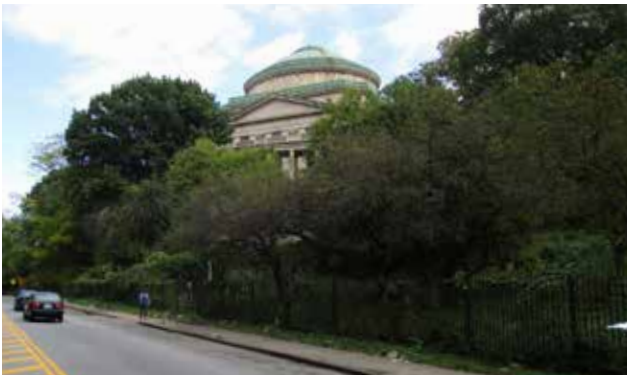
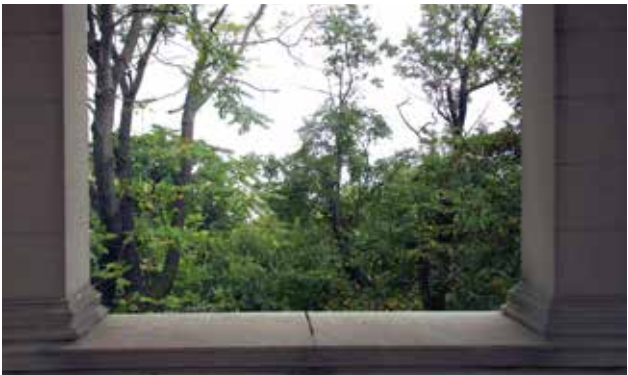
LV4 - LV6	<p><b>Obstruction of Views</b></p> <p>View from the HOF terrace overlooks the north west slope toward the University Woods below.</p> <p>View of the White complex from Sedgwick Drive is obstructed by invasive material and tree growth, adversely altering the setting of the historic campus.</p>	<p><b>Selective Removal &amp; Thinning</b></p> <p>Restore the visual relationships between the HOF/GML complex and Sedgwick Avenue by removal of invasive woody and herbaceous materials along the entirety of the frontage. Selective removal and thinning of tree canopies will improve the visual connections and provide historic vistas from the HOF covered walk. Selective thinning of trees atop the slope with removal of low shrub massing between Community Hall and HOF will improve the visual relationship between the structured areas and define this historic landscape area.</p>	Level 3

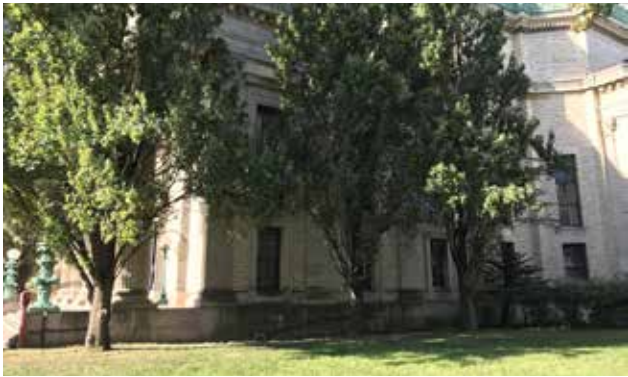
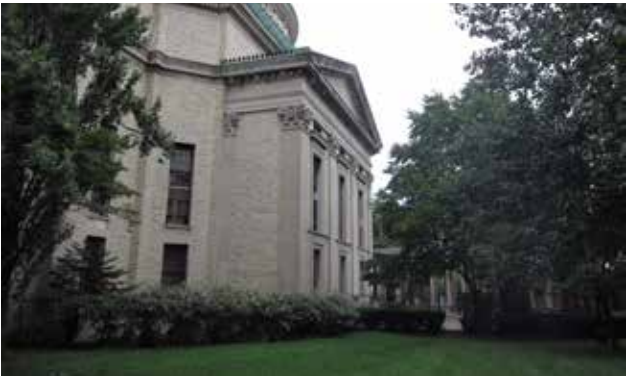
COMPONENT	CONDITION	TREATMENT	PRIORITY	REPRESENTATIVE PHOTO	
LA1 - LA2	<p><b>Site Accessibility</b></p> <p>The landscape areas north and south of GML do not contain paved pedestrian walks to allow ADA access to GML and the HOF, or egress at the lower level.</p> <p>The gated entry to the HOF is access across the turf covered lawns. The HOF is accessible via a concrete walk that links the Campus green and North Hall and Library to the north end of the HOF walk and terrace.</p> <p>FDNY access to standpipes is blocked by yew hedgelings and flowering abelia.</p>	<p><b>Provide Accessible Exterior Routes</b></p> <p>Provide ADA access to the GML by installing a combined walk-ramp to the north side of GML. The ramp is to maintain a low profile that respects the historic setting with modest detail that relate to the historic structures while discernible.</p> <p>Improve connectivity in this area of campus by installing pedestrian walk to the HOF terraces to either side of the GML.</p> <p>Remove vegetation at standpipes.</p>	Level 4

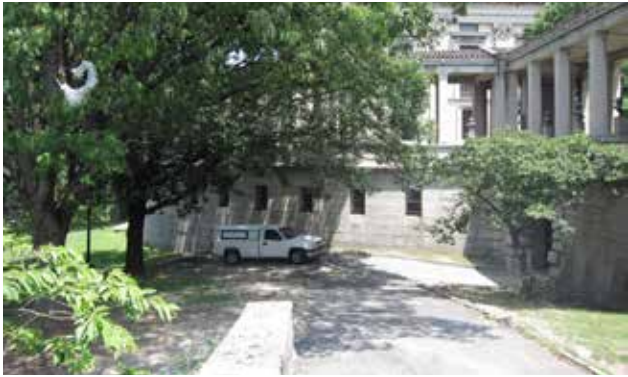
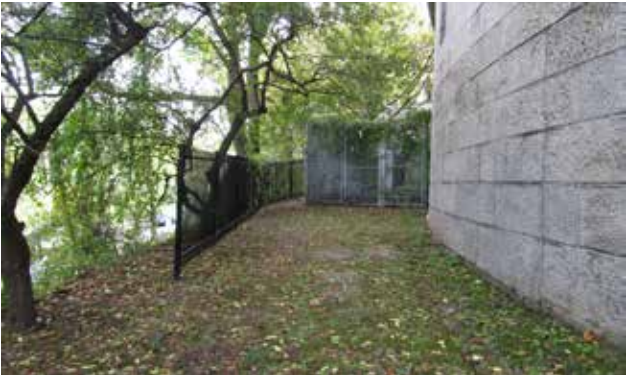
LA3 - LA4	<p><b>Site Accessibility</b></p> <p>The north auditorium archway and west slope is void of any pedestrian walkways. With exception of a path along the fenced AC condensing unit enclosure. The path is constructed of 24X36 inch bluestone paving set in a pea stone gravel.</p>	<p><b>Provide Accessible Exterior Route</b></p> <p>Construct walks to provide pedestrian, maintenance and emergency access to the west slope. Walk alignment should reflect historic carriage drive patterns and be constructed of durable materials able to accommodate vehicles and historically appropriate to the setting. Improve connectivity with Community Hall as a shared project with access to the GML Auditorium. Study grades for possible use of combined step, walk, and ramp configurations. Consider on grade emergency exiting below Community Hall to the south.</p>	Level 5

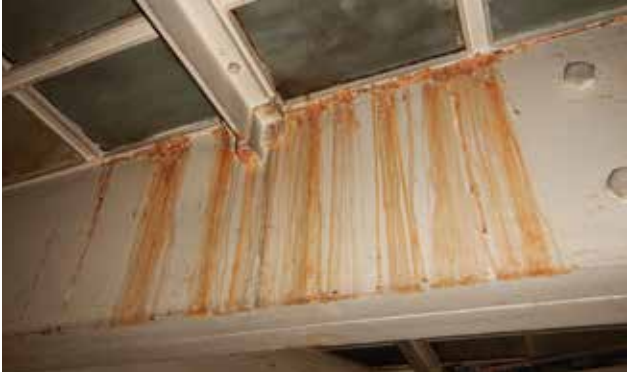
COMPONENT	CONDITION	TREATMENT	PRIORITY	REPRESENTATIVE PHOTO
<b>F1-MC</b>  Glass and Cast Iron Floor System	<b>Corrosion</b> <ul style="list-style-type: none"><li>Deterioration of cast iron structural members and connections by chemical reaction with their surrounding environment</li></ul>	<b>Removal of Deteriorated Material</b> <ul style="list-style-type: none"><li>Remove corrosion and corrosive products; in severe cases, replace and/or reinforce deteriorated members with new material to match existing.</li></ul>	Level 3

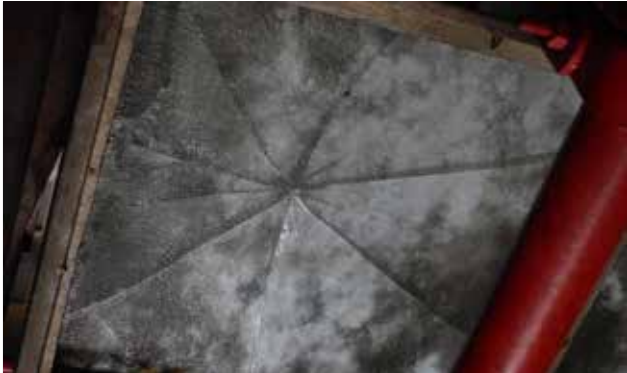
<b>F1-CR</b>  Glass and Cast Iron Floor System	<b>Cracking</b> <ul style="list-style-type: none"><li>1/16" to 1/2" wide visible fissures in glass surface, possibly penetrating through the material surface</li></ul>	<b>Material Patching or Replacement</b> <ul style="list-style-type: none"><li>Remove and replace damaged material.</li></ul>	Level 3

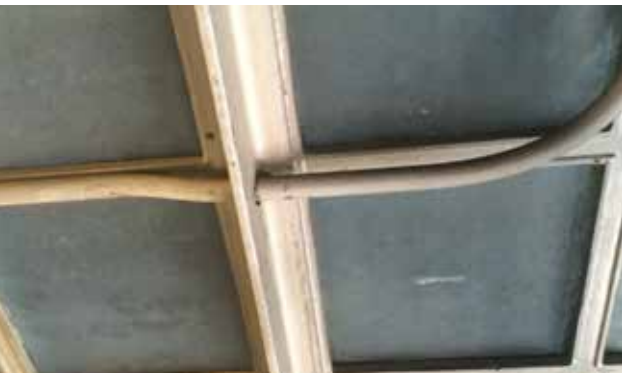
<b>F1-MD</b>  Glass and Cast Iron Floor System	<b>Mechanical Damage</b> <ul style="list-style-type: none"><li>Damage to material caused by mechanical components or equipment</li></ul>	<b>Material Repair or Replacement</b> <ul style="list-style-type: none"><li>Remove mechanical remnants and connections. Patch areas of missing or damaged material, if feasible; remove and replace material, as required.</li><li>Additional survey and analysis will be required to determine if penetrated beams require repair or reinforcement.</li></ul>	Level 3

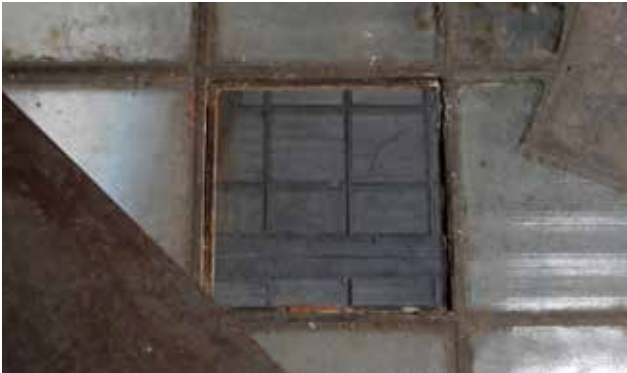
<b>F1-LM</b>  Glass and Cast Iron Floor System	<b>Material Loss</b> <ul style="list-style-type: none"><li>Loss of material leaving holes or exposing subsurface layers</li></ul>	<b>Material Patching or Replacement</b> <ul style="list-style-type: none"><li>Patch areas of missing material, if feasible, or replace material to match existing.</li></ul>	Level 3

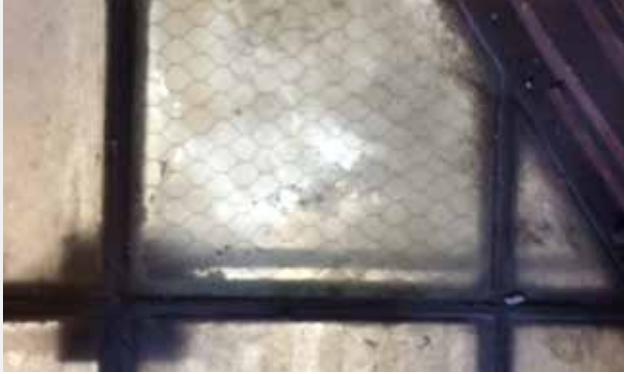
COMPONENT	CONDITION	TREATMENT	PRIORITY	REPRESENTATIVE PHOTO
<b>F1-SA</b>  Glass and Cast Iron Floor System	<b>Soiling</b> <ul style="list-style-type: none"><li>Surface staining caused by the build-up of pollutants</li></ul>	<b>Develop Cleaning Program</b> <ul style="list-style-type: none"><li>Develop a cleaning program if it can be implemented without damage to building elements.</li></ul>	Level 3

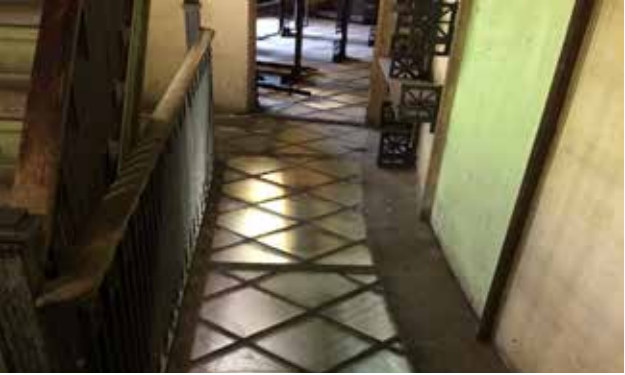
<b>F1-ST</b>  Glass and Cast Iron Floor System	<b>Staining</b> <ul style="list-style-type: none"><li>Surface problem caused by the build-up of pollutants, mineral deposits and water marks</li></ul>	<b>Develop Cleaning Program</b> <ul style="list-style-type: none"><li>Develop a cleaning program if it can be implemented without damage to building elements.</li></ul>	Level 3

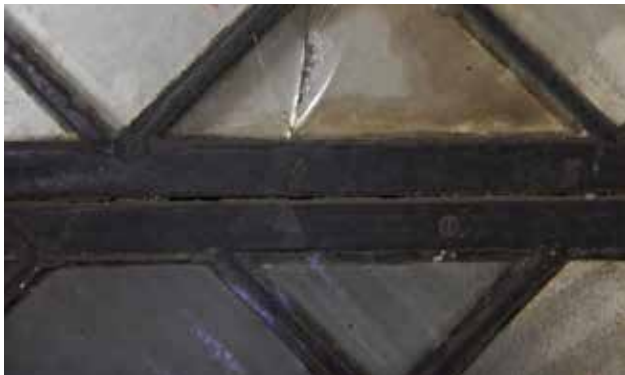
<b>F1-OJ</b>  Glass and Cast Iron Floor System	<b>Open Joints</b> <ul style="list-style-type: none"><li>Joints without caulking</li></ul>	<b>Material Replacement</b> <ul style="list-style-type: none"><li>Determine reason for missing caulk and reseal edges.</li></ul>	Level 3

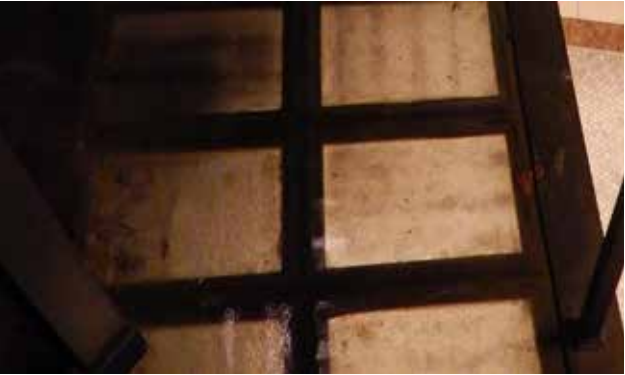
<b>F1-LC</b>  Glass and Cast Iron Floor System	<b>Paint Loss</b> <ul style="list-style-type: none"><li>Loss of surface paint.</li></ul>	<b>Material Replacement</b> <ul style="list-style-type: none"><li>Determine reason for paint loss, correct problem and repaint.</li></ul>	Level 3

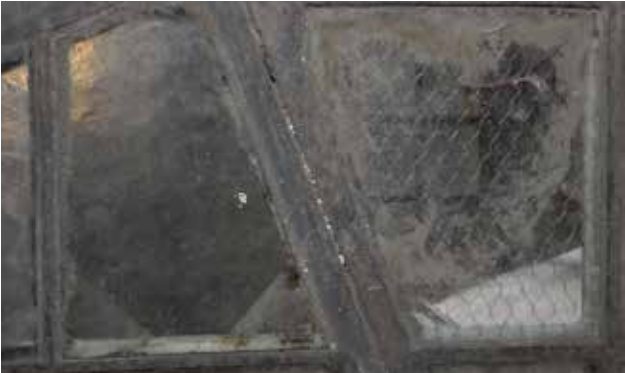
COMPONENT	CONDITION	TREATMENT	PRIORITY	REPRESENTATIVE PHOTO
<b>F1-W</b>  Glass and Cast Iron Floor System	<b>Wear</b> <ul style="list-style-type: none"><li>The gradual disintegration and erosion of materials caused by gradual use overtime.</li></ul>	<b>Material Patching or Replacement</b> <ul style="list-style-type: none"><li>Leave alone unless severe, then consider replacing.</li></ul>	Level 3	 
<b>F1-DGC</b>  Glass and Cast Iron Floor System	<b>Deteriorateid Glazing Putty</b> <ul style="list-style-type: none"><li>Minimal amounts of glazing putty at glass remain.</li></ul>	<b>Material Repair or Replacement</b> <ul style="list-style-type: none"><li>Scrape remaining glazing putty away and replace with new glazing compound.</li></ul>	Level 3

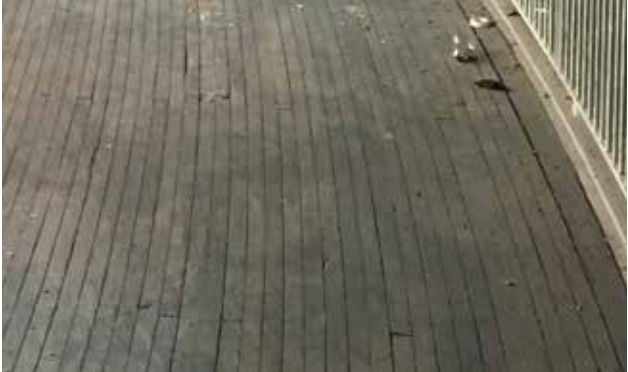
COMPONENT	CONDITION	TREATMENT	PRIORITY	REPRESENTATIVE PHOTO
<b>F2-OJ</b>  <b>Wood Floor System</b>	<b>Open Joints</b> <ul style="list-style-type: none"><li>• Joints between floor boards have opened and separated.</li></ul>	<b>Material Patching or Replacement</b> <ul style="list-style-type: none"><li>• Determine reason for opening of joints. Replace affected areas of floor system.</li></ul>	Level 3

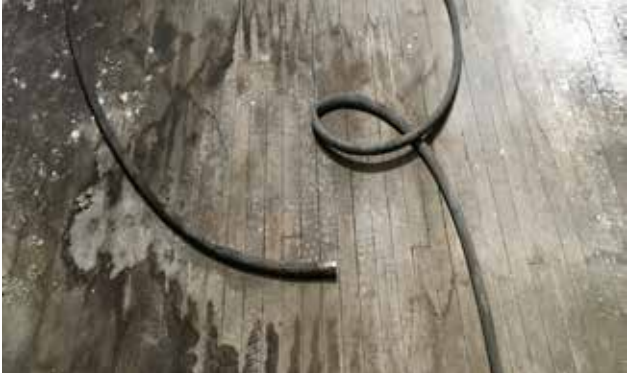
<b>F2-SW</b>  <b>Wood Floor System</b>	<b>Water Damage</b> <ul style="list-style-type: none"><li>• Biological growth, blistering, efflorescence, wood rot or staining caused by the infiltration of water.</li></ul>	<b>Removal of Deteriorated Material</b> <ul style="list-style-type: none"><li>• Identify source of water infiltration and remedy cause. Replace deteriorated and damaged material.</li></ul>	Level 3

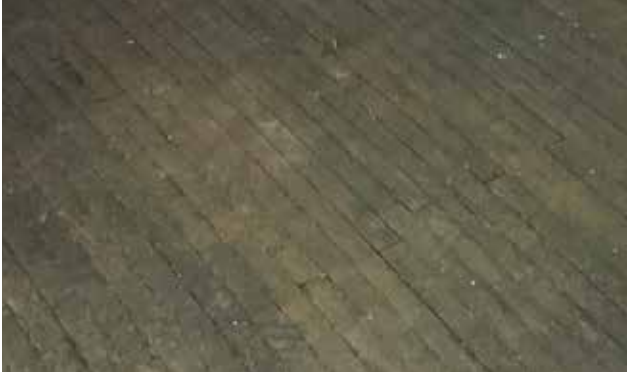
<b>F2-LC</b>  <b>Wood Floor System</b>	<b>Loss of Coating</b> <ul style="list-style-type: none"><li>• Loss of surface coating (stain).</li></ul>	<b>Material Patching or Replacement</b> <ul style="list-style-type: none"><li>• Determine reason for coating loss, correct problem and recoat.</li></ul>	Level 3

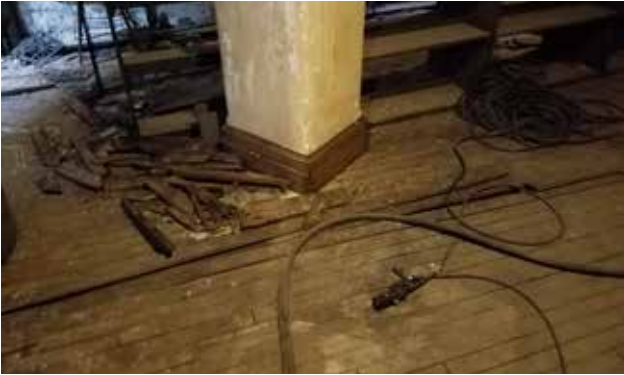
COMPONENT	CONDITION	TREATMENT	PRIORITY	REPRESENTATIVE PHOTO
<b>F2-CR</b>  Wood Floor System	<b>Cracking</b> <ul style="list-style-type: none"><li>• 1/16" to 1/2" wide visible fissures, possibly penetrating through the material surface</li></ul>	<b>Material Patching or Replacement</b> <ul style="list-style-type: none"><li>• Remove and replace damaged material.</li></ul>	Level 3

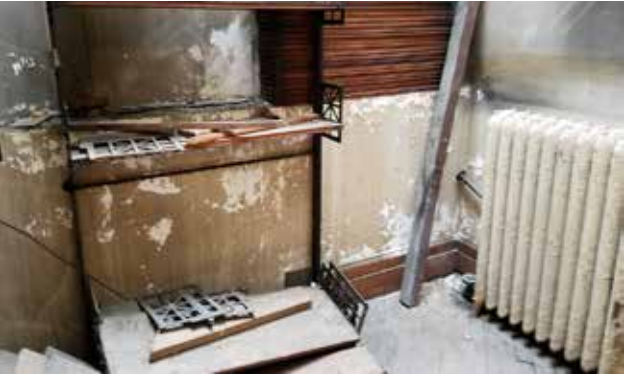
<b>F2-MD</b>  Wood Floor System	<b>Mechanical Damage</b> <ul style="list-style-type: none"><li>• Damage to material caused by mechanical components or equipment</li></ul>	<b>Material Repair or Replacement</b> <ul style="list-style-type: none"><li>• Remove mechanical remnants and connections. Patch areas of missing or damaged material, if feasible; remove and replace material, as required.</li></ul>	Level 3

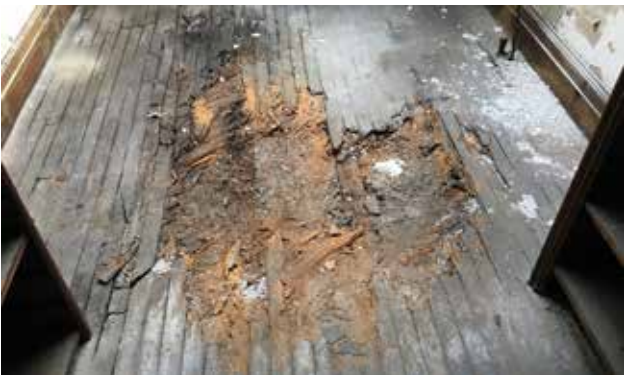
<b>F2-LM</b>  Wood Floor System	<b>Material Loss</b> <ul style="list-style-type: none"><li>• Loss of material leaving holes or exposing subsurface layers</li><li>• Holes or damage to structural (terra cotta) slab below floor system</li></ul>	<b>Material Patching or Replacement</b> <ul style="list-style-type: none"><li>• Patch areas of missing material, if feasible, or replace material to match existing.</li><li>• Additional investigation is required to understand extents of damage from material loss and to document layout of existing structural framing below floor system. Supplemental framing may be required around openings/area of material loss to remain.</li></ul>	Level 3

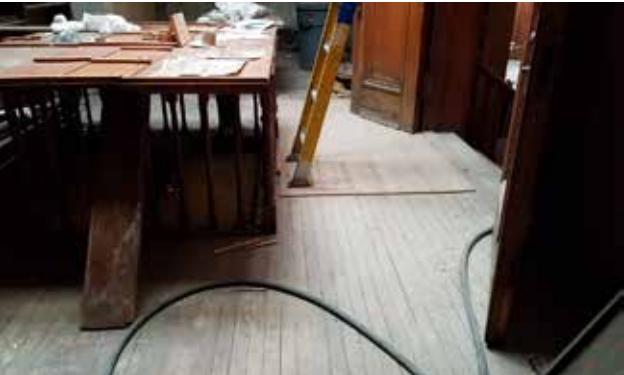
<b>F2-SA</b>  Wood Floor System	<b>Soiling</b> <ul style="list-style-type: none"><li>• Surface staining caused by the build-up of pollutants.</li></ul>	<b>Develop Cleaning Program</b> <ul style="list-style-type: none"><li>• Develop a cleaning program if it can be implemented without damage to building system.</li></ul>	Level 3

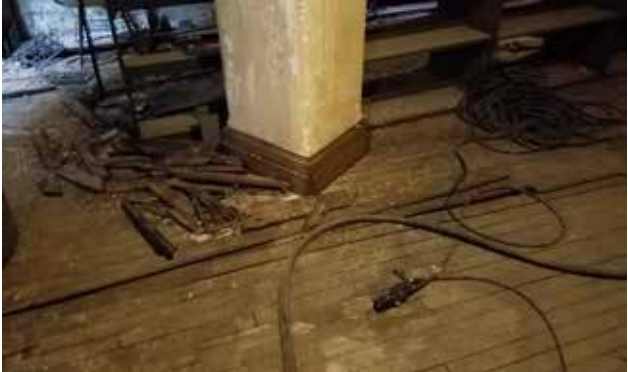
COMPONENT	CONDITION	TREATMENT	PRIORITY	REPRESENTATIVE PHOTO
<b>F2-SL</b>  Wood Floor System	<b>Splintering</b> <ul style="list-style-type: none"><li>Caused by the process of swelling from moisture and drying from heat, or mechanical damage.</li></ul>	<b>Material Repair</b> <ul style="list-style-type: none"><li>Repair by sanding or wood putty.</li></ul>	Level 3

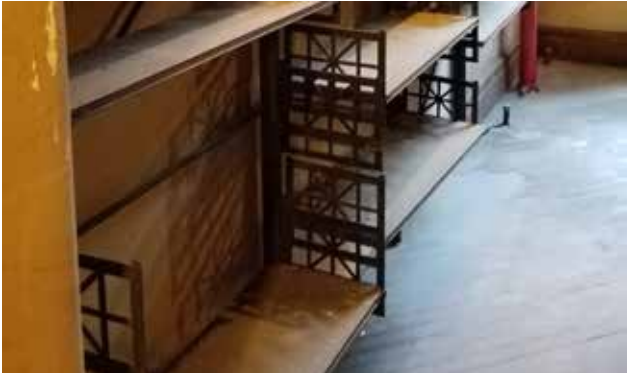
<b>F2-ST</b>  Wood Floor System	<b>Staining</b> <ul style="list-style-type: none"><li>Surface problem caused by the build-up of pollutants, mineral deposits and water marks.</li></ul>	<b>Develop Cleaning Program</b> <ul style="list-style-type: none"><li>Develop a cleaning program if it can be implemented without damage to bulding system.</li></ul>	Level 3

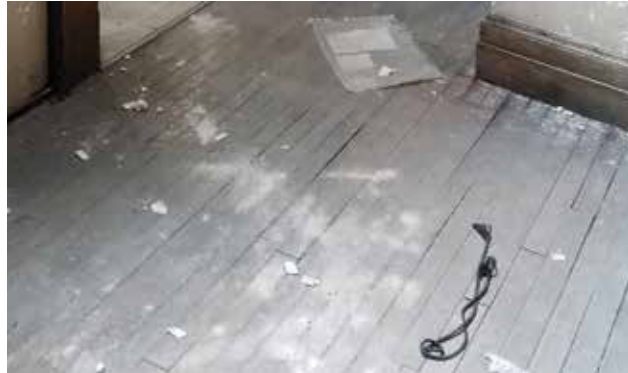
<b>F2-HW</b>  Wood Floor System	<b>Heaving Wood</b> <ul style="list-style-type: none"><li>Buckling of wood flooring caused by water infiltration, usually from the substrate.</li></ul>	<b>Material Replacement</b> <ul style="list-style-type: none"><li>Identify and elimatte water infiltration and replace damaged material.</li></ul>	Level 3

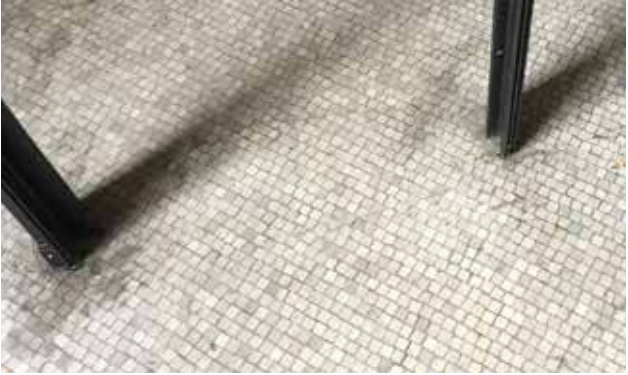
COMPONENT	CONDITION	TREATMENT	PRIORITY	REPRESENTATIVE PHOTO
<b>F3-SD</b>  Mosaic Tile Floor System	<b>Scratches / Dents</b> <ul style="list-style-type: none"><li>Damage to material caused by mechanical components or equipment</li></ul>	<b>Material Repair or Replacement</b> <ul style="list-style-type: none"><li>Patch areas of missing or damaged material, if feasible; remove and replace material, as required.</li></ul>	Level 3
