# Conditions Assessment

## Gould Memorial Library & Hall of Fame

FINAL REPORT | 15 MARCH 2018

**BRONX**  
**COMMUNITY**  
COLLEGE

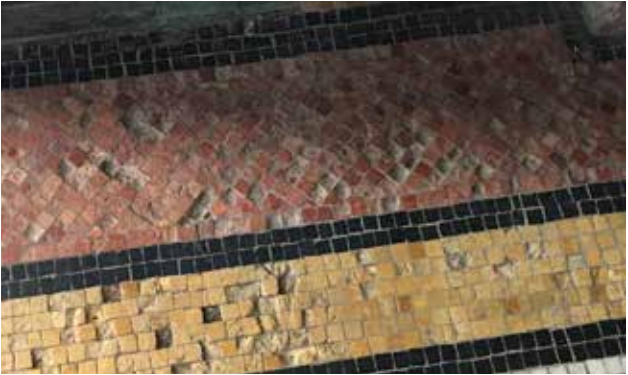
<b>F3-LM</b>  Mosaic Tile Floor System	<b>Material Loss</b> <ul style="list-style-type: none"><li>Loss of material leaving holes or exposing subsurface layers</li></ul>	<b>Material Replacement</b> <ul style="list-style-type: none"><li>Replace lost material to match existing.</li></ul>	Level 3

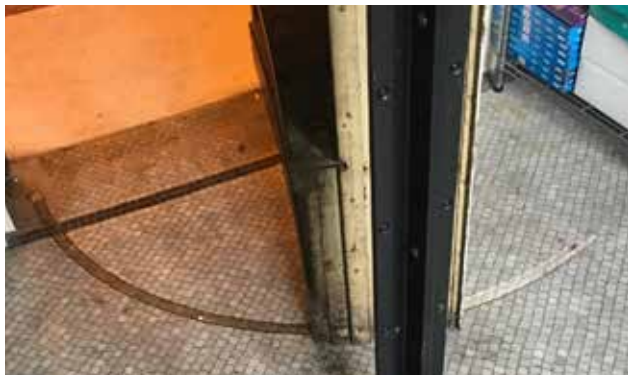
<b>F3-MD</b>  Mosaic Tile Floor System	<b>Mechanical Damage</b> <ul style="list-style-type: none"><li>Damage to material caused by mechanical components or equipment</li></ul>	<b>Material Repair or Replacement</b> <ul style="list-style-type: none"><li>Remove mechanical remnants and connections. Patch areas of missing or damaged material, if feasible; remove and replace material, as required.</li></ul>	Level 3

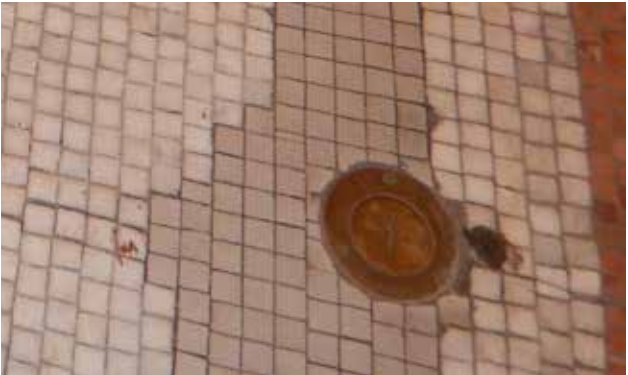
<b>F3-PR</b>  Mosaic Tile Floor System	<b>Previous Repair</b> <ul style="list-style-type: none"><li>Area where a previous repair was done, including repointing, patching and consolidation.</li></ul>	<b>Material Patching or Replacement</b> <ul style="list-style-type: none"><li>Replace inappropriate previous patches.</li></ul>	Level 3

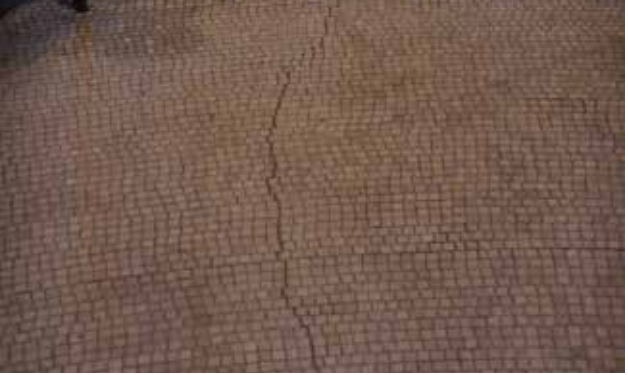
COMPONENT	CONDITION	TREATMENT	PRIORITY	REPRESENTATIVE PHOTO
<b>F3-CR</b>  Mosaic Tile Floor System	<b>Cracking</b> <ul style="list-style-type: none"><li>1/16" to 1/2" wide visible fissures, possibly penetrating through the material surface.</li></ul>	<b>Material Patching or Replacement</b> <ul style="list-style-type: none"><li>Remove and replace damaged material.</li></ul>	Level 3

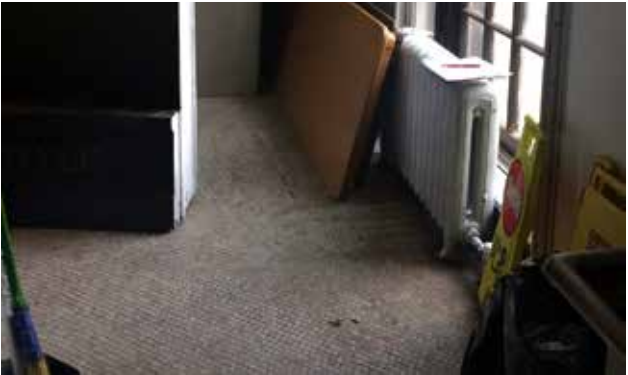
<b>F3-SA</b>  Mosaic Tile Floor System	<b>Soiling</b> <ul style="list-style-type: none"><li>Surface staining caused by the build-up of pollutants</li></ul>	<b>Develop Cleaning Program</b> <ul style="list-style-type: none"><li>Develop a cleaning program if it can be implemented without damage to bulding system.</li></ul>	Level 3

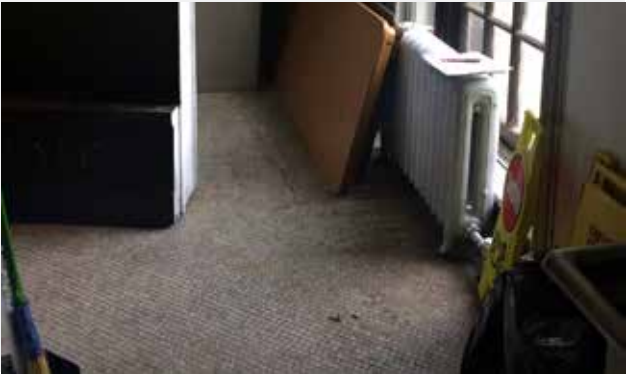
<b>F3-ST</b>  Mosaic Tile Floor System	<b>Staining</b> <ul style="list-style-type: none"><li>Surface problem caused by the build-up of pollutants, mineral deposits and water marks.</li></ul>	<b>Develop Cleaning Program</b> <ul style="list-style-type: none"><li>Develop a cleaning program if it can be implemented without damage to bulding system.</li></ul>	Level 3

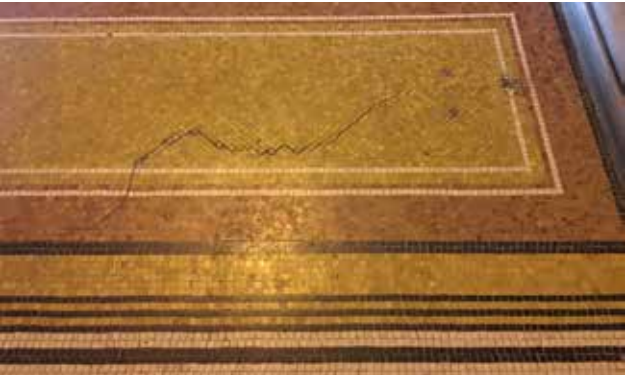
<b>F3-W</b>  Mosaic Tile Floor System	<b>Wear</b> <ul style="list-style-type: none"><li>The gradual disintegration and erosion of materials caused by gradual use overtime.</li></ul>	<b>Material Patching or Replacement</b> <ul style="list-style-type: none"><li>Leave alone unless severe, then consider replacing.</li></ul>	Level 3

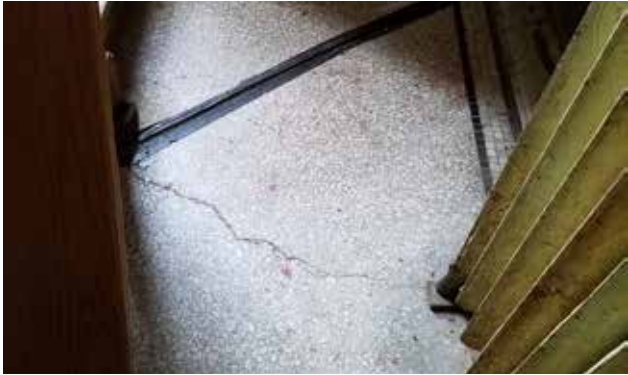
COMPONENT	CONDITION	TREATMENT	PRIORITY	REPRESENTATIVE PHOTO
<b>F4-CR</b>  Terrazzo Floor System	<b>Cracking</b> <ul style="list-style-type: none"><li>• 1/16" to 1/2" wide visible fissures in glass surface, possibly penetrating through the material surface</li></ul>	<b>Material Patching or Replacement</b> <ul style="list-style-type: none"><li>• Remove and replace damaged material.</li><li>• Radial cracks at rotunda floor system are most likely due to the deflection of the cantilevered floor structure. Provide patch material appropriate for increased floor flexibility.</li></ul>	Level 3

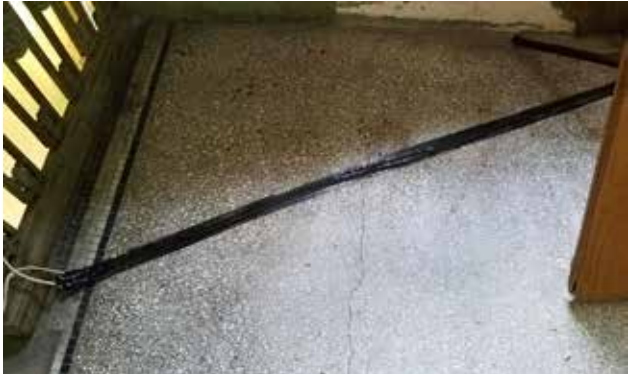
<b>F4-CH</b>  Terrazzo Floor System	<b>Hairline Cracking</b> <ul style="list-style-type: none"><li>• Numerous shallow cracks across the outer layer of a surface.</li></ul>	<b>Material Patching or Replacement</b> <ul style="list-style-type: none"><li>• Patch where appropriate.</li><li>• Radial cracks at rotunda floor system are most likely due to the deflection of the cantilevered floor structure. Provide patch material appropriate for increased floor flexibility.</li></ul>	Level 3

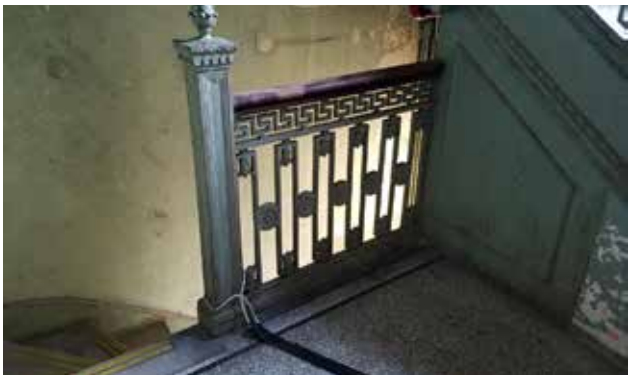
<b>F4-SA</b>  Terrazzo Floor System	<b>Soiling</b> <ul style="list-style-type: none"><li>• Surface staining caused by the build-up of pollutants</li></ul>	<b>Develop Cleaning Program</b> <ul style="list-style-type: none"><li>• Develop a cleaning program if it can be implemented without damage to building system.</li></ul>	Level 3

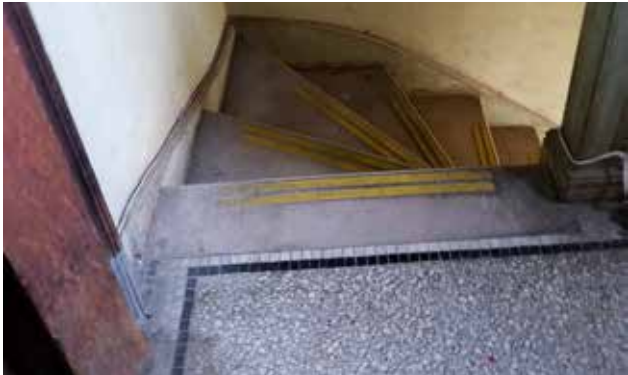
<b>F4-ST</b>  Terrazzo Floor System	<b>Staining</b> <ul style="list-style-type: none"><li>• Surface problem caused by the build-up of pollutants, mineral deposits and water marks.</li></ul>	<b>Develop Cleaning Program</b> <ul style="list-style-type: none"><li>• Develop a cleaning program if it can be implemented without damage to building system.</li></ul>	Level 3

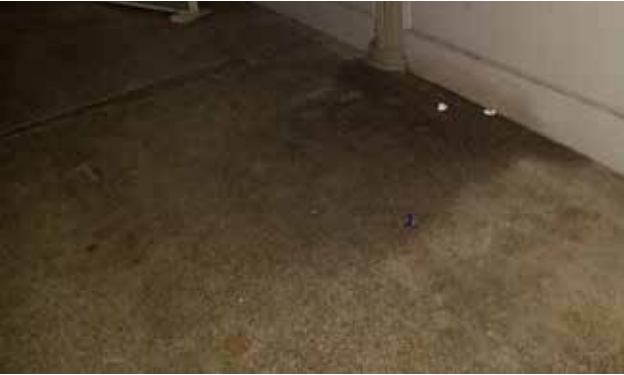
COMPONENT	CONDITION	TREATMENT	PRIORITY	REPRESENTATIVE PHOTO
<b>F4-W</b>  Terrazzo Floor System	<b>Wear</b> <ul style="list-style-type: none"><li>The gradual disintegration and erosion of materials caused by gradual use overtime.</li></ul>	<b>Material Patching or Replacement</b> <ul style="list-style-type: none"><li>Leave alone unless severe, then consider replacing.</li></ul>	Level 3

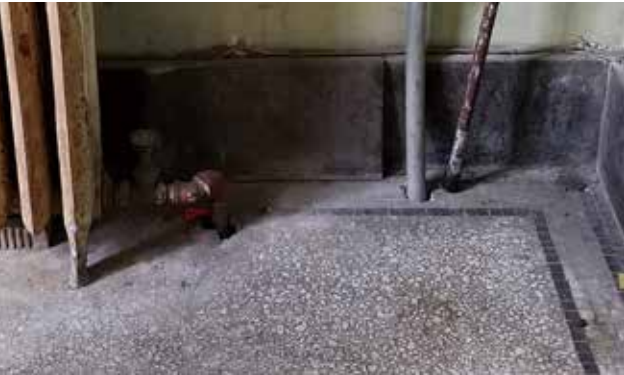
<b>F4-MD</b>  Terrazzo Floor System	<b>Mechanical Damage</b> <ul style="list-style-type: none"><li>Damage to material caused by mechanical components or equipment</li></ul>	<b>Material Repair or Replacement</b> <ul style="list-style-type: none"><li>Remove mechanical remnants and connections. Patch areas of missing or damaged material, if feasible; remove and replace material, as required.</li></ul>	Level 3

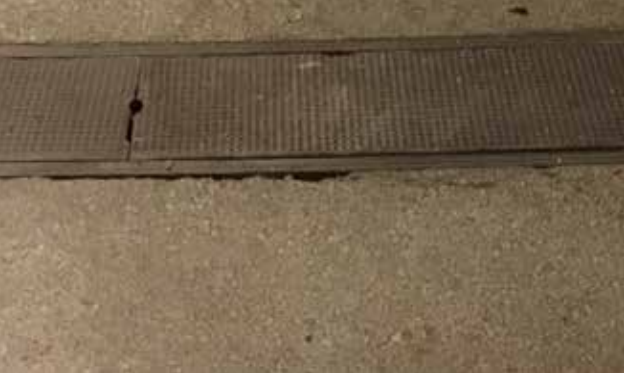
<b>F4-LM</b>  Terrazzo Floor System	<b>Material Loss</b> <ul style="list-style-type: none"><li>Loss of material leaving holes or exposing subsurface layers</li></ul>	<b>Material Patching or Replacement</b> <ul style="list-style-type: none"><li>Patch areas of missing material, if feasible, or replace material to match existing.</li></ul>	Level 3

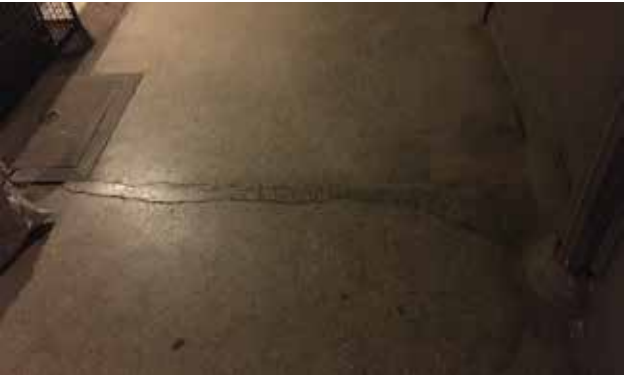
<b>F4-PR</b>  Terrazzo Floor System	<b>Previous Repair</b> <ul style="list-style-type: none"><li>Area where a previous repair was done, including repointing, patching and consolidation.</li></ul>	<b>Material Replacement</b> <ul style="list-style-type: none"><li>Replace inappropriate previous patches.</li></ul>	Level 3

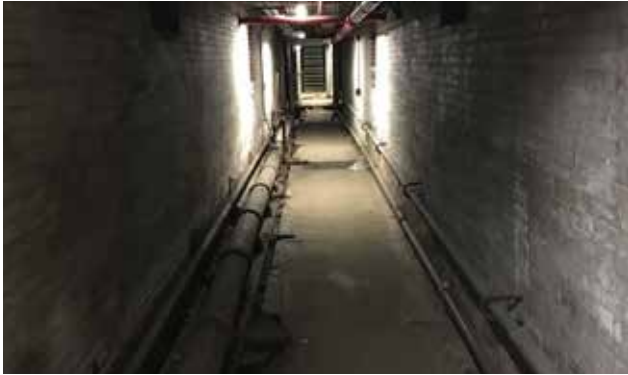
COMPONENT	CONDITION	TREATMENT	PRIORITY	REPRESENTATIVE PHOTO
<b>F5-LM</b>  Concrete Slab Floor System	<b>Material Loss</b> <ul style="list-style-type: none"><li>Loss of material leaving holes or exposing subsurface layers</li></ul>	<b>Material Patching or Replacement</b> <ul style="list-style-type: none"><li>Patch areas of missing material, if feasible, or replace material to match existing.</li><li>Additional investigation is required to understand extent of damage from penetration and to document layout of existing steel framing. Supplemental framing may be required around openings/areas of material loss that are to remain.</li></ul>	Level 3

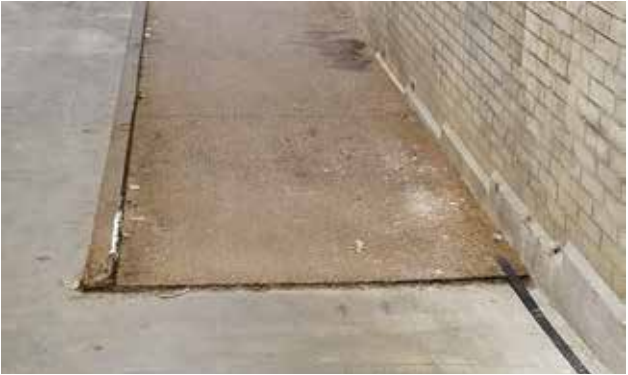
<b>F5-MC</b>  Concrete Slab Floor System	<b>Corrosion</b> <ul style="list-style-type: none"><li>Deterioration of cast iron structural members and connections by chemical reaction with their surrounding environment</li></ul>	<b>Removal of Deteriorated Material</b> <ul style="list-style-type: none"><li>Remove corrosion and corrosive products; in severe cases, replace deteriorated members with new material to match existing.</li><li>Refer to assesment of structural engineer for details on replacement of select cast iron members.</li></ul>	Level 3

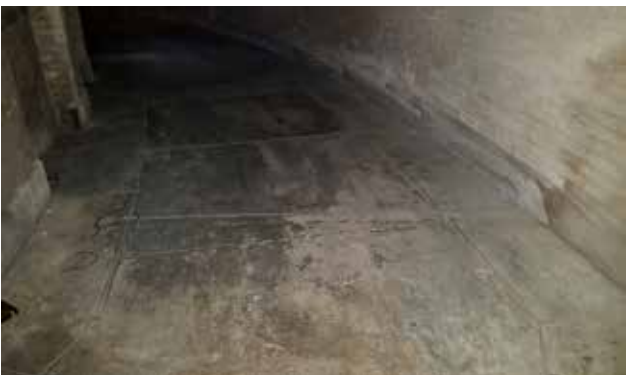
<b>F5-PR</b>  Concrete Slab Floor System	<b>Previous Repair</b> <ul style="list-style-type: none"><li>Area where a previous repair was done, including repointing, patching and consolidation.</li></ul>	<b>Material Replacement</b> <ul style="list-style-type: none"><li>Replace inappropriate previous patches.</li></ul>	Level 3

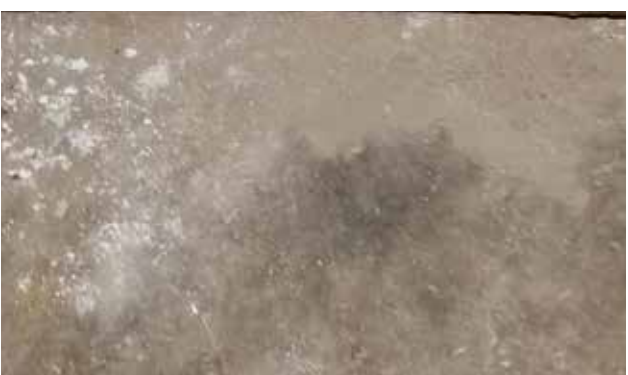
<b>F5-SD</b>  Concrete Slab Floor System	<b>Scratches / Dents</b> <ul style="list-style-type: none"><li>Damage to material caused by mechanical components or equipment</li></ul>	<b>Material Repair or Replacement</b> <ul style="list-style-type: none"><li>Patch areas of missing or damaged material, if feasible; remove and replace material, as required.</li></ul>	Level 3

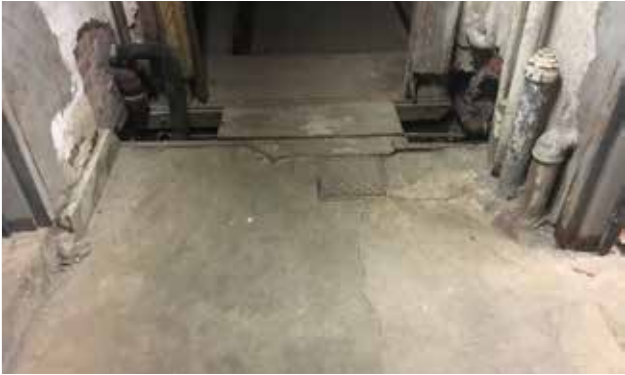
COMPONENT	CONDITION	TREATMENT	PRIORITY	REPRESENTATIVE PHOTO
<b>F5-CR</b>  Concrete Slab Floor System	<b>Cracking</b> <ul style="list-style-type: none"><li>1/16" to 1/2" wide visible fissures, possibly penetrating through the material surface</li></ul>	<b>Material Patching or Replacement</b> <ul style="list-style-type: none"><li>Remove and replace damaged material.</li></ul>	Level 3

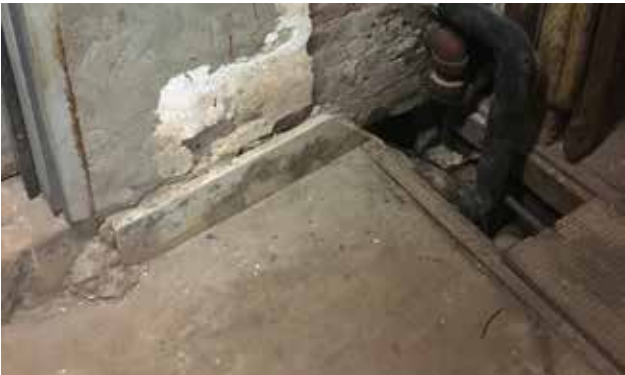
<b>F5-MD</b>  Concrete Slab Floor System	<b>Mechanical Damage</b> <ul style="list-style-type: none"><li>Damage to material caused by mechanical components or equipment</li></ul>	<b>Material Repair or Replacement</b> <ul style="list-style-type: none"><li>Remove mechanical remnants and connections. Patch areas of missing or damaged material, if feasible; remove and replace material, as required.</li><li>Additional investigation is required to understand extent of damage from penetration and to document layout of existing steel framing. Supplemental framing may be required around openings/areas of material loss that are to remain.</li></ul>	Level 3

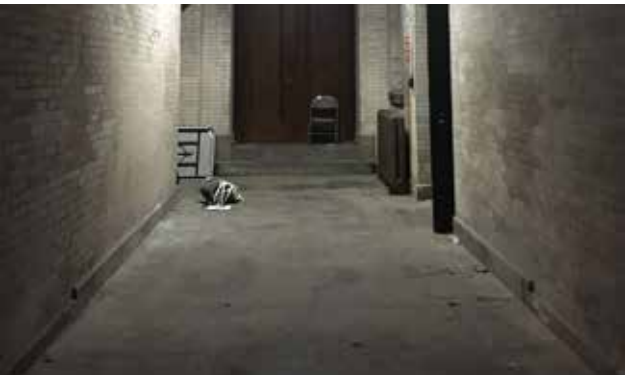
<b>F5-SA</b>  Concrete Slab Floor System	<b>Soiling</b> <ul style="list-style-type: none"><li>Surface staining caused by the build-up of pollutants</li></ul>	<b>Develop Cleaning Program</b> <ul style="list-style-type: none"><li>Develop a cleaning program if it can be implemented without damage to bulding system.</li></ul>	Level 3

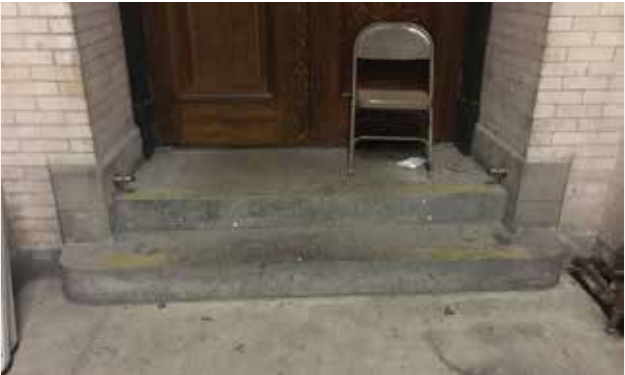
<b>F5-ST</b>  Concrete Slab Floor System	<b>Staining</b> <ul style="list-style-type: none"><li>Surface problem caused by the build-up of pollutants, mineral deposits and water marks.</li></ul>	<b>Develop Cleaning Program</b> <ul style="list-style-type: none"><li>Develop a cleaning program if it can be implemented without damage to bulding system.</li></ul>	Level 3

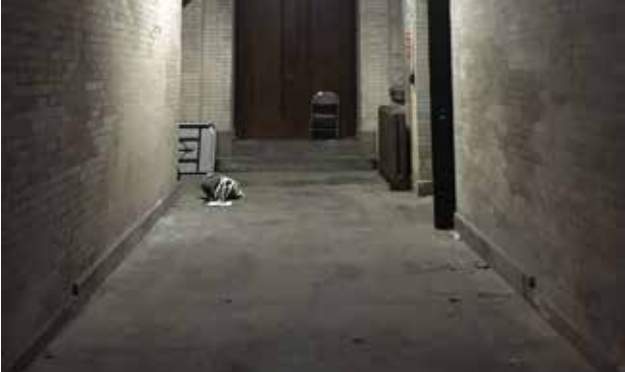
COMPONENT	CONDITION	TREATMENT	PRIORITY	REPRESENTATIVE PHOTO
<b>F5-W</b>  Concrete Slab Floor System	<b>Wear</b> <ul style="list-style-type: none"><li>The gradual disintegration and erosion of materials caused by gradual use overtime.</li></ul>	<b>Material Patching or Replacement</b> <ul style="list-style-type: none"><li>Leave alone unless severe, then consider replacing.</li></ul>	Level 3

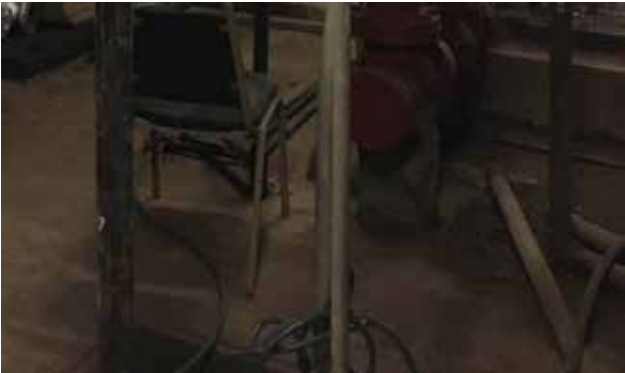
<b>F6-SA</b>  Brick Masonry Floor System	<b>Soiling</b> <ul style="list-style-type: none"><li>Surface staining caused by the build-up of pollutants</li></ul>	<b>Develop Cleaning Program</b> <ul style="list-style-type: none"><li>Develop a cleaning program if it can be implemented without damage to bulding system.</li></ul>	Level 3

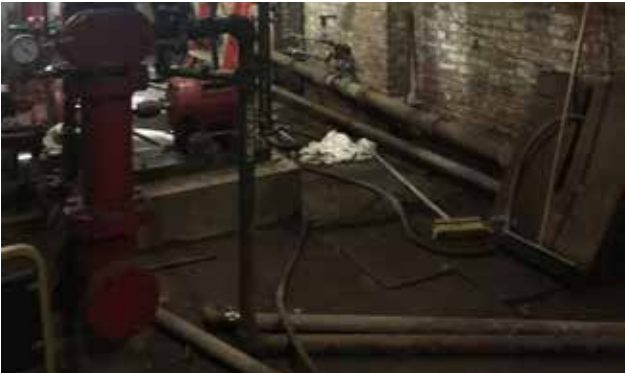
<b>F6-ST</b>  Brick Masonry Floor System	<b>Staining</b> <ul style="list-style-type: none"><li>Surface problem caused by the build-up of pollutants, mineral deposits and water marks.</li></ul>	<b>Develop Cleaning Program</b> <ul style="list-style-type: none"><li>Develop a cleaning program if it can be implemented without damage to bulding system.</li></ul>	Level 3

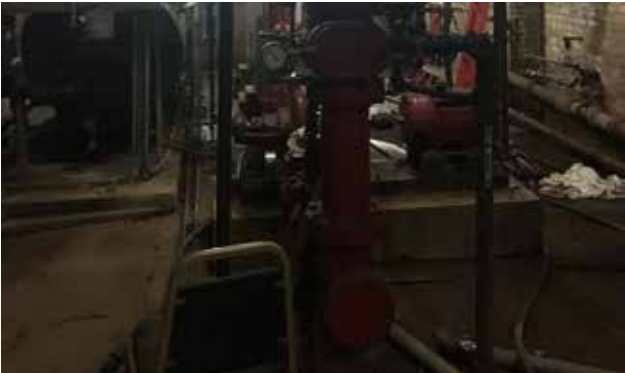
<b>F6-SD</b>  Brick Masonry Floor System	<b>Scratches / Dents</b> <ul style="list-style-type: none"><li>Damage to material caused by mechanical components or equipment</li></ul>	<b>Material Repair or Replacement</b> <ul style="list-style-type: none"><li>Patch areas of missing or damaged material, if feasible; remove and replace material, as required.</li></ul>	Level 3

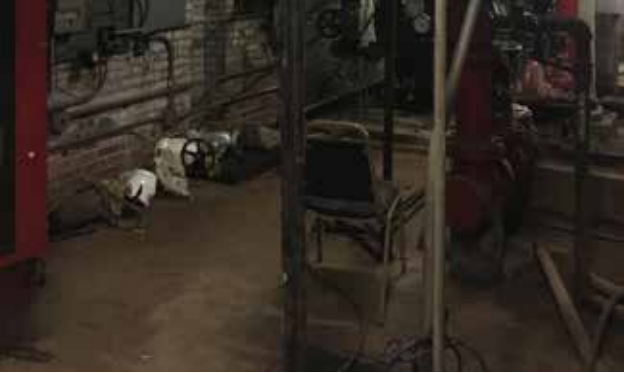
COMPONENT	CONDITION	TREATMENT	PRIORITY	REPRESENTATIVE PHOTO
<b>F6-PR</b>  Brick Masonry Floor System	<b>Previous Repair</b> <ul style="list-style-type: none"><li>Area where a previous repair was done, including repointing, patching and consolidation.</li></ul>	<b>Material Replacement</b> <ul style="list-style-type: none"><li>Replace inappropriate previous patches.</li></ul>	Level 3

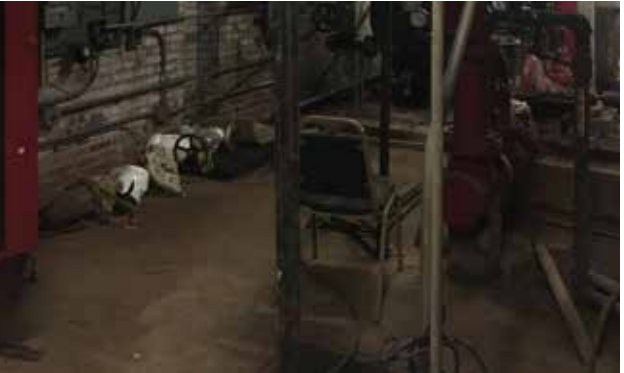
<b>F6-OJ</b>  Brick Masonry Floor System	<b>Open Joints</b> <ul style="list-style-type: none"><li>Joints without mortar.</li></ul>	<b>Material Replacement</b> <ul style="list-style-type: none"><li>Repoint masonry with an appropriate mortar.</li></ul>	Level 3

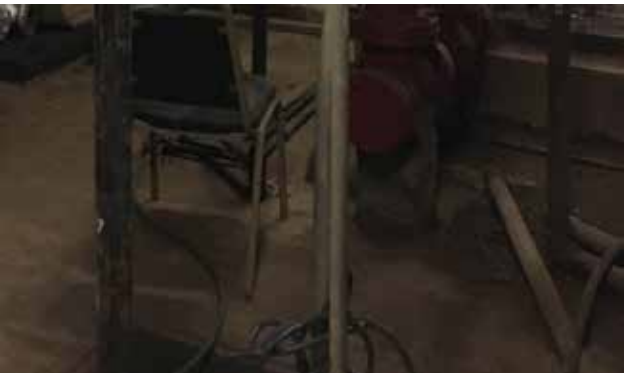
<b>F6-LC</b>  Brick Masonry Floor System	<b>Paint Loss</b> <ul style="list-style-type: none"><li>Loss of surface paint.</li></ul>	<b>Material Patching or Replacement</b> <ul style="list-style-type: none"><li>Determine reason for paint loss, correct problem and repaint.</li></ul>	Level 3

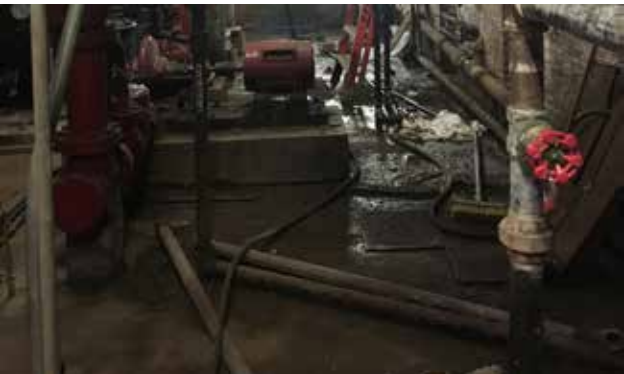
<b>F6-SP</b>  Brick Masonry Floor System	<b>Spalling</b> <ul style="list-style-type: none"><li>Uneven breaking off of the outer layers of masonry.</li></ul>	<b>Material Patching or Replacement</b> <ul style="list-style-type: none"><li>Remove deteriorated bricks and replace with new masonry.</li></ul>	Level 3

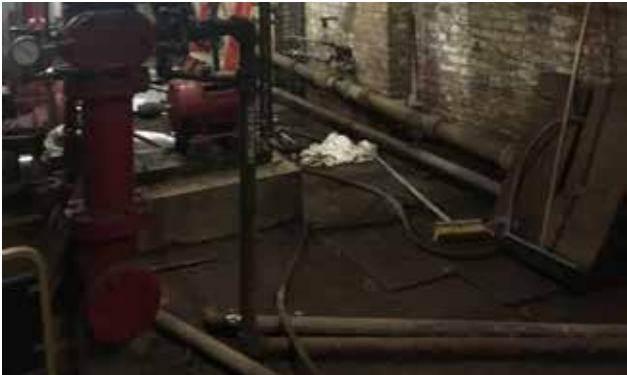
COMPONENT	CONDITION	TREATMENT	PRIORITY	REPRESENTATIVE PHOTO
<b>F6-EF</b>  Brick Masonry Floor System	<b>Efflorescence</b> <ul style="list-style-type: none"><li>Whitish haze of soluble salts left as deposits on masonry by evaporation of water, generally a symptom of a worse condition or a hint that trouble may be beginning.</li></ul>	<b>Removal of Deteriorated Material</b> <ul style="list-style-type: none"><li>Clean deposit, identify and eliminate water infiltration.</li></ul>	Level 3

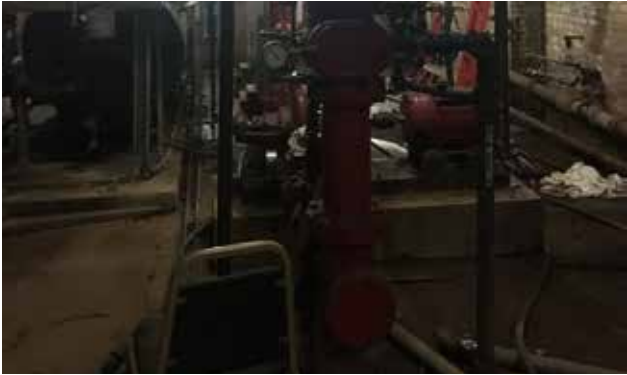
<b>F6-CR</b>  Brick Masonry Floor System	<b>Cracking</b> <ul style="list-style-type: none"><li>1/16" to 1/2" wide visible fissures, possibly penetrating through the material surface</li></ul>	<b>Material Replacement</b> <ul style="list-style-type: none"><li>Remove and replace damaged material.</li></ul>	Level 3

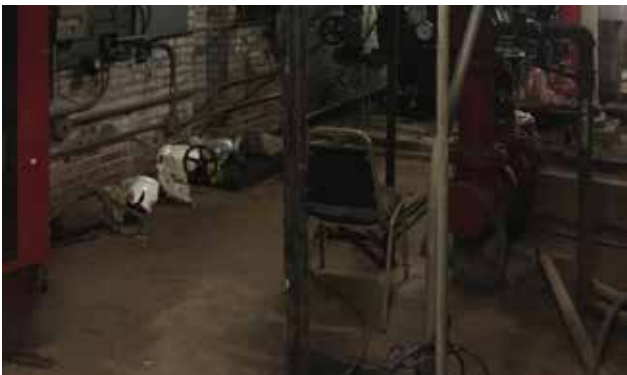
<b>F6-MD</b>  Brick Masonry Floor System	<b>Mechanical Damage</b> <ul style="list-style-type: none"><li>Damage to material caused by mechanical components or equipment</li></ul>	<b>Material Repair or Replacement</b> <ul style="list-style-type: none"><li>Remove mechanical remnants and connections. Patch areas of missing or damaged material, if feasible; remove and replace material, as required.</li></ul>	Level 3

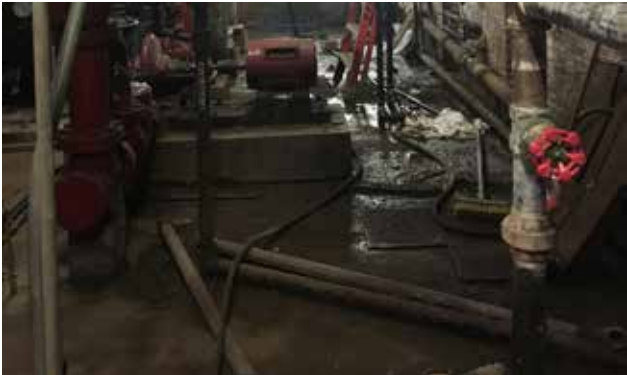
<b>F6-LM</b>  Brick Masonry Floor System	<b>Material Loss</b> <ul style="list-style-type: none"><li>Loss of material leaving holes or exposing subsurface layers</li></ul>	<b>Material Patching or Replacement</b> <ul style="list-style-type: none"><li>Patch areas of missing material, if feasible, or replace material to match existing.</li></ul>	Level 3

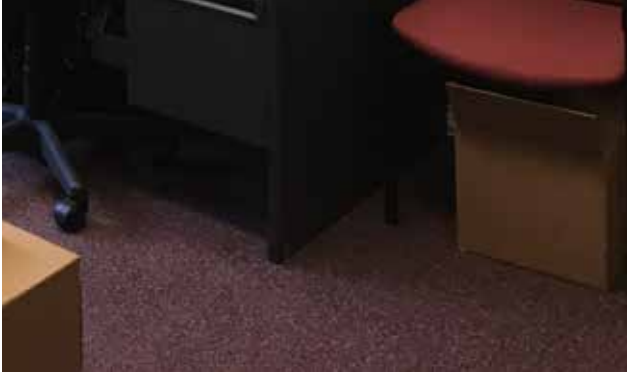
COMPONENT	CONDITION	TREATMENT	PRIORITY	REPRESENTATIVE PHOTO
<b>F7-E</b>  Carpet Floor System	<b>Extant</b> <ul style="list-style-type: none"><li>An existing building system in good condition.</li></ul>	<b>Cyclical Maintenance</b> <ul style="list-style-type: none"><li>Develop a cleaning program to extend life of building system.</li></ul>	Level 3

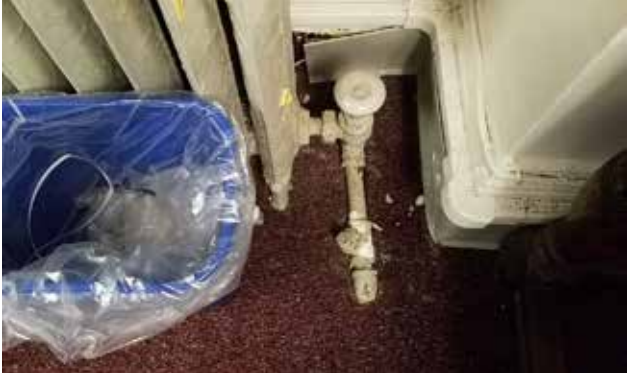
<b>F7-MD</b>  Carpet Floor System	<b>Mechanical Damage</b> <ul style="list-style-type: none"><li>Damage to material caused by mechanical components or equipment</li></ul>	<b>Material Repair or Replacement</b> <ul style="list-style-type: none"><li>Remove mechanical remnants and connections. Patch areas of missing or damaged material, if feasible; remove and replace material, as required.</li></ul>	Level 3

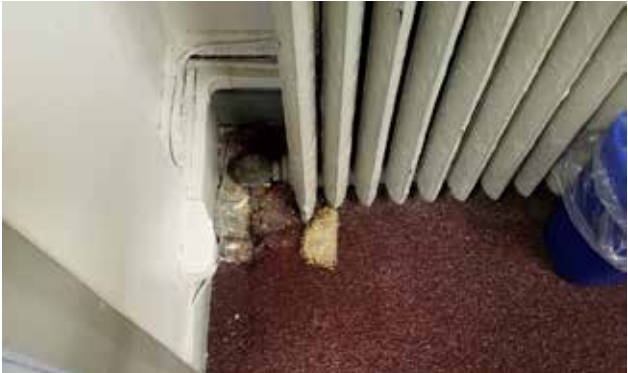
<b>F7-LM</b>  Carpet Floor System	<b>Material Loss</b> <ul style="list-style-type: none"><li>Loss of material leaving holes or exposing subsurface layers</li></ul>	<b>Material Replacement</b> <ul style="list-style-type: none"><li>Replace material to match existing.</li></ul>	Level 3

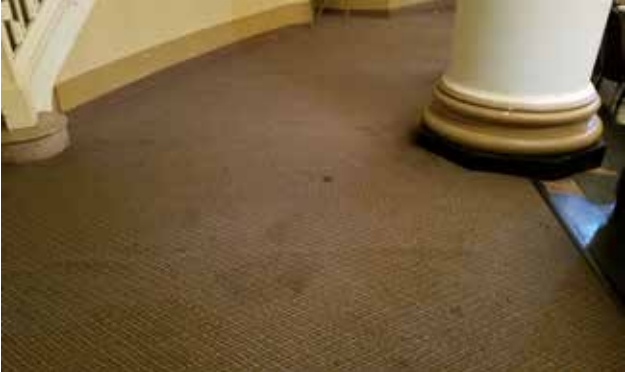
COMPONENT	CONDITION	TREATMENT	PRIORITY	REPRESENTATIVE PHOTO
<b>F7-ST</b>  Carpet Floor System	<b>Staining</b> <ul style="list-style-type: none"><li>Surface problem caused by the build-up of pollutants, mineral deposits and water marks.</li></ul>	<b>Develop Cleaning Program</b> <ul style="list-style-type: none"><li>Develop a cleaning program if it can be implemented without damage to bulding system.</li></ul>	Level 3

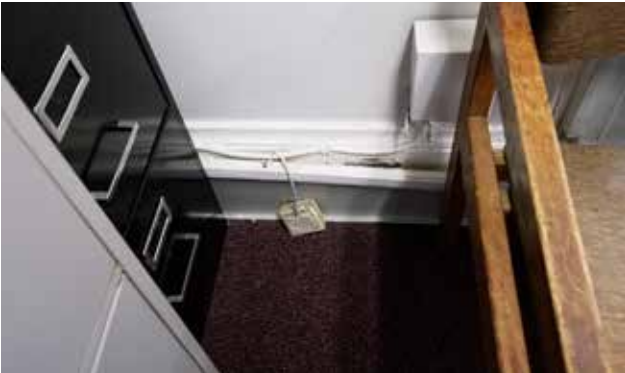
<b>F7-W</b>  Carpet Floor System	<b>Wear</b> <ul style="list-style-type: none"><li>The gradual disintegration and erosion of materials caused by gradual use overtime.</li></ul>	<b>Material Replacement</b> <ul style="list-style-type: none"><li>Leave alone unless severe, then consider replacing.</li></ul>	Level 3

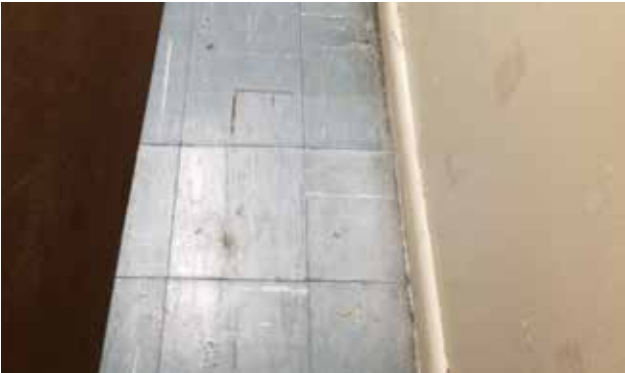
<b>F8-SD</b>  Linoleum Tile Floor System	<b>Scratches / Dents</b> <ul style="list-style-type: none"><li>Damage to material caused by mechanical components or equipment</li></ul>	<b>Material Repair or Replacement</b> <ul style="list-style-type: none"><li>Patch areas of missing or damaged material, if feasible; remove and replace material, as required.</li></ul>	Level 3

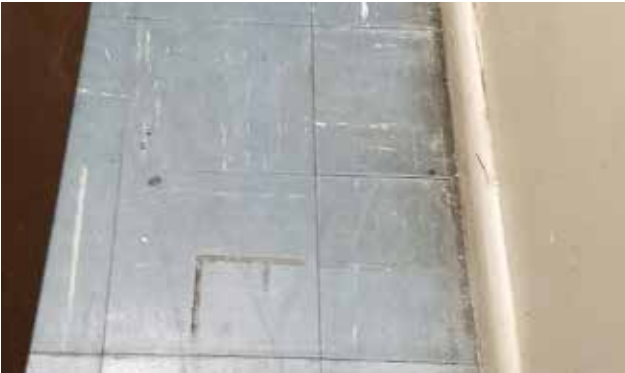
<b>F8-SA</b>  Linoleum Tile Floor System	<b>Soiling</b> <ul style="list-style-type: none"><li>Surface staining caused by the build-up of pollutants</li></ul>	<b>Develop Cleaning Program</b> <ul style="list-style-type: none"><li>Develop a cleaning program if it can be implemented without damage to bulding system.</li></ul>	Level 3

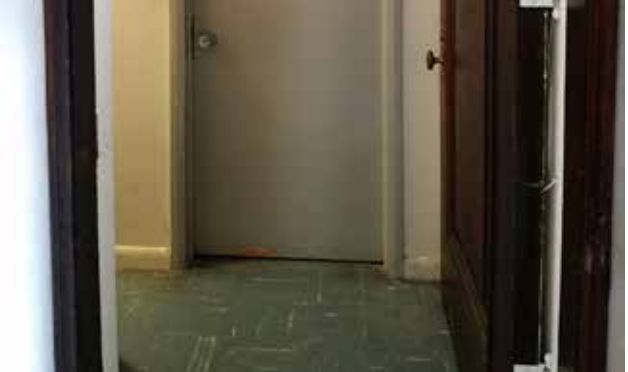
COMPONENT	CONDITION	TREATMENT	PRIORITY	REPRESENTATIVE PHOTO
<b>F8-ST</b>  Linoleum Tile Floor System	<b>Staining</b> <ul style="list-style-type: none"><li>Surface problem caused by the build-up of pollutants, mineral deposits and water marks.</li></ul>	<b>Develop Cleaning Program</b> <ul style="list-style-type: none"><li>Develop a cleaning program if it can be implemented without damage to bulding system.</li></ul>	Level 3

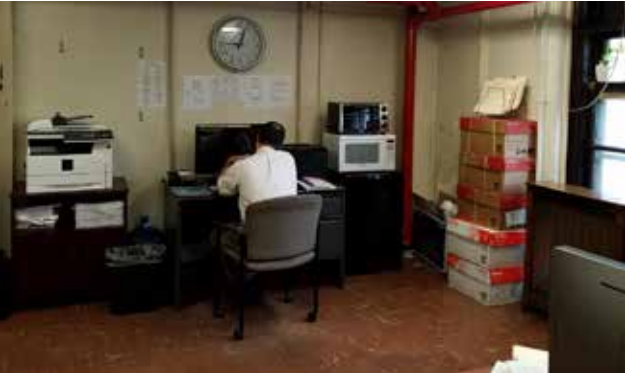
<b>F8-W</b>  Linoleum Tile Floor System	<b>Wear</b> <ul style="list-style-type: none"><li>The gradual disintegration and erosion of materials caused by gradual use overtime.</li></ul>	<b>Material Replacement</b> <ul style="list-style-type: none"><li>Leave alone unless severe, then consider replacing.</li></ul>	Level 3

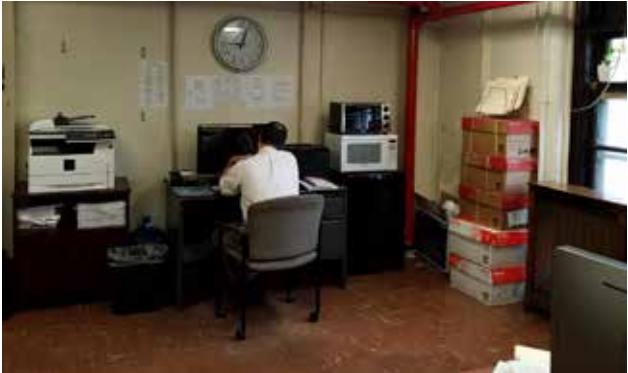
<b>F8-LM</b>  Linoleum Tile Floor System	<b>Material Loss</b> <ul style="list-style-type: none"><li>Loss of material leaving holes or exposing subsurface layers.</li></ul>	<b>Material Patching or Replacement</b> <ul style="list-style-type: none"><li>Patch areas of missing material, if feasible, or replace material to match existing.</li></ul>	Level 3

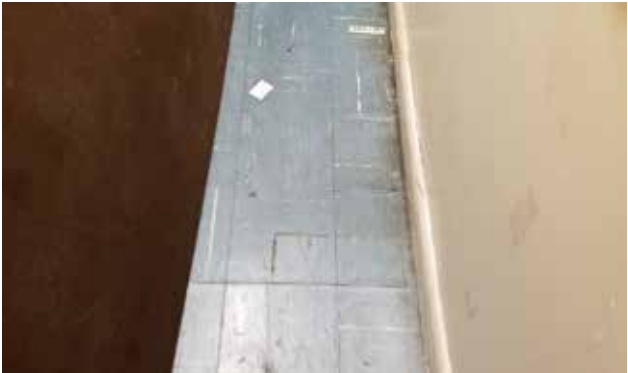
<b>F8-MD</b>  Linoleum Tile Floor System	<b>Mechanical Damage</b> <ul style="list-style-type: none"><li>Damage to material caused by mechanical components or equipment</li></ul>	<b>Material Repair or Replacement</b> <ul style="list-style-type: none"><li>Remove mechanical remnants and connections. Patch areas of missing or damaged material, if feasible; remove and replace material, as required.</li></ul>	Level 3

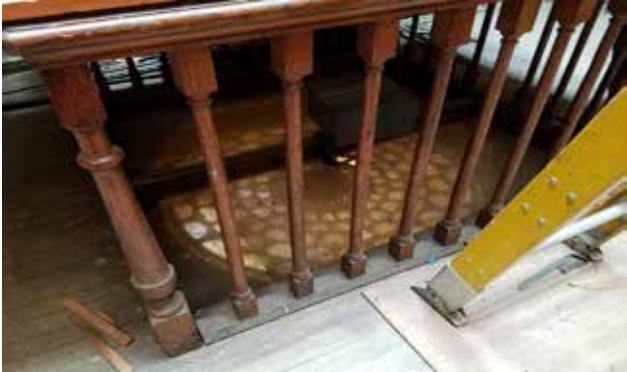
COMPONENT	CONDITION	TREATMENT	PRIORITY	REPRESENTATIVE PHOTO
<b>F9-SA</b>  Laylight over Tiffany Glass Floor System	<b>Soiling</b> <ul style="list-style-type: none"><li>Surface staining caused by the build-up of pollutants</li></ul>	<b>Develop Cleaning Program</b> <ul style="list-style-type: none"><li>Develop a cleaning program if it can be implemented without damage to building system.</li></ul>	Level 3

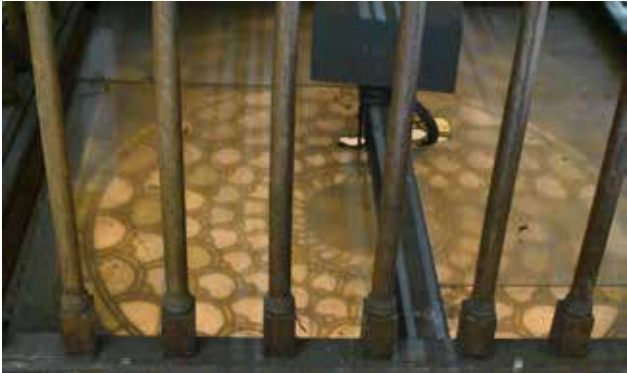
<b>F9-MD</b>  Laylight over Tiffany Glass Floor System	<b>Mechanical Damage</b> <ul style="list-style-type: none"><li>Damage to material caused by mechanical components or equipment</li></ul>	<b>Material Repair or Replacement</b> <ul style="list-style-type: none"><li>Remove mechanical remnants and connections. Patch areas of missing or damaged material, if feasible; remove and replace material, as required.</li></ul>	Level 3

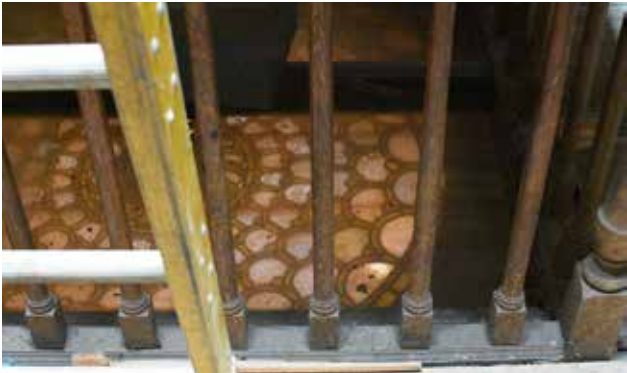
<b>F9-CR</b>  Laylight over Tiffany Glass Floor System	<b>Cracking</b> <ul style="list-style-type: none"><li>1/16" to 1/2" wide visible fissures, possibly penetrating through the material surface</li></ul>	<b>Material Replacement</b> <ul style="list-style-type: none"><li>Remove and replace damaged material.</li></ul>	Level 3

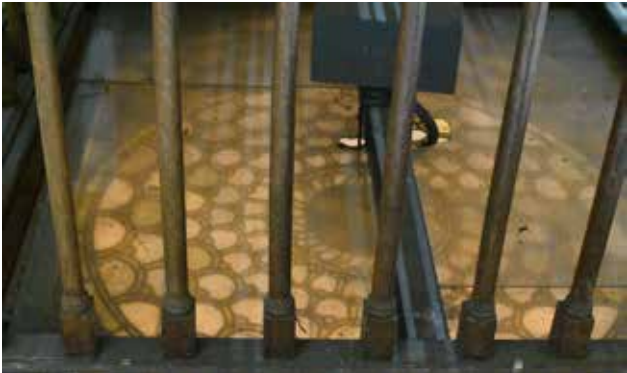
<b>F9-LM</b>  Laylight over Tiffany Glass Floor System	<b>Material Loss</b> <ul style="list-style-type: none"><li>Loss of material leaving holes or exposing subsurface layers.</li></ul>	<b>Material Patching or Replacement</b> <ul style="list-style-type: none"><li>Patch areas of missing material, if feasible, or replace material to match existing.</li></ul>	Level 3

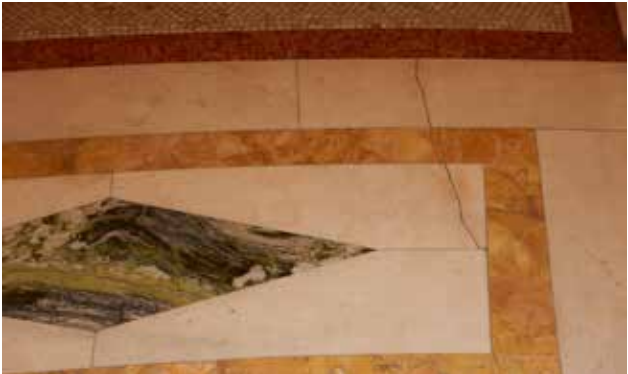
COMPONENT	CONDITION	TREATMENT	PRIORITY	REPRESENTATIVE PHOTO
<b>F10-CR</b>  Marble Slab Floor System	<b>Cracking</b> <ul style="list-style-type: none"><li>• 1/16" to 1/2" wide visible fissures in surface, possibly penetrating through the material surface</li></ul>	<b>Material Replacement</b> <ul style="list-style-type: none"><li>• Remove and replace damaged material.</li></ul>	Level 3

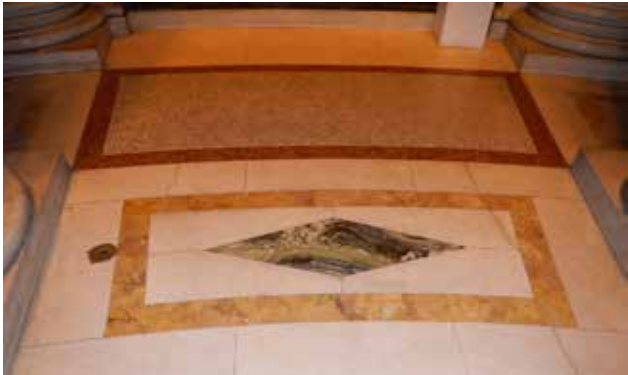
<b>F10-SD</b>  Marble Slab Floor System	<b>Scratches / Dents</b> <ul style="list-style-type: none"><li>• Damage to material caused by mechanical components or equipment</li></ul>	<b>Material Repair or Replacement</b> <ul style="list-style-type: none"><li>• Patch areas of missing or damaged material, if feasible; remove and replace material, as required.</li></ul>	Level 3

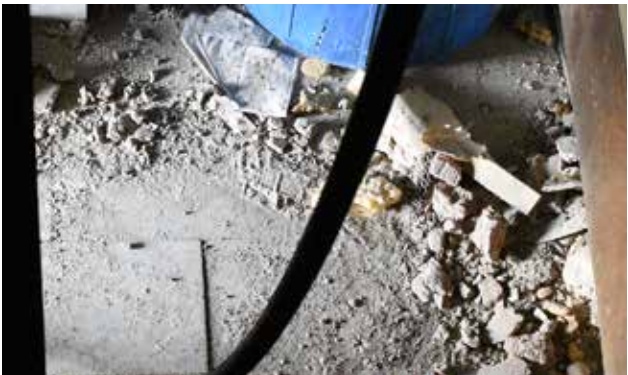
<b>F10-LM</b>  Marble Slab Floor System	<b>Material Loss</b> <ul style="list-style-type: none"><li>• Loss of material leaving holes or exposing subsurface layers.</li></ul>	<b>Material Patching or Replacement</b> <ul style="list-style-type: none"><li>• Patch areas of missing material, if feasible, or replace material to match existing.</li></ul>	Level 3

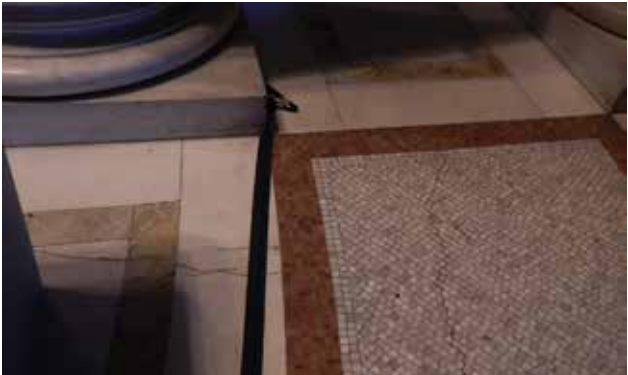
<b>F10-MD</b>  Marble Slab Floor System	<b>Mechanical Damage</b> <ul style="list-style-type: none"><li>• Damage to material caused by mechanical components or equipment</li></ul>	<b>Material Repair or Replacement</b> <ul style="list-style-type: none"><li>• Remove mechanical remnants and connections. Patch areas of missing or damaged material, if feasible; remove and replace material, as required.</li></ul>	Level 3

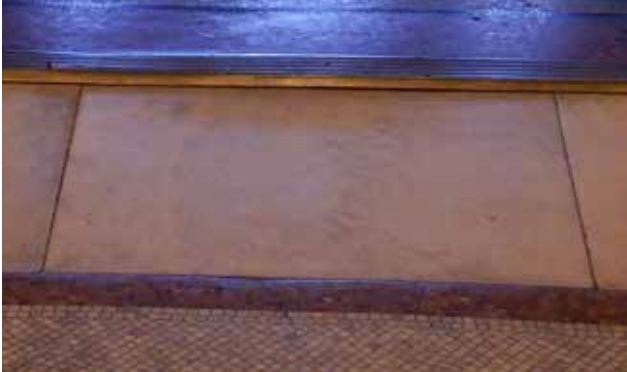
COMPONENT	CONDITION	TREATMENT	PRIORITY	REPRESENTATIVE PHOTO
<b>F10-OJ</b>  Marble Slab Floor System	<b>Open Joints</b> <ul style="list-style-type: none"><li>• Joints without grout</li></ul>	<b>Material Replacement</b> <ul style="list-style-type: none"><li>• Determine reason for missing grout and regrout.</li></ul>	Level 3

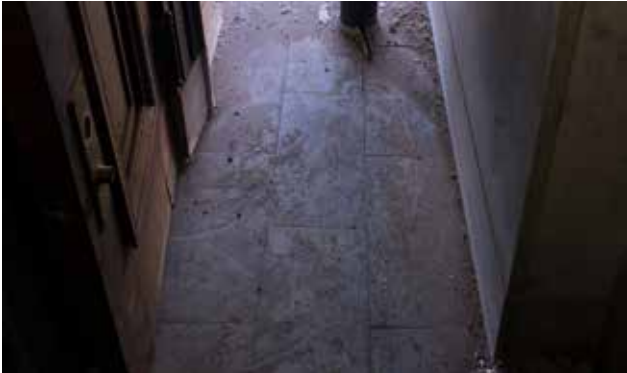
<b>F10-SA</b>  Marble Slab Floor System	<b>Soiling</b> <ul style="list-style-type: none"><li>• Surface staining caused by the build-up of pollutants</li></ul>	<b>Develop Cleaning Program</b> <ul style="list-style-type: none"><li>• Develop a cleaning program if it can be implemented without damage to bulding system.</li></ul>	Level 3

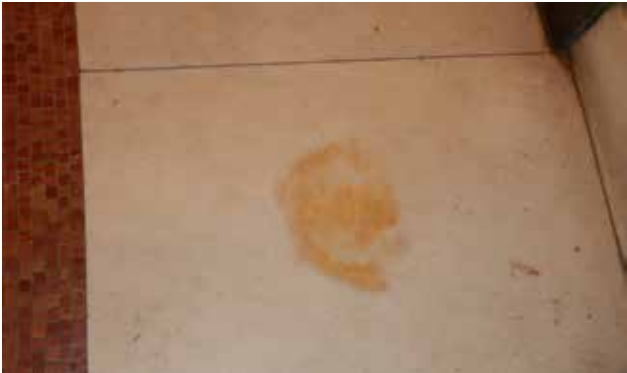
<b>F10-ST</b>  Marble Slab Floor System	<b>Staining</b> <ul style="list-style-type: none"><li>• Surface problem caused by the build-up of pollutants, mineral deposits and water marks.</li></ul>	<b>Develop Cleaning Program</b> <ul style="list-style-type: none"><li>• Develop a cleaning program if it can be implemented without damage to bulding system.</li></ul>	Level 3

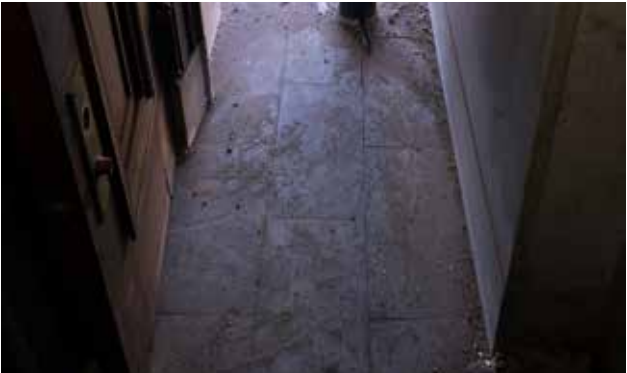
<b>F10-W</b>  Marble Slab Floor System	<b>Wear</b> <ul style="list-style-type: none"><li>• The gradual disintegration and erosion of materials caused by gradual use overtime.</li></ul>	<b>Material Patching or Replacement</b> <ul style="list-style-type: none"><li>• Leave alone unless severe, then consider replacing.</li></ul>	Level 3

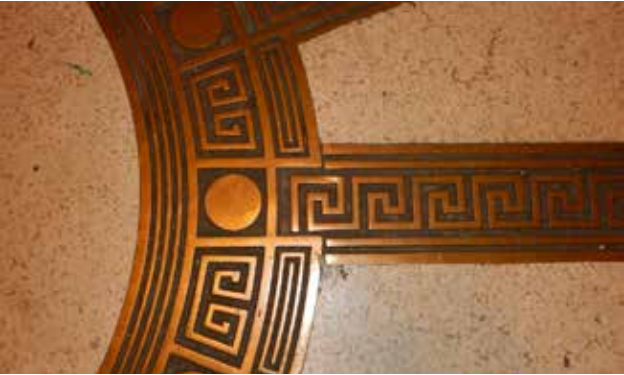
COMPONENT	CONDITION	TREATMENT	PRIORITY	REPRESENTATIVE PHOTO
<b>F11-LM</b>  Bronze Frame with Terrazzo Infill Floor System	<b>Material Loss</b> <ul style="list-style-type: none"><li>Loss of material leaving holes or exposing subsurface layers</li></ul>	<b>Material Patching or Replacement</b> <ul style="list-style-type: none"><li>Patch areas of missing material, if feasible, or replace material to match existing.</li></ul>	Level 3

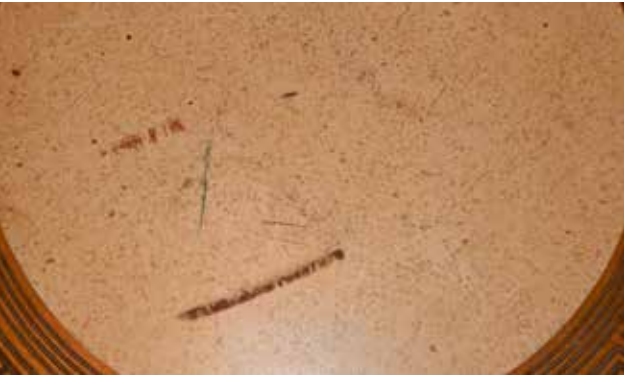
<b>F11-SD</b>  Bronze Frame with Terrazzo Infill Floor System	<b>Scratches / Dents</b> <ul style="list-style-type: none"><li>Damage to material caused by mechanical components or equipment</li></ul>	<b>Material Repair or Replacement</b> <ul style="list-style-type: none"><li>Patch areas of missing or damaged material, if feasible; remove and replace material, as required.</li></ul>	Level 3

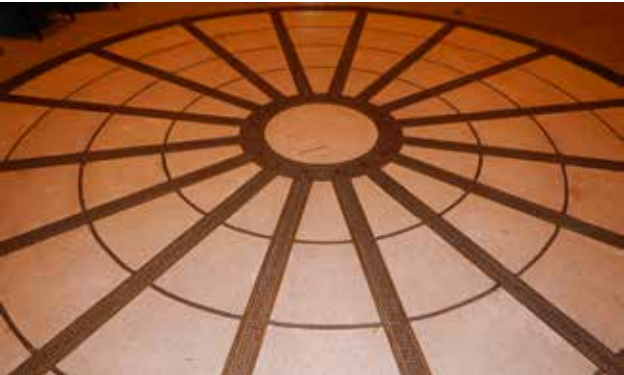
<b>F11-W</b>  Bronze Frame with Terrazzo Infill Floor System	<b>Wear</b> <ul style="list-style-type: none"><li>The gradual disintegration and erosion of materials caused by gradual use overtime.</li></ul>	<b>Material Patching or Replacement</b> <ul style="list-style-type: none"><li>Leave alone unless severe, then consider replacing.</li></ul>	Level 3

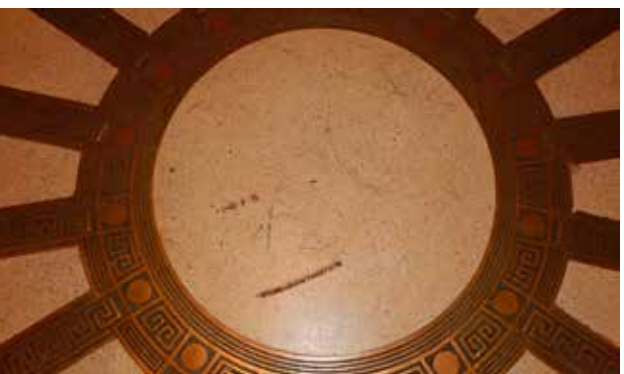
<b>F11-MD</b>  Bronze Frame with Terrazzo Infill Floor System	<b>Mechanical Damage</b> <ul style="list-style-type: none"><li>Damage to material caused by mechanical components or equipment</li></ul>	<b>Material Repair or Replacement</b> <ul style="list-style-type: none"><li>Remove mechanical remnants and connections. Patch areas of missing or damaged material, if feasible; remove and replace material, as required.</li></ul>	Level 3

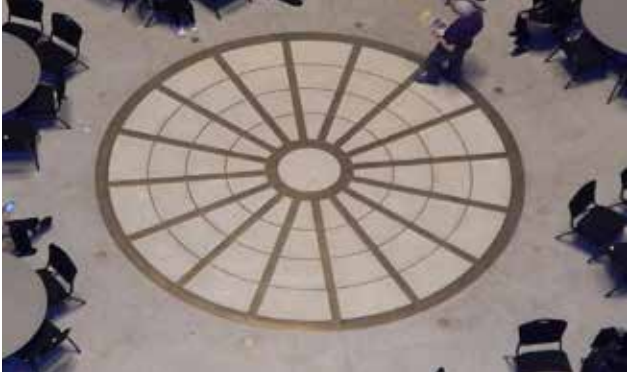
COMPONENT	CONDITION	TREATMENT	PRIORITY	REPRESENTATIVE PHOTO
<b>F11-SA</b>  Bronze Frame with Terrazzo Infill Floor System	<b>Soiling</b> <ul style="list-style-type: none"><li>• Surface staining caused by the build-up of pollutants</li></ul>	<b>Develop Cleaning Program</b> <ul style="list-style-type: none"><li>• Develop a cleaning program if it can be implemented without damage to bulding system.</li></ul>	Level 3

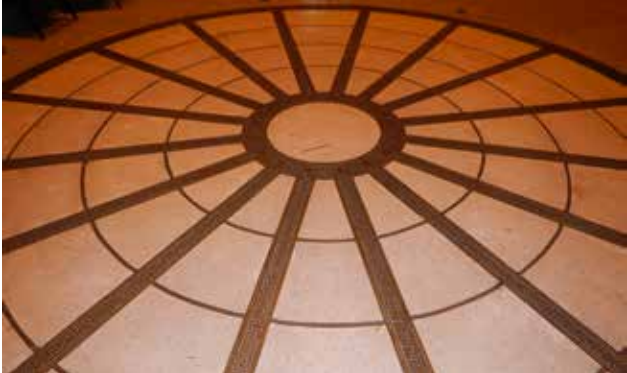
<b>F11-ST</b>  Bronze Frame with Terrazzo Infill Floor System	<b>Staining</b> <ul style="list-style-type: none"><li>• Surface problem caused by the build-up of pollutants, mineral deposits and water marks.</li></ul>	<b>Develop Cleaning Program</b> <ul style="list-style-type: none"><li>• Develop a cleaning program if it can be implemented without damage to bulding system.</li></ul>	Level 3

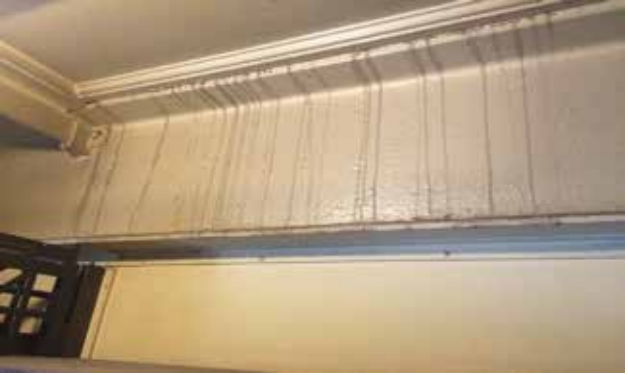
COMPONENT	CONDITION	TREATMENT	PRIORITY	REPRESENTATIVE PHOTO
<b>W1-MC</b>  Sheet Metal and Sheet Metal Soffit Wall System	<b>Corrosion</b> <ul style="list-style-type: none"><li>Deterioration of material by a chemical reaction with its environment.</li></ul>	<b>Removal of Deteriorated Material</b> <ul style="list-style-type: none"><li>Remove corrosion and corrosive products; in severe cases, replace deteriorated members with new material to match existing.</li><li>Refer to assesment of structural engineer for details on replacement of select cast iron members.</li></ul>	Level 3
