# Conditions Assessment

## Gould Memorial Library & Hall of Fame

FINAL REPORT | 15 MARCH 2018

**BRONX**  
**COMMUNITY**  
COLLEGE

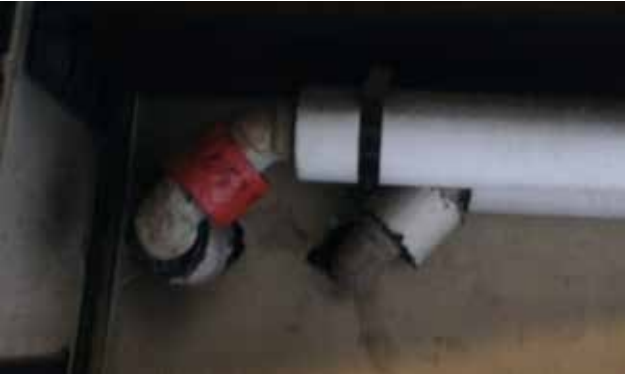
<b>W1-MD</b>  Sheet Metal and Sheet Metal Soffit Wall System	<b>Mechanical Damage</b> <ul style="list-style-type: none"><li>Damage to material caused by mechanical components or equipment</li></ul>	<b>Material Patching or Replacement</b> <ul style="list-style-type: none"><li>Remove mechanical remnants and connections. Patch areas of missing or damaged material, if feasible; remove and replace material, as required.</li></ul>	Level 3

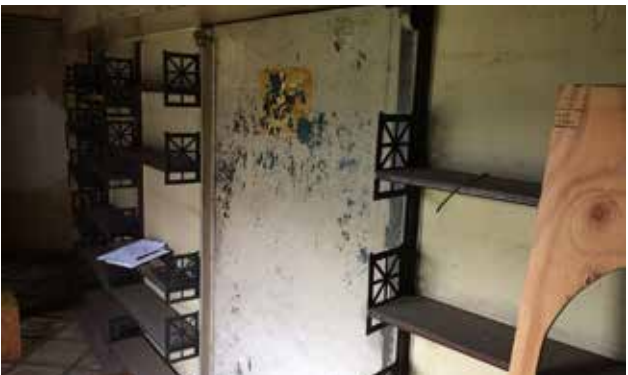
<b>W1-LC</b>  Sheet Metal and Sheet Metal Soffit Wall System	<b>Paint Loss</b> <ul style="list-style-type: none"><li>Loss of surface paint.</li></ul>	<b>Material Patching or Replacement</b> <ul style="list-style-type: none"><li>Determine reason for paint loss, correct problem, and repaint.</li></ul>	Level 3

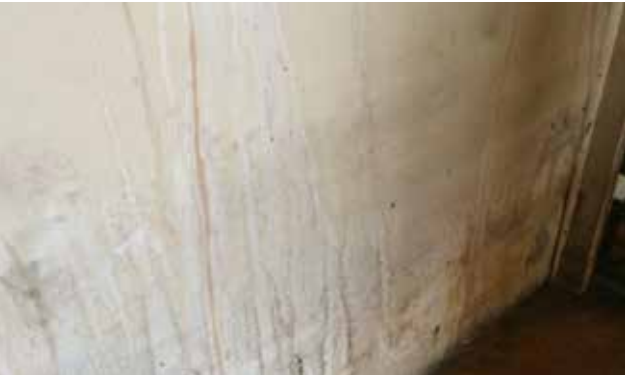
<b>W1-SA</b>  Sheet Metal and Sheet Metal Soffit Wall System	<b>Soiling</b> <ul style="list-style-type: none"><li>Surface staining caused by the build-up of pollutants.</li></ul>	<b>Develop Cleaning Program</b> <ul style="list-style-type: none"><li>Develop a cleaning program if it can be implemented without damage to bulding system.</li></ul>	Level 3

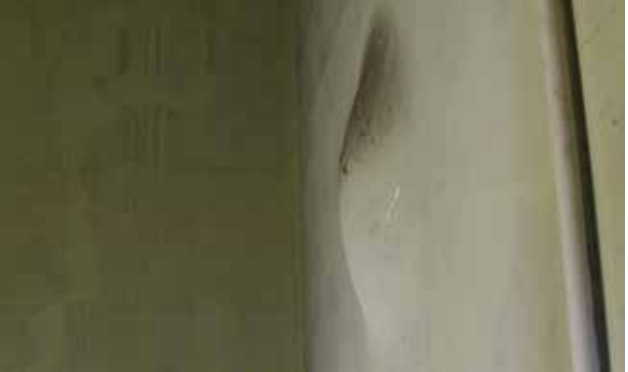
COMPONENT	CONDITION	TREATMENT	PRIORITY	REPRESENTATIVE PHOTO
<b>W2-BL</b>  Painted Plaster Wall System	<b>Blistering Paint</b> <ul style="list-style-type: none"><li>Swelling and rupturing of top layer, generally first stage of exfoliation.</li></ul>	<b>Material Patching or Replacement</b> <ul style="list-style-type: none"><li>Identify cause of blistering and remedy. Remove deteriorated paint and repaint.</li></ul>	Level 3

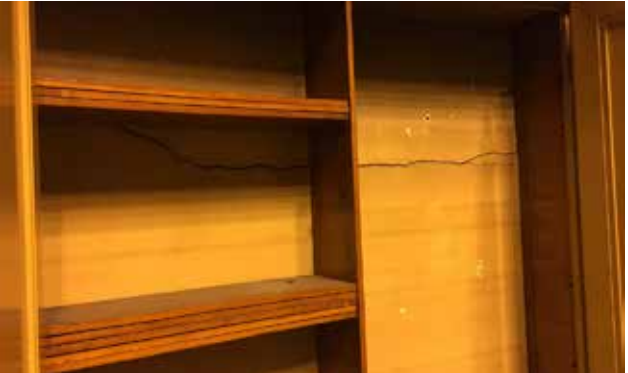
<b>W2-CR</b>  Painted Plaster Wall System	<b>Cracking</b> <ul style="list-style-type: none"><li>1/16" to 1/2" wide visible fissures, possibly penetrating through the material surface</li></ul>	<b>Material Replacement</b> <ul style="list-style-type: none"><li>Remove and replace damaged material.</li></ul>	Level 3

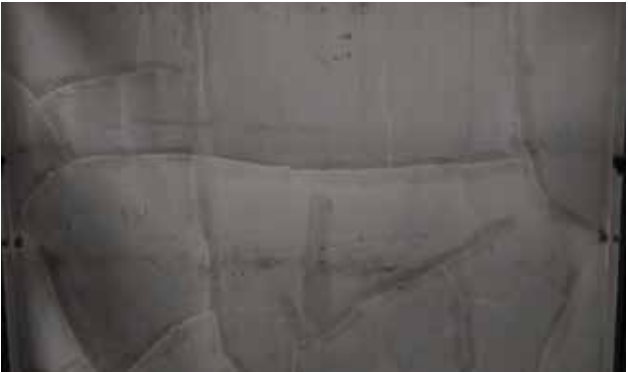
<b>W2-CH</b>  Painted Plaster Wall System	<b>Hairline Cracking</b> <ul style="list-style-type: none"><li>Numerous shallow cracks across the outer layer of a surface.</li></ul>	<b>Material Patching or Replacement</b> <ul style="list-style-type: none"><li>Patch where appropriate.</li></ul>	Level 3

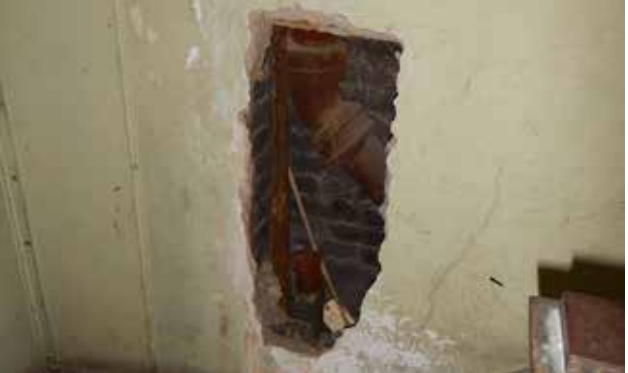
<b>W2-LM</b>  Painted Plaster Wall System	<b>Material Loss</b> <ul style="list-style-type: none"><li>Loss of material leaving holes or exposing inner layers.</li></ul>	<b>Material Patching or Replacement</b> <ul style="list-style-type: none"><li>Patch areas of missing material, if feasible, or replace material to match existing.</li></ul>	Level 3

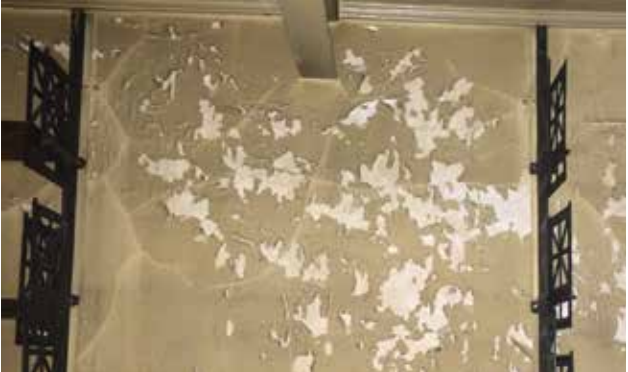
COMPONENT	CONDITION	TREATMENT	PRIORITY	REPRESENTATIVE PHOTO
<b>W2-LC</b>  Painted Plaster Wall System	<b>Paint Loss</b> <ul style="list-style-type: none"><li>Loss of surface paint.</li></ul>	<b>Material Replacement</b> <ul style="list-style-type: none"><li>Determine reason for paint loss, correct problem and repaint.</li></ul>	Level 3

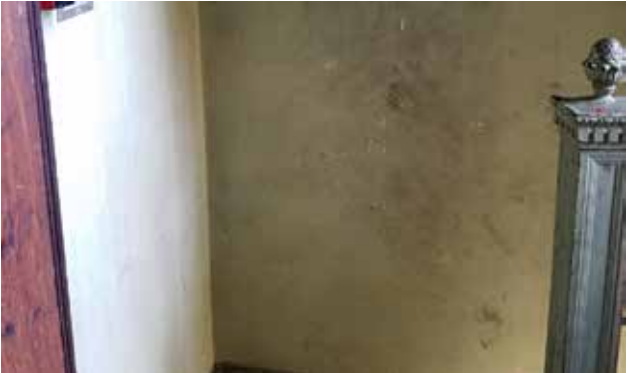
<b>W2-SA</b>  Painted Plaster Wall System	<b>Soiling</b> <ul style="list-style-type: none"><li>Surface staining caused by the build-up of pollutants.</li></ul>	<b>Develop Cleaning Program</b> <ul style="list-style-type: none"><li>Develop a cleaning program if it can be implemented without damage to building system.</li></ul>	Level 3

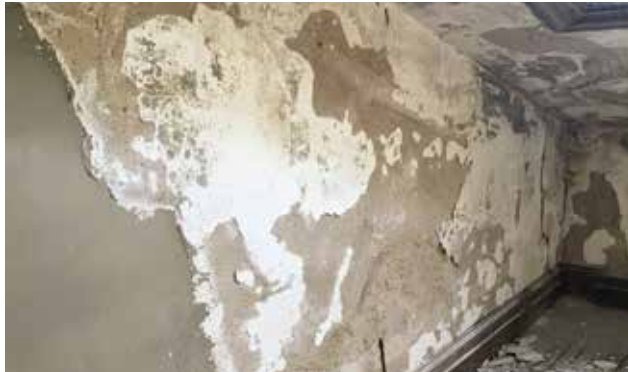
<b>W2-SP</b>  Painted Plaster Wall System	<b>Spalling</b> <ul style="list-style-type: none"><li>Uneven breaking off of the outer layers of plaster.</li></ul>	<b>Material Patching or Replacement</b> <ul style="list-style-type: none"><li>Remove decayed plaster to sound material; patch or replace with new plaster. Repaint.</li></ul>	Level 3

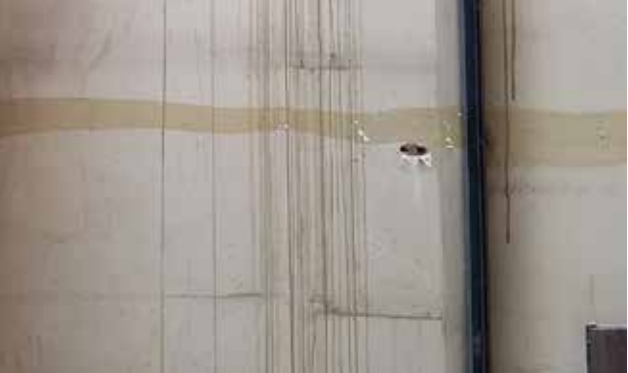
<b>W2-ST</b>  Painted Plaster Wall System	<b>Staining</b> <ul style="list-style-type: none"><li>Surface problem caused by the build-up of pollutants, mineral deposits and water marks.</li></ul>	<b>Develop Cleaning Program</b> <ul style="list-style-type: none"><li>Develop a cleaning program if it can be implemented without damage to building system.</li></ul>	Level 3

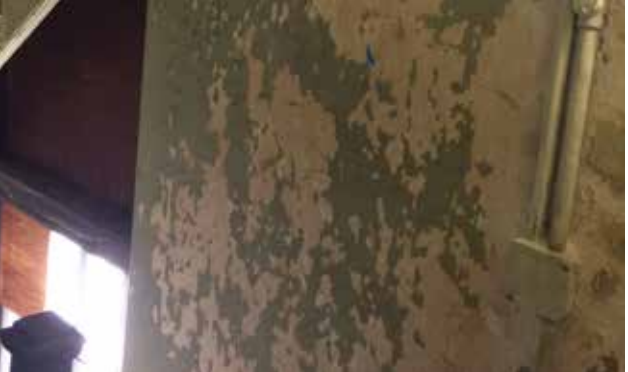
COMPONENT	CONDITION	TREATMENT	PRIORITY	REPRESENTATIVE PHOTO
<b>W2-SW</b>  Painted Plaster Wall System	<b>Water Damage</b> <ul style="list-style-type: none"><li>Biological growth, blistering, efflorescence, wood rot or staining caused by the infiltration of water.</li></ul>	<b>Removal of Deteriorated Material</b> <ul style="list-style-type: none"><li>Identify source of water infiltration and remedy cause. Replace deteriorated and damaged material.</li></ul>	Level 3

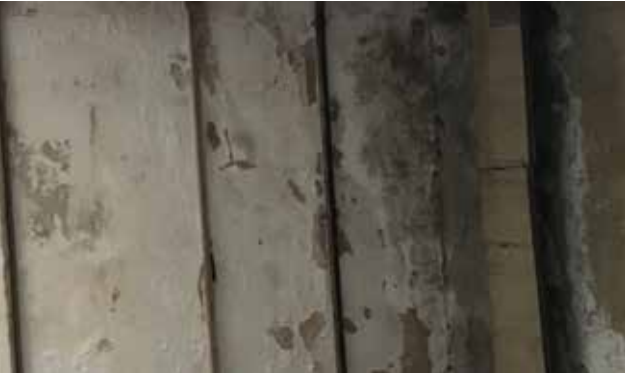
<b>W2-EF</b>  Painted Plaster Wall System	<b>Efflorescence</b> <ul style="list-style-type: none"><li>Whitish haze of soluble salts left as deposits on masonry by evaporation of water, generally a symptom of a worse condition or a hint that trouble may be beginning.</li></ul>	<b>Removal of Biological Material</b> <ul style="list-style-type: none"><li>Clean deposit, identify and eliminate water infiltration. If plaster behind efflorescence is damaged, remove and replace.</li></ul>	Level 3

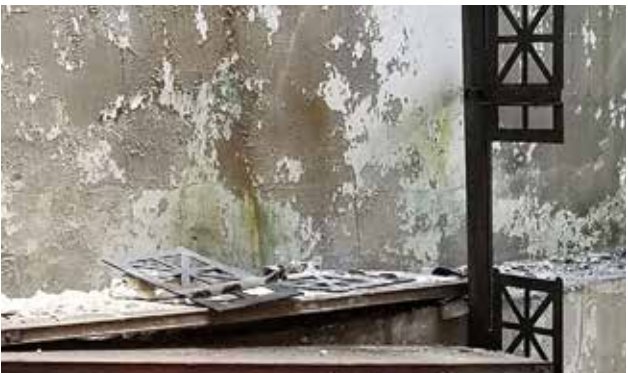
<b>W2-SB</b>  Painted Plaster Wall System	<b>Biological Growth</b> <ul style="list-style-type: none"><li>Surface growth having biological origins, typically found in damp locations.</li></ul>	<b>Develop Cleaning Program</b> <ul style="list-style-type: none"><li>Clean, identify source of water infiltration and remedy cause. If severe, replace deteriorated material.</li></ul>	Level 3

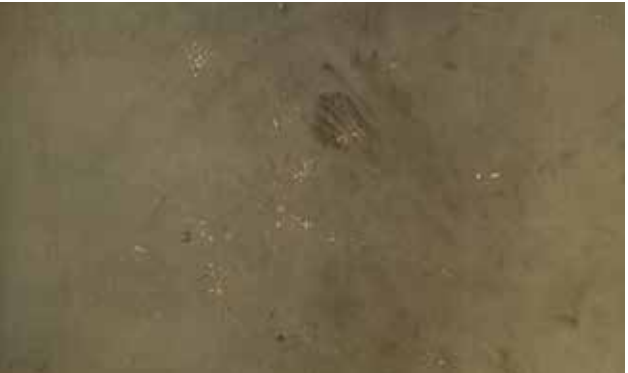
<b>W2-W</b>  Painted Plaster Wall System	<b>Wear</b> <ul style="list-style-type: none"><li>The gradual disintegration and erosion of materials caused by gradual use overtime.</li></ul>	<b>Material Patching or Replacement</b> <ul style="list-style-type: none"><li>Leave alone unless severe, then consider replacing.</li></ul>	Level 3

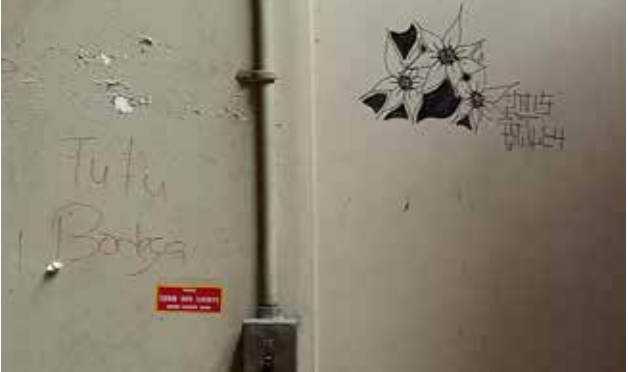
COMPONENT	CONDITION	TREATMENT	PRIORITY	REPRESENTATIVE PHOTO
<b>W2-G</b>  Painted Plaster Wall System	<b>Graffiti</b> <ul style="list-style-type: none"><li>Paint sprayed on surface.</li></ul>	<b>Develop Cleaning Program</b> <ul style="list-style-type: none"><li>Investigate proper removal methods, where appropriate, without damaging material.</li></ul>	Level 3

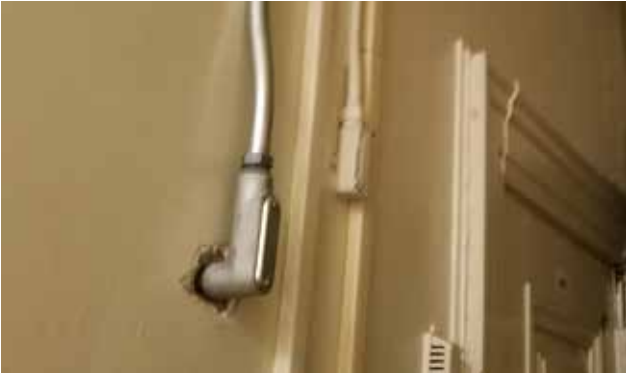
<b>W2-MD</b>  Painted Plaster Wall System	<b>Mechanical Damage</b> <ul style="list-style-type: none"><li>Damage to material caused by mechanical components or equipment</li></ul>	<b>Material Repair or Replacement</b> <ul style="list-style-type: none"><li>Remove mechanical remnants and connections. Patch areas of missing or damaged material, if feasible; remove and replace material, as required.</li></ul>	Level 3

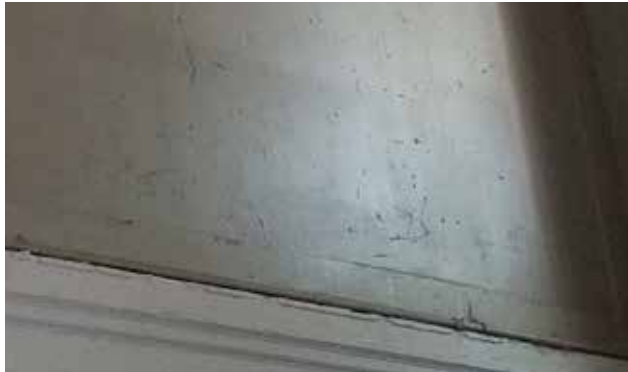
<b>W2-SD</b>  Painted Plaster Wall System	<b>Scratches / Dents</b> <ul style="list-style-type: none"><li>Damage to material caused by mechanical components or equipment</li></ul>	<b>Material Repair or Replacement</b> <ul style="list-style-type: none"><li>Patch areas of missing or damaged material, if feasible; remove and replace material, as required.</li></ul>	Level 3

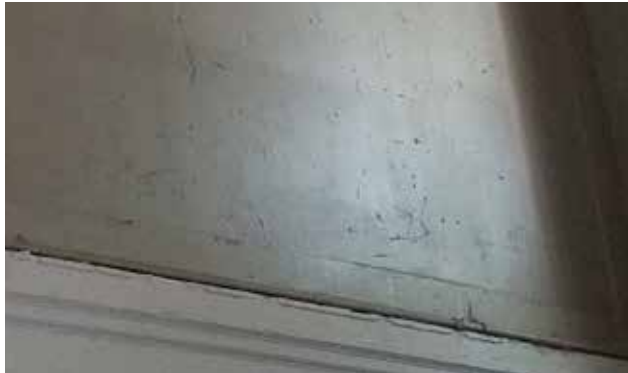
<b>W2-OJ</b>  Painted Plaster Wall System	<b>Open Joints</b> <ul style="list-style-type: none"><li>Joints without caulking</li></ul>	<b>Material Patching or Replacement</b> <ul style="list-style-type: none"><li>Determine reason for missing caulk and reseal edges.</li></ul>	Level 3

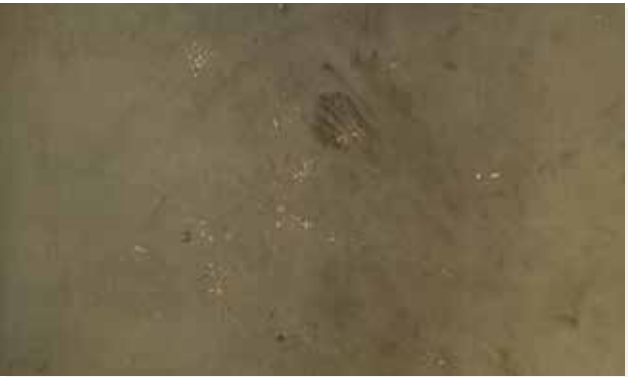
COMPONENT	CONDITION	TREATMENT	PRIORITY	REPRESENTATIVE PHOTO
<b>W2-OP</b>  Painted Plaster Wall System	<b>Overpainted</b> <ul style="list-style-type: none"><li>Multiple layers of paint.</li></ul>	<b>Material Patching or Replacement</b> <ul style="list-style-type: none"><li>Leave alone unless other forms of deterioration, then scrape to substrate and repaint.</li></ul>	Level 3

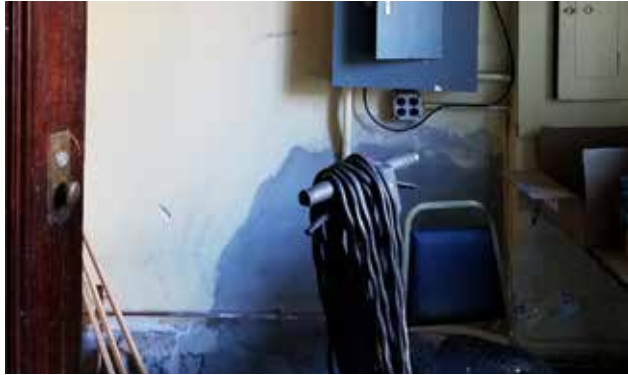
<b>W2-PR</b>  Painted Plaster Wall System	<b>Previous Repair</b> <ul style="list-style-type: none"><li>Area where a previous repair was done, including repointing, patching and consolidation.</li></ul>	<b>Material Replacement</b> <ul style="list-style-type: none"><li>Replace inappropriate previous patches.</li></ul>	Level 3

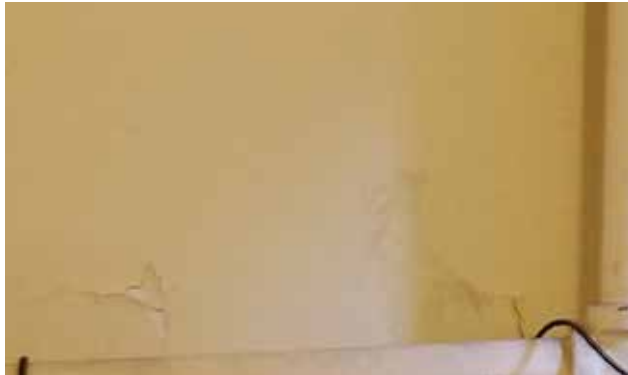
<b>W2-ED</b>  Painted Plaster Wall System	<b>Deformation</b> <ul style="list-style-type: none"><li>Distortion or changing in shape of a material, usually through the application of pressure.</li></ul>	<b>Material Repair or Replacement</b> <ul style="list-style-type: none"><li>Determine reason for deformation and repair or replace material if necessary.</li></ul>	Level 3

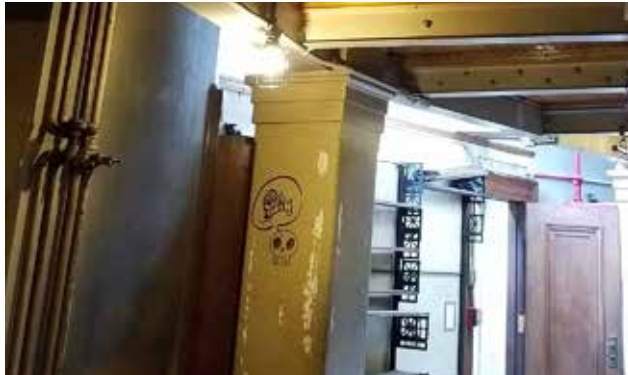
<b>W3-G</b>  Brick Masonry Wall System	<b>Graffiti</b> <ul style="list-style-type: none"><li>Paint sprayed on surface.</li></ul>	<b>Develop Cleaning Program</b> <ul style="list-style-type: none"><li>Investigate proper removal methods where appropriate without damaging material.</li></ul>	Level 3

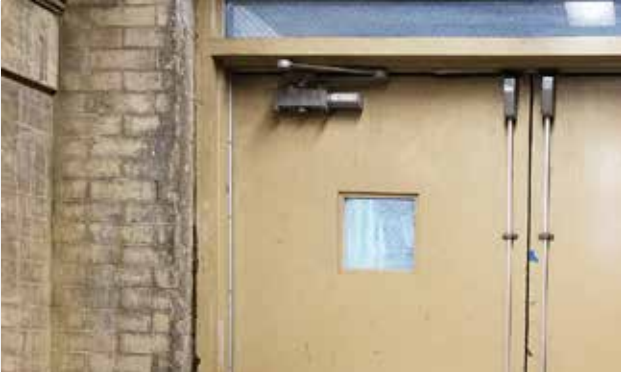
COMPONENT	CONDITION	TREATMENT	PRIORITY	REPRESENTATIVE PHOTO
<b>W3-SP</b>  Brick Masonry Wall System	<b>Spalling</b> <ul style="list-style-type: none"><li>Uneven breaking off of the outer layers of masonry.</li></ul>	<b>Material Replacement</b> <ul style="list-style-type: none"><li>Remove deteriorated masonry and replace with new bricks and appropriate mortar.</li></ul>	Level 3

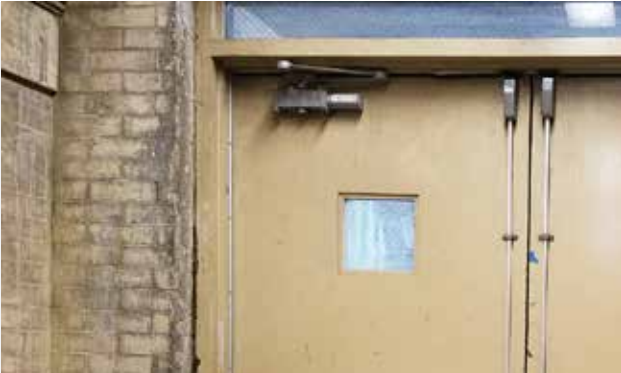
<b>W3-CR</b>  Brick Masonry Wall System	<b>Cracking</b> <ul style="list-style-type: none"><li>1/16" to 1/2" wide visible fissures, possibly penetrating through the material surface</li></ul>	<b>Material Replacement</b> <ul style="list-style-type: none"><li>Remove deteriorated bricks and replace with new masonry.</li></ul>	Level 3

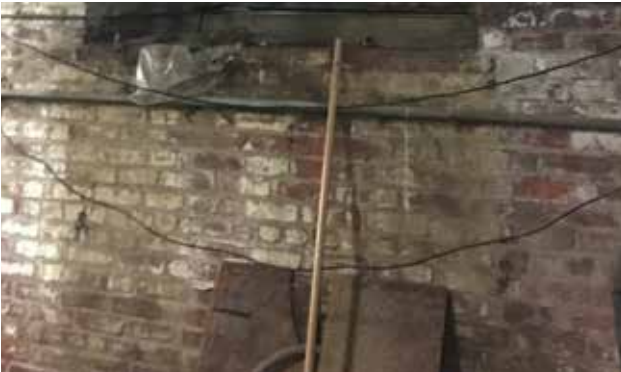
<b>W3-LC</b>  Brick Masonry Wall System	<b>Paint Loss</b> <ul style="list-style-type: none"><li>Loss of surface paint.</li></ul>	<b>Material Replacement</b> <ul style="list-style-type: none"><li>Determine reason for paint loss, correct problem and repaint.</li></ul>	Level 3

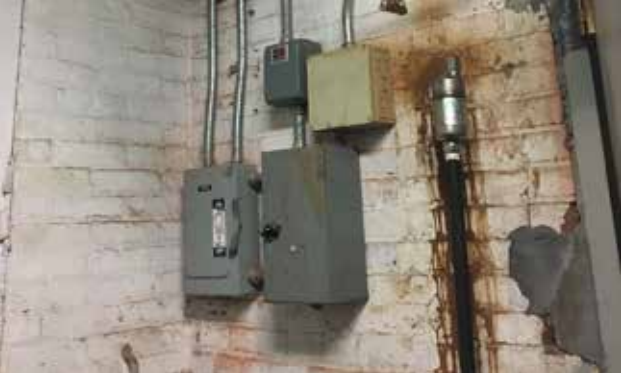
<b>W3-PR</b>  Brick Masonry Wall System	<b>Previous Repair</b> <ul style="list-style-type: none"><li>Area where a previous repair was done, including repointing, patching and consolidation.</li></ul>	<b>Material Replacement</b> <ul style="list-style-type: none"><li>Replace inappropriate previous patches.</li></ul>	Level 3

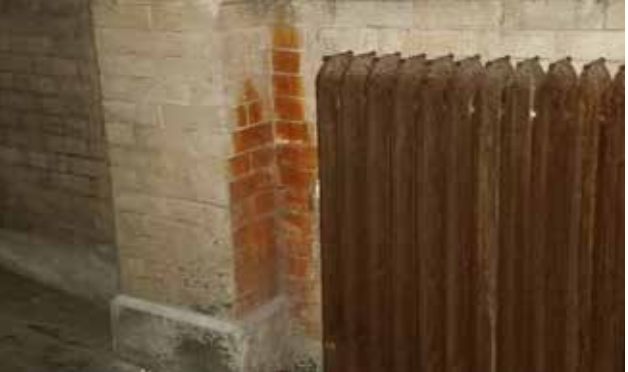
COMPONENT	CONDITION	TREATMENT	PRIORITY	REPRESENTATIVE PHOTO
<b>W3-ST</b>  Brick Masonry Wall System	<b>Staining</b> <ul style="list-style-type: none"><li>Surface problem caused by the build-up of pollutants, mineral deposits and water marks.</li></ul>	<b>Develop Cleaning Program</b> <ul style="list-style-type: none"><li>Develop a cleaning program if it can be implemented without damage to bulding system.</li></ul>	Level 3

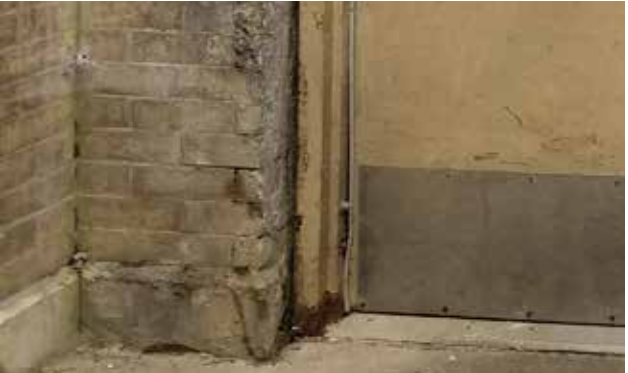
<b>W3-SB</b>  Brick Masonry Wall System	<b>Biological Growth</b> <ul style="list-style-type: none"><li>Surface growth having biological origins, typically found in damp locations.</li></ul>	<b>Develop Cleaning Program</b> <ul style="list-style-type: none"><li>Clean, identify source of water infiltration and remedy cause. If severe, replace deteriorated material.</li></ul>	Level 3

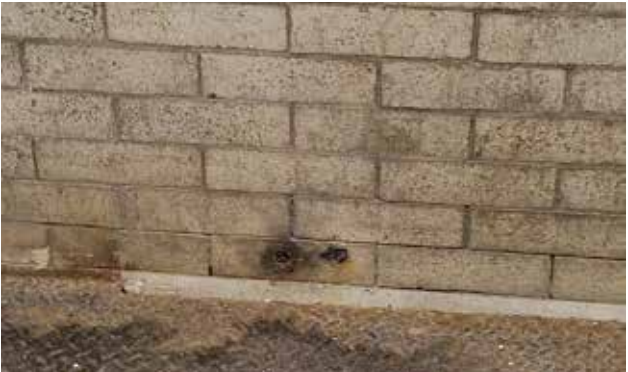
<b>W3-MD</b>  Brick Masonry Wall System	<b>Mechanical Damage</b> <ul style="list-style-type: none"><li>Damage to material caused by mechanical components or equipment</li></ul>	<b>Material Repair or Replacement</b> <ul style="list-style-type: none"><li>Remove mechanical remnants and connections. Patch areas of missing or damaged material, if feasible; remove and replace material, as required.</li><li>If mechanical element is to remain, install new lintel above existing penetration.</li></ul>	Level 3

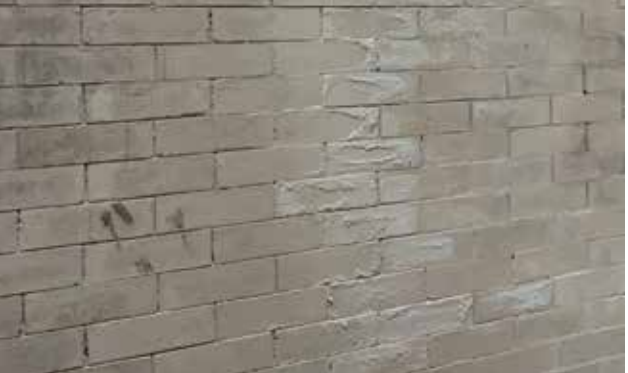
<b>W3-EF</b>  Brick Masonry Wall System	<b>Efflorescence</b> <ul style="list-style-type: none"><li>Whitish haze of soluble salts left as deposits on masonry by evaporation of water, generally a symptom of a worse condition or a hint that trouble may be beginning.</li></ul>	<b>Develop Cleaning Program</b> <ul style="list-style-type: none"><li>Clean deposit, identify and eliminate water infiltration.</li></ul>	Level 3

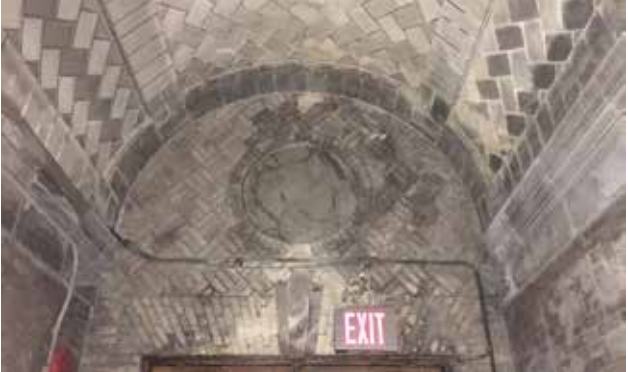
COMPONENT	CONDITION	TREATMENT	PRIORITY	REPRESENTATIVE PHOTO
<b>W3-SA</b>  Brick Masonry Wall System	<b>Soiling</b> <ul style="list-style-type: none"><li>Surface staining caused by the build-up of pollutants.</li></ul>	<b>Develop Cleaning Program</b> <ul style="list-style-type: none"><li>Develop a cleaning program if it can be implemented without damage to bulding system.</li></ul>	Level 3

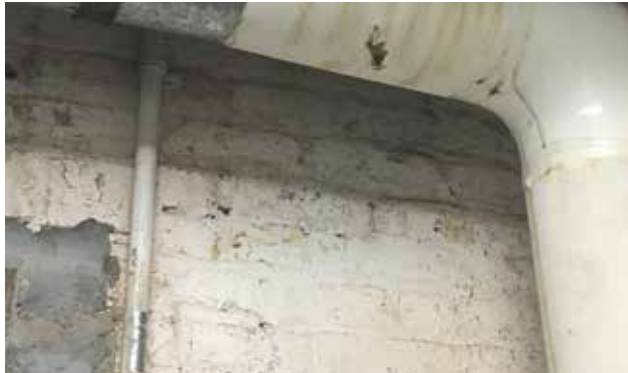
<b>W3-SD</b>  Brick Masonry Wall System	<b>Scratches / Dents</b> <ul style="list-style-type: none"><li>Damage to material caused by mechanical components or equipment</li></ul>	<b>Material Repair or Replacement</b> <ul style="list-style-type: none"><li>Patch areas of missing or damaged material, if feasible; remove and replace material, as required.</li></ul>	Level 3

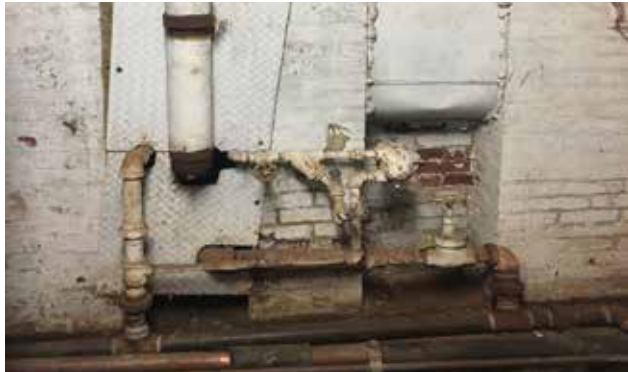
<b>W3-OJ</b>  Brick Masonry Wall System	<b>Open Joints</b> <ul style="list-style-type: none"><li>Joints without mortar</li></ul>	<b>Material Repair or Replacement</b> <ul style="list-style-type: none"><li>Repoint masonry with an appropriate mortar.</li></ul>	Level 3

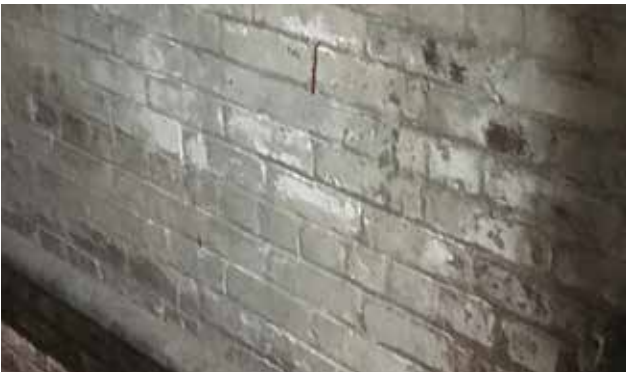
<b>W3-LM</b>  Brick Masonry Wall System	<b>Material Loss</b> <ul style="list-style-type: none"><li>Loss of material leaving holes or exposing inner layers.</li></ul>	<b>Material Patching or Replacement</b> <ul style="list-style-type: none"><li>Patch areas of missing material, if feasible, or replace material to match existing.</li></ul>	Level 3

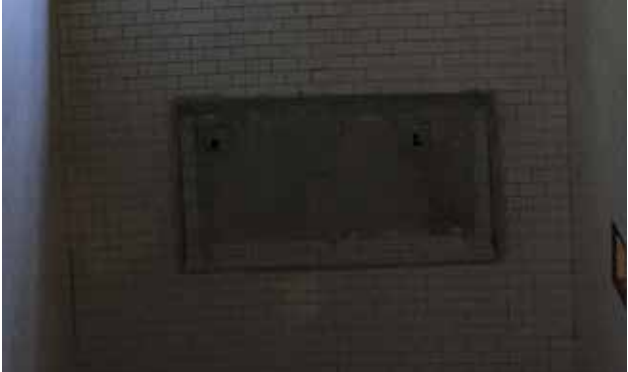
COMPONENT	CONDITION	TREATMENT	PRIORITY	REPRESENTATIVE PHOTO
<b>W4-MD</b>  Tile Wall System	<b>Mechanical Damage</b> <ul style="list-style-type: none"><li>Damage to material caused by mechanical components or equipment</li></ul>	<b>Material Repair or Replacement</b> <ul style="list-style-type: none"><li>Remove mechanical remnants and connections. Patch areas of missing or damaged material, if feasible; remove and replace material, as required.</li></ul>	Level 3

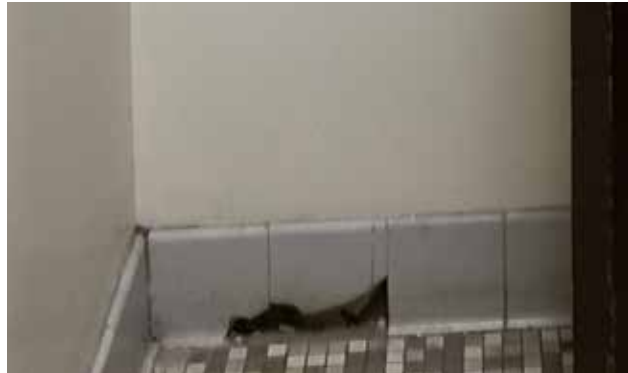
<b>W4-LM</b>  Tile Wall System	<b>Material Loss</b> <ul style="list-style-type: none"><li>Loss of material leaving holes or exposing inner layers.</li></ul>	<b>Material Patching or Replacement</b> <ul style="list-style-type: none"><li>Patch areas of missing material, if feasible, or replace material to match existing.</li></ul>	Level 3

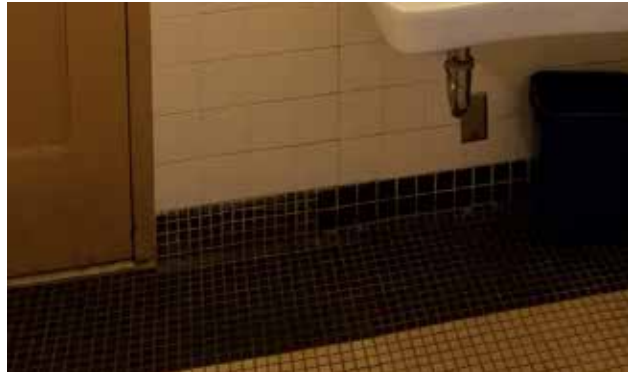
<b>W4-SA</b>  Tile Wall System	<b>Soiling</b> <ul style="list-style-type: none"><li>Surface staining caused by the build-up of pollutants.</li></ul>	<b>Develop Cleaning Program</b> <ul style="list-style-type: none"><li>Develop a cleaning program if it can be implemented without damage to bulding system.</li></ul>	Level 3

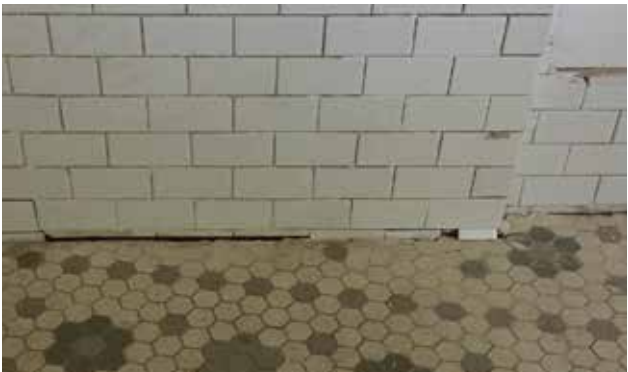
<b>W4-SP</b>  Tile Wall System	<b>Spalling</b> <ul style="list-style-type: none"><li>Uneven breaking off of the outer layers of masonry.</li></ul>	<b>Material Replacement</b> <ul style="list-style-type: none"><li>Remove deteriorated tile. Replace with new tile and appropriate setting bed and grout.</li></ul>	Level 3

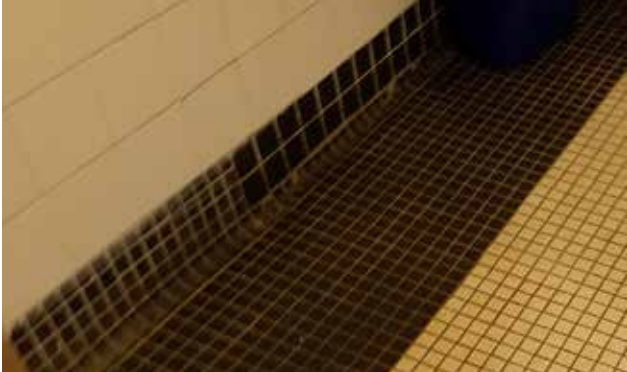
COMPONENT	CONDITION	TREATMENT	PRIORITY	REPRESENTATIVE PHOTO
<b>W4-PR</b>  Tile Wall System	<b>Previous Repair</b> <ul style="list-style-type: none"><li>Area where a previous repair was done, including repointing, patching and consolidation.</li></ul>	<b>Material Replacement</b> <ul style="list-style-type: none"><li>Replace inappropriate previous patches.</li></ul>	Level 3

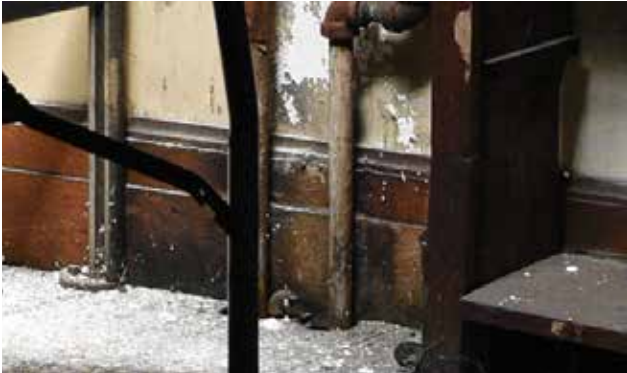
<b>W5-RT</b>  Wood Trim Wall System	<b>Wood Rot</b> <ul style="list-style-type: none"><li>The growth of fungi when oxygen, warmth and moisture are present in wood.</li></ul>	<b>Material Replacement and Treatment</b> <ul style="list-style-type: none"><li>Replace rotted elements and treat new wood to repel agents that cause rotting.</li></ul>	Level 3

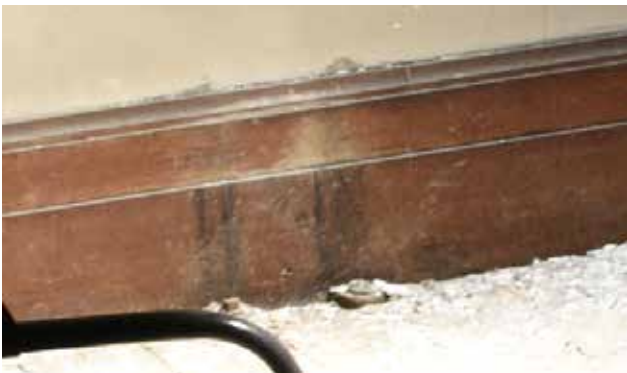
<b>W5-SA</b>  Wood Trim Wall System	<b>Soiling</b> <ul style="list-style-type: none"><li>Surface staining caused by the build-up of pollutants.</li></ul>	<b>Develop Cleaning Program</b> <ul style="list-style-type: none"><li>Develop a cleaning program if it can be implemented without damage to bulding system.</li></ul>	Level 3

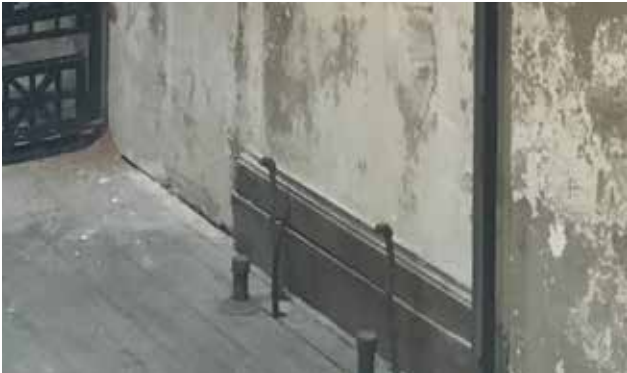
<b>W5-LM</b>  Wood Trim Wall System	<b>Material Loss</b> <ul style="list-style-type: none"><li>Loss of material leaving holes or exposing inner layers.</li></ul>	<b>Material Patching or Replacement</b> <ul style="list-style-type: none"><li>Patch areas of missing material, if feasible, or replace material to match existing.</li></ul>	Level 3

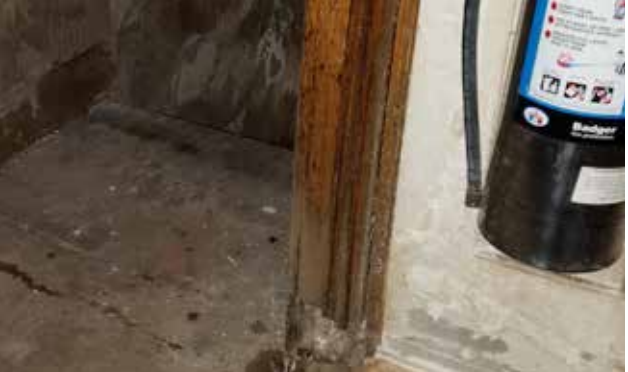
COMPONENT	CONDITION	TREATMENT	PRIORITY	REPRESENTATIVE PHOTO
<b>W5-W</b>  Wood Trim Wall System	<b>Wear</b> <ul style="list-style-type: none"><li>The gradual disintegration and erosion of materials caused by gradual use overtime.</li></ul>	<b>Material Patching or Replacement</b> <ul style="list-style-type: none"><li>Leave alone unless severe, then consider replacing.</li></ul>	Level 3

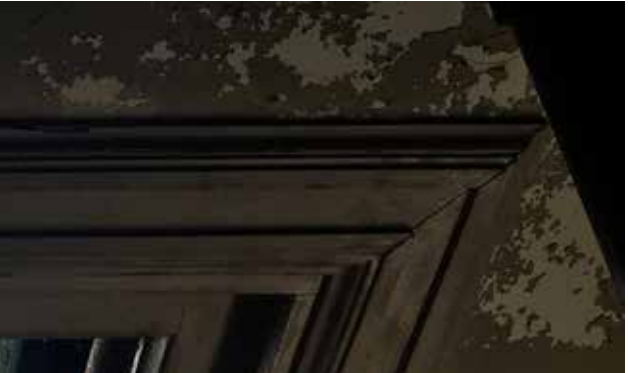
<b>W5-OJ</b>  Wood Trim Wall System	<b>Open Joints</b> <ul style="list-style-type: none"><li>Open and separating joints between adjoining wood elements.</li></ul>	<b>Material Patching or Replacement</b> <ul style="list-style-type: none"><li>Determine reason for opening joints and fill open joints.</li></ul>	Level 3

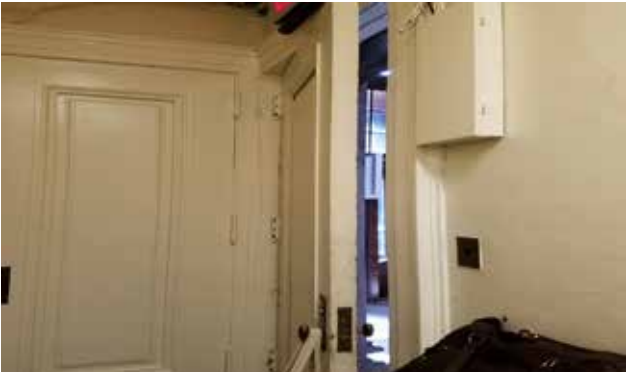
<b>W5-LC</b>  Wood Trim Wall System	<b>Paint Loss</b> <ul style="list-style-type: none"><li>Loss of surface paint.</li></ul>	<b>Material Replacement</b> <ul style="list-style-type: none"><li>Determine reason for paint loss, correct problem and repaint.</li></ul>	Level 3

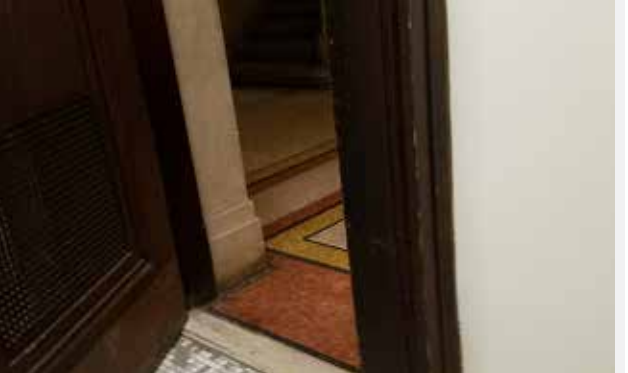
<b>W5-SD</b>  Wood Trim Wall System	<b>Scratches / Dents</b> <ul style="list-style-type: none"><li>Damage to material caused by mechanical components or equipment</li></ul>	<b>Material Repair or Replacement</b> <ul style="list-style-type: none"><li>Patch areas of missing or damaged material, if feasible; remove and replace material, as required.</li></ul>	Level 3

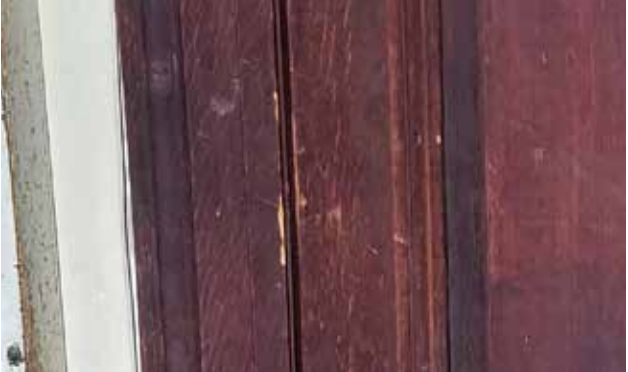
COMPONENT	CONDITION	TREATMENT	PRIORITY	REPRESENTATIVE PHOTO
<b>W5-SL</b>  Wood Trim Wall System	<b>Splintering</b> <ul style="list-style-type: none"><li>Caused by the process of swelling from moisture and drying from heat, or mechanical damage.</li></ul>	<b>Repair of Deteriorated Material</b> <ul style="list-style-type: none"><li>Repair by sanding or wood putty.</li></ul>	Level 3

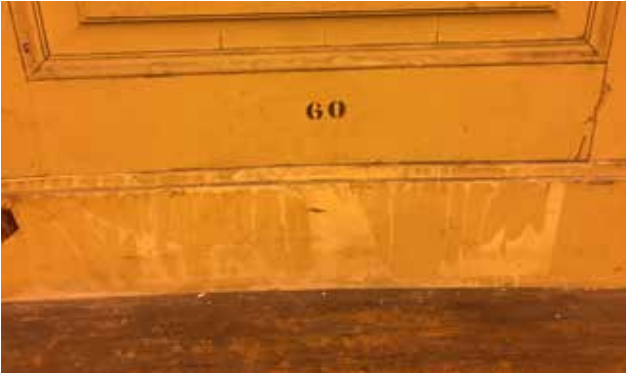
<b>W5-ST</b>  Wood Trim Wall System	<b>Staining</b> <ul style="list-style-type: none"><li>Surface problem caused by the build-up of pollutants, mineral deposits and water marks.</li></ul>	<b>Develop Cleaning Program</b> <ul style="list-style-type: none"><li>Develop a cleaning program if it can be implemented without damage to bulding system.</li></ul>	Level 3

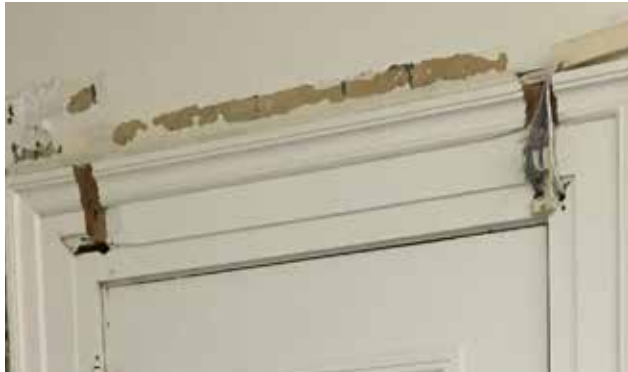
<b>W5-MD</b>  Wood Trim Wall System	<b>Mechanical Damage</b> <ul style="list-style-type: none"><li>Damage to material caused by mechanical components or equipment</li></ul>	<b>Material Repair or Replacement</b> <ul style="list-style-type: none"><li>Remove mechanical remnants and connections. Patch areas of missing or damaged material, if feasible; remove and replace material, as required.</li></ul>	Level 3

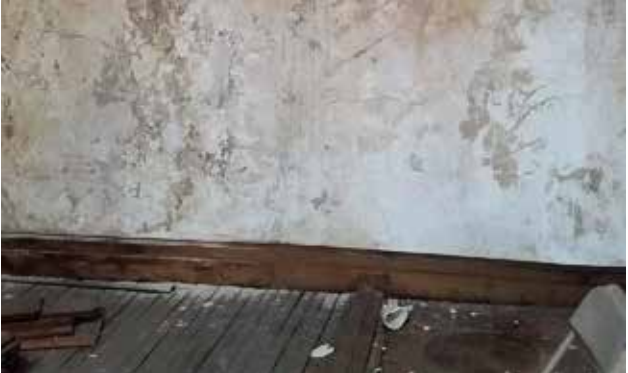
<b>W5-CR</b>  Wood Trim Wall System	<b>Crack</b> <ul style="list-style-type: none"><li>1/16 to 1/2 inch wide visible fissure, possibly penetrating through the surface.</li></ul>	<b>Material Replacement</b> <ul style="list-style-type: none"><li>Remove and replace damaged material.</li></ul>	Level 3

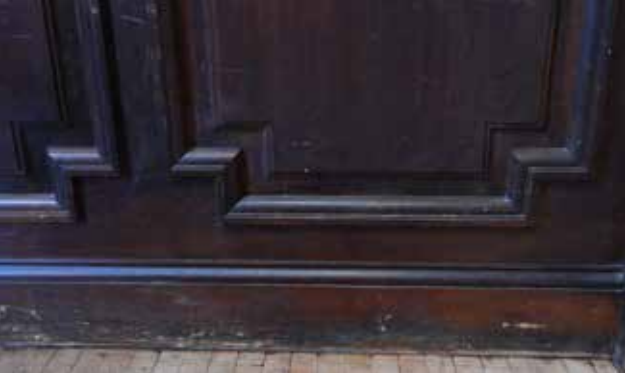
COMPONENT	CONDITION	TREATMENT	PRIORITY	REPRESENTATIVE PHOTO
<b>W6-MD</b>  Wood Panel Wall System	<b>Mechanical Damage</b> <ul style="list-style-type: none"><li>Damage to material caused by mechanical components or equipment</li></ul>	<b>Material Repair or Replacement</b> <ul style="list-style-type: none"><li>Remove mechanical remnants and connections. Patch areas of missing or damaged material, if feasible; remove and replace material, as required.</li></ul>	Level 3

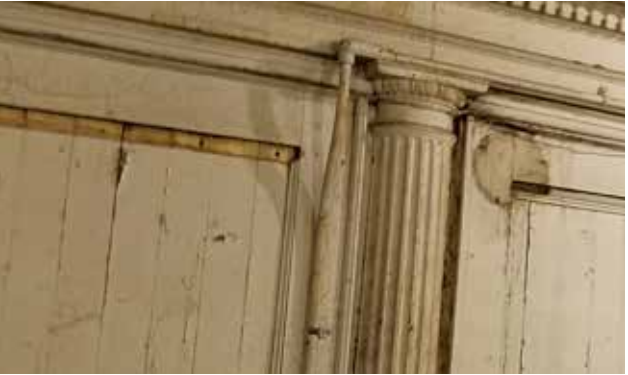
<b>W6-LM</b>  Wood Panel Wall System	<b>Material Loss</b> <ul style="list-style-type: none"><li>Loss of material leaving holes or exposing inner layers.</li></ul>	<b>Material Patching or Replacement</b> <ul style="list-style-type: none"><li>Patch areas of missing material, if feasible, or replace material to match existing.</li></ul>	Level 3

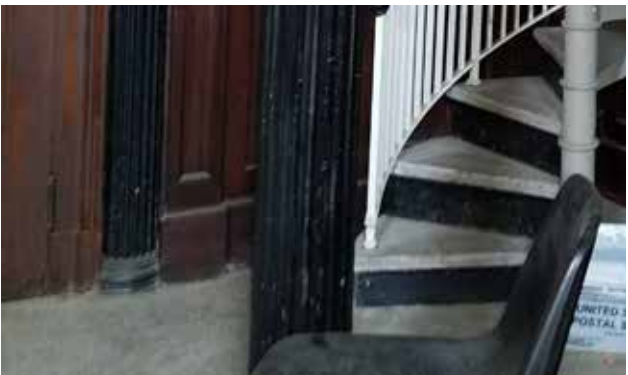
<b>W6-SA</b>  Wood Panel Wall System	<b>Soiling</b> <ul style="list-style-type: none"><li>Surface staining caused by the build-up of pollutants.</li></ul>	<b>Develop Cleaning Program</b> <ul style="list-style-type: none"><li>Develop a cleaning program if it can be implemented without damage to building system.</li></ul>	Level 3

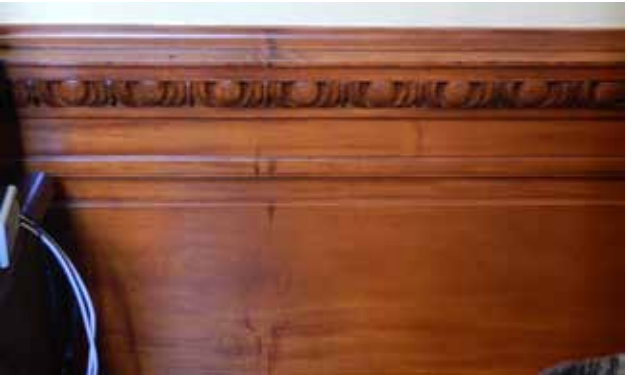
<b>W6-W</b>  Wood Panel Wall System	<b>Wear</b> <ul style="list-style-type: none"><li>The gradual disintegration and erosion of materials caused by gradual use overtime.</li></ul>	<b>Material Patching or Replacement</b> <ul style="list-style-type: none"><li>Leave alone unless severe, then consider replacing.</li></ul>	Level 3

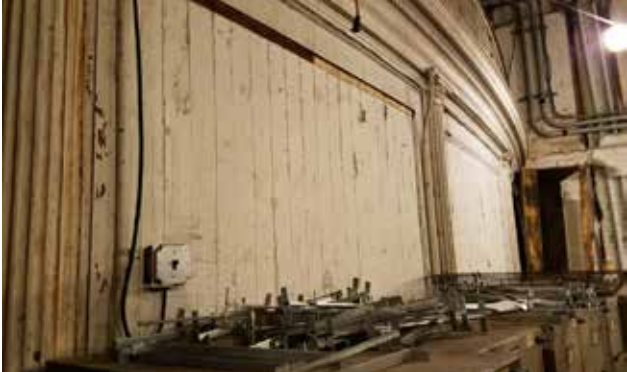
COMPONENT	CONDITION	TREATMENT	PRIORITY	REPRESENTATIVE PHOTO
<b>W6-LC</b>  Wood Panel Wall System	<b>Paint Loss</b> <ul style="list-style-type: none"><li>Loss of surface paint.</li></ul>	<b>Material Replacement</b> <ul style="list-style-type: none"><li>Determine reason for paint loss, correct problem and repaint.</li></ul>	Level 3

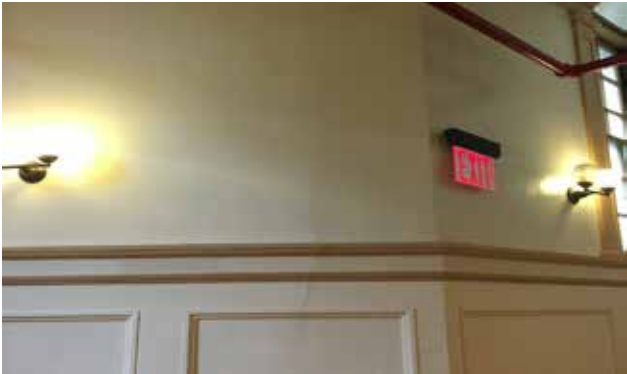
<b>W6-CH</b>  Wood Panel Wall System	<b>Hairline Cracking</b> <ul style="list-style-type: none"><li>Numerous shallow cracks across the outer layer of a surface.</li></ul>	<b>Material Patching or Replacement</b> <ul style="list-style-type: none"><li>Patch where appropriate.</li></ul>	Level 3

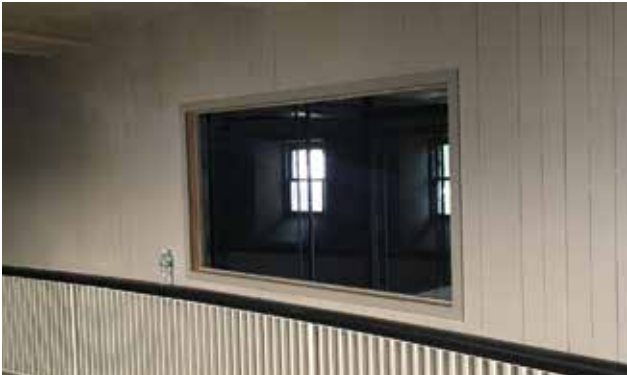
<b>W6-ST</b>  Wood Panel Wall System	<b>Staining</b> <ul style="list-style-type: none"><li>Surface problem caused by the build-up of pollutants, mineral deposits and water marks.</li></ul>	<b>Develop Cleaning Program</b> <ul style="list-style-type: none"><li>Develop a cleaning program if it can be implemented without damage to building system.</li></ul>	Level 3

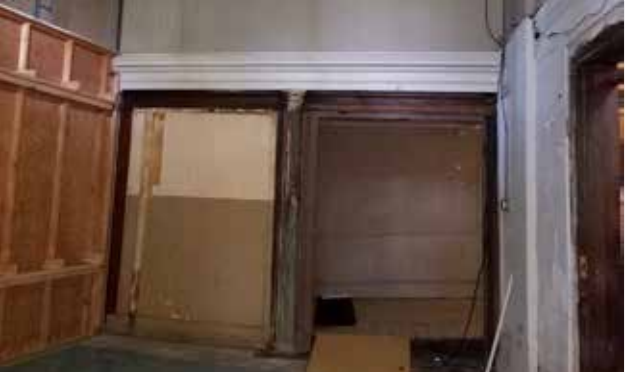
COMPONENT	CONDITION	TREATMENT	PRIORITY	REPRESENTATIVE PHOTO
<b>W6-RT</b>  Wood Panel Wall System	<b>Wood Rot</b> <ul style="list-style-type: none"><li>The growth of fungi when oxygen, warmth and moisture are present in wood.</li></ul>	<b>Material Replacement and Treatment</b> <ul style="list-style-type: none"><li>Replace rotted elements and treat new wood to repel agents that cause rotting.</li></ul>	Level 3

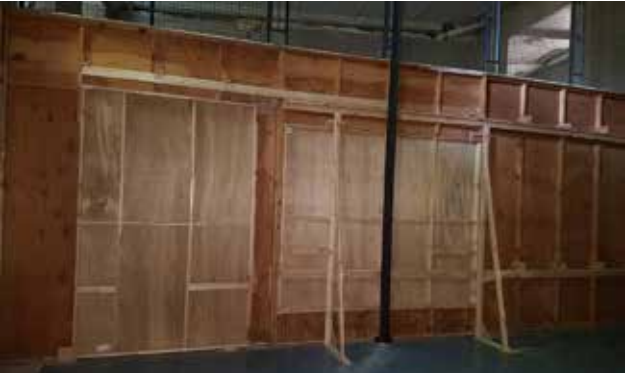
<b>W7-SA</b>  Wood Framed Plywood Partition Wall System	<b>Soiling</b> <ul style="list-style-type: none"><li>Surface staining caused by the build-up of pollutants.</li></ul>	<b>Develop Cleaning Program</b> <ul style="list-style-type: none"><li>Develop a cleaning program if it can be implemented without damage to bulding system.</li></ul>	Level 3

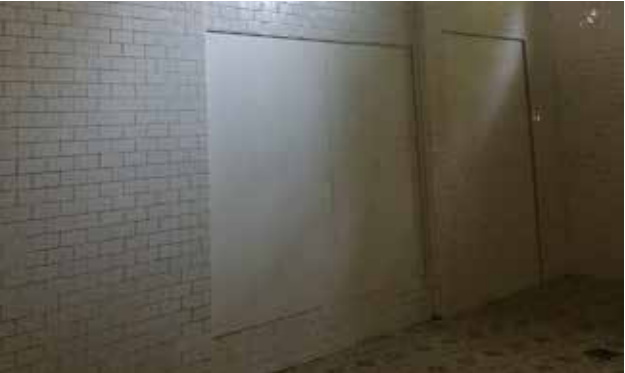
<b>W7-OJ</b>  Wood Framed Plywood Partition Wall System	<b>Open Joints</b> <ul style="list-style-type: none"><li>Joints without caulking</li></ul>	<b>Material Patching or Replacement</b> <ul style="list-style-type: none"><li>Determine reason for missing caulk and reseal edges.</li></ul>	Level 3

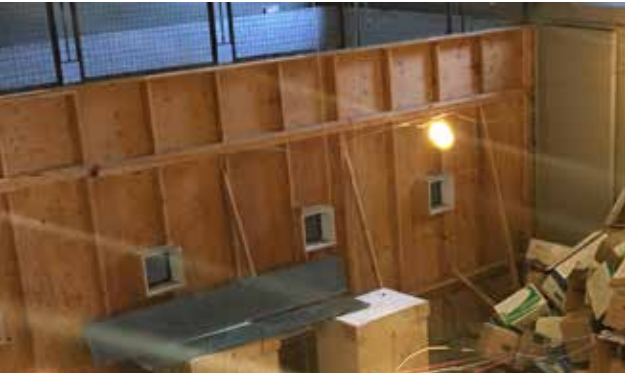
<b>W7-MD</b>  Wood Framed Plywood Partition Wall System	<b>Mechanical Damage</b> <ul style="list-style-type: none"><li>Damage to material caused by mechanical components or equipment</li></ul>	<b>Material Repair or Replacement</b> <ul style="list-style-type: none"><li>Remove mechanical remnants and connections. Patch areas of missing or damaged material, if feasible; remove and replace material, as required.</li></ul>	Level 3

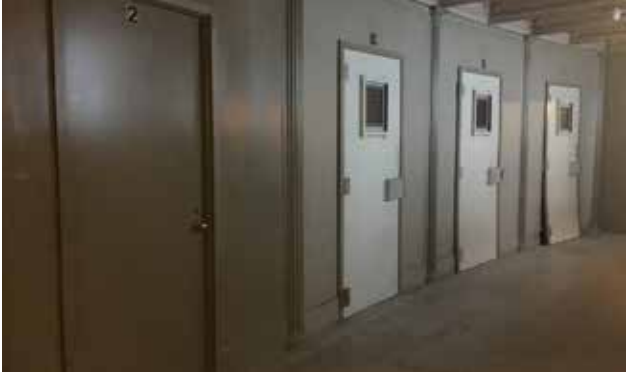
COMPONENT	CONDITION	TREATMENT	PRIORITY	REPRESENTATIVE PHOTO
<b>W7-LM</b>  Wood Framed Plywood Partition Wall System	<b>Material Loss</b> <ul style="list-style-type: none"><li>Loss of material leaving holes or exposing inner layers.</li></ul>	<b>Material Patching or Replacement</b> <ul style="list-style-type: none"><li>Patch areas of missing material, if feasible, or replace material to match existing.</li></ul>	Level 3

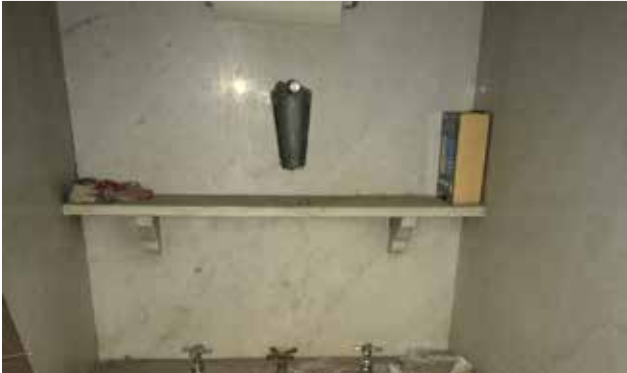
<b>W8-SA</b>  Marble Slab Wall System	<b>Soiling</b> <ul style="list-style-type: none"><li>Surface staining caused by the build-up of pollutants.</li></ul>	<b>Develop Cleaning Program</b> <ul style="list-style-type: none"><li>Develop a cleaning program if it can be implemented without damage to building system.</li></ul>	Level 3

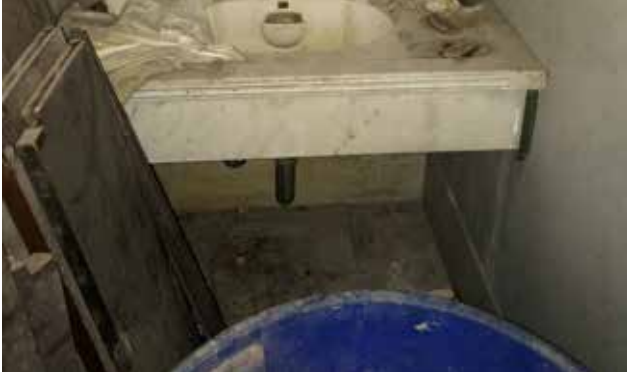
<b>W8-ST</b>  Marble Slab Wall System	<b>Staining</b> <ul style="list-style-type: none"><li>Surface problem caused by the build-up of pollutants, mineral deposits and water marks.</li></ul>	<b>Develop Cleaning Program</b> <ul style="list-style-type: none"><li>Develop a cleaning program if it can be implemented without damage to building system.</li></ul>	Level 3

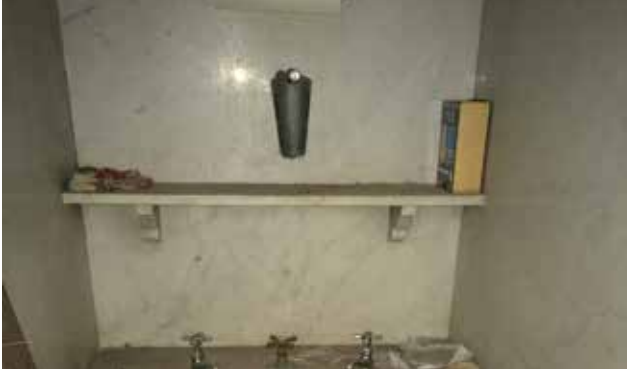
<b>W8-OJ</b>  Marble Slab Wall System	<b>Open Joints</b> <ul style="list-style-type: none"><li>Joints without caulking or grout</li></ul>	<b>Material Patching or Replacement</b> <ul style="list-style-type: none"><li>Determine reason for missing joint sealant and reseal.</li></ul>	Level 3

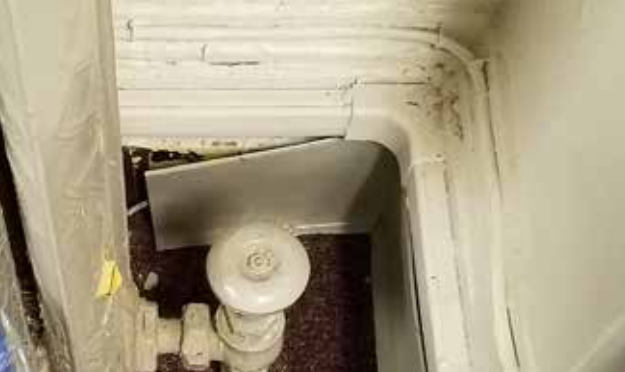
COMPONENT	CONDITION	TREATMENT	PRIORITY	REPRESENTATIVE PHOTO
<b>W9-OJ</b>  Vinyl Trim Wall System	<b>Open Joints</b> <ul style="list-style-type: none"><li>Open, separating joints between segments of vinyl trim.</li></ul>	<b>Material Reapir or Replacement</b> <ul style="list-style-type: none"><li>Reinstall trim to eliminate gaps at joints between segments, if possible; if necessary, replace segments of trim to allow closed joints between segments.</li></ul>	Level 3
