# Conditions Assessment

## Gould Memorial Library & Hall of Fame

FINAL REPORT | 15 MARCH 2018

**BRONX**  
**COMMUNITY**  
COLLEGE

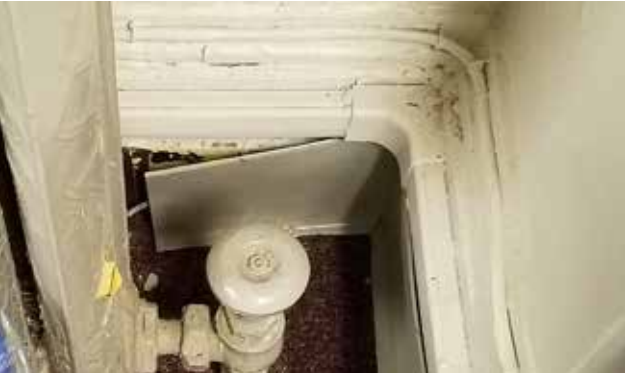
<b>W9-SD</b>  Vinyl Trim Wall System	<b>Scratches / Dents</b> <ul style="list-style-type: none"><li>Damage to material caused by mechanical components or equipment</li></ul>	<b>Material Repair or Replacement</b> <ul style="list-style-type: none"><li>Patch areas of missing or damaged material, if feasible; remove and replace material, as required.</li></ul>	Level 3

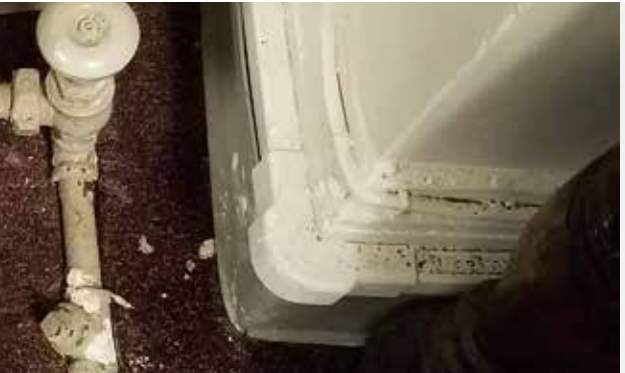
<b>W9-SA</b>  Vinyl Trim Wall System	<b>Soiling</b> <ul style="list-style-type: none"><li>Surface staining caused by the build-up of pollutants.</li></ul>	<b>Develop Cleaning Program</b> <ul style="list-style-type: none"><li>Develop a cleaning program if it can be implemented without damage to bulding system.</li></ul>	Level 3

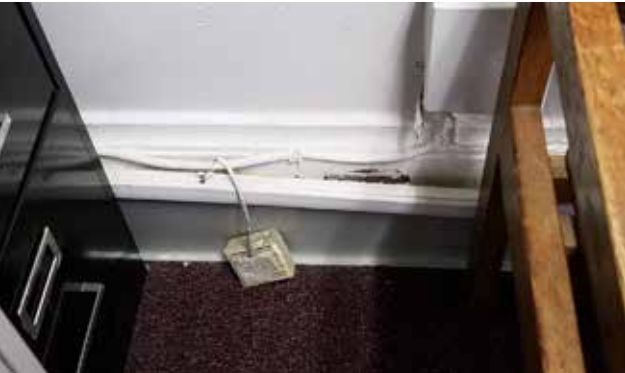
<b>W9-MD</b>  Vinyl Trim Wall System	<b>Mechanical Damage</b> <ul style="list-style-type: none"><li>Damage to material caused by mechanical components or equipment</li></ul>	<b>Material Repair or Replacement</b> <ul style="list-style-type: none"><li>Remove mechanical remnants and connections. Patch areas of missing or damaged material, if feasible; remove and replace material, as required.</li></ul>	Level 3

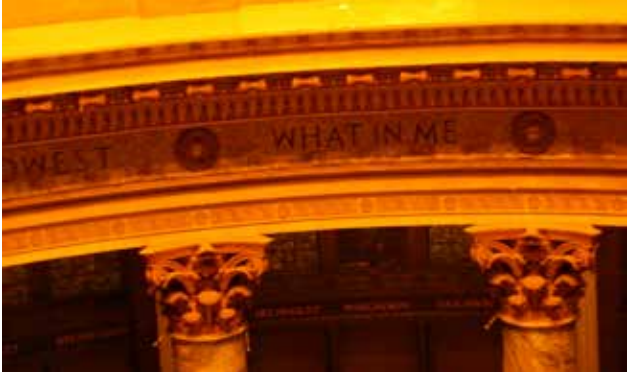
COMPONENT	CONDITION	TREATMENT	PRIORITY	REPRESENTATIVE PHOTO
<b>W10-SA</b>  Mosaic Frieze Wall System	<b>Soiling</b> <ul style="list-style-type: none"><li>Surface staining caused by the build-up of pollutants.</li></ul>	<b>Develop Cleaning Program</b> <ul style="list-style-type: none"><li>Develop a cleaning program if it can be implemented without damage to building system.</li></ul>	Level 3

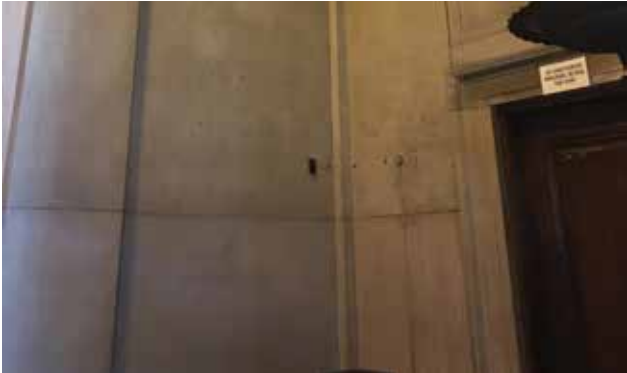
<b>W11-W</b>  Stone Masonry Wall System	<b>Wear</b> <ul style="list-style-type: none"><li>The gradual disintegration and erosion of materials caused by gradual use overtime.</li></ul>	<b>Material Patching or Replacement</b> <ul style="list-style-type: none"><li>Leave alone unless severe, then consider replacing.</li></ul>	Level 3

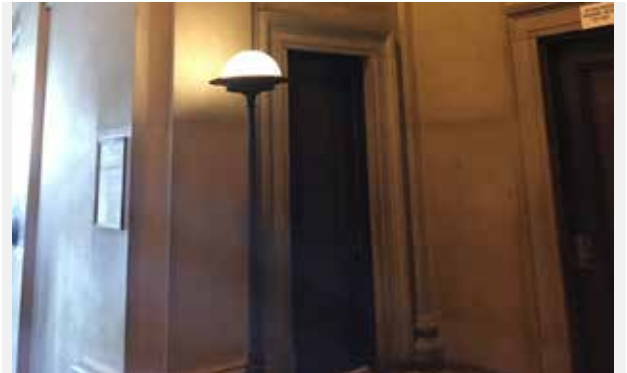
<b>W11-OJ</b>  Stone Masonry Wall System	<b>Open Joints</b> <ul style="list-style-type: none"><li>Joints without mortar or caulk</li></ul>	<b>Material Replacement</b> <ul style="list-style-type: none"><li>Repoint with appropriate mortar; install new caulk if expansion joint is required.</li></ul>	Level 3

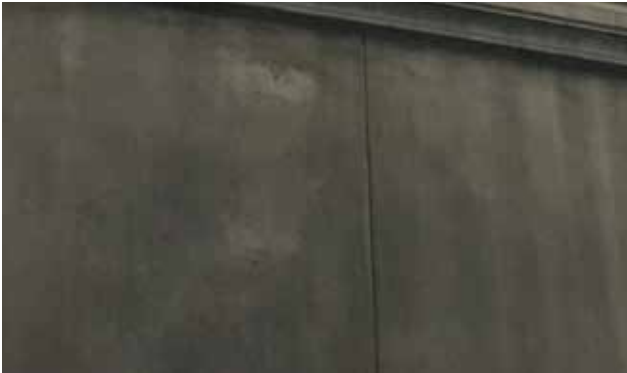
<b>W11-SA</b>  Stone Masonry Wall System	<b>Soiling</b> <ul style="list-style-type: none"><li>Surface staining caused by the build-up of pollutants.</li></ul>	<b>Develop Cleaning Program</b> <ul style="list-style-type: none"><li>Develop a cleaning program if it can be implemented without damage to building system.</li></ul>	Level 3

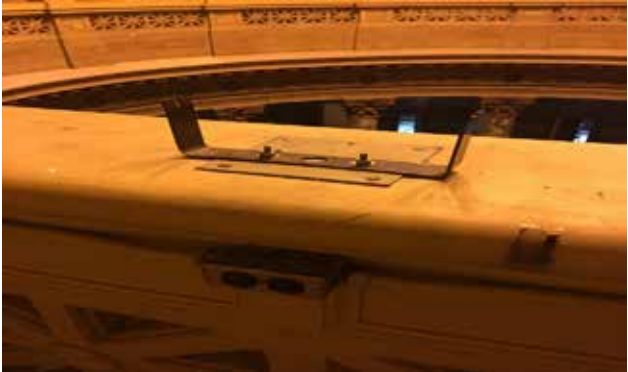
COMPONENT	CONDITION	TREATMENT	PRIORITY	REPRESENTATIVE PHOTO
<b>W12-SA</b>  Plaster Balustrade Wall System	<b>Soiling</b> <ul style="list-style-type: none"><li>Surface staining caused by the build-up of pollutants.</li></ul>	<b>Develop Cleaning Program</b> <ul style="list-style-type: none"><li>Develop a cleaning program if it can be implemented without damage to building system.</li></ul>	Level 3

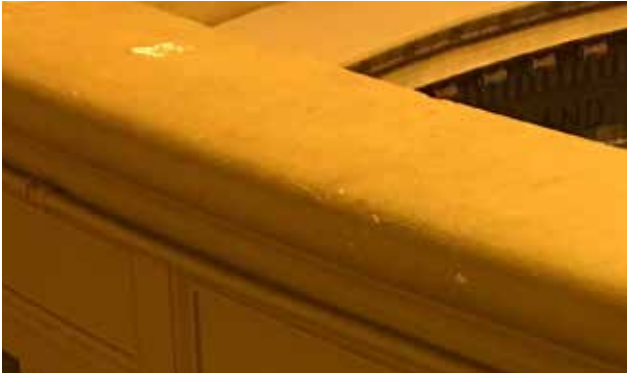
<b>W12-LC</b>  Plaster Balustrade Wall System	<b>Paint Loss</b> <ul style="list-style-type: none"><li>Loss of surface paint.</li></ul>	<b>Material Replacement</b> <ul style="list-style-type: none"><li>Determine reason for paint loss, correct problem and repaint.</li></ul>	Level 3

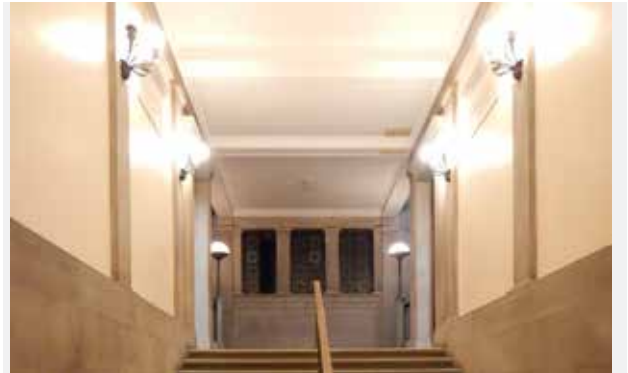
<b>W13-OJ</b>  Concrete Coated Pier and Door Surround Wall System	<b>Open Joints</b> <ul style="list-style-type: none"><li>Joints without mortar or caulking</li></ul>	<b>Material Replacement</b> <ul style="list-style-type: none"><li>Repoint with appropriate mortar; install new caulk if expansion joint is required.</li></ul>	Level 3

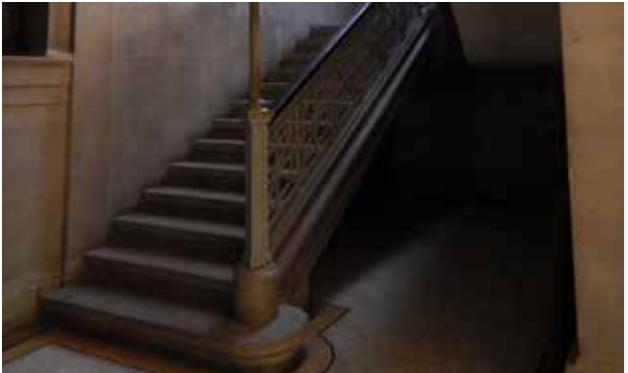
<b>W13-W</b>  Concrete Coated Pier and Door Surround Wall System	<b>Wear</b> <ul style="list-style-type: none"><li>The gradual disintegration and erosion of materials caused by gradual use overtime.</li></ul>	<b>Material Patching or Replacement</b> <ul style="list-style-type: none"><li>Leave alone unless severe, then consider replacing.</li></ul>	Level 3

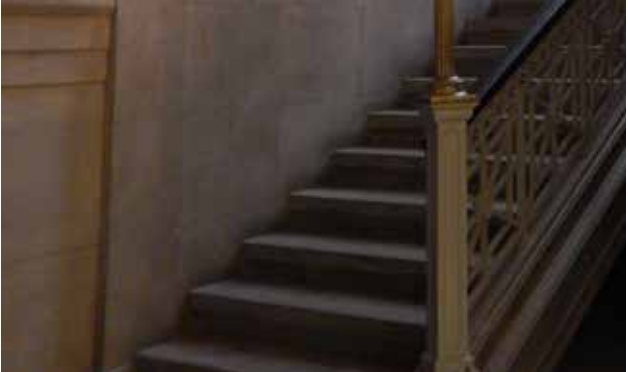
COMPONENT	CONDITION	TREATMENT	PRIORITY	REPRESENTATIVE PHOTO
<b>W13-SA</b>  Concrete Coated Pier and Door Surround Wall System	<b>Soiling</b> <ul style="list-style-type: none"><li>Surface staining caused by the build-up of pollutants.</li></ul>	<b>Develop Cleaning Program</b> <ul style="list-style-type: none"><li>Develop a cleaning program if it can be implemented without damage to bulding system.</li></ul>	Level 3

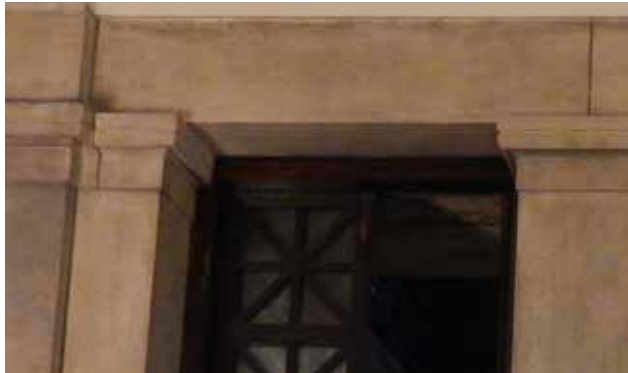
<b>W13-CR</b>  Concrete Coated Pier and Door Surround Wall System	<b>Cracking</b> <ul style="list-style-type: none"><li>1/16 to 1/2 inch wide visible fissure in a surface, possibly penetrating through the surface.</li></ul>	<b>Material Patching or Replacement</b> <ul style="list-style-type: none"><li>Remove and replace damaged material.</li></ul>	Level 3

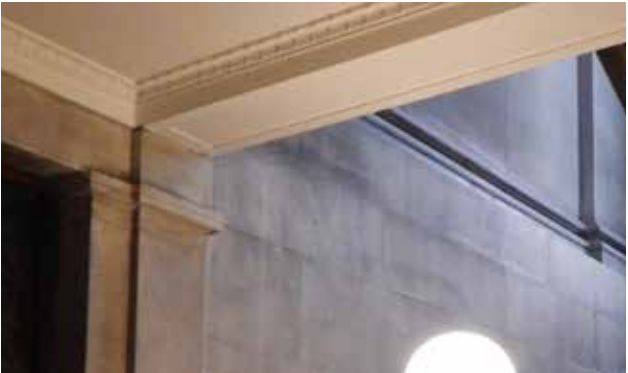
<b>w13-ST</b>  Concrete Coated Pier and Door Surround Wall System	<b>Staining</b> <ul style="list-style-type: none"><li>Surface problem caused by the build-up of pollutants, mineral deposits and water marks.</li></ul>	<b>Develop Cleaning Program</b> <ul style="list-style-type: none"><li>Develop a cleaning program if it can be implemented without damage to bulding system.</li></ul>	Level 3

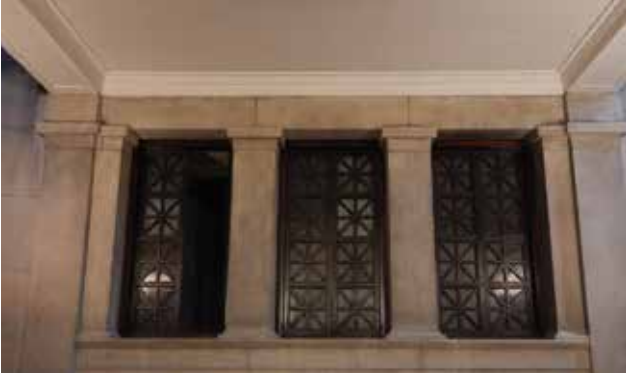
<b>w13-MD</b>  Concrete Coated Pier and Door Surround Wall System	<b>Mechanical Damage</b> <ul style="list-style-type: none"><li>Damage to material caused by mechanical components or equipment</li></ul>	<b>Material Repair or Replacement</b> <ul style="list-style-type: none"><li>Remove mechanical remnants and connections. Patch areas of missing or damaged material, if feasible; remove and replace material, as required.</li></ul>	Level 3

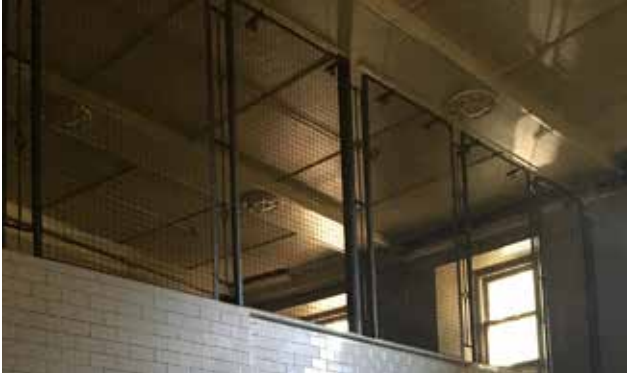
COMPONENT	CONDITION	TREATMENT	PRIORITY	REPRESENTATIVE PHOTO
<b>W14-SA</b>  Metal Mesh Partition Wall System	<b>Soiling</b> <ul style="list-style-type: none"><li>Surface staining caused by the build-up of pollutants.</li></ul>	<b>Develop Cleaning Program</b> <ul style="list-style-type: none"><li>Develop a cleaning program if it can be implemented without damage to building system.</li></ul>	Level 3

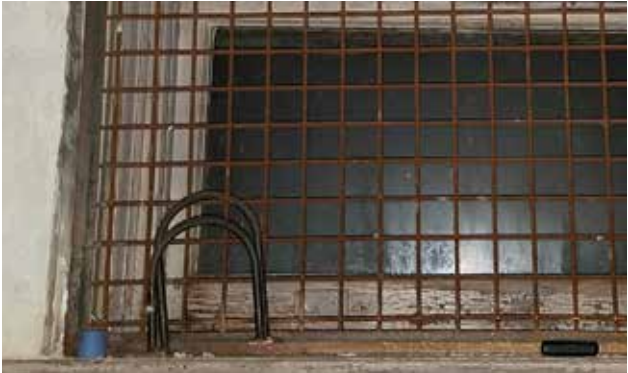
<b>W14-LC</b>  Metal Mesh Partition Wall System	<b>Paint Loss</b> <ul style="list-style-type: none"><li>Loss of surface paint.</li></ul>	<b>Material Replacement</b> <ul style="list-style-type: none"><li>Determine reason for paint loss, correct problem and repaint.</li></ul>	Level 3

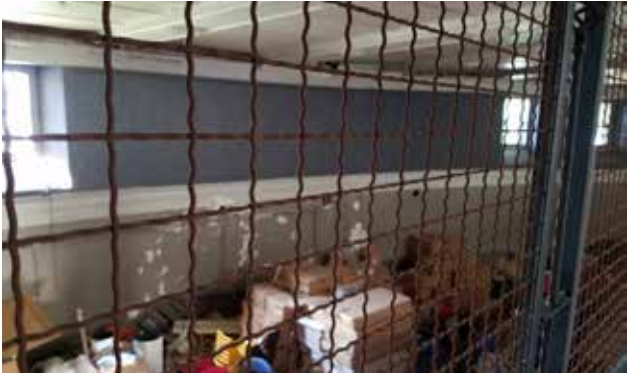
<b>W14-MC</b>  Metal Mesh Partition Wall System	<b>Corrosion</b> <ul style="list-style-type: none"><li>Deterioration of material by a chemical reaction with its environment.</li></ul>	<b>Removal of Deteriorated Material</b> <ul style="list-style-type: none"><li>Remove corrosion and corrosive products; in severe cases, replace deteriorated members with new material to match existing.</li><li>Refer to assesment of structural engineer for details on replacement of select cast iron members.</li></ul>	Level 3

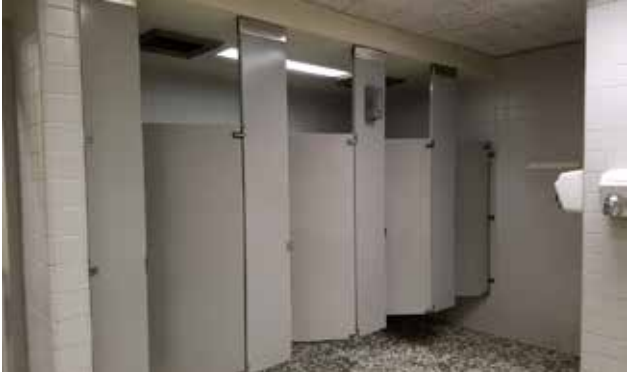
COMPONENT	CONDITION	TREATMENT	PRIORITY	REPRESENTATIVE PHOTO
<b>W15-MD</b>  Toilet Partitions Wall System	<b>Mechanical Damage</b> <ul style="list-style-type: none"><li>Damage to material caused by mechanical components or equipment</li></ul>	<b>Material Repair or Replacement</b> <ul style="list-style-type: none"><li>Remove mechanical remnants and connections. Patch areas of missing or damaged material, if feasible; remove and replace material, as required.</li></ul>	Level 3

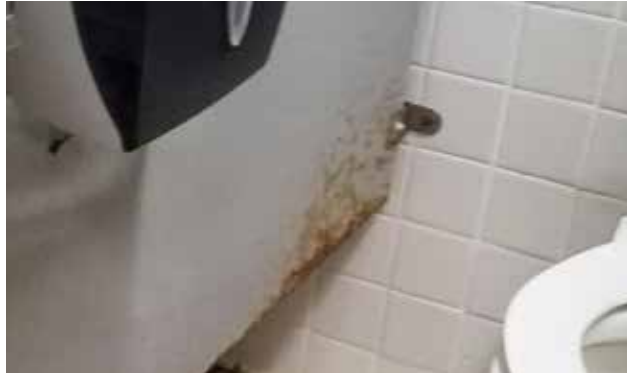
<b>W15-MC</b>  Toilet Partitions Wall System	<b>Corrosion</b> <ul style="list-style-type: none"><li>Deterioration of material by a chemical reaction with its environment.</li></ul>	<b>Removal of Deteriorated Material</b> <ul style="list-style-type: none"><li>Remove corrosion and corrosive products; in severe cases, replace deteriorated members with new material to match existing.</li><li>Refer to assesment of structural engineer for details on replacement of select cast iron members.</li></ul>	Level 3

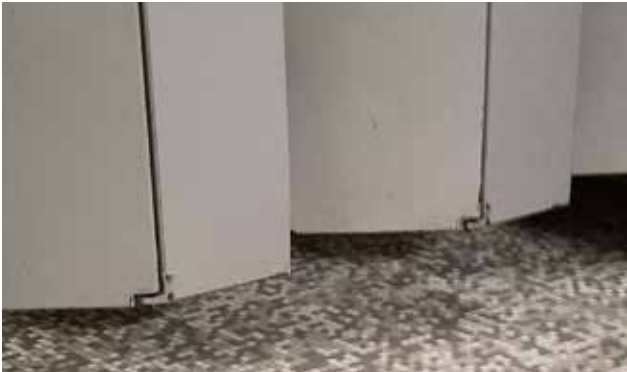
<b>W15-LC</b>  Toilet Partitions Wall System	<b>Paint Loss</b> <ul style="list-style-type: none"><li>Loss of surface paint.</li></ul>	<b>Material Replacement</b> <ul style="list-style-type: none"><li>Determine reason for paint loss, correct problem and repaint.</li></ul>	Level 3

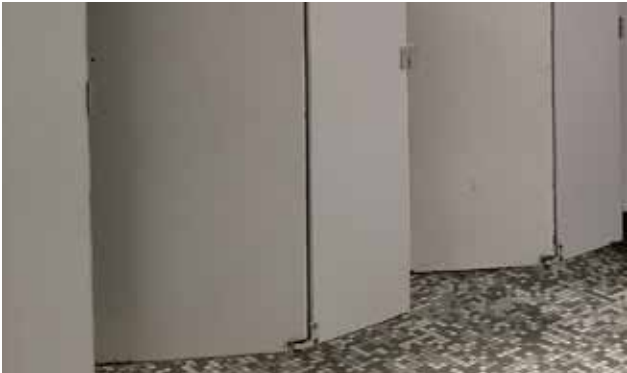
<b>W15-SD</b>  Toilet Partitions Wall System	<b>Scratches / Dents</b> <ul style="list-style-type: none"><li>Damage to material caused by mechanical components or equipment</li></ul>	<b>Material Repair or Replacement</b> <ul style="list-style-type: none"><li>Patch areas of missing or damaged material, if feasible; remove and replace material, as required.</li></ul>	Level 3

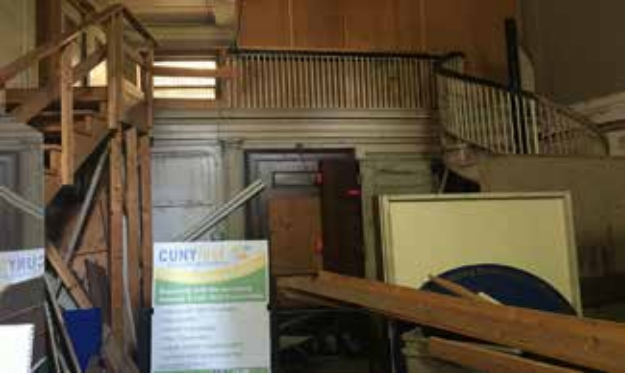
COMPONENT	CONDITION	TREATMENT	PRIORITY	REPRESENTATIVE PHOTO
<b>CM1-MC</b>  Cast Iron Column System	<b>Corrosion</b> <ul style="list-style-type: none"><li>Deterioration of material by a chemical reaction with its environment.</li></ul>	<b>Removal of Deteriorated Material</b> <ul style="list-style-type: none"><li>Remove corrosion and corrosive products; in severe cases, replace and/or reinforce deteriorated members with new material to match existing.</li></ul>	Level 3

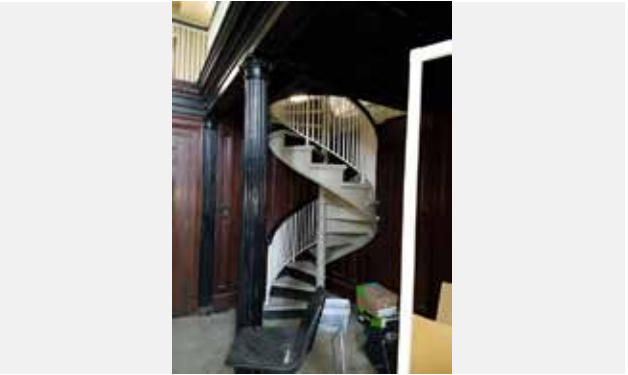
<b>CM1-SA</b>  Cast Iron Column System	<b>Soiling</b> <ul style="list-style-type: none"><li>Surface staining caused by the build-up of pollutants.</li></ul>	<b>Develop Cleaning Program</b> <ul style="list-style-type: none"><li>Develop a cleaning program if it can be implemented without damage to building system.</li></ul>	Level 3

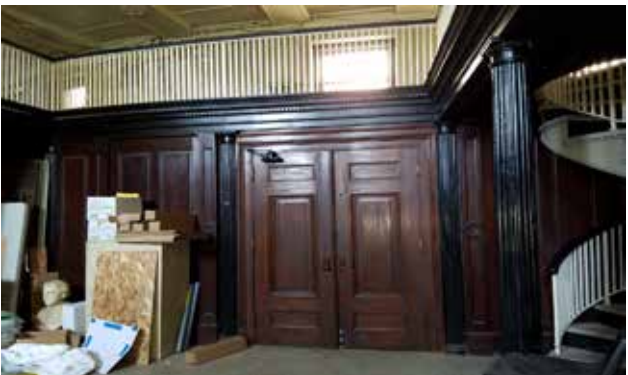
<b>CM1-ST</b>  Cast Iron Column System	<b>Staining</b> <ul style="list-style-type: none"><li>Surface problem caused by the build-up of pollutants, mineral deposits and water marks.</li></ul>	<b>Develop Cleaning Program</b> <ul style="list-style-type: none"><li>Develop a cleaning program if it can be implemented without damage to building system.</li></ul>	Level 3

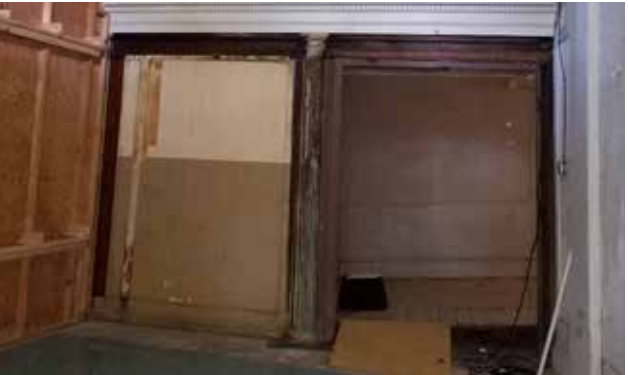
<b>CM1-LC</b>  Cast Iron Column System	<b>Paint Loss</b> <ul style="list-style-type: none"><li>Loss of surface paint.</li></ul>	<b>Material Replacement</b> <ul style="list-style-type: none"><li>Determine reason for paint loss, correct problem and repaint.</li></ul>	Level 3

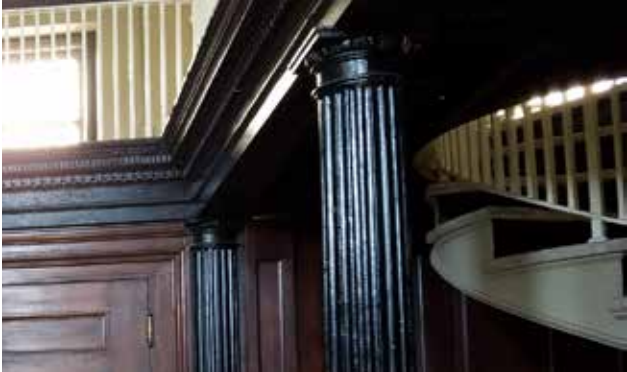
COMPONENT	CONDITION	TREATMENT	PRIORITY	REPRESENTATIVE PHOTO
<b>CM1-OP</b>  Cast Iron Column System	<b>Overpainted</b> <ul style="list-style-type: none"><li>Multiple layers of paint.</li></ul>	<b>Material Patching or Replacement</b> <ul style="list-style-type: none"><li>Leave alone unless other forms of deterioration are present, then scrape to substrate and repaint.</li></ul>	Level 3

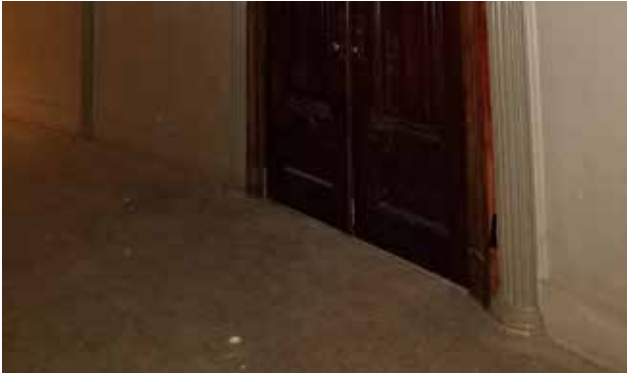
<b>CM1-SD</b>  Cast Iron Column System	<b>Scratches / Dents</b> <ul style="list-style-type: none"><li>Damage to material caused by mechanical components or equipment</li></ul>	<b>Material Repair or Replacement</b> <ul style="list-style-type: none"><li>Patch areas of missing or damaged material, if feasible; remove and replace material, as required.</li></ul>	Level 3

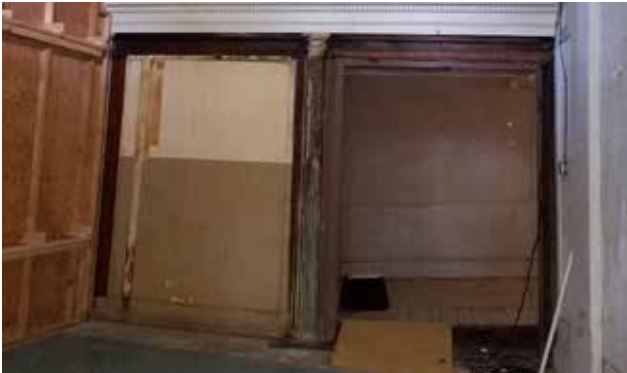
<b>CM1-CR</b>  Cast Iron Column System	<b>Crack</b> <ul style="list-style-type: none"><li>1/16 to 1/2 inch wide visible fissure, possibly penetrating through the surface.</li></ul>	<b>Material Patching or Replacement</b> <ul style="list-style-type: none"><li>Remove and replace damaged material.</li></ul>	Level 3

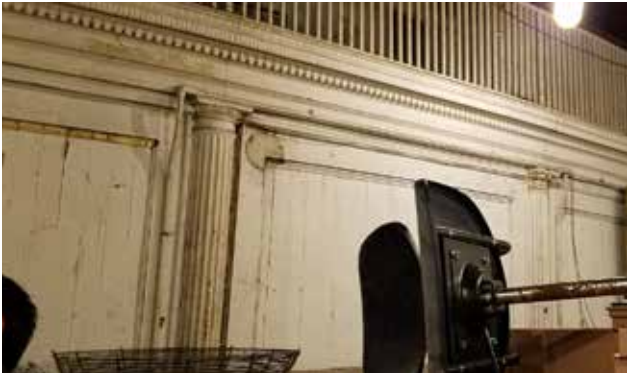
<b>CM1-MD</b>  Cast Iron Column System	<b>Mechanical Damage</b> <ul style="list-style-type: none"><li>Damage to material caused by mechanical components or equipment</li></ul>	<b>Material Repair or Replacement</b> <ul style="list-style-type: none"><li>Remove mechanical remnants and connections. Patch areas of missing or damaged material, if feasible; remove and replace material, as required.</li></ul>	Level 3

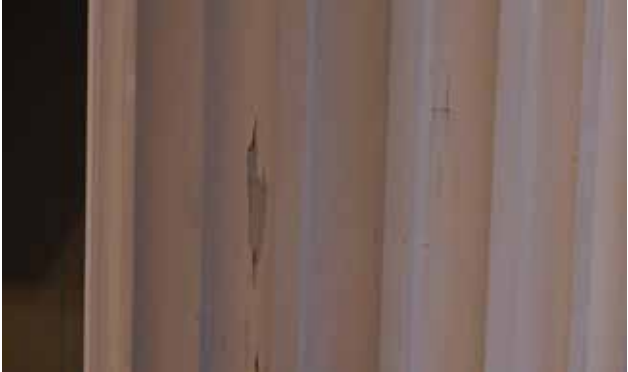
COMPONENT	CONDITION	TREATMENT	PRIORITY	REPRESENTATIVE PHOTO
<b>CM2-LC</b>  Engaged Sheet Metal with Plaster Capital Column System	<b>Paint Loss</b> <ul style="list-style-type: none"><li>Loss of surface paint.</li></ul>	<b>Material Replacement</b> <ul style="list-style-type: none"><li>Determine reason for paint loss, correct problem and repaint.</li></ul>	Level 3

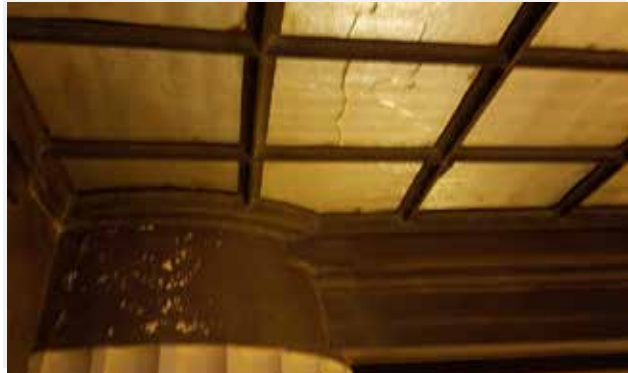
<b>CM2-ST</b>  Engaged Sheet Metal with Plaster Capital Column System	<b>Staining</b> <ul style="list-style-type: none"><li>Surface problem caused by the build-up of pollutants, mineral deposits and water marks.</li></ul>	<b>Develop Cleaning Program</b> <ul style="list-style-type: none"><li>Develop a cleaning program if it can be implemented without damage to bulding system.</li></ul>	Level 3

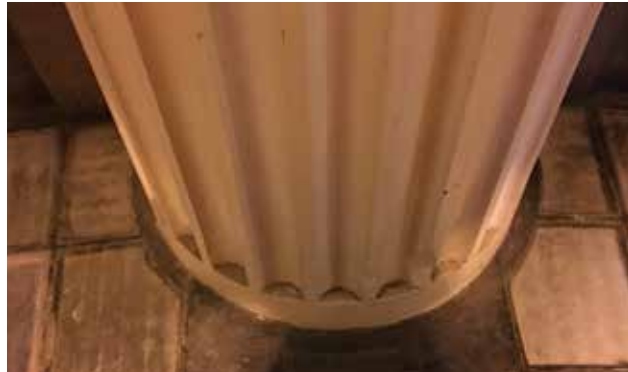
<b>CM2-SA</b>  Engaged Sheet Metal with Plaster Capital Column System	<b>Soiling</b> <ul style="list-style-type: none"><li>Surface staining caused by the build-up of pollutants.</li></ul>	<b>Develop Cleaning Program</b> <ul style="list-style-type: none"><li>Develop a cleaning program if it can be implemented without damage to bulding system.</li></ul>	Level 3

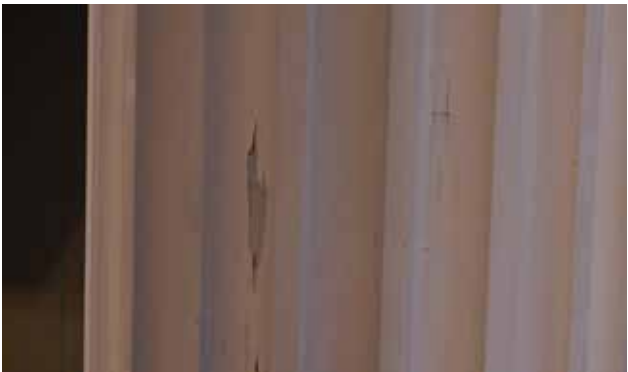
<b>CM2-CR</b>  Engaged Sheet Metal with Plaster Capital Column System	<b>Crack</b> <ul style="list-style-type: none"><li>1/16 to 1/2 inch wide visible fissure in surface, possibly penetrating through the surface.</li></ul>	<b>Material Patching or Replacement</b> <ul style="list-style-type: none"><li>Remove and replace damaged material.</li></ul>	Level 3

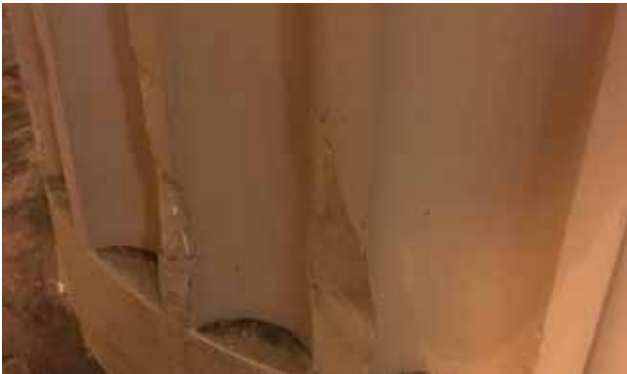
COMPONENT	CONDITION	TREATMENT	PRIORITY	REPRESENTATIVE PHOTO
<b>CM2-LM</b>  Engaged Sheet Metal with Plaster Capital Column System	<b>Material Loss</b> <ul style="list-style-type: none"><li>Loss of material leaving holes or exposing inner layers.</li></ul>	<b>Material Patching or Replacement</b> <ul style="list-style-type: none"><li>Patch areas of missing material, if feasible, or replace material to match existing.</li></ul>	Level 3

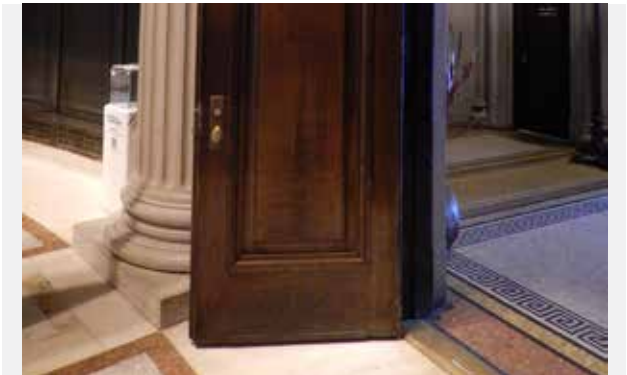
<b>CM2-MD</b>  Engaged Sheet Metal with Plaster Capital Column System	<b>Mechanical Damage</b> <ul style="list-style-type: none"><li>Damage to material caused by mechanical components or equipment</li></ul>	<b>Material Repair or Replacement</b> <ul style="list-style-type: none"><li>Remove mechanical remnants and connections. Patch areas of missing or damaged material, if feasible; remove and replace material, as required.</li></ul>	Level 3

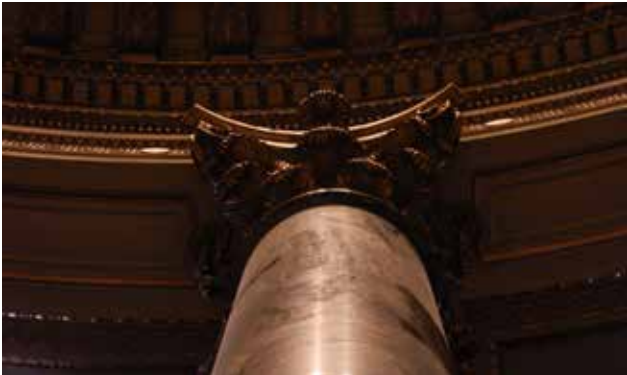
<b>CM3-SA</b>  Marble with Plaster Capital Column System	<b>Soiling</b> <ul style="list-style-type: none"><li>Surface staining caused by the build-up of pollutants.</li></ul>	<b>Develop Cleaning Program</b> <ul style="list-style-type: none"><li>Develop a cleaning program if it can be implemented without damage to bulding system.</li></ul>	Level 3

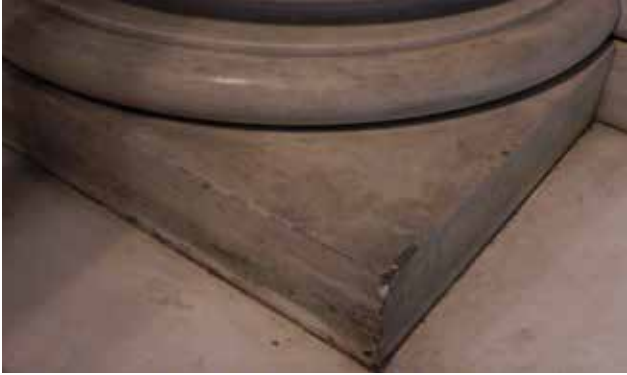
<b>CM3-MD</b>  Marble with Plaster Capital Column System	<b>Mechanical Damage</b> <ul style="list-style-type: none"><li>Damage to material caused by mechanical components or equipment</li></ul>	<b>Material Repair or Replacement</b> <ul style="list-style-type: none"><li>Remove mechanical remnants and connections. Patch areas of missing or damaged material, if feasible; remove and replace material, as required.</li></ul>	Level 3

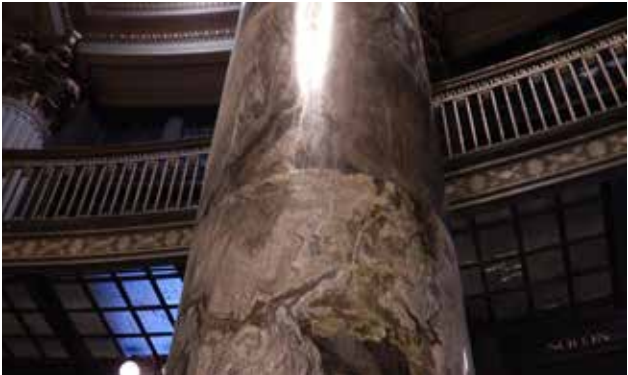
COMPONENT	CONDITION	TREATMENT	PRIORITY	REPRESENTATIVE PHOTO
<b>CM3-ST</b>  Marble with Plaster Capital Column System	<b>Staining</b> <ul style="list-style-type: none"><li>Surface problem caused by the build-up of pollutants, mineral deposits and water marks.</li></ul>	<b>Develop Cleaning Program</b> <ul style="list-style-type: none"><li>Develop a cleaning program if it can be implemented without damage to bulding system.</li></ul>	Level 3

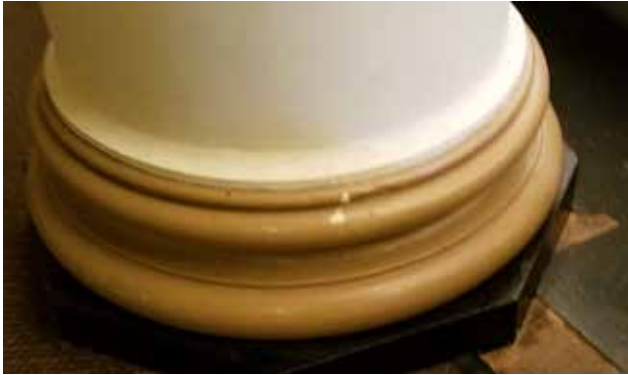
<b>CM4-LC</b>  Plaster with Plaster Capital Column System	<b>Paint Loss</b> <ul style="list-style-type: none"><li>Loss of surface paint.</li></ul>	<b>Material Replacement</b> <ul style="list-style-type: none"><li>Determine reason for paint loss, correct problem and repaint.</li></ul>	Level 3

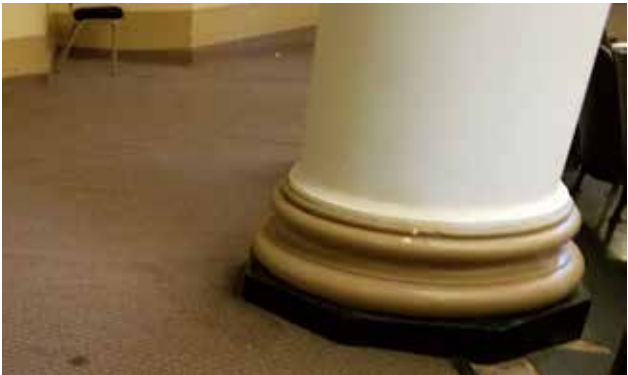
<b>CM4-SD</b>  Plaster with Plaster Capital Column System	<b>Scratches / Dents</b> <ul style="list-style-type: none"><li>Damage to material caused by mechanical components or equipment</li></ul>	<b>Material Repair or Replacement</b> <ul style="list-style-type: none"><li>Patch areas of missing or damaged material, if feasible; remove and replace material, as required.</li></ul>	Level 3

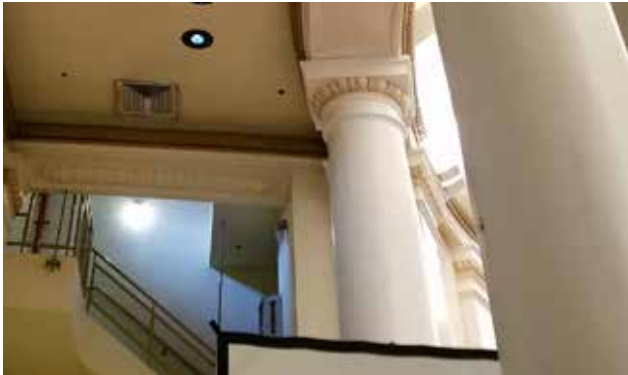
<b>CM4-SA</b>  Plaster with Plaster Capital Column System	<b>Soiling</b> <ul style="list-style-type: none"><li>Surface staining caused by the build-up of pollutants.</li></ul>	<b>Develop Cleaning Program</b> <ul style="list-style-type: none"><li>Develop a cleaning program if it can be implemented without damage to bulding system.</li></ul>	Level 3

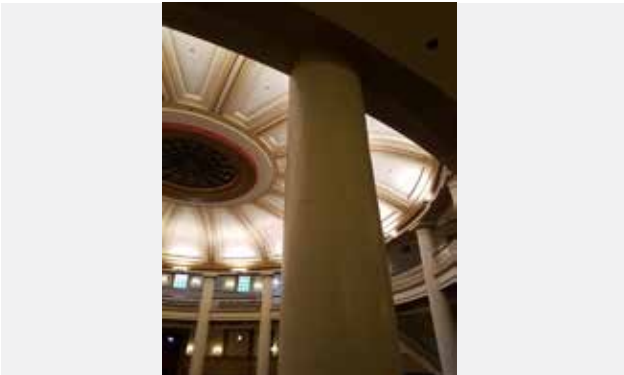
COMPONENT	CONDITION	TREATMENT	PRIORITY	REPRESENTATIVE PHOTO
<b>CM4-CR</b>  Plaster with Plaster Capital Column System	<b>Crack</b> <ul style="list-style-type: none"><li>1/16 to 1/2 inch wide visible fissure in a surface, possibly penetrating through the surface.</li></ul>	<b>Material Patching or Replacement</b> <ul style="list-style-type: none"><li>Remove and replace damaged material.</li></ul>	Level 3

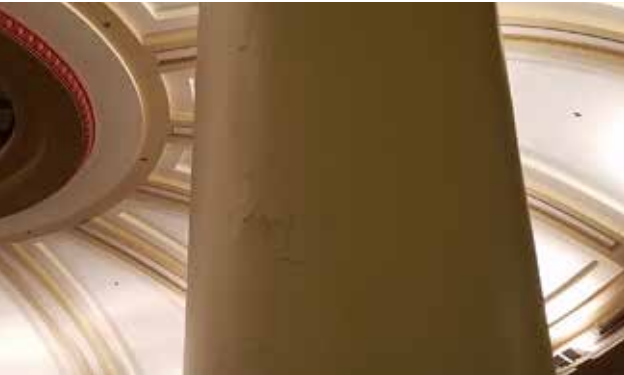
<b>CM4-CH</b>  Plaster with Plaster Capital Column System	<b>Hairline Cracking</b> <ul style="list-style-type: none"><li>Numerous shallow cracks across the outer layer of a surface.</li></ul>	<b>Material Patching or Replacement</b> <ul style="list-style-type: none"><li>Patch where appropriate.</li></ul>	Level 3

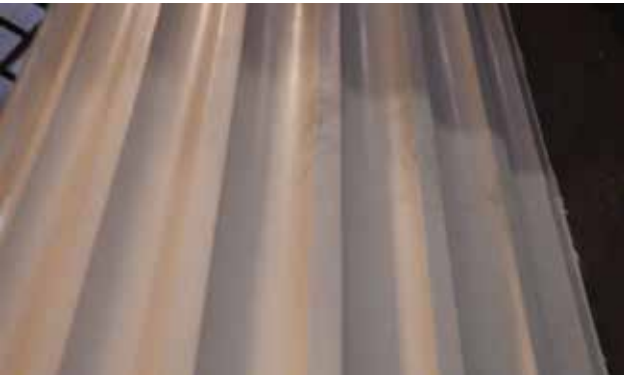
<b>CM4-MD</b>  Plaster with Plaster Capital Column System	<b>Mechanical Damage</b> <ul style="list-style-type: none"><li>Damage to material caused by mechanical components or equipment</li></ul>	<b>Material Repair or Replacement</b> <ul style="list-style-type: none"><li>Remove mechanical remnants and connections. Patch areas of missing or damaged material, if feasible; remove and replace material, as required.</li></ul>	Level 3

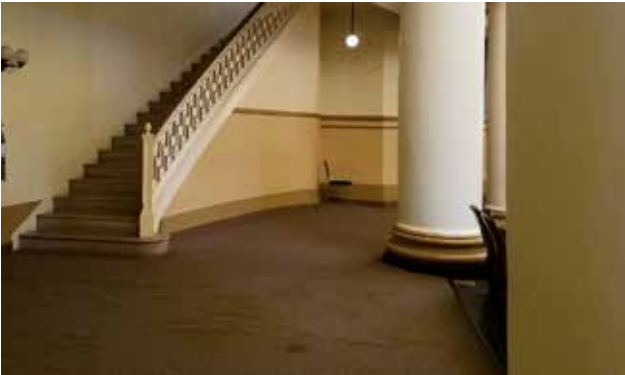
<b>CM4-W</b>  Plaster with Plaster Capital Column System	<b>Wear</b> <ul style="list-style-type: none"><li>The gradual disintegration and erosion of materials caused by gradual use overtime.</li></ul>	<b>Material Patching or Replacement</b> <ul style="list-style-type: none"><li>Leave alone unless severe, then consider replacing.</li></ul>	Level 3

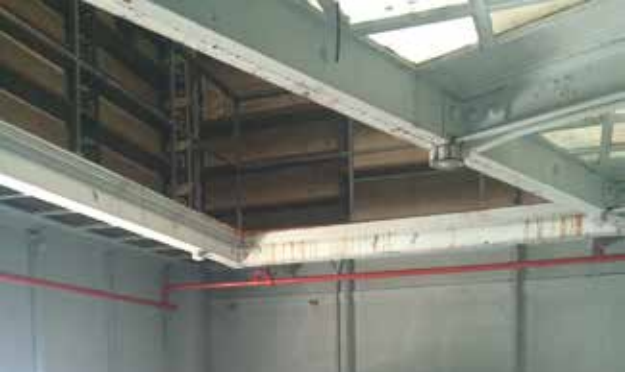
COMPONENT	CONDITION	TREATMENT	PRIORITY	REPRESENTATIVE PHOTO
<b>C1-MC</b>  Cast Iron Ceiling Support (beams/ grid) Ceiling System	<b>Corrosion</b> <ul style="list-style-type: none"><li>Deterioration of material by a chemical reaction with its environment.</li></ul>	<b>Removal of Deteriorated Material</b> <ul style="list-style-type: none"><li>Remove corrosion and corrosive products; in severe cases, replace and/or reinforce deteriorated members with new material to match existing.</li></ul>	Level 3

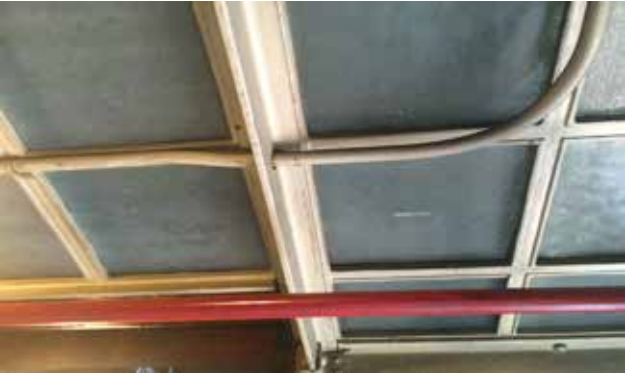
<b>C1-MD</b>  Cast Iron Ceiling Support (beams/ grid) Ceiling System	<b>Mechanical Damage</b> <ul style="list-style-type: none"><li>Damage to material caused by mechanical components or equipment</li></ul>	<b>Material Repair or Replacement</b> <ul style="list-style-type: none"><li>Remove mechanical remnants and connections. Patch areas of missing or damaged material, if feasible; remove and replace material, as required.</li></ul>	Level 3

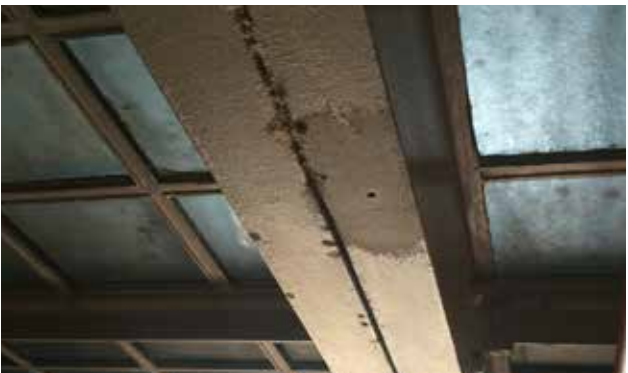
<b>C1-SA</b>  Cast Iron Ceiling Support (beams/ grid) Ceiling System	<b>Soiling</b> <ul style="list-style-type: none"><li>Surface staining caused by the build-up of pollutants.</li></ul>	<b>Develop Cleaning Program</b> <ul style="list-style-type: none"><li>Develop a cleaning program if it can be implemented without damage to building system.</li></ul>	Level 3

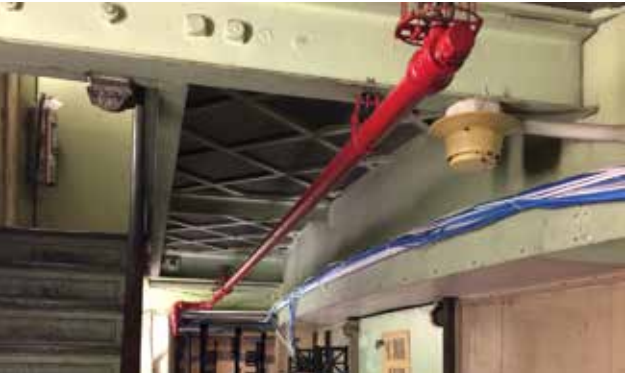
<b>C1-LC</b>  Cast Iron Ceiling Support (beams/ grid) Ceiling System	<b>Paint Loss</b> <ul style="list-style-type: none"><li>Loss of surface paint.</li></ul>	<b>Material Replacement</b> <ul style="list-style-type: none"><li>Determine reason for paint loss, correct problem and repaint.</li></ul>	Level 3

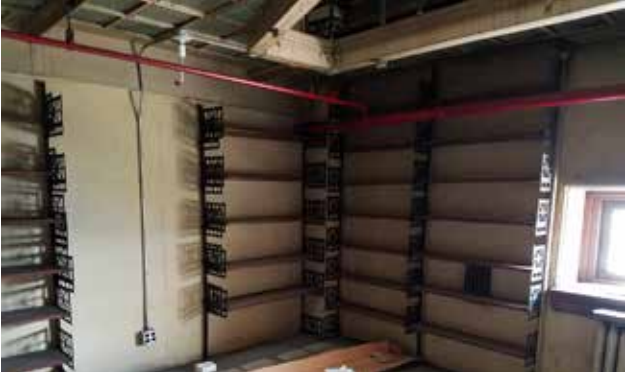
COMPONENT	CONDITION	TREATMENT	PRIORITY	REPRESENTATIVE PHOTO
<b>C1-ST</b>  Cast Iron Ceiling Support (beams/ grid) Ceiling System	<b>Staining</b> <ul style="list-style-type: none"><li>Surface problem caused by the build-up of pollutants, mineral deposits and water marks.</li></ul>	<b>Develop Cleaning Program</b> <ul style="list-style-type: none"><li>Develop a cleaning program if it can be implemented without damage to bulding system.</li></ul>	Level 3

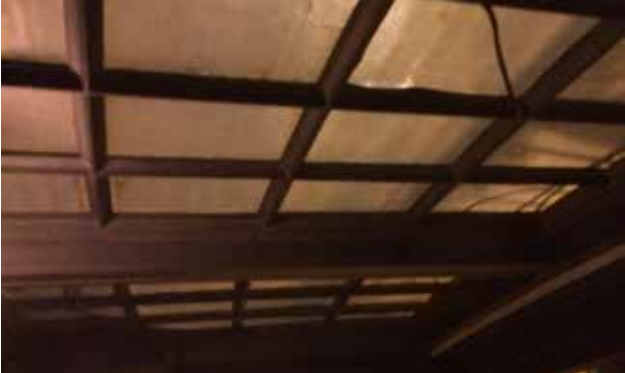
<b>C1-CR</b>  Cast Iron Ceiling Support (beams/ grid) Ceiling System	<b>Cracking</b> <ul style="list-style-type: none"><li>1/16 to 1/2 inch wide visible fissure in a surface, possibly penetrating through the surface.</li></ul>	<b>Material Replacement</b> <ul style="list-style-type: none"><li>Remove and replace damaged material.</li></ul>	Level 3

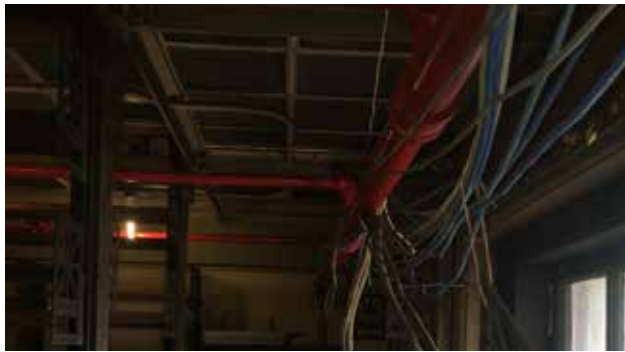
<b>C1-DGC</b>  Cast Iron Ceiling Support (beams/ grid) Ceiling System	<b>Deteriorateid Glazing Putty</b> <ul style="list-style-type: none"><li>Minimal amounts of glazing putty remain.</li></ul>	<b>Material Repair or Replacement</b> <ul style="list-style-type: none"><li>Scrape remaining glazing putty away and replace with new glazing compound.</li></ul>	Level 3

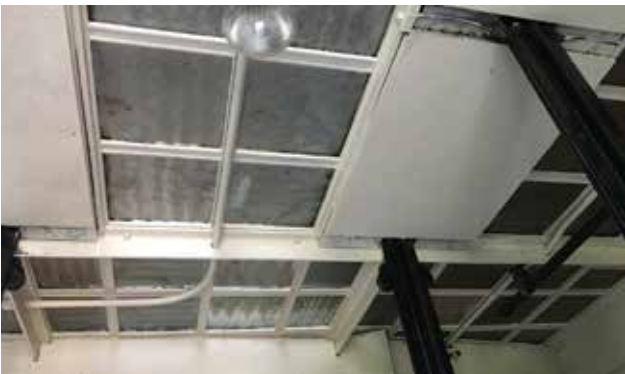
<b>C1-LM</b>  Cast Iron Ceiling Support (beams/ grid) Ceiling System	<b>Material Loss</b> <ul style="list-style-type: none"><li>Loss of material leaving holes or exposing inner layers.</li></ul>	<b>Material Patching or Replacement</b> <ul style="list-style-type: none"><li>Patch areas of missing material, if feasible, or replace material to match existing.</li></ul>	Level 3

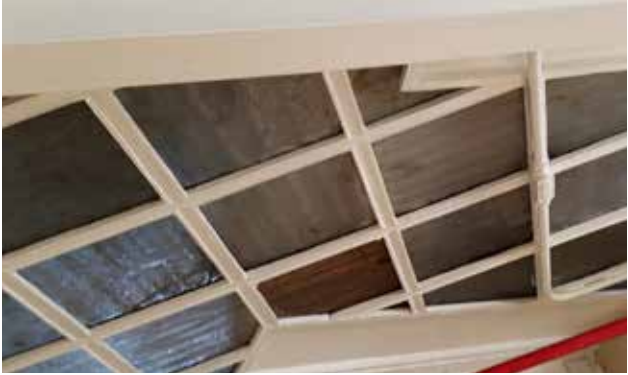
COMPONENT	CONDITION	TREATMENT	PRIORITY	REPRESENTATIVE PHOTO
<b>C1-PR</b>  Cast Iron Ceiling Support (beams/ grid) Ceiling System	<b>Previous Repair</b> <ul style="list-style-type: none"><li>Area where a previous repair was done, including repointing, patching and consolidation.</li></ul>	<b>Material Replacement</b> <ul style="list-style-type: none"><li>Replace inappropriate previous patches.</li></ul>	Level 3

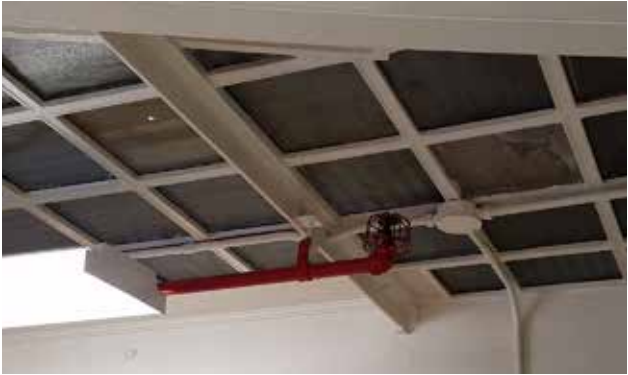
<b>C1-SD</b>  Cast Iron Ceiling Support (beams/ grid) Ceiling System	<b>Scratches / Dents</b> <ul style="list-style-type: none"><li>Damage to material caused by mechanical components or equipment</li></ul>	<b>Material Repair or Replacement</b> <ul style="list-style-type: none"><li>Patch areas of missing or damaged material, if feasible; remove and replace material, as required.</li></ul>	Level 3

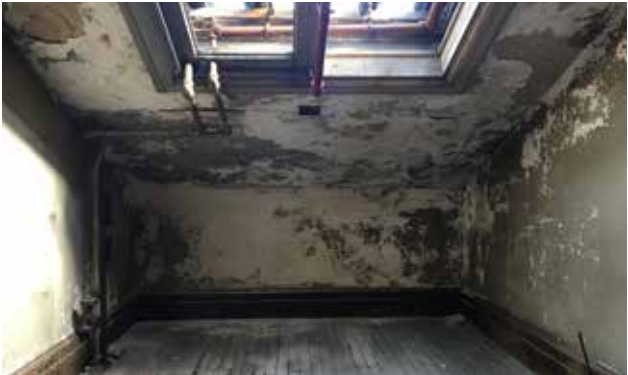
<b>C2-EF</b>  Painted Plaster Ceiling System	<b>Efflorescence</b> <ul style="list-style-type: none"><li>Whitish haze of soluble salts left as deposits on masonry by evaporation of water, generally a symptom of a worse condition or a hint that trouble may be beginning.</li></ul>	<b>Develop Cleaning Program</b> <ul style="list-style-type: none"><li>Clean deposit, identify and eliminate water infiltration.</li></ul>	Level 3

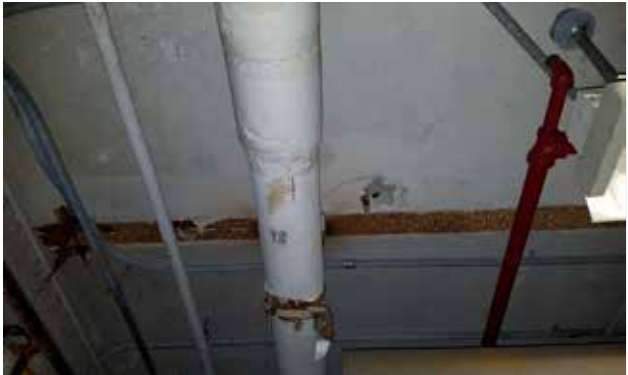
<b>C2-MD</b>  Painted Plaster Ceiling System	<b>Mechanical Damage</b> <ul style="list-style-type: none"><li>Damage to material caused by mechanical components or equipment</li></ul>	<b>Material Repair or Replacement</b> <ul style="list-style-type: none"><li>Remove mechanical remnants and connections. Patch areas of missing or damaged material, if feasible; remove and replace material, as required.</li></ul>	Level 3

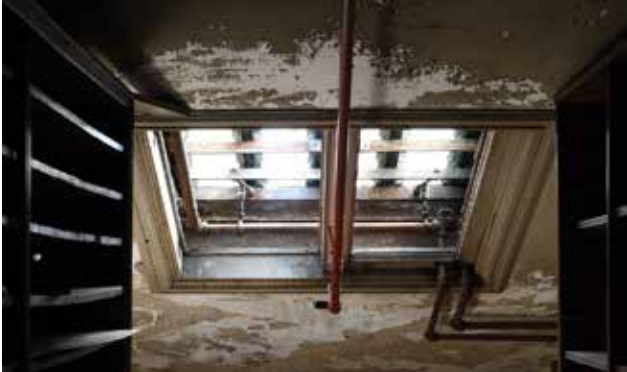
COMPONENT	CONDITION	TREATMENT	PRIORITY	REPRESENTATIVE PHOTO
<b>C2-BL</b>  Painted Plaster Ceiling System	<b>Blistering Paint</b> <ul style="list-style-type: none"><li>Swelling and rupturing of top layer, generally first stage of exfoliation.</li></ul>	<b>Material Repair or Replacement</b> <ul style="list-style-type: none"><li>Clean, identify source of water infiltration and remedy cause. Repair substrate, if necessary, and repaint.</li></ul>	Level 3

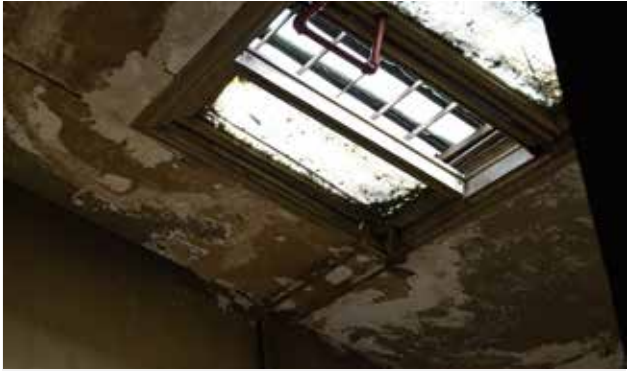
<b>C2-CR</b>  Painted Plaster Ceiling System	<b>Cracking</b> <ul style="list-style-type: none"><li>1/16 to 1/2 inch wide visible fissure in a surface, possibly penetrating through the surface.</li></ul>	<b>Material Patching or Replacement</b> <ul style="list-style-type: none"><li>Remove and replace damaged material.</li></ul>	Level 3

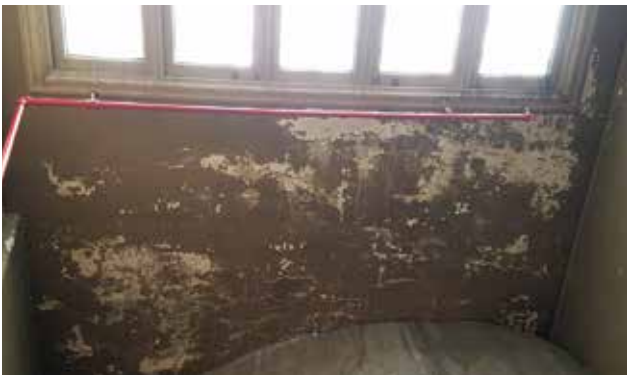
<b>C2-CH</b>  Painted Plaster Ceiling System	<b>Hairline Cracking</b> <ul style="list-style-type: none"><li>Numerous shallow cracks across the outer layer of a surface.</li></ul>	<b>Material Patching or Replacement</b> <ul style="list-style-type: none"><li>Patch where appropriate.</li></ul>	Level 3

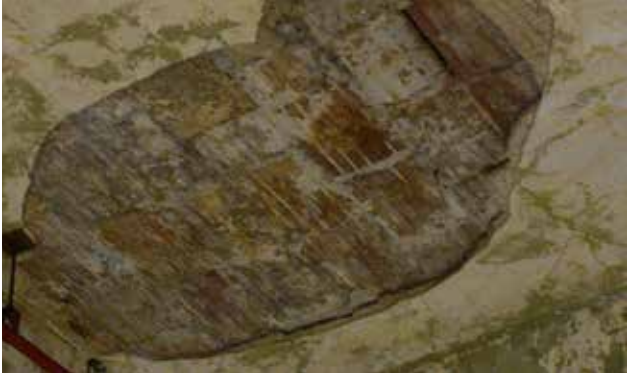
<b>C2-LM</b>  Painted Plaster Ceiling System	<b>Material Loss</b> <ul style="list-style-type: none"><li>Loss of material leaving holes or exposing inner layers.</li></ul>	<b>Material Patching or Replacement</b> <ul style="list-style-type: none"><li>Patch areas of missing material, if feasible, or replace material to match existing.</li><li>Additional investigation will be required to understand extent of damage from loss of material and substrate and to document the layout of the existing structural framing. Supplemental framing may be required around openings/areas of material loss that are to remain.</li></ul>	Level 3

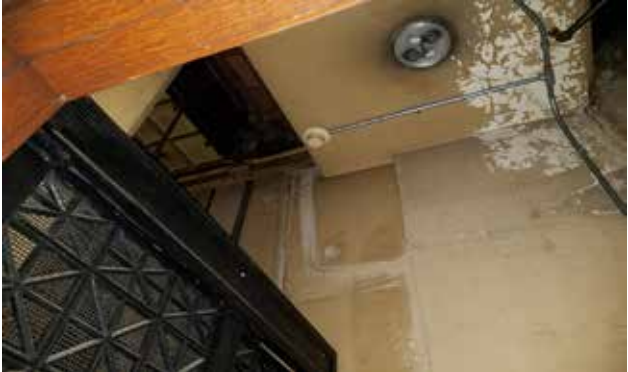
COMPONENT	CONDITION	TREATMENT	PRIORITY	REPRESENTATIVE PHOTO
<b>C2-LC</b>  Painted Plaster Ceiling System	<b>Paint Loss</b> <ul style="list-style-type: none"><li>Loss of surface paint.</li></ul>	<b>Material Replacement</b> <ul style="list-style-type: none"><li>Determine reason for paint loss, correct problem and repaint.</li></ul>	Level 3

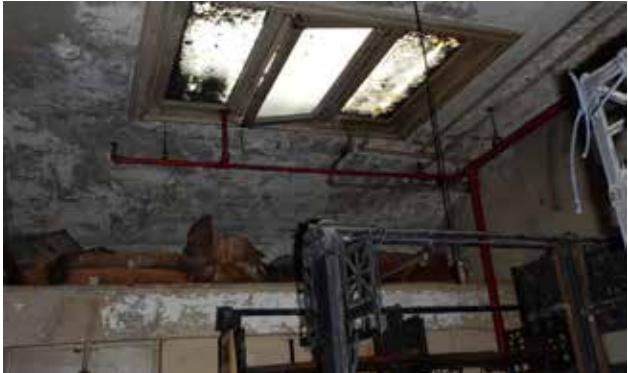
<b>C2-SA</b>  Painted Plaster Ceiling System	<b>Soiling</b> <ul style="list-style-type: none"><li>Surface staining caused by the build-up of pollutants.</li></ul>	<b>Develop Cleaning Program</b> <ul style="list-style-type: none"><li>Develop a cleaning program if it can be implemented without damage to building system.</li></ul>	Level 3

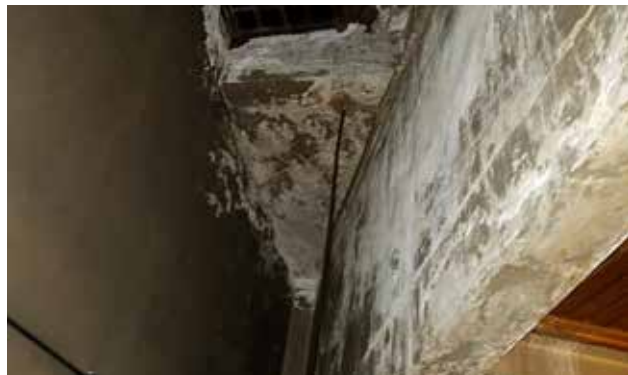
<b>C2-SP</b>  Painted Plaster Ceiling System	<b>Spalling</b> <ul style="list-style-type: none"><li>Uneven breaking off of the outer layers of masonry.</li></ul>	<b>Material Patching or Replacement</b> <ul style="list-style-type: none"><li>Remove decayed plaster to sound material; patch or replace with new plaster. Repaint.</li></ul>	Level 3

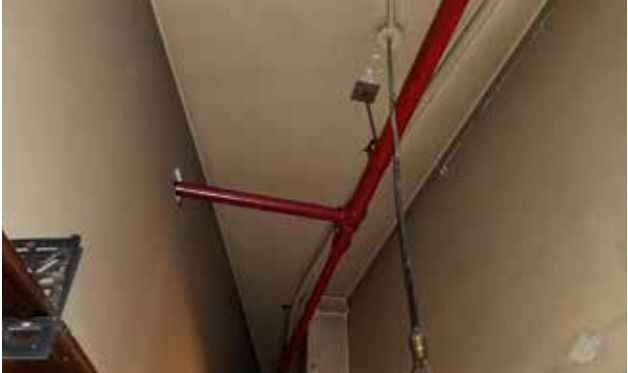
<b>C2-ST</b>  Painted Plaster Ceiling System	<b>Staining</b> <ul style="list-style-type: none"><li>Surface problem caused by the build-up of pollutants, mineral deposits and water marks.</li></ul>	<b>Develop Cleaning Program</b> <ul style="list-style-type: none"><li>Develop a cleaning program if it can be implemented without damage to building system.</li></ul>	Level 3
