# Conditions Assessment

## Gould Memorial Library & Hall of Fame

FINAL REPORT | 15 MARCH 2018

**BRONX**  
**COMMUNITY**  
COLLEGE

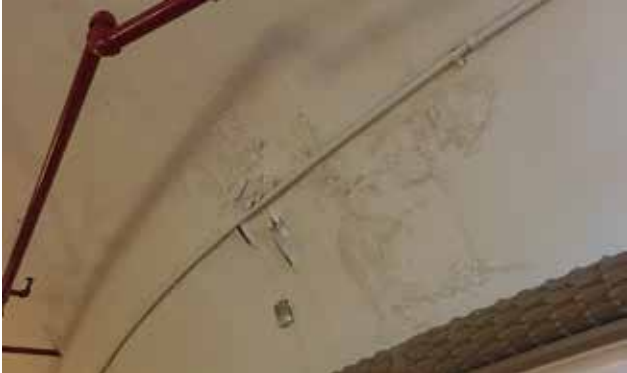
COMPONENT	CONDITION	TREATMENT	PRIORITY	REPRESENTATIVE PHOTO
<b>C2-SW</b>  Painted Plaster Ceiling System	<b>Water Damage</b> <ul style="list-style-type: none"><li>Biological growth, blistering, efflorescence, wood rot or staining caused by the infiltration of water.</li></ul>	<b>Removal of Deteriorated Material</b> <ul style="list-style-type: none"><li>Identify source of water infiltration and remedy cause. Replace deteriorated and damaged material.</li></ul>	Level 3

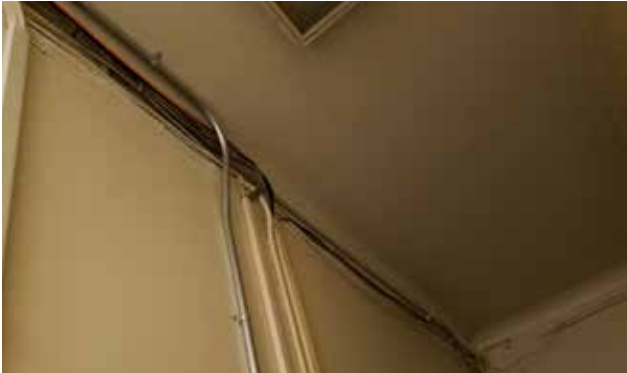
<b>C2-PR</b>  Painted Plaster Ceiling System	<b>Previous Repair</b> <ul style="list-style-type: none"><li>Area where a previous repair was done, including repointing, patching and consolidation.</li></ul>	<b>Material Patching or Replacement</b> <ul style="list-style-type: none"><li>Replace inappropriate previous patches.</li></ul>	Level 3

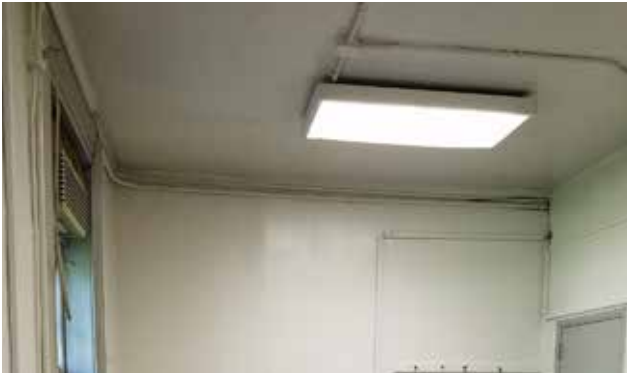
<b>C2-W</b>  Painted Plaster Ceiling System	<b>Wear</b> <ul style="list-style-type: none"><li>The gradual disintegration and erosion of materials caused by gradual use overtime.</li></ul>	<b>Material Patching or Replacement</b> <ul style="list-style-type: none"><li>Leave alone unless severe, then consider replacing.</li></ul>	Level 3

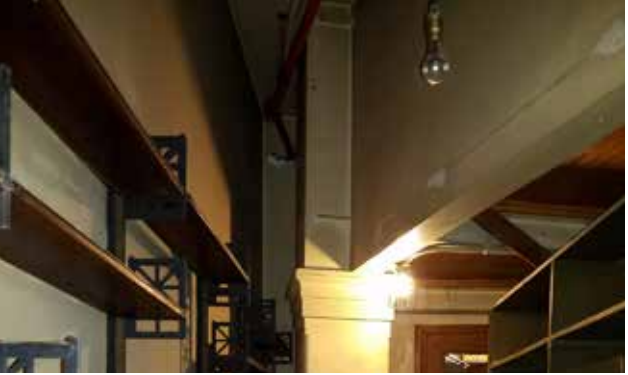
COMPONENT	CONDITION	TREATMENT	PRIORITY	REPRESENTATIVE PHOTO
<b>C3-PR</b>  Plaster Soffit Ceiling System	<b>Previous Repair</b> <ul style="list-style-type: none"><li>Area where a previous repair was done, including repointing, patching and consolidation.</li></ul>	<b>Material Patching or Replacement</b> <ul style="list-style-type: none"><li>Replace inappropriate previous patches.</li></ul>	Level 3

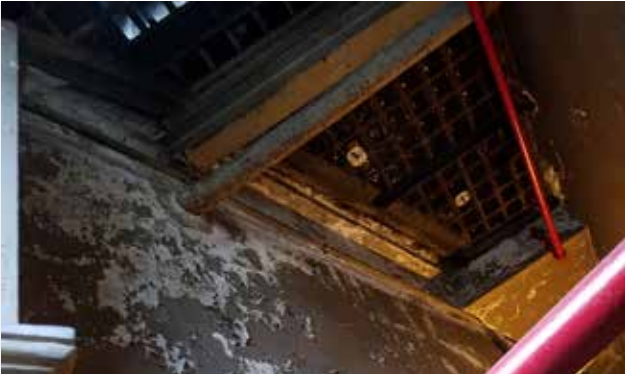
<b>C3-SP</b>  Plaster Soffit Ceiling System	<b>Spalling</b> <ul style="list-style-type: none"><li>Uneven breaking off of the outer layers of plaster.</li></ul>	<b>Material Patching or Replacement</b> <ul style="list-style-type: none"><li>Remove decayed plaster to sound material; patch or replace with new plaster. Repaint.</li></ul>	Level 3

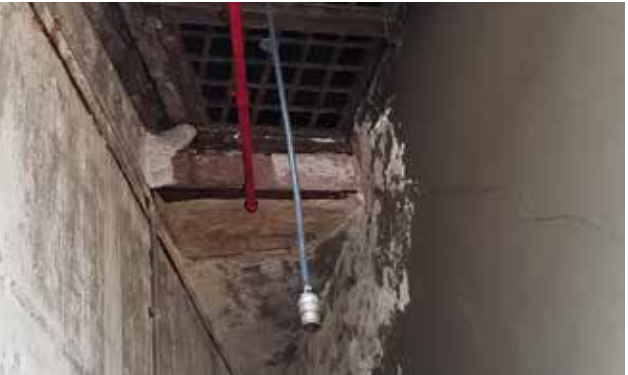
<b>C3-LM</b>  Plaster Soffit Ceiling System	<b>Material Loss</b> <ul style="list-style-type: none"><li>Loss of material leaving holes or exposing inner layers.</li></ul>	<b>Material Patching or Replacement</b> <ul style="list-style-type: none"><li>Patch areas of missing material, if feasible, or replace material to match existing.</li></ul>	Level 3

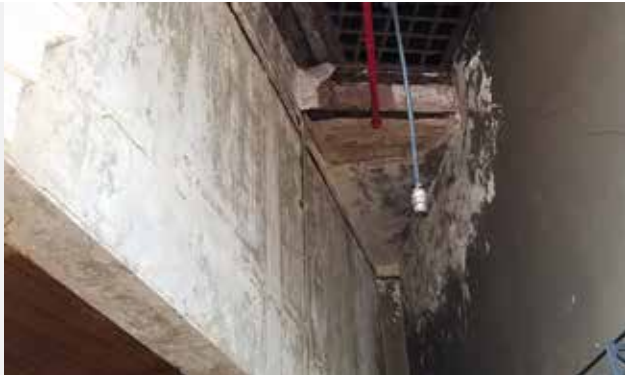
<b>C3-LC</b>  Plaster Soffit Ceiling System	<b>Paint Loss</b> <ul style="list-style-type: none"><li>Loss of surface paint.</li></ul>	<b>Material Replacement</b> <ul style="list-style-type: none"><li>Determine reason for paint loss, correct problem and repaint.</li></ul>	Level 3

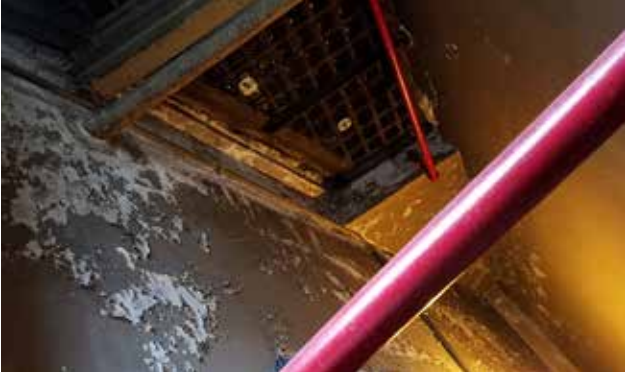
COMPONENT	CONDITION	TREATMENT	PRIORITY	REPRESENTATIVE PHOTO
<b>C3-MD</b>  Plaster Soffit Ceiling System	<b>Mechanical Damage</b> <ul style="list-style-type: none"><li>Damage to material caused by mechanical components or equipment</li></ul>	<b>Material Repair or Replacement</b> <ul style="list-style-type: none"><li>Remove mechanical remnants and connections. Patch areas of missing or damaged material, if feasible; remove and replace material, as required.</li></ul>	Level 3

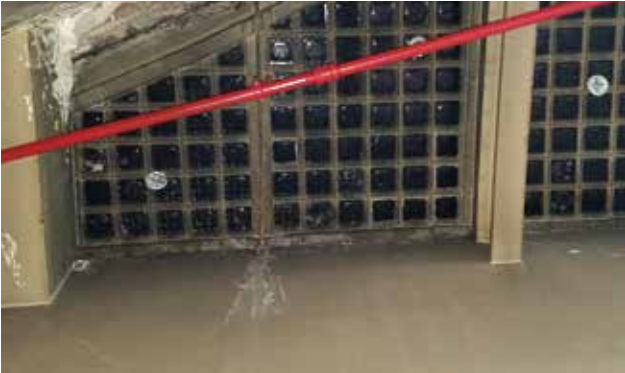
<b>C3-ST</b>  Plaster Soffit Ceiling System	<b>Staining</b> <ul style="list-style-type: none"><li>Surface problem caused by the build-up of pollutants, mineral deposits and water marks.</li></ul>	<b>Develop Cleaning Program</b> <ul style="list-style-type: none"><li>Develop a cleaning program if it can be implemented without damage to bulding system.</li></ul>	Level 3

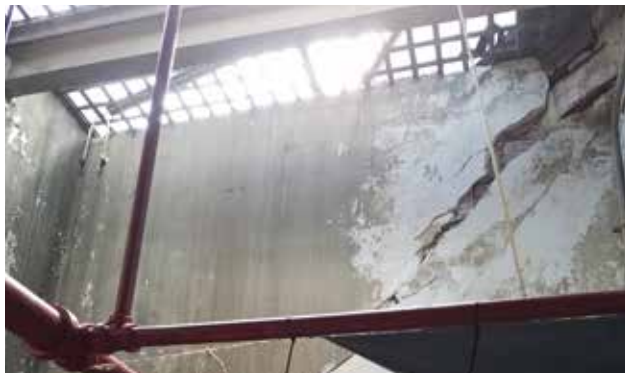
<b>C3-CR</b>  Plaster Soffit Ceiling System	<b>Cracking</b> <ul style="list-style-type: none"><li>1/16 to 1/2 inch wide visible fissure in a surface, possibly penetrating through the surface.</li></ul>	<b>Material Patching or Replacement</b> <ul style="list-style-type: none"><li>Remove and replace damaged material.</li></ul>	Level 3

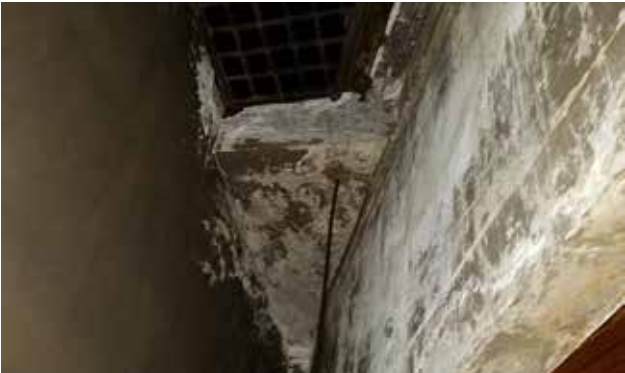
<b>C3-SB</b>  Plaster Soffit Ceiling System	<b>Biological Growth</b> <ul style="list-style-type: none"><li>Surface growth having biological origins, typically found in damp locations.</li></ul>	<b>Develop Cleaning Program</b> <ul style="list-style-type: none"><li>Clean, identify source of water infiltration and remedy cause. If severe, replace deteriorated material.</li></ul>	Level 3

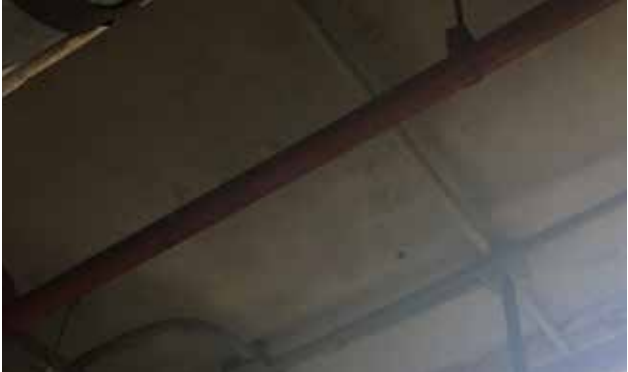
COMPONENT	CONDITION	TREATMENT	PRIORITY	REPRESENTATIVE PHOTO
<b>C4-SA</b>  Concrete Slab Ceiling System	<b>Soiling</b> <ul style="list-style-type: none"><li>Surface staining caused by the build-up of pollutants.</li></ul>	<b>Develop Cleaning Program</b> <ul style="list-style-type: none"><li>Develop a cleaning program if it can be implemented without damage to building system.</li></ul>	Level 3

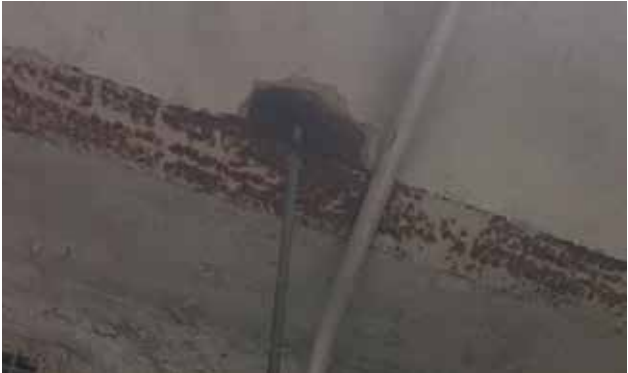
<b>C4-MD</b>  Concrete Slab Ceiling System	<b>Mechanical Damage</b> <ul style="list-style-type: none"><li>Damage to material caused by mechanical components or equipment</li></ul>	<b>Material Repair or Replacement</b> <ul style="list-style-type: none"><li>Remove mechanical remnants and connections. Patch areas of missing or damaged material, if feasible; remove and replace material, as required.</li></ul>	Level 3

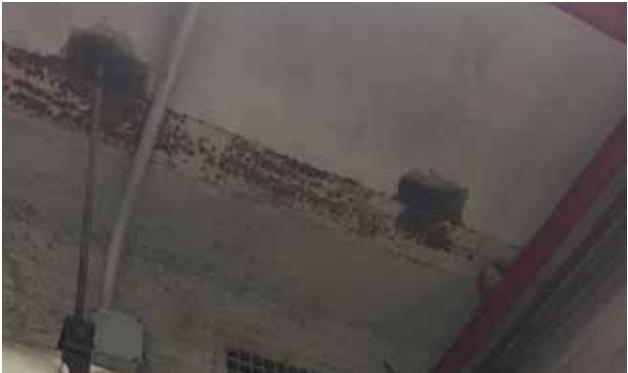
<b>C4-SP</b>  Concrete Slab Ceiling System	<b>Spalling</b> <ul style="list-style-type: none"><li>Uneven breaking off of the outer layers of masonry.</li></ul>	<b>Material Patching or Replacement</b> <ul style="list-style-type: none"><li>Cutting and resurfacing, remove decayed layers and patch; in severe cases, replace with new masonry and concrete.</li></ul>	Level 3

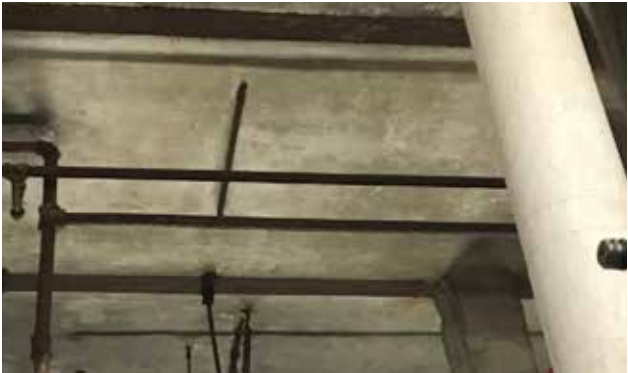
<b>C4-ST</b>  Concrete Slab Ceiling System	<b>Staining</b> <ul style="list-style-type: none"><li>Surface problem caused by the build-up of pollutants, mineral deposits and water marks.</li></ul>	<b>Develop Cleaning Program</b> <ul style="list-style-type: none"><li>Develop a cleaning program if it can be implemented without damage to building system.</li></ul>	Level 3

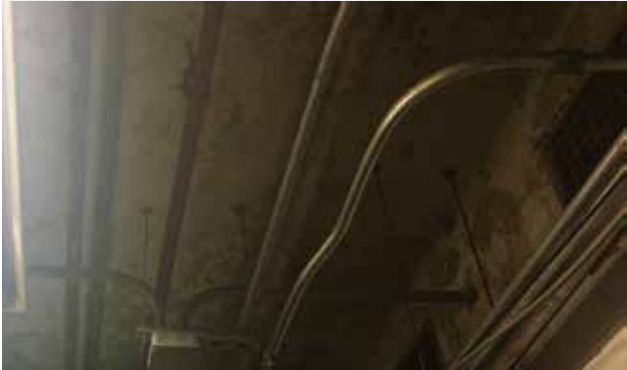
COMPONENT	CONDITION	TREATMENT	PRIORITY	REPRESENTATIVE PHOTO
<b>C4-CR</b>  Concrete Slab Ceiling System	<b>Cracking</b> <ul style="list-style-type: none"><li>1/16 to 1/2 inch wide visible fissure in surface, possibly penetrating through the surface.</li></ul>	<b>Material Patching or Replacement</b> <ul style="list-style-type: none"><li>Remove and replace damaged material.</li></ul>	Level 3

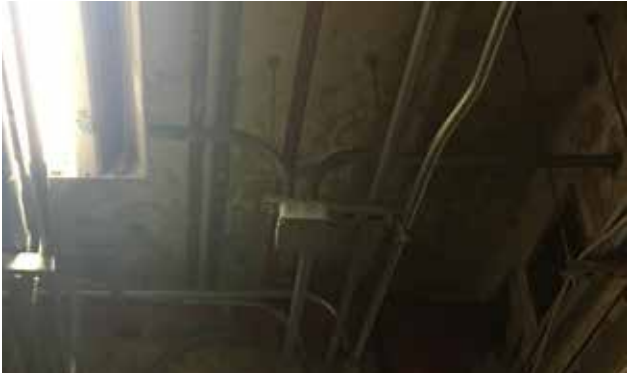
<b>C4-LC</b>  Concrete Slab Ceiling System	<b>Paint Loss</b> <ul style="list-style-type: none"><li>Loss of surface paint.</li></ul>	<b>Material Replacement</b> <ul style="list-style-type: none"><li>Determine reason for paint loss, correct problem and repaint.</li></ul>	Level 3

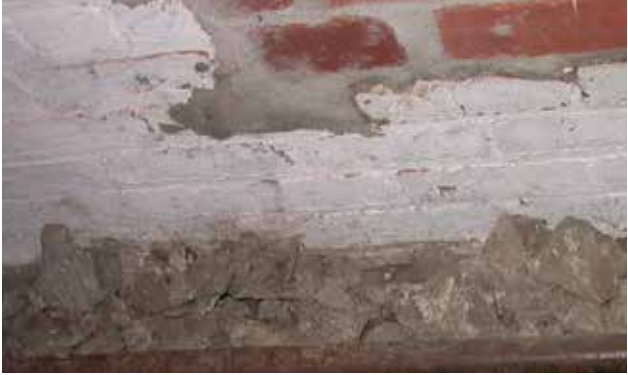
COMPONENT	CONDITION	TREATMENT	PRIORITY	REPRESENTATIVE PHOTO
C5-LC  Brick Masonry Ceiling System	Paint Loss <ul style="list-style-type: none"><li>Loss of surface paint.</li></ul>	Material Replacement <ul style="list-style-type: none"><li>Determine reason for paint loss, correct problem and repaint.</li></ul>	Level 3

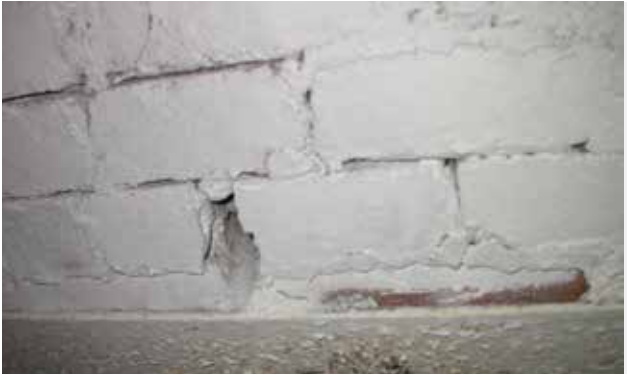
C5-OJ  Brick Masonry Ceiling System	Open Joints <ul style="list-style-type: none"><li>Joints without mortar.</li></ul>	Material Repair or Replacement <ul style="list-style-type: none"><li>Repoint masonry with an appropriate mortar.</li></ul>	Level 3

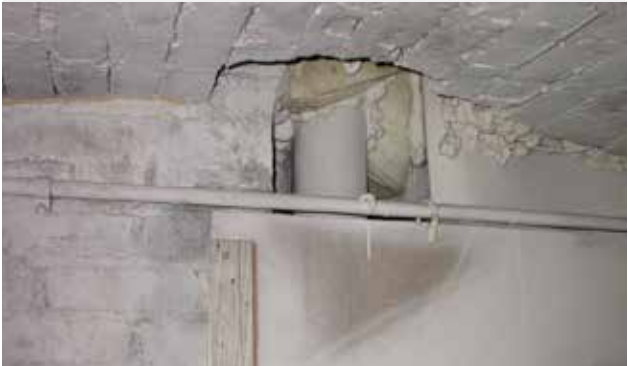
C5-MD  Brick Masonry Ceiling System	Mechanical Damage <ul style="list-style-type: none"><li>Damage to material caused by mechanical components or equipment</li></ul>	Material Repair or Replacement <ul style="list-style-type: none"><li>Remove mechanical remnants and connections. Patch areas of missing or damaged material, if feasible; remove and replace material, as required.</li></ul>	Level 3

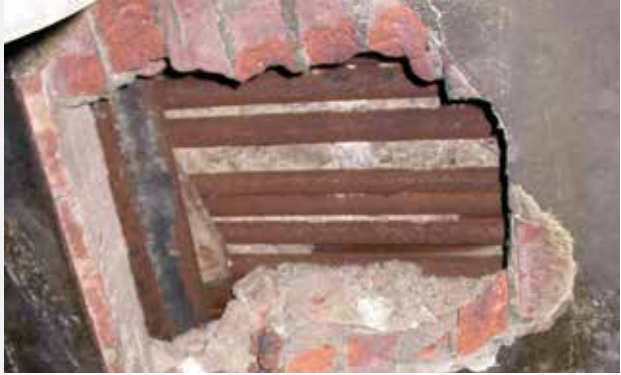
C5-LM  Brick Masonry Ceiling System	Material Loss <ul style="list-style-type: none"><li>Loss of material leaving holes or exposing inner layers.</li></ul>	Material Patching or Replacement <ul style="list-style-type: none"><li>Patch areas of missing material, if feasible, or replace material to match existing.</li></ul>	Level 3

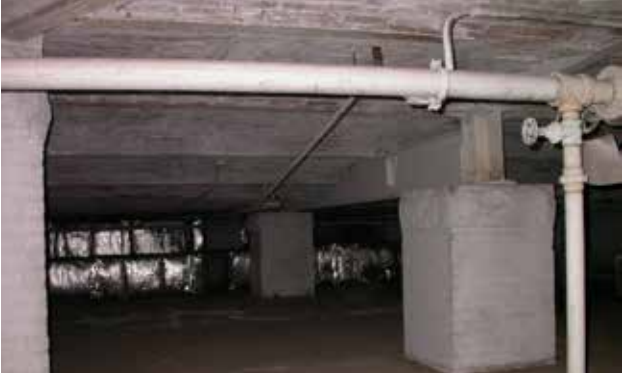
COMPONENT	CONDITION	TREATMENT	PRIORITY	REPRESENTATIVE PHOTO
C5-SA  Brick Masonry Ceiling System	<b>Soiling</b> <ul style="list-style-type: none"><li>• Surface staining caused by the build-up of pollutants.</li></ul>	<b>Develop Cleaning Program</b> <ul style="list-style-type: none"><li>• Develop a cleaning program if it can be implemented without damage to bulding system.</li></ul>	Level 3

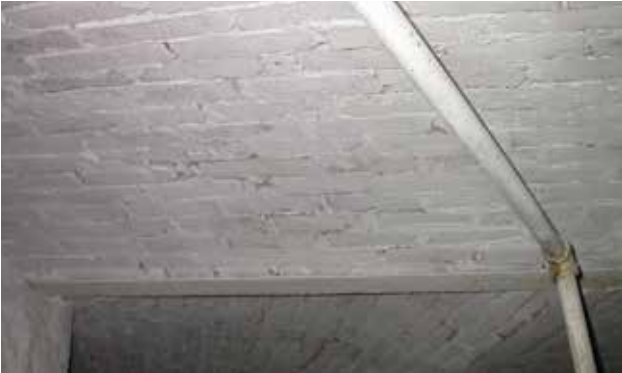
C5-CR  Brick Masonry Ceiling System	<b>Cracking</b> <ul style="list-style-type: none"><li>• 1/16 to 1/2 inch wide visible fissure in a surface, possible penetrating through the surface.</li></ul>	<b>Material Replacement</b> <ul style="list-style-type: none"><li>• Remove and replace damaged material.</li></ul>	Level 3

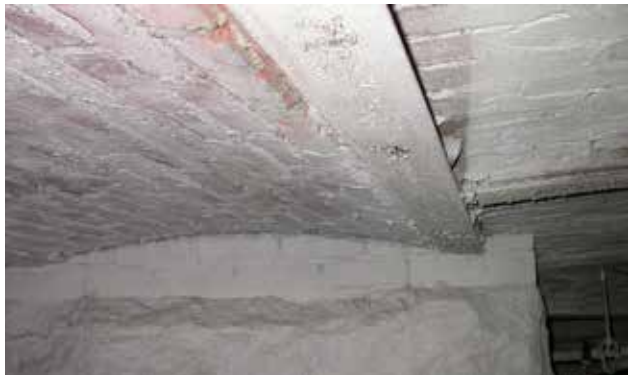
C5-SP  Brick Masonry Ceiling System	<b>Spalling</b> <ul style="list-style-type: none"><li>• Uneven breaking off of the outer layers of masonry.</li></ul>	<b>Material Replacement</b> <ul style="list-style-type: none"><li>• Remove deteriorated masonry and replace with new bricks and appropriate mortar.</li></ul>	Level 3

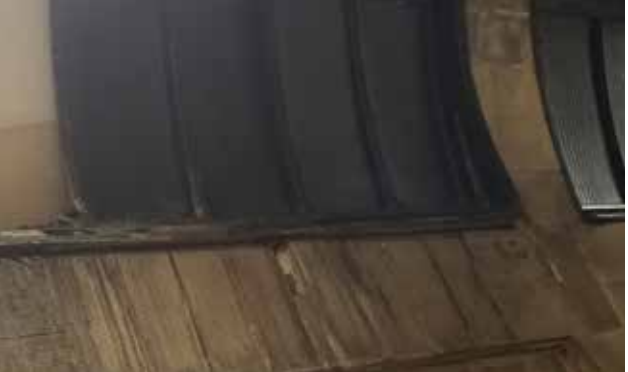
COMPONENT	CONDITION	TREATMENT	PRIORITY	REPRESENTATIVE PHOTO
<b>C6-LM</b>  Guastavino Tile Ceiling System	<b>Material Loss</b> <ul style="list-style-type: none"><li>Loss of material leaving holes or exposing inner layers.</li></ul>	<b>Material Patching or Replacement</b> <ul style="list-style-type: none"><li>Patch areas of missing material, if feasible, or replace material to match existing.</li></ul>	Level 3

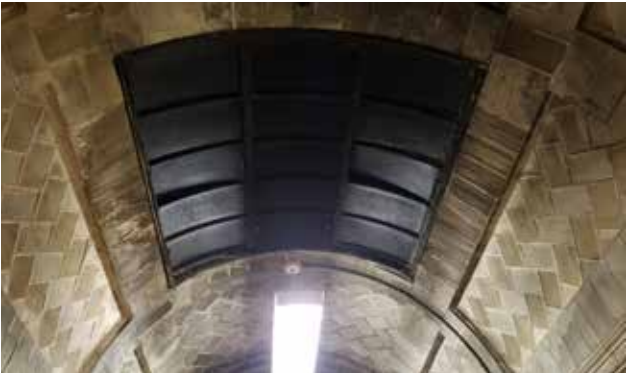
<b>C6-SA</b>  Guastavino Tile Ceiling System	<b>Soiling</b> <ul style="list-style-type: none"><li>Surface staining caused by the build-up of pollutants.</li></ul>	<b>Develop Cleaning Program</b> <ul style="list-style-type: none"><li>Develop a cleaning program if it can be implemented without damage to building system.</li></ul>	Level 3

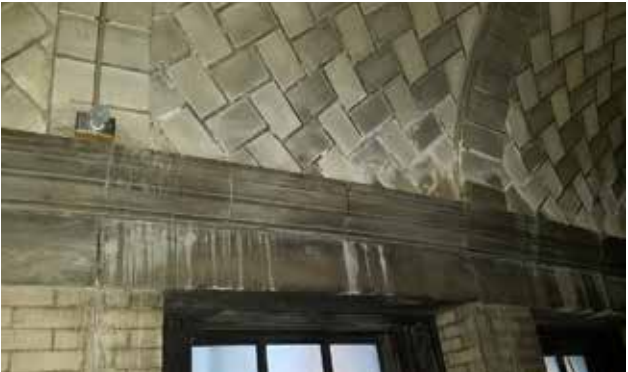
<b>C6-OJ</b>  Guastavino Tile Ceiling System	<b>Open Joints</b> <ul style="list-style-type: none"><li>Joints without mortar</li></ul>	<b>Material Repair or Replacement</b> <ul style="list-style-type: none"><li>Repoint tile with an appropriate mortar.</li></ul>	Level 3

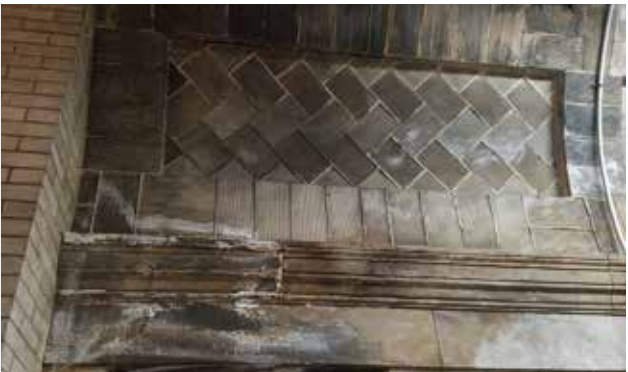
<b>C6-EF</b>  Guastavino Tile Ceiling System	<b>Efflorescence</b> <ul style="list-style-type: none"><li>Whitish haze of soluble salts left as deposits on masonry by evaporation of water, generally a symptom of a worse condition or a hint that trouble may be beginning.</li></ul>	<b>Develop Cleaning Program</b> <ul style="list-style-type: none"><li>Clean deposit, identify and eliminate water infiltration.</li></ul>	Level 3

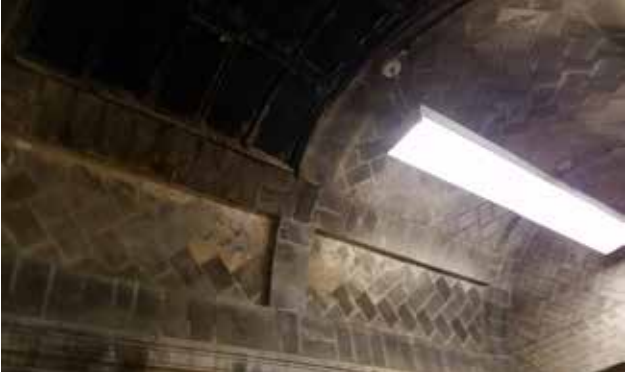
COMPONENT	CONDITION	TREATMENT	PRIORITY	REPRESENTATIVE PHOTO
<b>C6-SP</b>  Guastavino Tile Ceiling System	<b>Spalling</b> <ul style="list-style-type: none"><li>Uneven breaking off of the intrados of the masonry.</li></ul>	<b>Material Replacement</b> <ul style="list-style-type: none"><li>Remove deteriorated tile and replace with new tiles and appropriate mortar.</li></ul>	Level 3

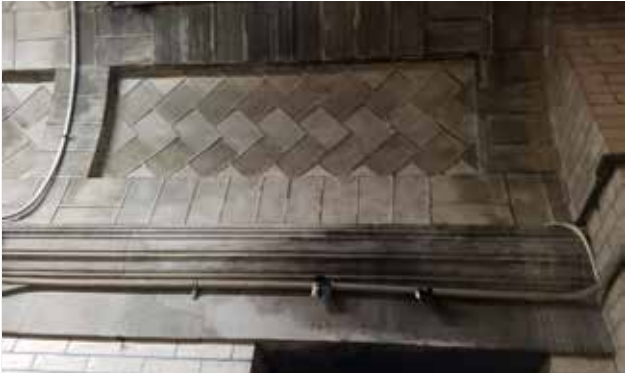
<b>C6-ST</b>  Guastavino Tile Ceiling System	<b>Staining</b> <ul style="list-style-type: none"><li>Surface problem caused by the build-up of pollutants, mineral deposits and water marks.</li></ul>	<b>Develop Cleaning Program</b> <ul style="list-style-type: none"><li>Develop a cleaning program if it can be implemented without damage to bulding system.</li></ul>	Level 3

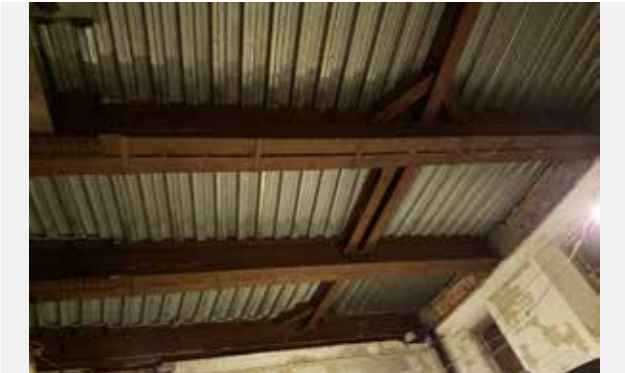
<b>C7-MC</b> Steel Beams Ceiling System  (Brick Vault or Corrugated Metal Deck Infill)	<b>Corrosion</b> <ul style="list-style-type: none"><li>Deterioration of material by a chemical reaction with its environment.</li></ul>	<b>Removal of Deteriorated Material</b> <ul style="list-style-type: none"><li>Remove (scrape) corrosion and corrosive products and paint steel to remain; in severe cases, replace deteriorated members with new material to match existing.</li></ul>	Level 3

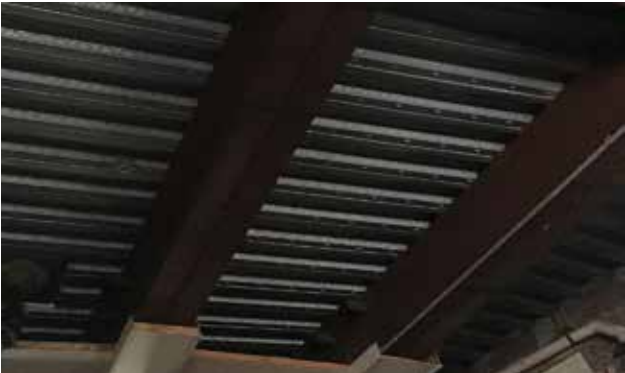
<b>C7-LC</b>  Steel Beams Ceiling System  (Brick Vault or Corrugated Metal Deck Infill)	<b>Paint Loss</b> <ul style="list-style-type: none"><li>Loss of surface paint.</li></ul>	<b>Material Replacement</b> <ul style="list-style-type: none"><li>Determine reason for paint loss, correct problem and repaint.</li></ul>	Level 3

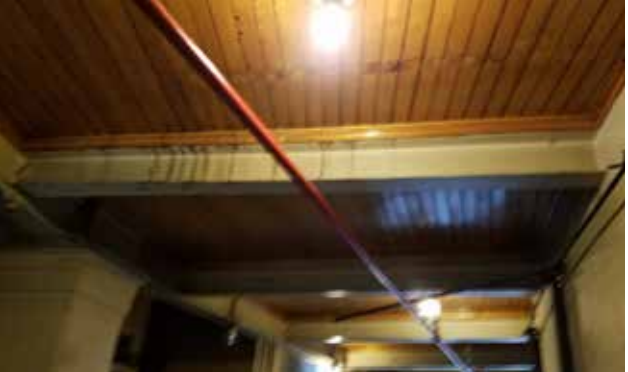
COMPONENT	CONDITION	TREATMENT	PRIORITY	REPRESENTATIVE PHOTO
<b>C8-CR</b>  Cast Iron Grid with Wood Bead Board Ceiling System	<b>Cracking</b> <ul style="list-style-type: none"><li>1/16 to 1/2 inch wide visible fissure in surface, possibly penetrating through the surface.</li></ul>	<b>Material Patching or Replacement</b> <ul style="list-style-type: none"><li>Remove and replace damaged material.</li></ul>	Level 3

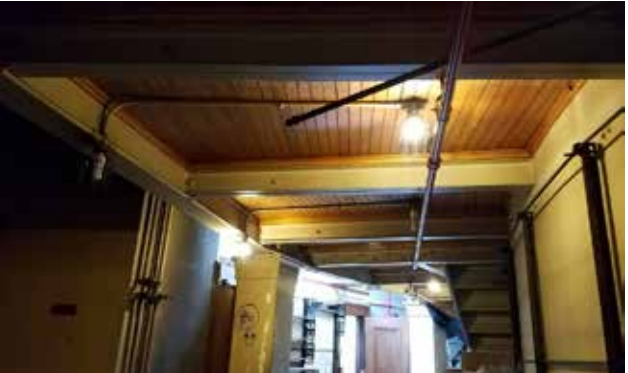
<b>C8-W</b>  Cast Iron Grid with Wood Bead Board Ceiling System	<b>Wear</b> <ul style="list-style-type: none"><li>The gradual disintegration and erosion of materials caused by gradual use overtime.</li></ul>	<b>Material Patching or Replacement</b> <ul style="list-style-type: none"><li>Leave alone unless severe, then consider replacing.</li></ul>	Level 3

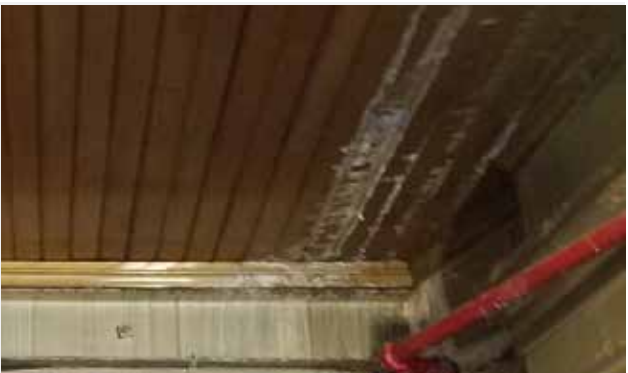
<b>C8-EF</b>  Cast Iron Grid with Wood Bead Board Ceiling System	<b>Efflorescence</b> <ul style="list-style-type: none"><li>Whitish haze of soluble salts left as deposits on masonry by evaporation of water, generally a symptom of a worse condition or a hint that trouble may be beginning.</li></ul>	<b>Develop Cleaning Program</b> <ul style="list-style-type: none"><li>Clean deposit, identify and eliminate water infiltration.</li></ul>	Level 3

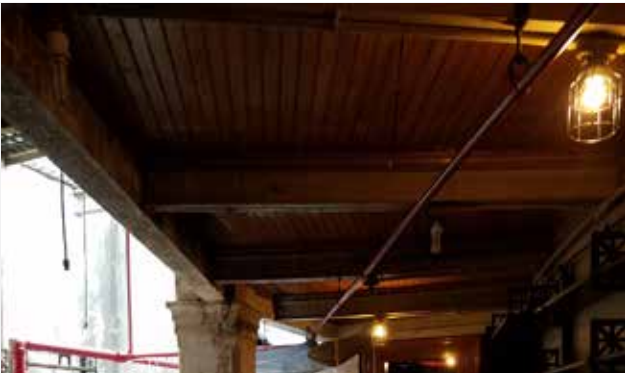
<b>C8-G</b>  Cast Iron Grid with Wood Bead Board Ceiling System	<b>Graffiti</b> <ul style="list-style-type: none"><li>Paint sprayed on surface.</li></ul>	<b>Develop Cleaning Program</b> <ul style="list-style-type: none"><li>Investigate proper removal methods where appropriate without damaging material.</li></ul>	Level 3

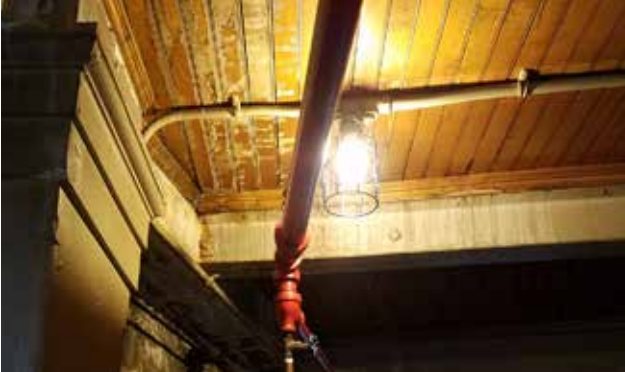
COMPONENT	CONDITION	TREATMENT	PRIORITY	REPRESENTATIVE PHOTO
<b>C8-MC</b>  Cast Iron Grid with Wood Bead Board Ceiling System	<b>Corrosion</b> <ul style="list-style-type: none"><li>Deterioration of material by a chemical reaction with its environment.</li></ul>	<b>Removal of Deteriorated Material</b> <ul style="list-style-type: none"><li>Remove corrosion and corrosive products; in severe cases, replace deteriorated members with new material to match existing.</li><li>Refer to assesment of structural engineer for details on replacement of select cast iron members.</li></ul>	Level 3

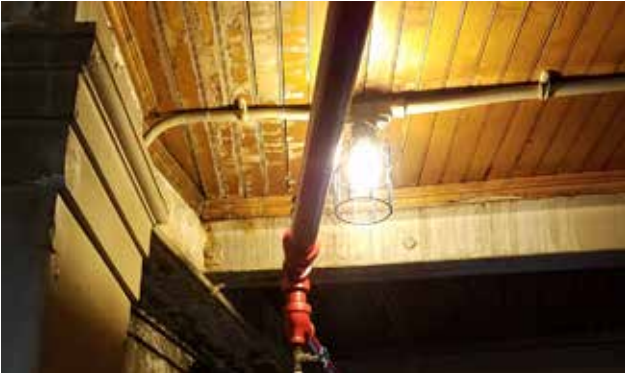
<b>C8-ST</b>  Cast Iron Grid with Wood Bead Board Ceiling System	<b>Staining</b> <ul style="list-style-type: none"><li>Surface problem caused by the build-up of pollutants, mineral deposits and water marks.</li></ul>	<b>Develop Cleaning Program</b> <ul style="list-style-type: none"><li>Develop a cleaning program if it can be implemented without damage to bulding system.</li></ul>	Level 3

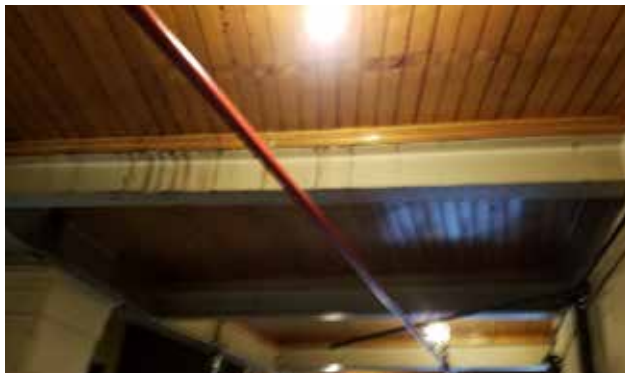
<b>C8-SA</b>  Cast Iron Grid with Wood Bead Board Ceiling System	<b>Soiling</b> <ul style="list-style-type: none"><li>Surface staining caused by the build-up of pollutants.</li></ul>	<b>Develop Cleaning Program</b> <ul style="list-style-type: none"><li>Develop a cleaning program if it can be implemented without damage to bulding system.</li></ul>	Level 3

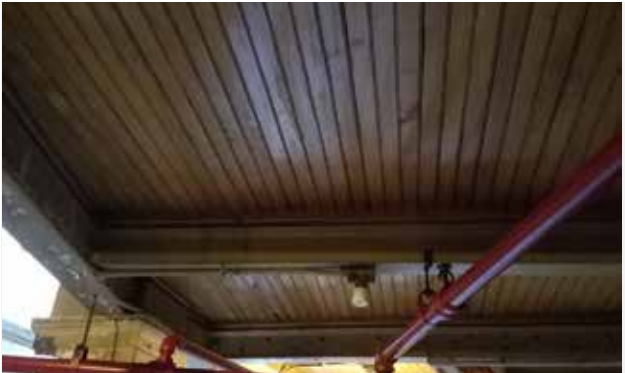
<b>C8-MD</b>  Cast Iron Grid with Wood Bead Board Ceiling System	<b>Mechanical Damage</b> <ul style="list-style-type: none"><li>Damage to material caused by mechanical components or equipment</li></ul>	<b>Material Repair or Replacement</b> <ul style="list-style-type: none"><li>Remove mechanical remnants and connections. Patch areas of missing or damaged material, if feasible; remove and replace material, as required.</li></ul>	Level 3

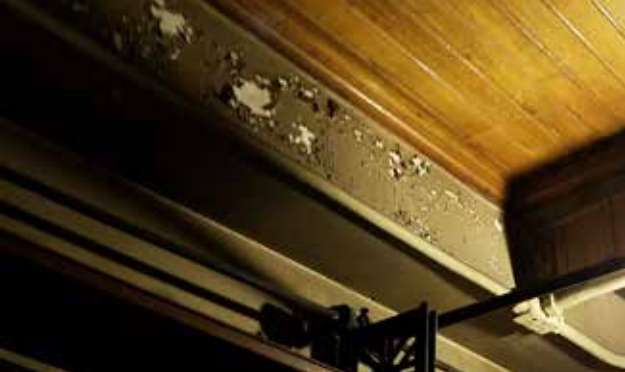
COMPONENT	CONDITION	TREATMENT	PRIORITY	REPRESENTATIVE PHOTO
<b>C8-LC</b>  Cast Iron Grid with Wood Bead Board Ceiling System	<b>Paint Loss</b> <ul style="list-style-type: none"><li>Loss of surface paint.</li></ul>	<b>Material Replacement</b> <ul style="list-style-type: none"><li>Determine reason for paint loss, correct problem and repaint.</li></ul>	Level 3

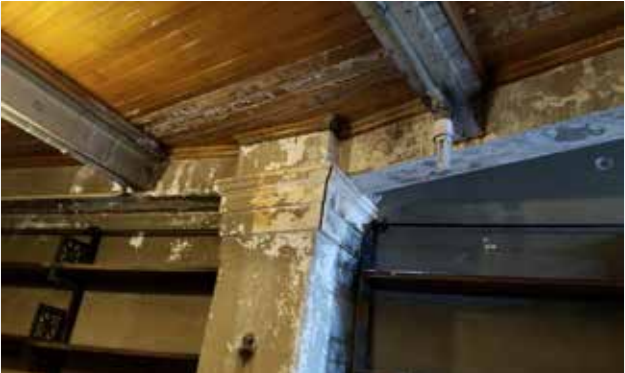
<b>C8-SB</b>  Cast Iron Grid with Wood Bead Board Ceiling System	<b>Biological Growth</b> <ul style="list-style-type: none"><li>Surface growth having biological origins, typically found in damp locations.</li></ul>	<b>Develop Cleaning Program</b> <ul style="list-style-type: none"><li>Clean, identify source of water infiltration and remedy cause. If severe, replace deteriorated material.</li></ul>	Level 3

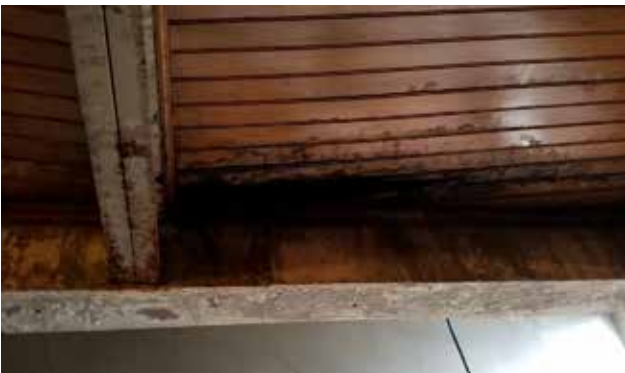
<b>C8-RT</b>  Cast Iron Grid with Wood Bead Board Ceiling System	<b>Wood Rot</b> <ul style="list-style-type: none"><li>The growth of fungi when oxygen, warmth and moisture are present in wood.</li></ul>	<b>Material Repair or Replacement</b> <ul style="list-style-type: none"><li>Replace rotted elements and treat new wood to repel agents that cause rotting.</li></ul>	Level 3

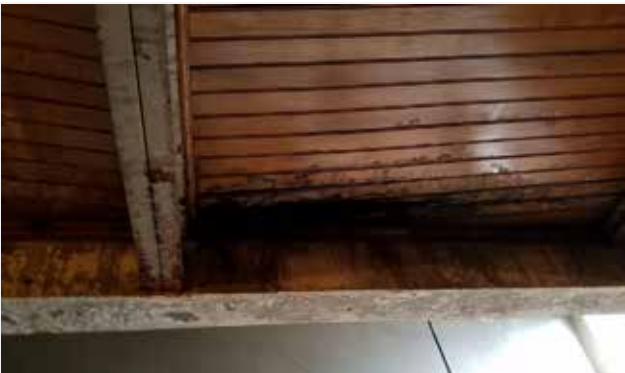
<b>C8-LM</b>  Cast Iron Grid with Wood Bead Board Ceiling System	<b>Material Loss</b> <ul style="list-style-type: none"><li>Loss of material leaving holes or exposing inner layers.</li></ul>	<b>Material Patching or Replacement</b> <ul style="list-style-type: none"><li>Patch areas of missing material, if feasible, or replace material to match existing.</li></ul>	Level 3

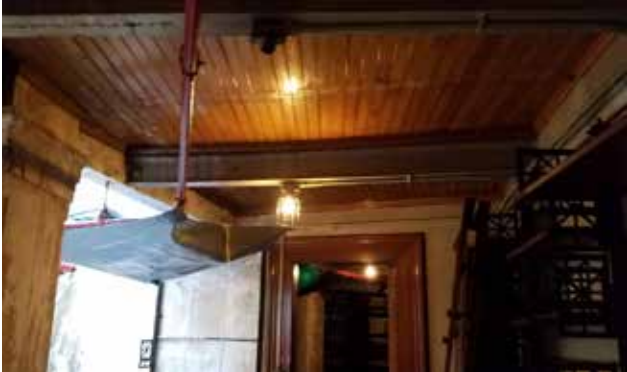
COMPONENT	CONDITION	TREATMENT	PRIORITY	REPRESENTATIVE PHOTO
<b>C8-PR</b>  Cast Iron Grid with Wood Bead Board Ceiling System	<b>Previous Repair</b> <ul style="list-style-type: none"><li>Area where a previous repair was done, including repointing, patching and consolidation.</li></ul>	<b>Material Patching or Replacement</b> <ul style="list-style-type: none"><li>Replace inappropriate previous patches.</li></ul>	Level 3

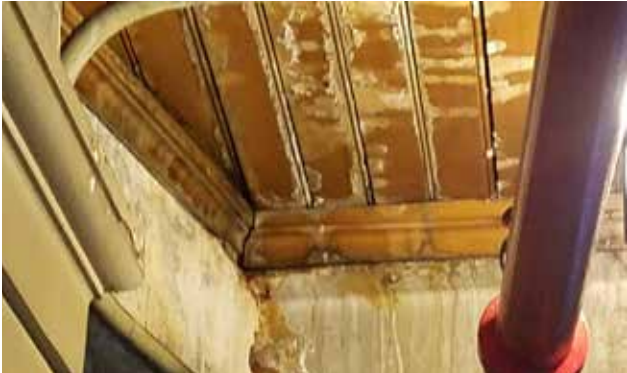
<b>C8-OJ</b>  Cast Iron Grid with Wood Bead Board Ceiling System	<b>Open Joints</b> <ul style="list-style-type: none"><li>Joints without caulking</li></ul>	<b>Material Patching or Replacement</b> <ul style="list-style-type: none"><li>Determine reason for opening of joints. Replace affected areas.</li></ul>	Level 3

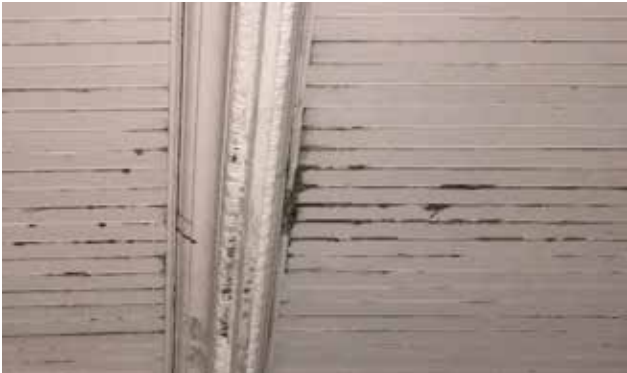
<b>C9-SA</b>  Wood Bead Board Ceiling and Soffits Ceiling System	<b>Soiling</b> <ul style="list-style-type: none"><li>Surface staining caused by the build-up of pollutants.</li></ul>	<b>Develop Cleaning Program</b> <ul style="list-style-type: none"><li>Develop a cleaning program if it can be implemented without damage to bulding system.</li></ul>	Level 3

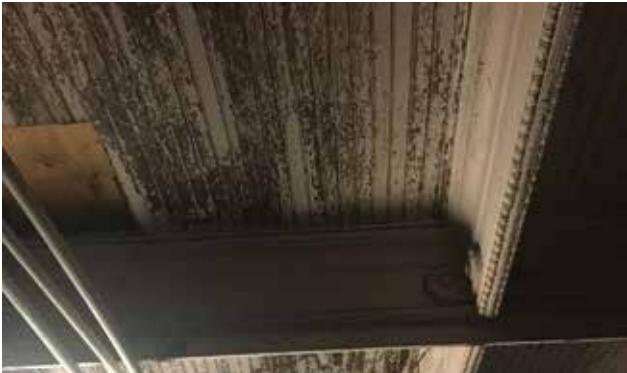
<b>C9-LC</b>  Wood Bead Board Ceiling and Soffits Ceiling System	<b>Paint Loss</b> <ul style="list-style-type: none"><li>Loss of surface paint.</li></ul>	<b>Material Replacement</b> <ul style="list-style-type: none"><li>Determine reason for paint loss, correct problem and repaint.</li></ul>	Level 3

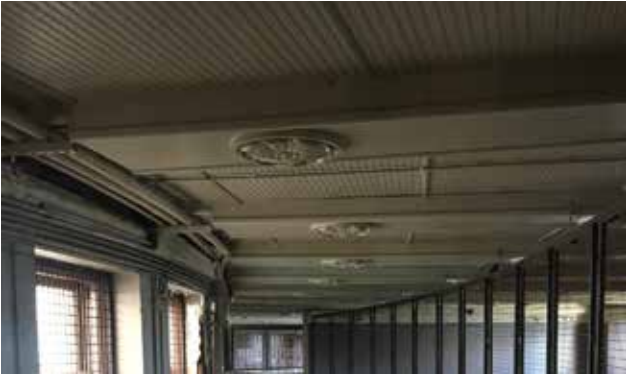
COMPONENT	CONDITION	TREATMENT	PRIORITY	REPRESENTATIVE PHOTO
<b>C9-MD</b>  Wood Bead Board Ceiling and Soffits Ceiling System	<b>Mechanical Damage</b> <ul style="list-style-type: none"><li>Damage to material caused by mechanical components or equipment</li></ul>	<b>Material Repair or Replacement</b> <ul style="list-style-type: none"><li>Remove mechanical remnants and connections. Patch areas of missing or damaged material, if feasible; remove and replace material, as required.</li></ul>	Level 3

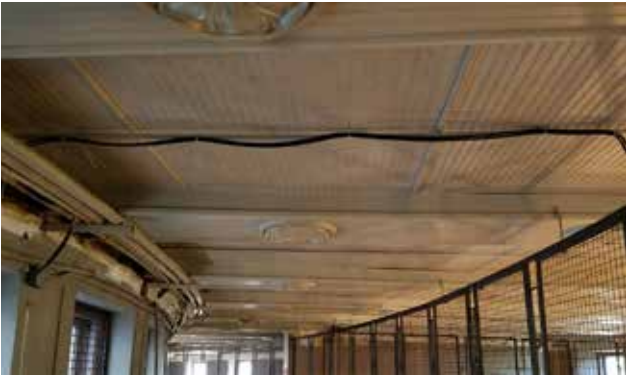
<b>C9-CR</b>  Wood Bead Board Ceiling and Soffits Ceiling System	<b>Cracking</b> <ul style="list-style-type: none"><li>1/16" to 1/2" wide visible fissures, possibly penetrating through the material surface</li></ul>	<b>Material Patching or Replacement</b> <ul style="list-style-type: none"><li>Remove and replace damaged material.</li></ul>	Level 3

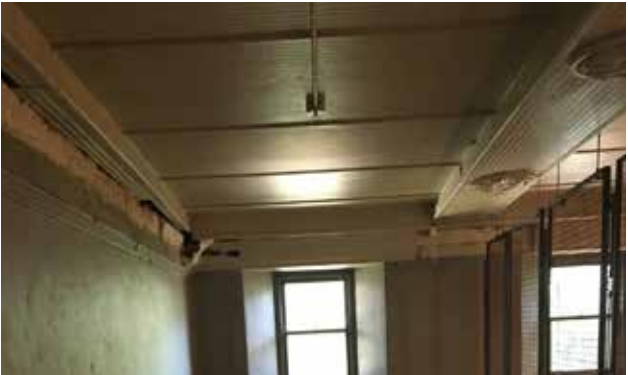
<b>C9-LM</b>  Wood Bead Board Ceiling and Soffits Ceiling System	<b>Material Loss</b> <ul style="list-style-type: none"><li>Loss of material leaving holes or exposing inner layers.</li></ul>	<b>Material Patching or Replacement</b> <ul style="list-style-type: none"><li>Patch areas of missing material, if feasible, or replace material to match existing.</li></ul>	Level 3

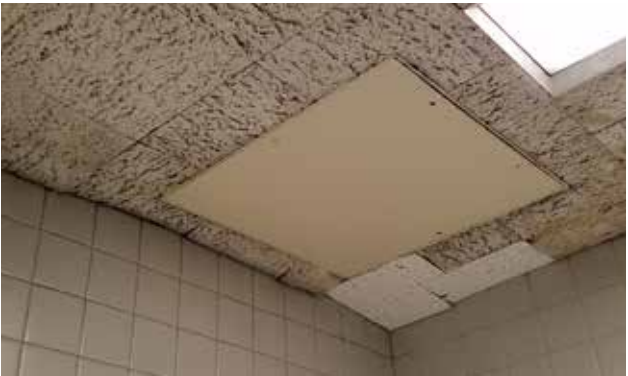
<b>C10-SW</b>  Acoustic Ceiling Tile Ceiling System	<b>Water Damage</b> <ul style="list-style-type: none"><li>Biological growth, blistering, efflorescence, wood rot or staining caused by the infiltration of water.</li></ul>	<b>Removal of Deteriorated Material</b> <ul style="list-style-type: none"><li>Identify source of water infiltration and remedy cause. Replace deteriorated and damaged material.</li></ul>	Level 3

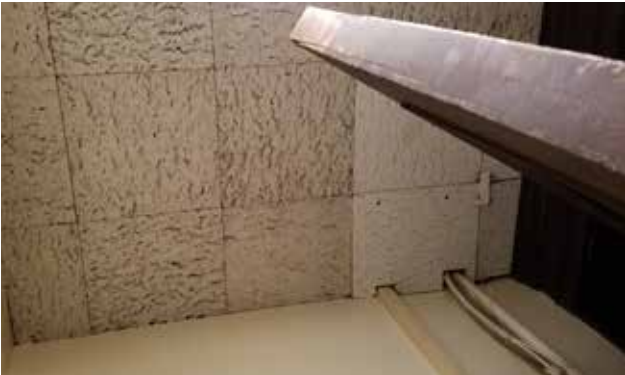
COMPONENT	CONDITION	TREATMENT	PRIORITY	REPRESENTATIVE PHOTO
<b>C10-DS</b>  Acoustic Ceiling Tile Ceiling System	<b>Displacement</b> <ul style="list-style-type: none"><li>• Movement of a building material or element from its original location.</li></ul>	<b>Removal of Deteriorated Material</b> <ul style="list-style-type: none"><li>• Investigation to determine cause of movement and then subsequent repair.</li></ul>	Level 3

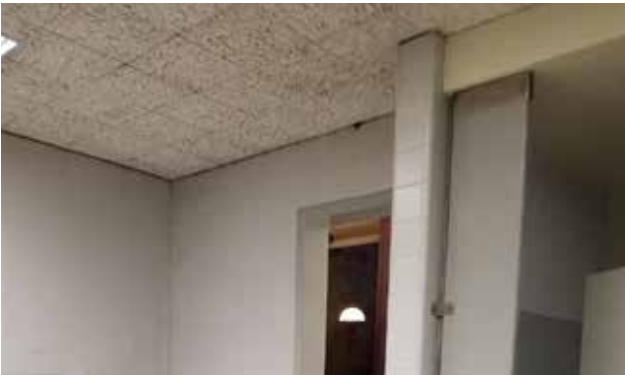
<b>C10-ST</b>  Acoustic Ceiling Tile Ceiling System	<b>Staining</b> <ul style="list-style-type: none"><li>• Surface problem caused by the build-up of pollutants, mineral deposits and water marks.</li></ul>	<b>Develop Cleaning Program</b> <ul style="list-style-type: none"><li>• Develop a cleaning program if it can be implemented without damage to bulding system.</li></ul>	Level 3

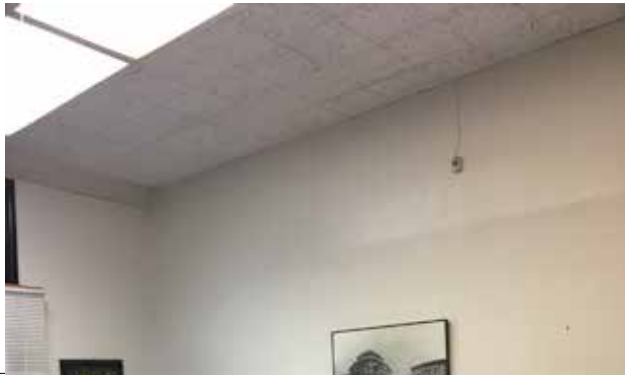
<b>C10-MD</b>  Acoustic Ceiling Tile Ceiling System	<b>Mechanical Damage</b> <ul style="list-style-type: none"><li>• Damage to material caused by mechanical components or equipment</li></ul>	<b>Material Repair or Replacement</b> <ul style="list-style-type: none"><li>• Remove mechanical remnants and connections. Patch areas of missing or damaged material, if feasible; remove and replace material, as required.</li></ul>	Level 3

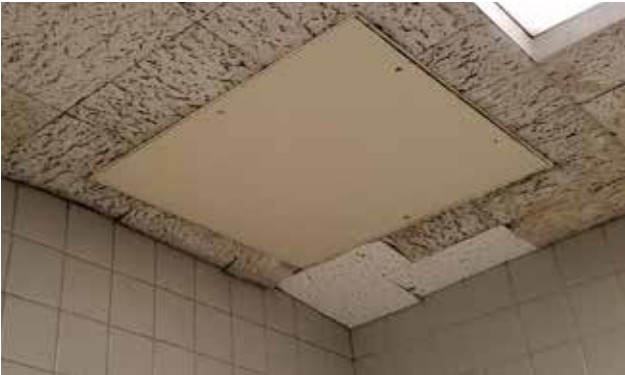
<b>C10-LM</b>  Acoustic Ceiling Tile Ceiling System	<b>Material Loss</b> <ul style="list-style-type: none"><li>• Loss of material leaving holes or exposing inner layers.</li></ul>	<b>Material Replacement</b> <ul style="list-style-type: none"><li>• Replace material to match existing.</li></ul>	Level 3

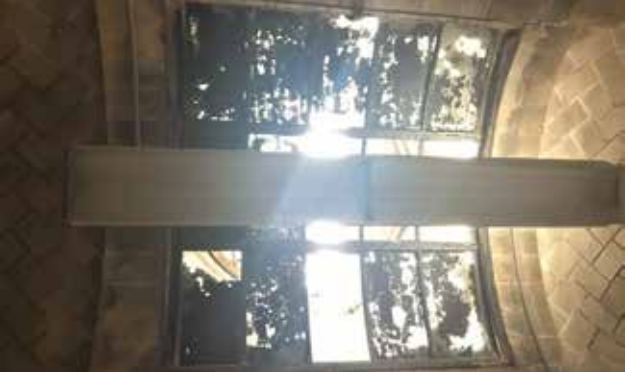
COMPONENT	CONDITION	TREATMENT	PRIORITY	REPRESENTATIVE PHOTO
<b>C11-CR</b>  Cast Iron and Glass Skylight Ceiling System	<b>Cracking</b> <ul style="list-style-type: none"><li>1/16 to ½ inch wide visible fissure in glass surface, possibly penetrating through the surface.</li></ul>	<b>Material Patching or Replacement</b> <ul style="list-style-type: none"><li>Remove and replace damaged material.</li></ul>	Level 3

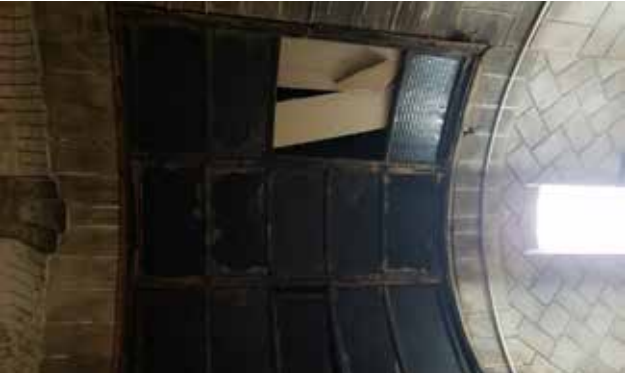
<b>C11-LM</b>  Cast Iron and Glass Skylight Ceiling System	<b>Material Loss</b> <ul style="list-style-type: none"><li>Loss of material leaving holes or exposing inner layers.</li></ul>	<b>Material Patching or Replacement</b> <ul style="list-style-type: none"><li>Patch areas of missing material, if feasible, or replace material to match existing.</li></ul>	Level 3

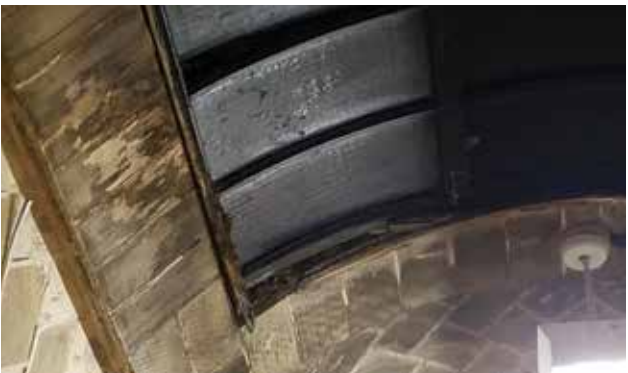
<b>C11-MC</b>  Cast Iron and Glass Skylight Ceiling System	<b>Corrosion</b> <ul style="list-style-type: none"><li>Deterioration of material by a chemical reaction with its environment.</li></ul>	<b>Removal of Deteriorated Material</b> <ul style="list-style-type: none"><li>Remove corrosion and corrosive products; in severe cases, replace deteriorated members with new material to match existing.</li><li>Refer to assesment of structural engineer for details on replacement of select cast iron members.</li></ul>	Level 3

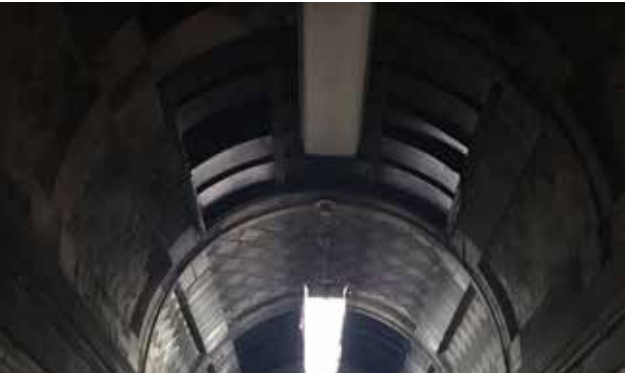
<b>C11-PR</b>  Cast Iron and Glass Skylight Ceiling System	<b>Previous Repair</b> <ul style="list-style-type: none"><li>Area where a previous repair was done, including repointing, patching and consolidation.</li></ul>	<b>Material Patching or Replacement</b> <ul style="list-style-type: none"><li>Replace inappropriate previous patches.</li></ul>	Level 3

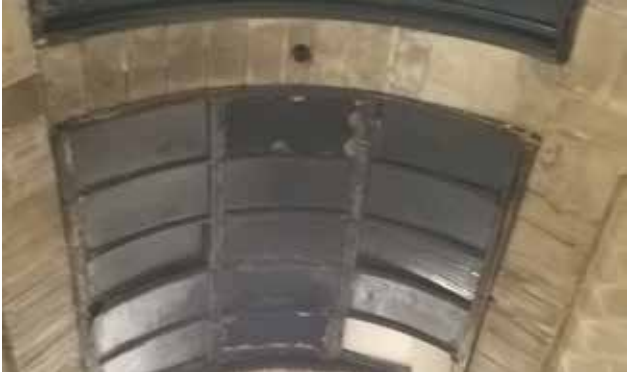
COMPONENT	CONDITION	TREATMENT	PRIORITY	REPRESENTATIVE PHOTO
<b>C11-SA</b>  Cast Iron and Glass Skylight Ceiling System	<b>Soiling</b> <ul style="list-style-type: none"><li>Surface staining caused by the build-up of pollutants.</li></ul>	<b>Develop Cleaning Program</b> <ul style="list-style-type: none"><li>Develop a cleaning program if it can be implemented without damage to building system.</li></ul>	Level 3

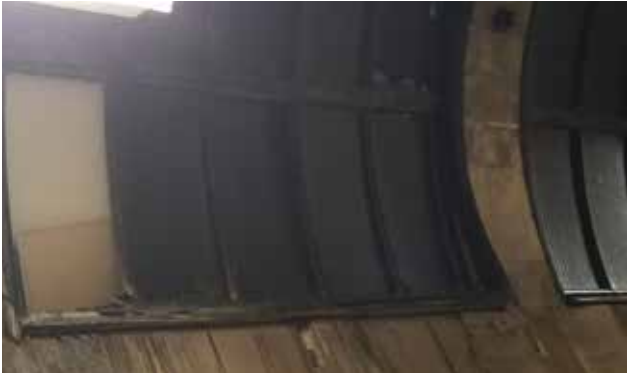
<b>C11-DS</b>  Cast Iron and Glass Skylight Ceiling System	<b>Displacement</b> <ul style="list-style-type: none"><li>Movement of a building material or element from its original location.</li></ul>	<b>Removal of Deteriorated Material</b> <ul style="list-style-type: none"><li>Investigate to determine cause of movement and then subsequent repair.</li></ul>	Level 3

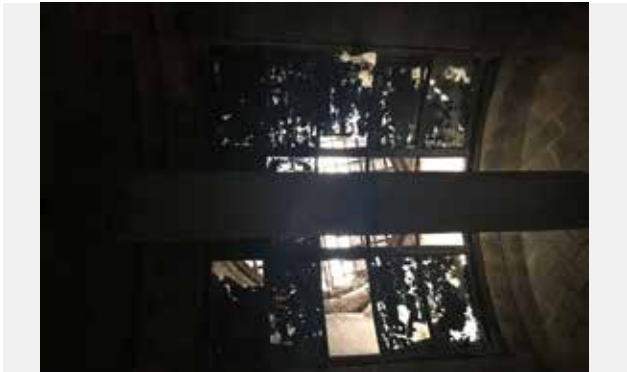
<b>C11-ST</b>  Cast Iron and Glass Skylight Ceiling System	<b>Staining</b> <ul style="list-style-type: none"><li>Surface problem caused by the build-up of pollutants, mineral deposits and water marks.</li></ul>	<b>Develop Cleaning Program</b> <ul style="list-style-type: none"><li>Develop a cleaning program if it can be implemented without damage to building system.</li></ul>	Level 3

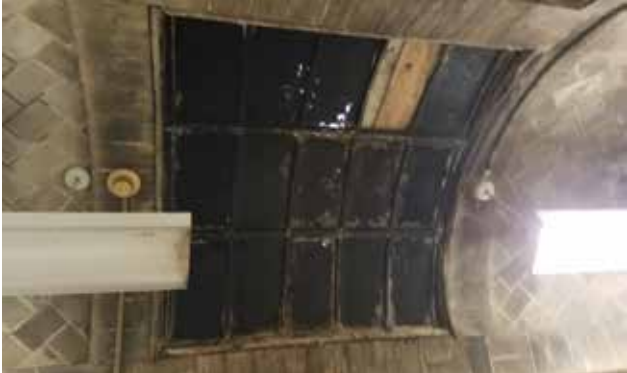
<b>C11-DGC</b>  Cast Iron and Glass Skylight Ceiling System	<b>Deteriorated Glazing Putty</b> <ul style="list-style-type: none"><li>Minimal amounts of glazing putty at glass remain.</li></ul>	<b>Material Repair or Replacement</b> <ul style="list-style-type: none"><li>Scrape remaining glazing putty away and replace with new glazing compound.</li></ul>	Level 3

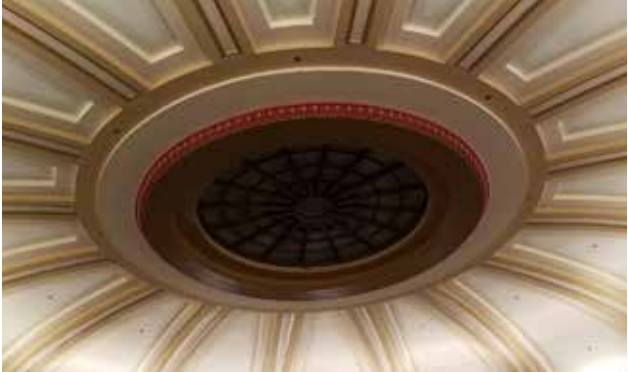
COMPONENT	CONDITION	TREATMENT	PRIORITY	REPRESENTATIVE PHOTO
<b>C12-SA</b>  Cast Iron and Glass Oculus Ceiling System	<b>Soiling</b> <ul style="list-style-type: none"><li>Surface staining caused by the build-up of pollutants.</li></ul>	<b>Develop Cleaning Program</b> <ul style="list-style-type: none"><li>Develop a cleaning program if it can be implemented without damage to building system.</li></ul>	Level 3

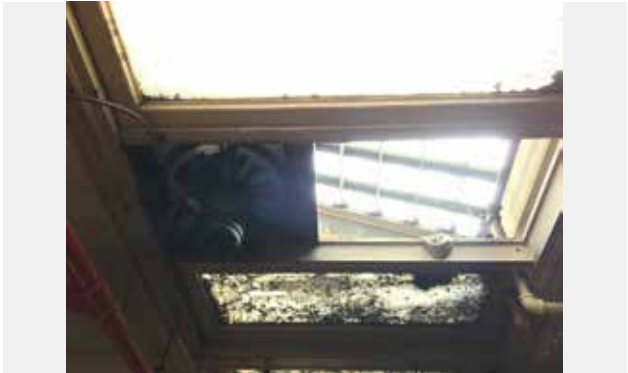
<b>C13-LM</b>  Wood and Glass Laylight Ceiling System	<b>Material Loss</b> <ul style="list-style-type: none"><li>Loss of material leaving holes or exposing inner layers.</li></ul>	<b>Material Patching or Replacement</b> <ul style="list-style-type: none"><li>Patch areas of missing material, if feasible, or replace material to match existing.</li></ul>	Level 3
