# Conditions Assessment

## Gould Memorial Library & Hall of Fame

FINAL REPORT | 15 MARCH 2018

**BRONX**  
**COMMUNITY**  
COLLEGE

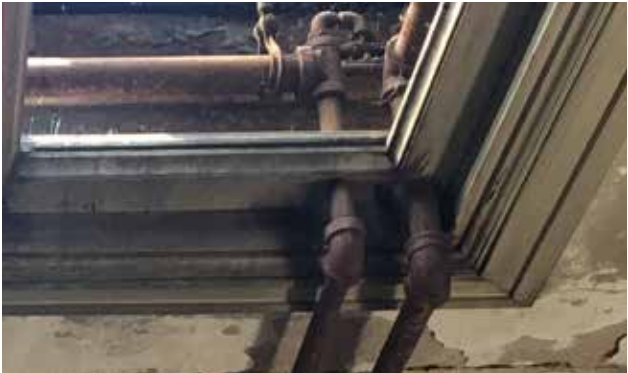
<b>C13-MD</b>  Wood and Glass Laylight Ceiling System	<b>Mechanical Damage</b> <ul style="list-style-type: none"><li>Damage to material caused by mechanical components or equipment</li></ul>	<b>Material Repair or Replacement</b> <ul style="list-style-type: none"><li>Remove mechanical remnants and connections. Patch areas of missing or damaged material, if feasible; remove and replace material, as required.</li></ul>	Level 3

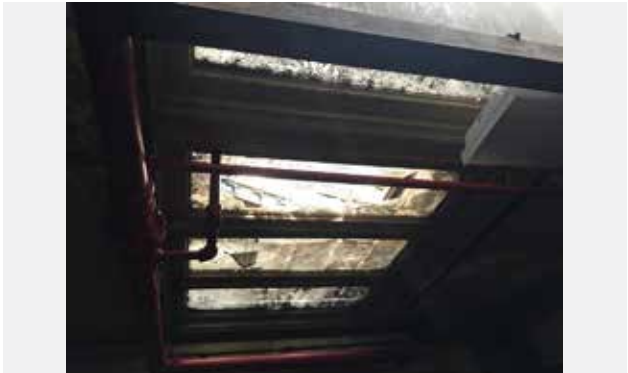
<b>C13-CR</b>  Wood and Glass Laylight Ceiling System	<b>Crack</b> <ul style="list-style-type: none"><li>1/16 to 1/2 inch wide visible fissure in a surface, possibly penetrating through the surface.</li></ul>	<b>Material Patching or Replacement</b> <ul style="list-style-type: none"><li>Remove and replace damaged material.</li></ul>	Level 3

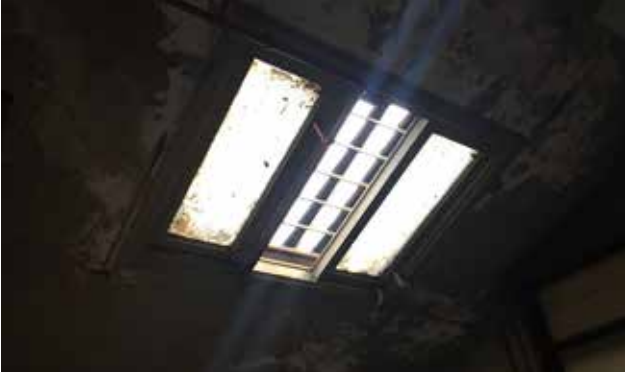
COMPONENT	CONDITION	TREATMENT	PRIORITY	REPRESENTATIVE PHOTO
<b>C13-SL</b>  Wood and Glass Laylight Ceiling System	<b>Splintering</b> <ul style="list-style-type: none"><li>Caused by the process of swelling from moisture and drying from heat, or mechanical damage.</li></ul>	<b>Removal of Deteriorated Material</b> <ul style="list-style-type: none"><li>Repair by sanding or wood putty.</li></ul>	Level 3

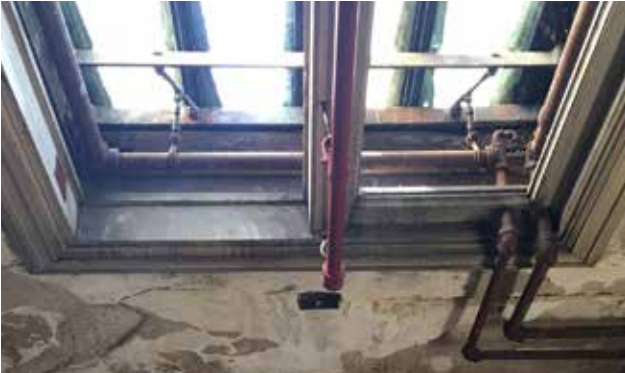
<b>C13-SW</b>  Wood and Glass Laylight Ceiling System	<b>Water Damage</b> <ul style="list-style-type: none"><li>Biological growth, blistering, efflorescence, wood rot or staining caused by the infiltration of water.</li></ul>	<b>Removal of Deteriorated Material</b> <ul style="list-style-type: none"><li>Identify source of water infiltration and remedy cause. Replace deteriorated and damaged material.</li></ul>	Level 3

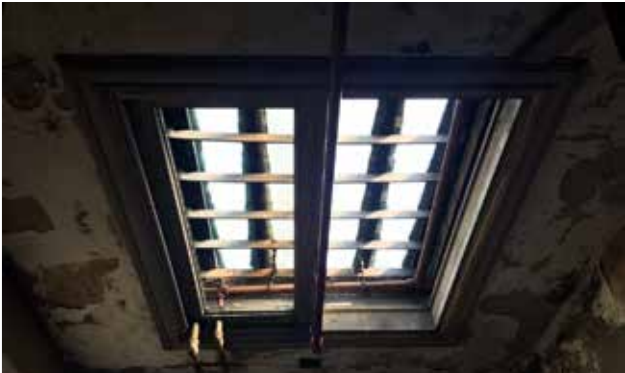
<b>C13-LC</b>  Wood and Glass Laylight Ceiling System	<b>Paint Loss</b> <ul style="list-style-type: none"><li>Loss of surface paint.</li></ul>	<b>Material Replacement</b> <ul style="list-style-type: none"><li>Determine reason for paint loss, correct problem and repaint.</li></ul>	Level 3

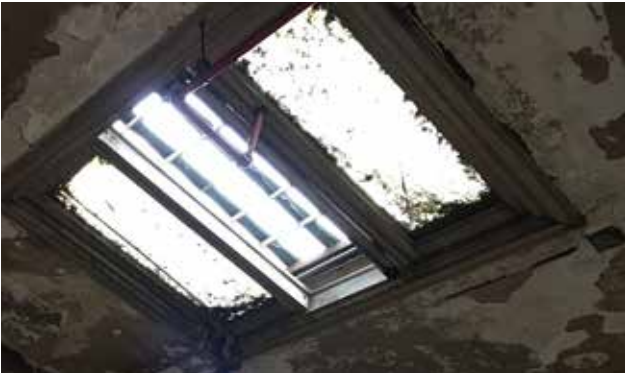
<b>C13-ST</b>  Wood and Glass Laylight Ceiling System	<b>Staining</b> <ul style="list-style-type: none"><li>Surface problem caused by the build-up of pollutants, mineral deposits and water marks.</li></ul>	<b>Develop Cleaning Program</b> <ul style="list-style-type: none"><li>Develop a cleaning program if it can be implemented without damage to building system.</li></ul>	Level 3

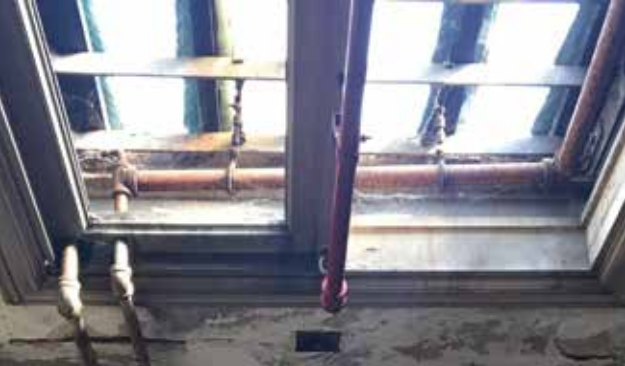
COMPONENT	CONDITION	TREATMENT	PRIORITY	REPRESENTATIVE PHOTO
<b>C13-SA</b>  Wood and Glass Laylight Ceiling System	<b>Soiling</b> <ul style="list-style-type: none"><li>• Surface staining caused by the build-up of pollutants.</li></ul>	<b>Develop Cleaning Program</b> <ul style="list-style-type: none"><li>• Develop a cleaning program if it can be implemented without damage to building system.</li></ul>	Level 3

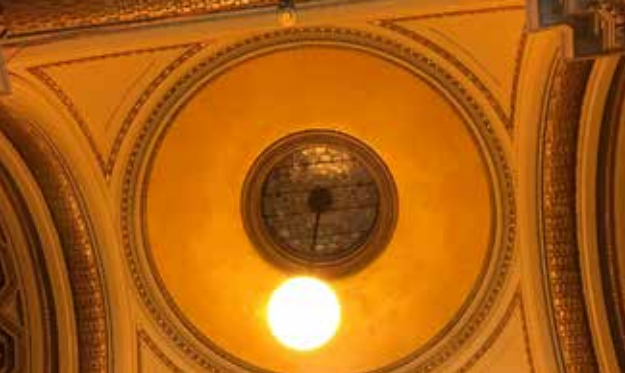
<b>C14-E</b>  Tiffany Stained Glass Oculus Ceiling System	<b>Extant</b> <ul style="list-style-type: none"><li>• An existing building system in good condition.</li></ul>	<b>Cyclical Maintenance</b> <ul style="list-style-type: none"><li>• Develop a cleaning program to extend life of building system.</li></ul>	Level 3

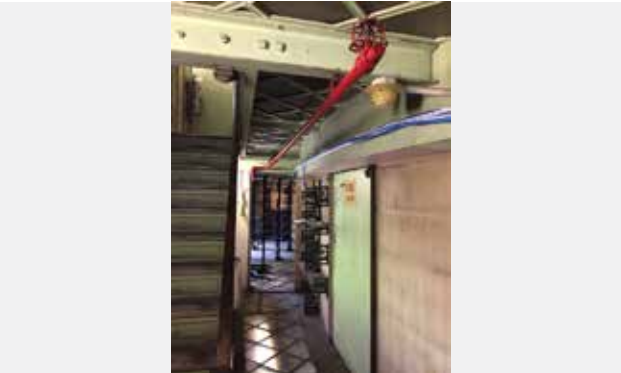
COMPONENT	CONDITION	TREATMENT	PRIORITY	REPRESENTATIVE PHOTO
<b>S1-W</b>  Cast Iron Stair System	<b>Wear</b> <ul style="list-style-type: none"><li>The gradual disintegration and erosion of materials caused by gradual use overtime.</li></ul>	<b>Material Patching or Replacement</b> <ul style="list-style-type: none"><li>Leave alone unless severe, then consider replacing.</li></ul>	Level 3	 
<b>S1-SA</b>  Cast Iron Stair System	<b>Soiling</b> <ul style="list-style-type: none"><li>Surface staining caused by the build-up of pollutants.</li></ul>	<b>Develop Cleaning Program</b> <ul style="list-style-type: none"><li>Develop a cleaning program if it can be implemented without damage to bulding system.</li></ul>	Level 3

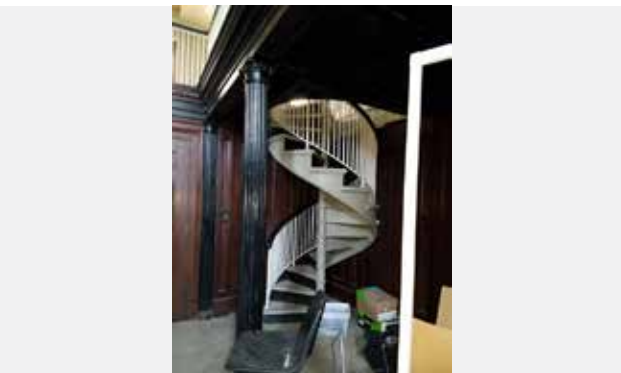
<b>S1-ST</b>  Cast Iron Stair System	<b>Staining</b> <ul style="list-style-type: none"><li>Surface problem caused by the build-up of pollutants, mineral deposits and water marks.</li></ul>	<b>Develop Cleaning Program</b> <ul style="list-style-type: none"><li>Develop a cleaning program if it can be implemented without damage to bulding system.</li></ul>	Level 3

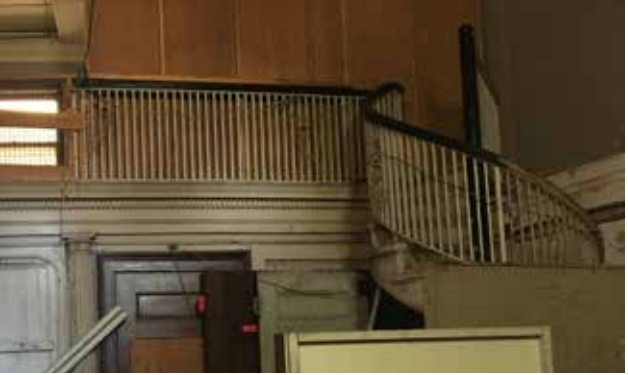
COMPONENT	CONDITION	TREATMENT	PRIORITY	REPRESENTATIVE PHOTO
<b>S1-MC</b>  Cast Iron Stair System	<b>Corrosion</b> <ul style="list-style-type: none"><li>Deterioration of material by a chemical reaction with its environment.</li></ul>	<b>Removal of Deteriorated Material</b> <ul style="list-style-type: none"><li>Remove corrosion and corrosive products; in severe cases, replace and/or reinforce deteriorated members with new material to match existing.</li></ul>	Level 3

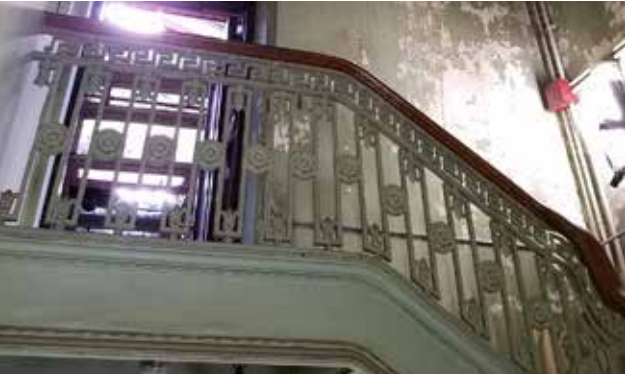
<b>S1-CR</b>  Cast Iron Stair System	<b>Cracking</b> <ul style="list-style-type: none"><li>1/16" to 1/2" wide visible fissures, possibly penetrating through the material surface</li></ul>	<b>Material Patching or Replacement</b> <ul style="list-style-type: none"><li>Remove and replace damaged material.</li></ul>	Level 3

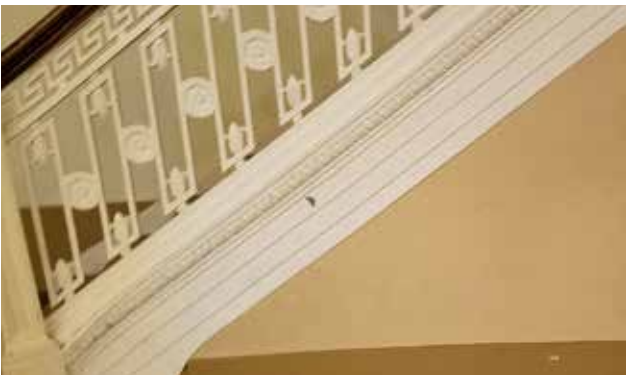
<b>S1-LM</b>  Cast Iron Stair System	<b>Material Loss</b> <ul style="list-style-type: none"><li>Loss of material leaving holes or exposing inner layers.</li></ul>	<b>Material Patching or Replacement</b> <ul style="list-style-type: none"><li>Patch areas of missing material, if feasible, or replace material to match existing.</li></ul>	Level 3

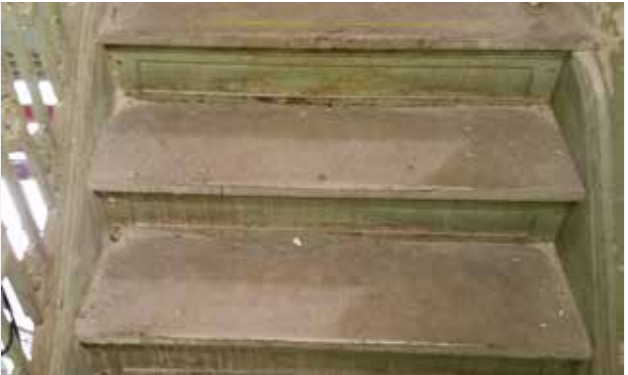
<b>S1-SD</b>  Cast Iron Stair System	<b>Scratches / Dents</b> <ul style="list-style-type: none"><li>Damage to material caused by mechanical components or equipment</li></ul>	<b>Material Repair or Replacement</b> <ul style="list-style-type: none"><li>Patch areas of missing or damaged material, if feasible; remove and replace material, as required.</li></ul>	Level 3

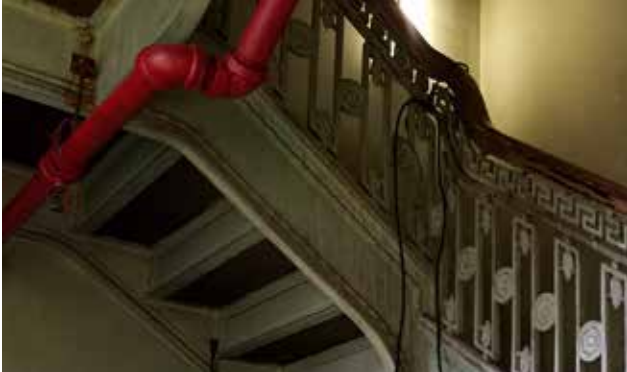
COMPONENT	CONDITION	TREATMENT	PRIORITY	REPRESENTATIVE PHOTO
<b>S1-MD</b>  Cast Iron Stair System	<b>Mechanical Damage</b> <ul style="list-style-type: none"><li>Damage to material caused by mechanical components or equipment</li></ul>	<b>Material Repair or Replacement</b> <ul style="list-style-type: none"><li>Remove mechanical remnants and connections. Patch areas of missing or damaged material, if feasible; remove and replace material, as required.</li></ul>	Level 3

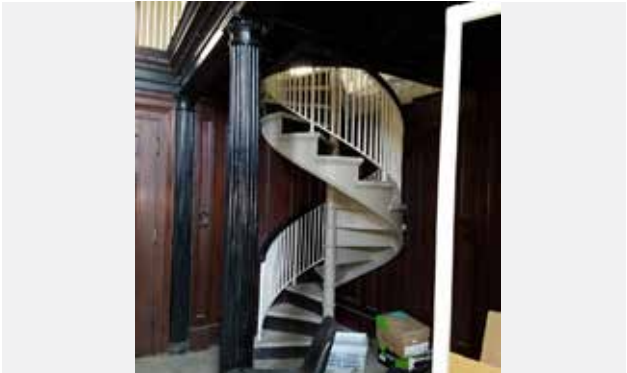
<b>S1-OP</b>  Cast Iron Stair System	<b>Overpainted</b> <ul style="list-style-type: none"><li>Multiple layers of paint.</li></ul>	<b>Material Patching or Replacement</b> <ul style="list-style-type: none"><li>Leave alone unless other forms of deterioration are present, then scrape to substrate and repaint.</li></ul>	Level 3

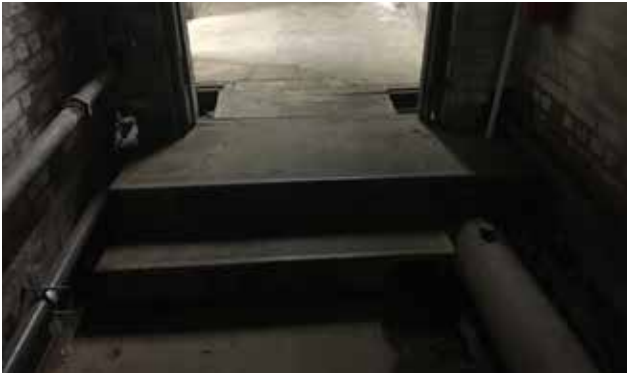
<b>S2-LC</b>  Steel Stair and Railing Stair System	<b>Paint Loss</b> <ul style="list-style-type: none"><li>Loss of surface paint.</li></ul>	<b>Material Replacement</b> <ul style="list-style-type: none"><li>Determine reason for paint loss, correct problem and repaint.</li></ul>	Level 3

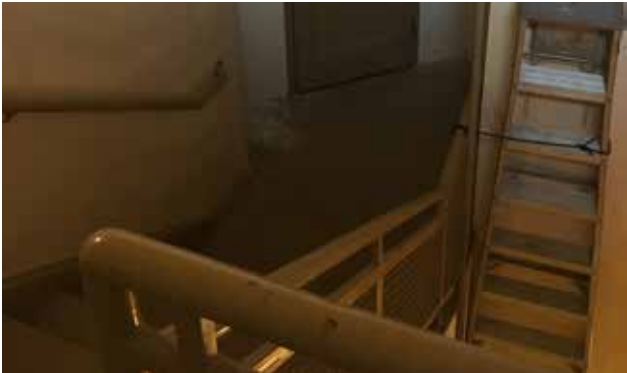
<b>S2-SA</b>  Steel Stair and Railing Stair System	<b>Soiling</b> <ul style="list-style-type: none"><li>Surface staining caused by the build-up of pollutants.</li></ul>	<b>Develop Cleaning Program</b> <ul style="list-style-type: none"><li>Develop a cleaning program if it can be implemented without damage to building system.</li></ul>	Level 3

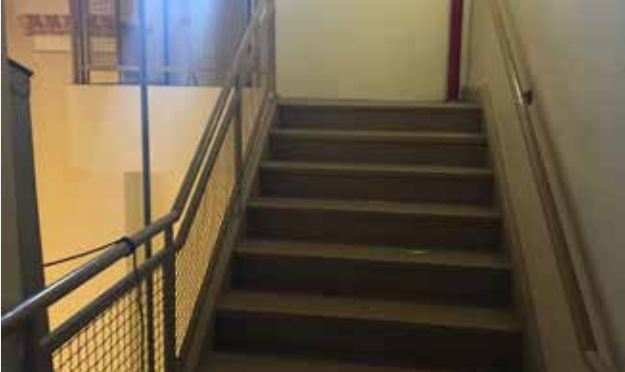
COMPONENT	CONDITION	TREATMENT	PRIORITY	REPRESENTATIVE PHOTO
<b>S2-W</b>  Steel Stair and Railing Stair System	<b>Wear</b> <ul style="list-style-type: none"><li>The gradual disintegration and erosion of materials caused by gradual use overtime.</li></ul>	<b>Material Patching or Replacement</b> <ul style="list-style-type: none"><li>Leave alone unless severe, then consider replacing.</li></ul>	Level 3

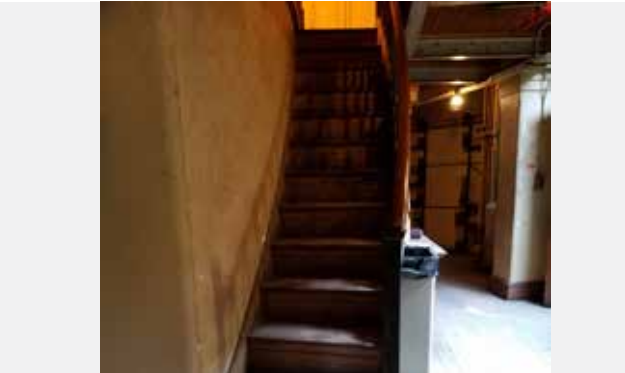
<b>S3-LC</b>  Wood Treads Stair System	<b>Paint Loss</b> <ul style="list-style-type: none"><li>Loss of surface paint.</li></ul>	<b>Material Replacement</b> <ul style="list-style-type: none"><li>Determine reason for paint loss, correct problem and repaint.</li></ul>	Level 3

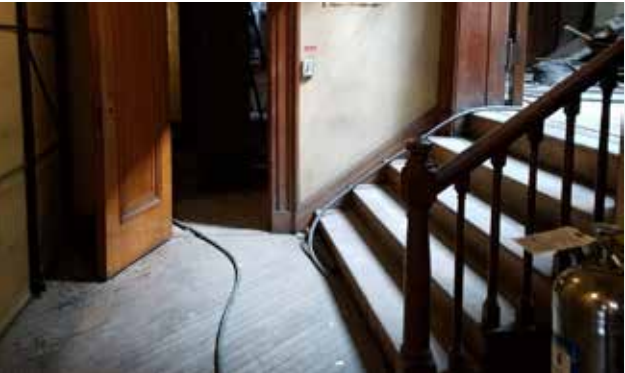
<b>S3-G</b>  Wood Treads Stair System	<b>Graffiti</b> <ul style="list-style-type: none"><li>Paint sprayed on surface.</li></ul>	<b>Develop Cleaning Program</b> <ul style="list-style-type: none"><li>Investigate proper removal methods where appropriate without damaging material.</li></ul>	Level 3

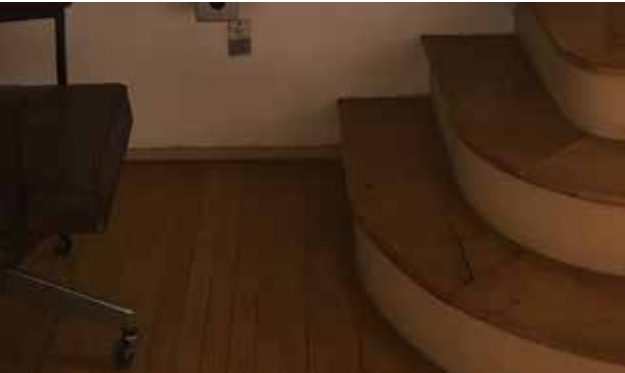
<b>S3-OJ</b>  Wood Treads Stair System	<b>Open Joints</b> <ul style="list-style-type: none"><li>Open separating joints between wood elements</li></ul>	<b>Material Patching or Replacement</b> <ul style="list-style-type: none"><li>Determine reason for missing caulk and rejoin; if severe, replace affected areas of wood floor finish.</li></ul>	Level 3

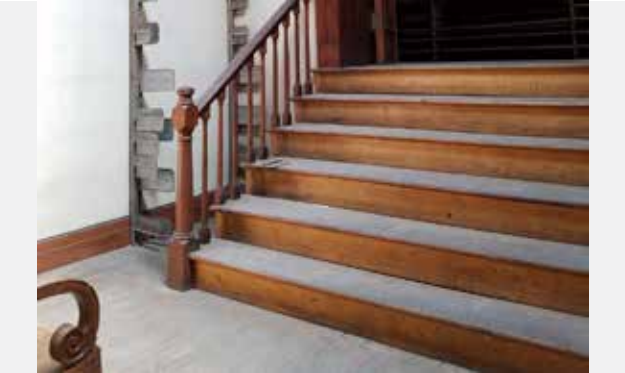
COMPONENT	CONDITION	TREATMENT	PRIORITY	REPRESENTATIVE PHOTO
<b>S3-ST</b>  Wood Treads Stair System	<b>Staining</b> <ul style="list-style-type: none"><li>Surface problem caused by the build-up of pollutants, mineral deposits and water marks.</li></ul>	<b>Develop Cleaning Program</b> <ul style="list-style-type: none"><li>Develop a cleaning program if it can be implemented without damage to bulding system.</li></ul>	Level 3

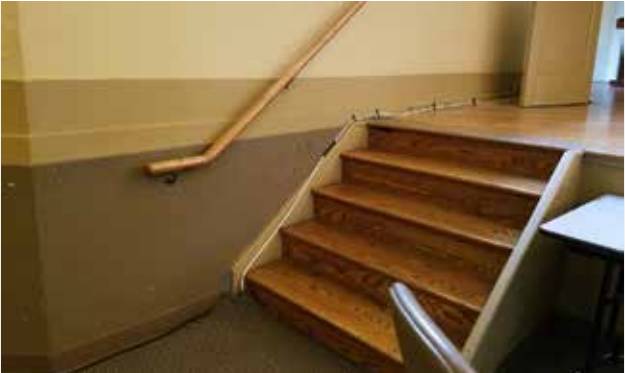
<b>S3-LM</b>  Wood Treads Stair System	<b>Material Loss</b> <ul style="list-style-type: none"><li>Loss of material leaving holes or exposing inner layers.</li></ul>	<b>Material Patching or Replacement</b> <ul style="list-style-type: none"><li>Patch areas of missing material, if feasible, or replace material to match existing.</li></ul>	Level 3

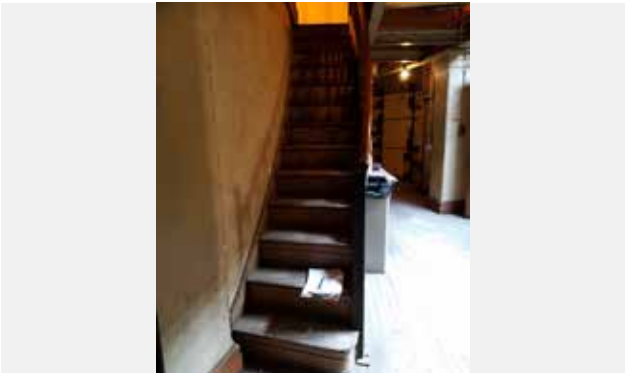
<b>S3-PR</b>  Wood Treads Stair System	<b>Previous Repair</b> <ul style="list-style-type: none"><li>Area where a previous repair was done, including repointing, patching and consolidation.</li></ul>	<b>Material Replacement</b> <ul style="list-style-type: none"><li>Replace inappropriate previous patches.</li></ul>	Level 3

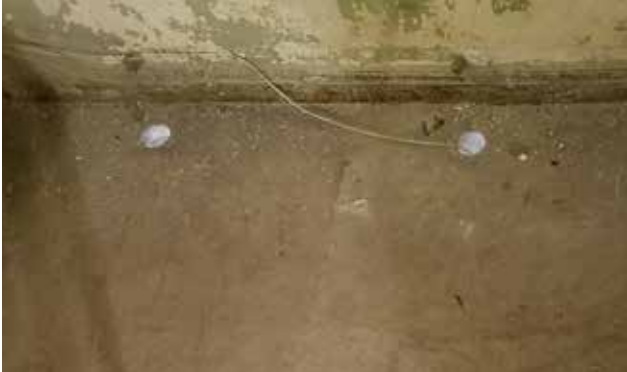
COMPONENT	CONDITION	TREATMENT	PRIORITY	REPRESENTATIVE PHOTO
<b>S4-LM</b>  Marble Treads Stair System	<b>Material Loss</b> <ul style="list-style-type: none"><li>Loss of material leaving holes or exposing inner layers.</li></ul>	<b>Material Patching or Replacement</b> <ul style="list-style-type: none"><li>Patch areas of missing material, if feasible, or replace material to match existing.</li></ul>	Level 3

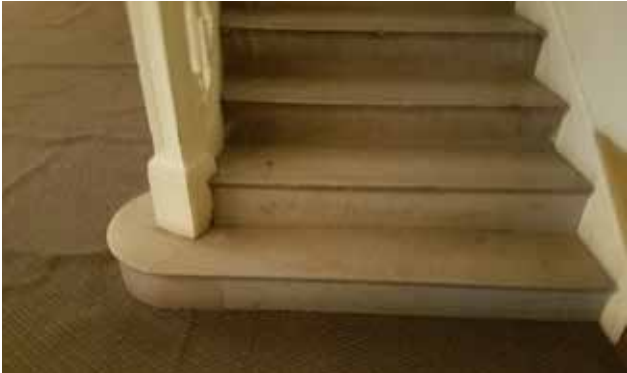
<b>S4-SD</b>  Marble Treads Stair System	<b>Scratches / Dents</b> <ul style="list-style-type: none"><li>Damage to material caused by mechanical components or equipment</li></ul>	<b>Material Repair or Replacement</b> <ul style="list-style-type: none"><li>Patch areas of missing or damaged material, if feasible; remove and replace material, as required.</li></ul>	Level 3

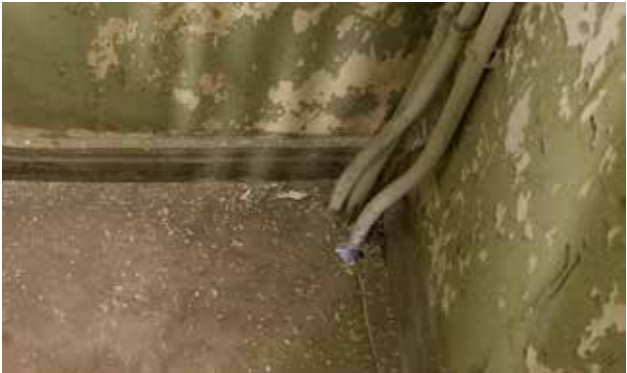
<b>S4-MD</b>  Marble Treads Stair System	<b>Mechanical Damage</b> <ul style="list-style-type: none"><li>Damage to material caused by mechanical components or equipment</li></ul>	<b>Material Repair or Replacement</b> <ul style="list-style-type: none"><li>Remove mechanical remnants and connections. Patch areas of missing or damaged material, if feasible; remove and replace material, as required.</li></ul>	Level 3

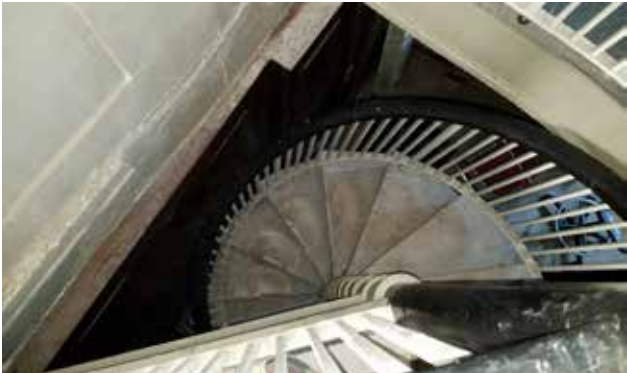
<b>S4-ST</b>  Marble Treads Stair System	<b>Staining</b> <ul style="list-style-type: none"><li>Surface problem caused by the build-up of pollutants, mineral deposits and water marks.</li></ul>	<b>Develop Cleaning Program</b> <ul style="list-style-type: none"><li>Develop a cleaning program if it can be implemented without damage to building system.</li></ul>	Level 3

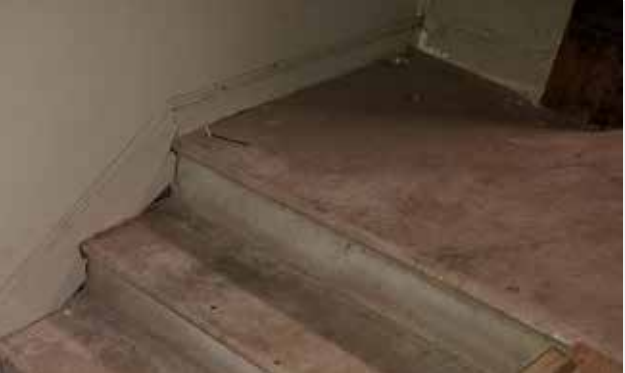
COMPONENT	CONDITION	TREATMENT	PRIORITY	REPRESENTATIVE PHOTO
<b>S4-CR</b>  Marble Treads Stair System	<b>Cracking</b> <ul style="list-style-type: none"><li>1/16" to 1/2" wide visible fissures in surface, possibly penetrating through the material surface</li></ul>	<b>Material Patching or Replacement</b> <ul style="list-style-type: none"><li>Patch damaged material, if feasible; remove and replace damaged material, as required.</li></ul>	Level 3

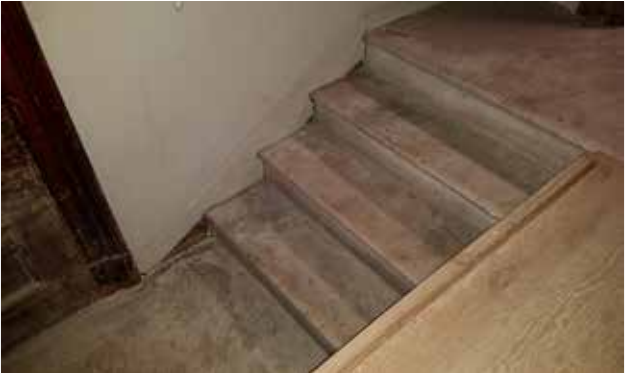
<b>S4-SA</b>  Marble Treads Stair System	<b>Soiling</b> <ul style="list-style-type: none"><li>Surface staining caused by the build-up of pollutants.</li></ul>	<b>Develop Cleaning Program</b> <ul style="list-style-type: none"><li>Develop a cleaning program if it can be implemented without damage to building system.</li></ul>	Level 3

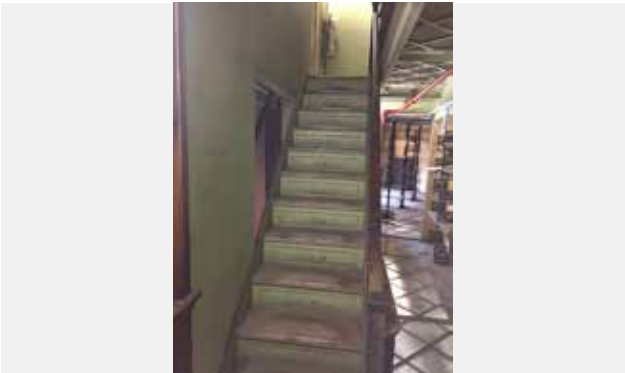
<b>S4-W</b>  Marble Treads Stair System	<b>Wear</b> <ul style="list-style-type: none"><li>The gradual disintegration and erosion of materials caused by gradual use overtime.</li></ul>	<b>Material Patching or Replacement</b> <ul style="list-style-type: none"><li>Leave alone unless severe, then consider replacing.</li></ul>	Level 3

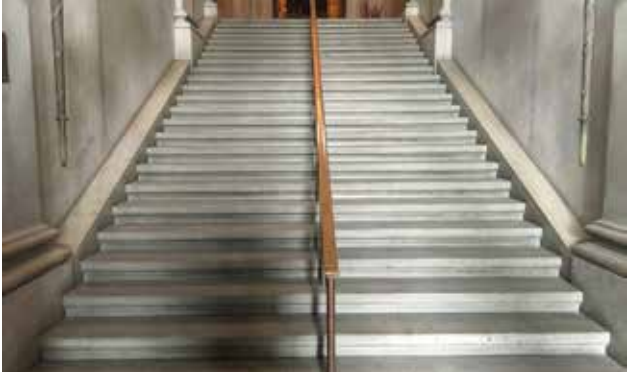
COMPONENT	CONDITION	TREATMENT	PRIORITY	REPRESENTATIVE PHOTO
<b>S5-LM</b>  Concrete Coated Treads Stair System	<b>Material Loss</b> <ul style="list-style-type: none"><li>Loss of material leaving holes or exposing inner layers.</li></ul>	<b>Material Patching or Replacement</b> <ul style="list-style-type: none"><li>Patch areas of missing material, if feasible, or replace material to match existing.</li></ul>	Level 3

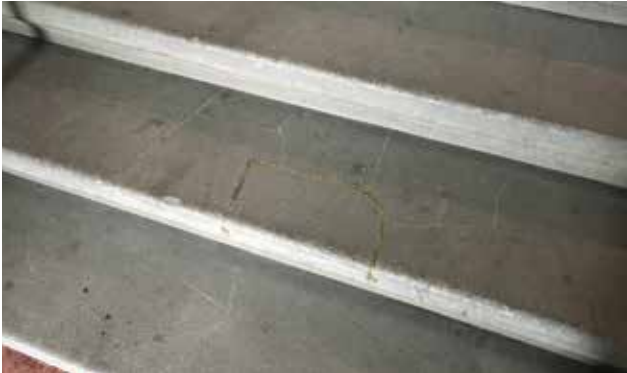
<b>S5-PR</b>  Concrete Coated Treads Stair System	<b>Previous Repair</b> <ul style="list-style-type: none"><li>Area where a previous repair was done, including repointing, patching and consolidation.</li></ul>	<b>Material Patching or Replacement</b> <ul style="list-style-type: none"><li>Replace inappropriate previous patches.</li></ul>	Level 3

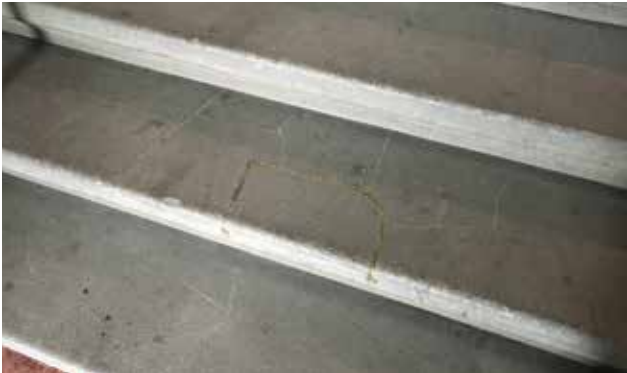
<b>S5-CR</b>  Concrete Coated Treads Stair System	<b>Cracking</b> <ul style="list-style-type: none"><li>1/16" to 1/2" wide visible fissures in surface, possibly penetrating through the material surface</li></ul>	<b>Material Patching or Replacement</b> <ul style="list-style-type: none"><li>Patch damaged material, if feasible; remove and replace damaged material, as required.</li></ul>	Level 3

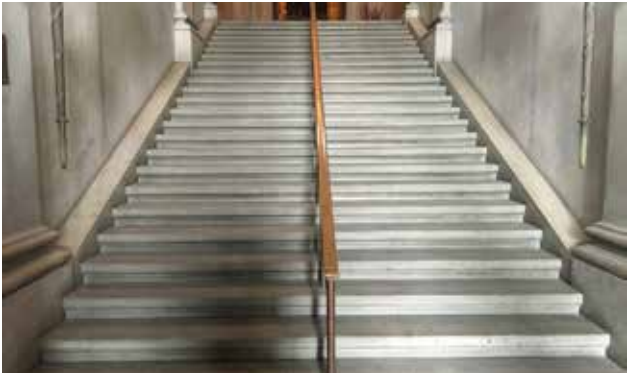
<b>S5-ST</b>  Concrete Coated Treads Stair System	<b>Staining</b> <ul style="list-style-type: none"><li>Surface problem caused by the build-up of pollutants, mineral deposits and water marks.</li></ul>	<b>Develop Cleaning Program</b> <ul style="list-style-type: none"><li>Develop a cleaning program if it can be implemented without damage to bulding system.</li></ul>	Level 3

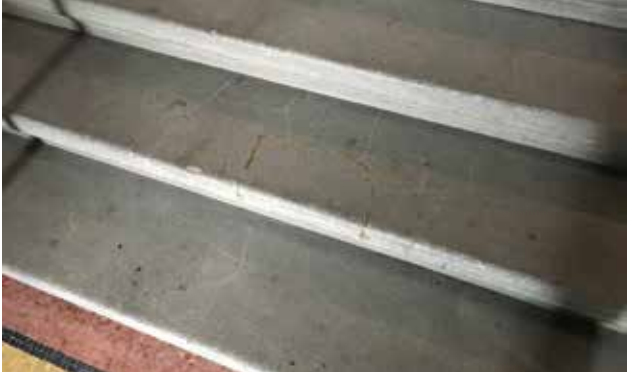
COMPONENT	CONDITION	TREATMENT	PRIORITY	REPRESENTATIVE PHOTO
<b>S5-W</b>  Concrete Coated Treads Stair System	<b>Wear</b> <ul style="list-style-type: none"><li>The gradual disintegration and erosion of materials caused by gradual use overtime.</li></ul>	<b>Material Patching or Replacement</b> <ul style="list-style-type: none"><li>Leave alone unless severe, then consider replacing.</li></ul>	Level 3

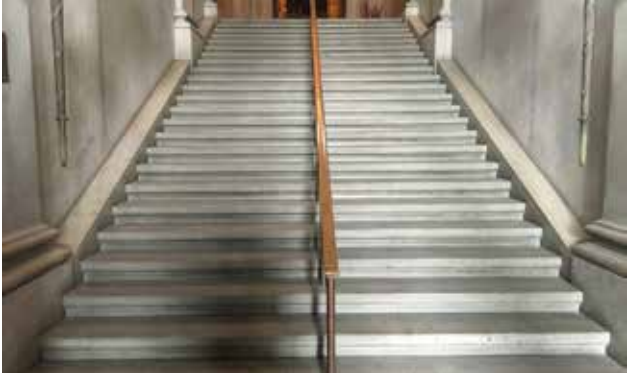
<b>S5-SA</b>  Concrete Coated Treads Stair System	<b>Soiling</b> <ul style="list-style-type: none"><li>Surface staining caused by the build-up of pollutants.</li></ul>	<b>Develop Cleaning Program</b> <ul style="list-style-type: none"><li>Develop a cleaning program if it can be implemented without damage to bulding system.</li></ul>	Level 3

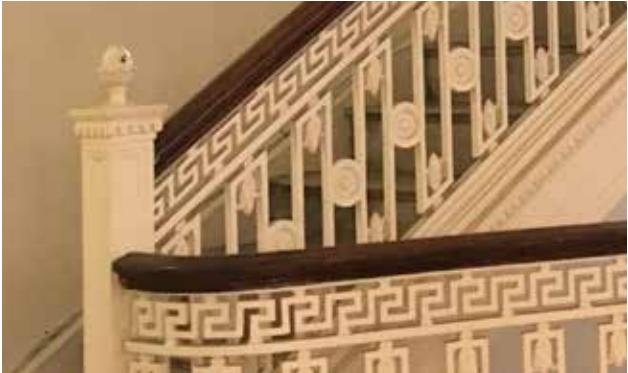
<b>S6-LC</b>  Iron Railing with Wood Handrail Stair System	<b>Paint Loss</b> <ul style="list-style-type: none"><li>Loss of surface paint.</li></ul>	<b>Material Replacement</b> <ul style="list-style-type: none"><li>Determine reason for paint loss, correct problem and repaint.</li></ul>	Level 3

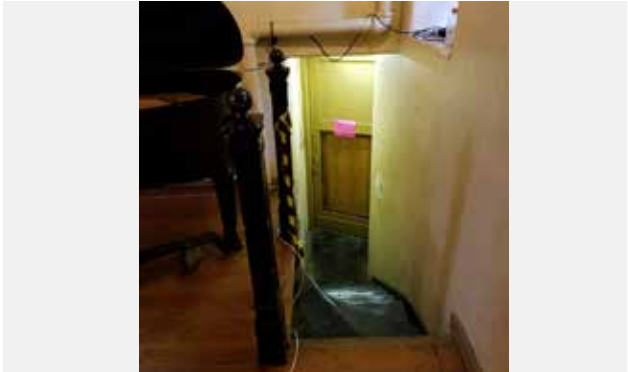
<b>S6-NE</b>  Iron Railing with Wood Handrail Stair System	<b>Non-Extant</b> <ul style="list-style-type: none"><li>Describes the absence of a particular building system or component of building system.</li></ul>	<b>Material Replacement</b> <ul style="list-style-type: none"><li>Replace missing building element.</li></ul>	Level 3

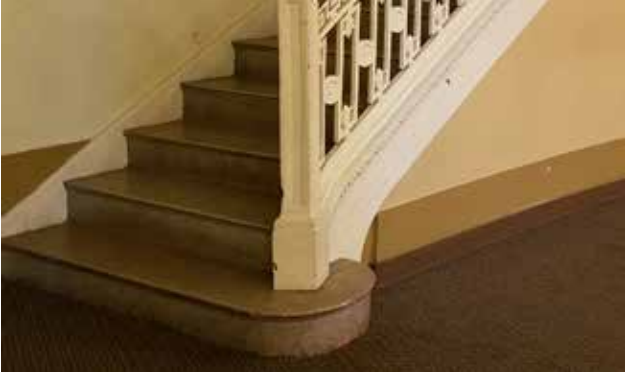
COMPONENT	CONDITION	TREATMENT	PRIORITY	REPRESENTATIVE PHOTO
<b>S6-MD</b>  Iron Railing with Wood Handrail Stair System	<b>Mechanical Damage</b> <ul style="list-style-type: none"><li>Damage to material caused by mechanical components or equipment</li></ul>	<b>Material Repair or Replacement</b> <ul style="list-style-type: none"><li>Remove mechanical remnants and connections. Patch areas of missing or damaged material, if feasible; remove and replace material, as required.</li></ul>	Level 3

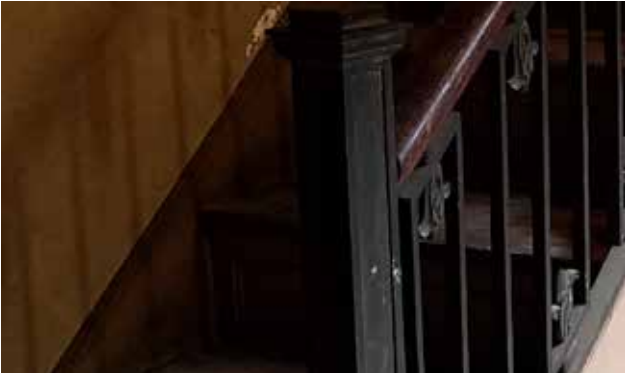
<b>S6-SD</b>  Iron Railing with Wood Handrail Stair System	<b>Scratches / Dents</b> <ul style="list-style-type: none"><li>Damage to material caused by mechanical components or equipment</li></ul>	<b>Material Repair or Replacement</b> <ul style="list-style-type: none"><li>Patch areas of missing or damaged material, if feasible; remove and replace material, as required.</li></ul>	Level 3

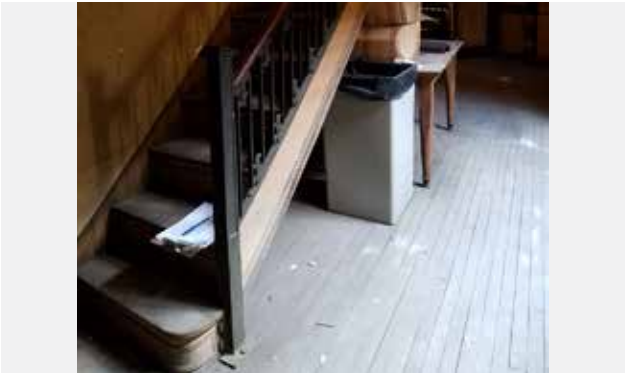
<b>S6-OP</b>  Iron Railing with Wood Handrail Stair System	<b>Overpainted</b> <ul style="list-style-type: none"><li>Multiple layers of paint.</li></ul>	<b>Material Patching or Replacement</b> <ul style="list-style-type: none"><li>Leave alone unless other forms of deterioration are present, then scrape to substrate and repaint.</li></ul>	Level 3

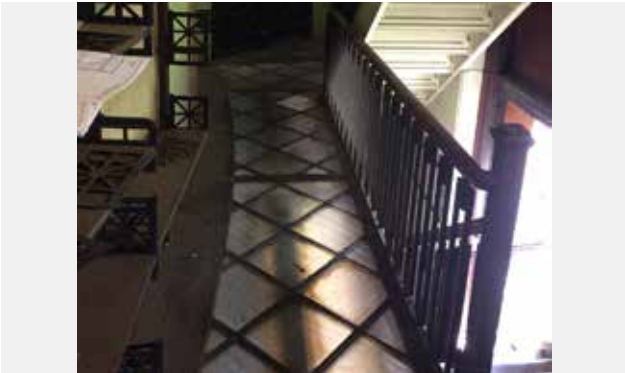
<b>S6-CR</b>  Iron Railing with Wood Handrail Stair System	<b>Cracking</b> <ul style="list-style-type: none"><li>1/16" to 1/2" wide visible fissures in surface, possibly penetrating through the material surface</li></ul>	<b>Material Patching or Replacement</b> <ul style="list-style-type: none"><li>Patch material, if feasible; remove and replace damaged material as required.</li></ul>	Level 3

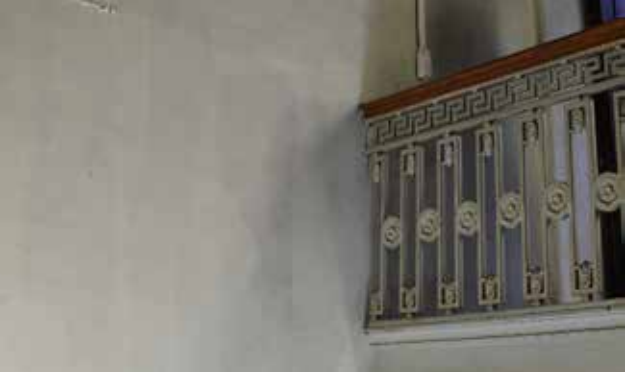
COMPONENT	CONDITION	TREATMENT	PRIORITY	REPRESENTATIVE PHOTO
<b>S6-ST</b>  Iron Railing with Wood Handrail Stair System	<b>Staining</b> <ul style="list-style-type: none"><li>Surface problem caused by the build-up of pollutants, mineral deposits and water marks.</li></ul>	<b>Develop Cleaning Program</b> <ul style="list-style-type: none"><li>Develop a cleaning program if it can be implemented without damage to bulding system.</li></ul>	Level 3

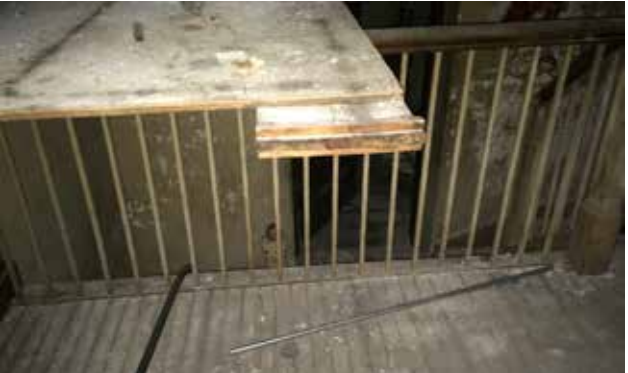
<b>S6-SA</b>  Iron Railing with Wood Handrail Stair System	<b>Soiling</b> <ul style="list-style-type: none"><li>Surface staining caused by the build-up of pollutants.</li></ul>	<b>Develop Cleaning Program</b> <ul style="list-style-type: none"><li>Develop a cleaning program if it can be implemented without damage to bulding system.</li></ul>	Level 3

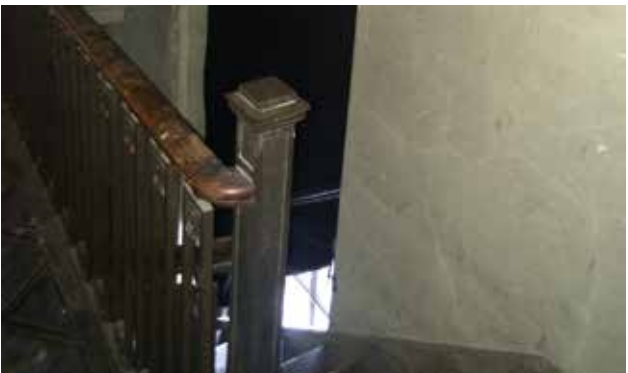
<b>S6-W</b>  Iron Railing with Wood Handrail Stair System	<b>Wear</b> <ul style="list-style-type: none"><li>The gradual disintegration and erosion of materials caused by gradual use overtime.</li></ul>	<b>Material Patching or Replacement</b> <ul style="list-style-type: none"><li>Leave alone unless severe, then consider replacing.</li></ul>	Level 3

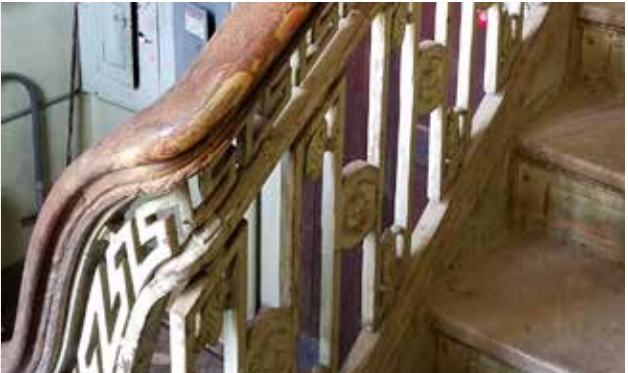
<b>S6-LM</b>  Iron Railing with Wood Handrail Stair System	<b>Material Loss</b> <ul style="list-style-type: none"><li>Loss of material leaving holes or exposing inner layers.</li></ul>	<b>Material Patching or Replacement</b> <ul style="list-style-type: none"><li>Patch areas of missing material, if feasible, or replace material to match existing.</li></ul>	Level 3

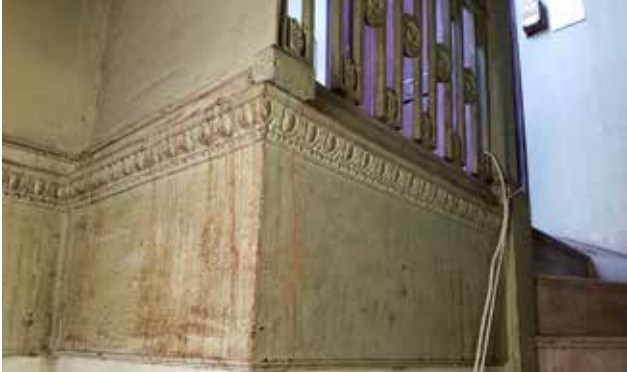
COMPONENT	CONDITION	TREATMENT	PRIORITY	REPRESENTATIVE PHOTO
<b>S6-MC</b>  Iron Railing with Wood Handrail Stair System	<b>Corrosion</b> <ul style="list-style-type: none"><li>Deterioration of material by a chemical reaction with its environment.</li></ul>	<b>Removal of Deteriorated Material</b> <ul style="list-style-type: none"><li>Remove corrosion and corrosive products; in severe cases, replace deteriorated members with new material to match existing.</li><li>Refer to assesment of structural engineer for details on replacement of select cast iron members.</li></ul>	Level 3

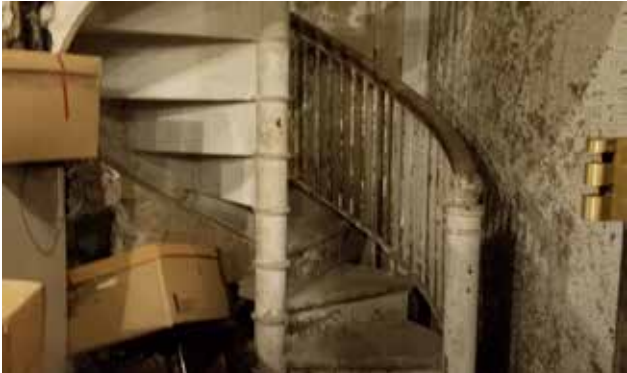
<b>S6-OJ</b>  Iron Railing with Wood Handrail Stair System	<b>Open Joints</b> <ul style="list-style-type: none"><li>Joints without caulking</li></ul>	<b>Material Patching or Replacement</b> <ul style="list-style-type: none"><li>Determine reason for missing caulk and reseal edges.</li></ul>	Level 3

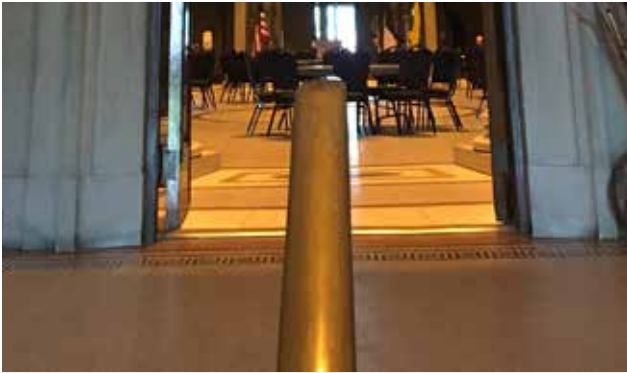
<b>S7-W</b>  Brass Railing Stair System	<b>Wear</b> <ul style="list-style-type: none"><li>The gradual disintegration and erosion of materials caused by gradual use overtime.</li></ul>	<b>Material Patching or Replacement</b> <ul style="list-style-type: none"><li>Leave alone unless severe, then consider replacing.</li></ul>	Level 3

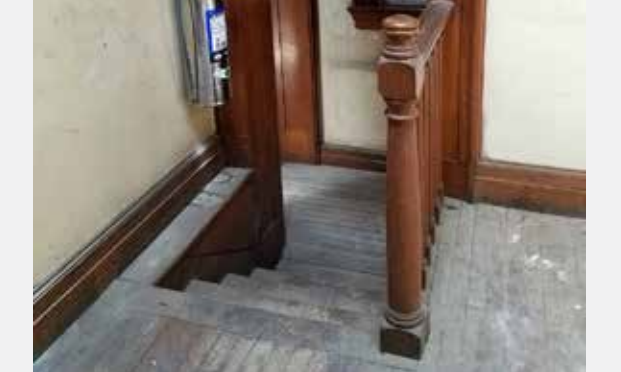
COMPONENT	CONDITION	TREATMENT	PRIORITY	REPRESENTATIVE PHOTO
<b>S8-W</b>  Wood Stair with Wood Handrail Stair System	<b>Wear</b> <ul style="list-style-type: none"><li>The gradual disintegration and erosion of materials caused by gradual use overtime.</li></ul>	<b>Material Patching or Replacement</b> <ul style="list-style-type: none"><li>Leave alone unless severe, then consider replacing.</li></ul>	Level 3

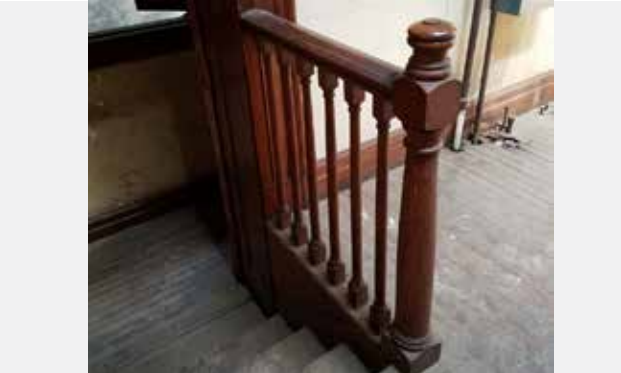
<b>S8-SD</b>  Wood Stair with Wood Handrail Stair System	<b>Scratches / Dents</b> <ul style="list-style-type: none"><li>Damage to material caused by mechanical components or equipment</li></ul>	<b>Material Repair or Replacement</b> <ul style="list-style-type: none"><li>Patch areas of missing or damaged material, if feasible; remove and replace material, as required.</li></ul>	Level 3

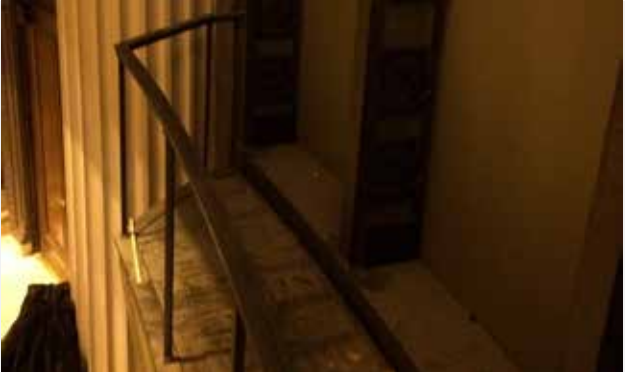
COMPONENT	CONDITION	TREATMENT	PRIORITY	REPRESENTATIVE PHOTO
<b>R1-W</b>  Balcony Railing at Mezzanine, Balcony and Auditorium Railing System	<b>Wear</b> <ul style="list-style-type: none"><li>The gradual disintegration and erosion of materials caused by gradual use overtime.</li></ul>	<b>Material Patching or Replacement</b> <ul style="list-style-type: none"><li>Leave alone unless severe, then consider replacing.</li></ul>	Level 3

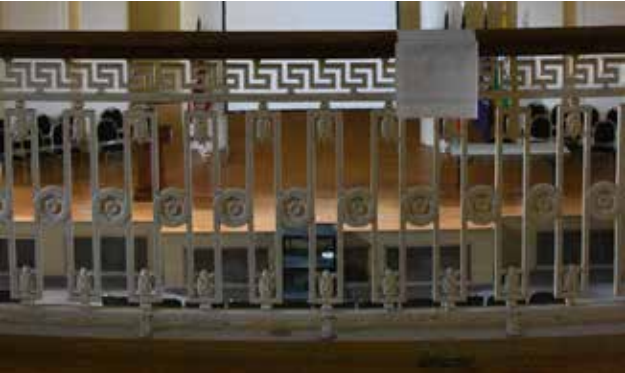
<b>R1-ST</b>  Balcony Railing at Mezzanine, Balcony and Auditorium Railing System	<b>Staining</b> <ul style="list-style-type: none"><li>Surface problem caused by the build-up of pollutants, mineral deposits and water marks.</li></ul>	<b>Develop Cleaning Program</b> <ul style="list-style-type: none"><li>Develop a cleaning program if it can be implemented without damage to bulding system.</li></ul>	Level 3

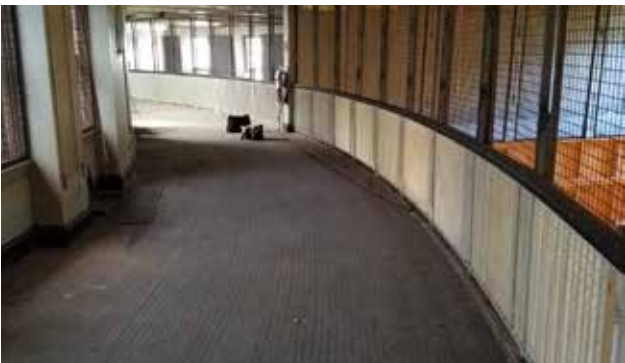
<b>R1-MD</b>  Balcony Railing at Mezzanine, Balcony and Auditorium Railing System	<b>Mechanical Damage</b> <ul style="list-style-type: none"><li>Damage to material caused by mechanical components or equipment</li></ul>	<b>Material Repair or Replacement</b> <ul style="list-style-type: none"><li>Remove mechanical remnants and connections. Patch areas of missing or damaged material, if feasible; remove and replace material, as required.</li></ul>	Level 3

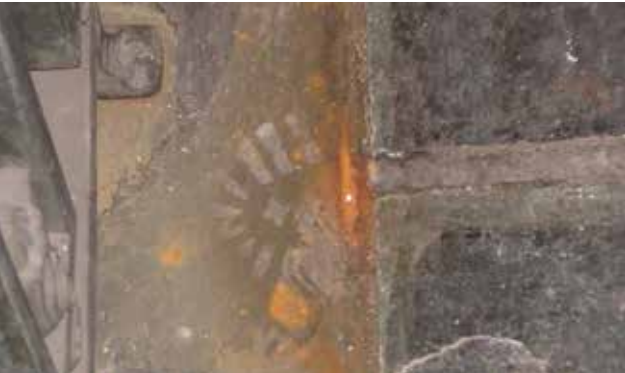
<b>R1-MC</b>  Balcony Railing at Mezzanine, Balcony and Auditorium Railing System	<b>Corrosion</b> <ul style="list-style-type: none"><li>Deterioration of material by a chemical reaction with its environment.</li></ul>	<b>Removal of Deteriorated Material</b> <ul style="list-style-type: none"><li>Remove corrosion and corrosive products; in severe cases, replace deteriorated members with new material to match existing.</li><li>Refer to assesment of structural engineer for details on replacement of select cast iron members.</li></ul>	Level 3

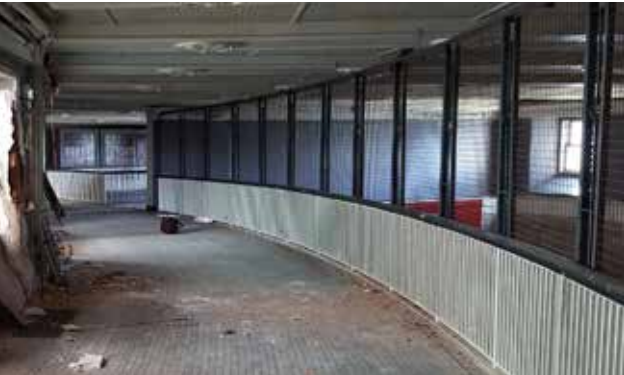
COMPONENT	CONDITION	TREATMENT	PRIORITY	REPRESENTATIVE PHOTO
<b>R1-SA</b>  Balcony Railing at Mezzanine, Balcony and Auditorium Railing System	<b>Soiling</b> <ul style="list-style-type: none"><li>Surface staining caused by the build-up of pollutants.</li></ul>	<b>Develop Cleaning Program</b> <ul style="list-style-type: none"><li>Develop a cleaning program if it can be implemented without damage to building system.</li></ul>	Level 3

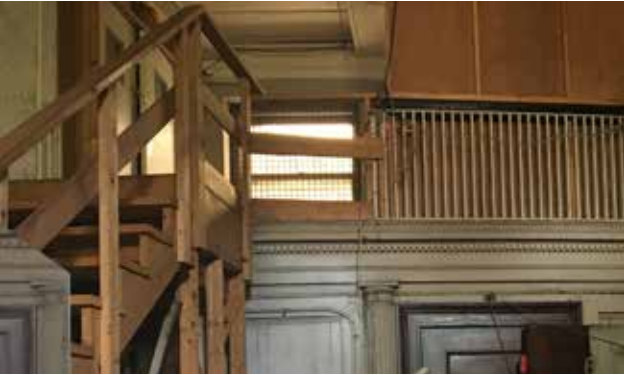
<b>R1-LM</b>  Balcony Railing at Mezzanine, Balcony and Auditorium Railing System	<b>Material Loss</b> <ul style="list-style-type: none"><li>Loss of material leaving holes or exposing inner layers.</li></ul>	<b>Material Patching or Replacement</b> <ul style="list-style-type: none"><li>Patch areas of missing material, if feasible, or replace material to match existing.</li></ul>	Level 3

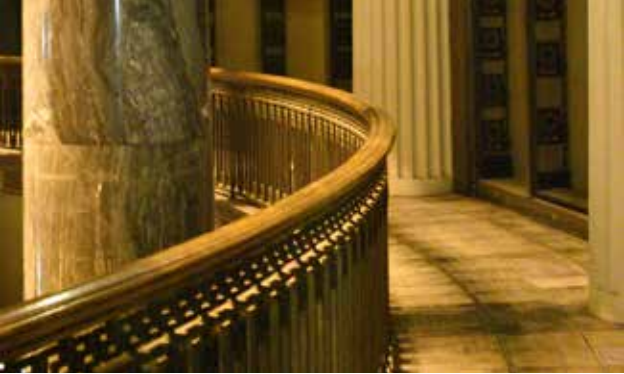
<b>R1-CR</b>  Balcony Railing at Mezzanine, Balcony and Auditorium Railing System	<b>Cracking</b> <ul style="list-style-type: none"><li>1/16" to 1/2" wide visible fissures in surface, possibly penetrating through the material surface</li></ul>	<b>Material Patching or Replacement</b> <ul style="list-style-type: none"><li>Patch material, if feasible; remove and replace damaged material as required.</li></ul>	Level 3

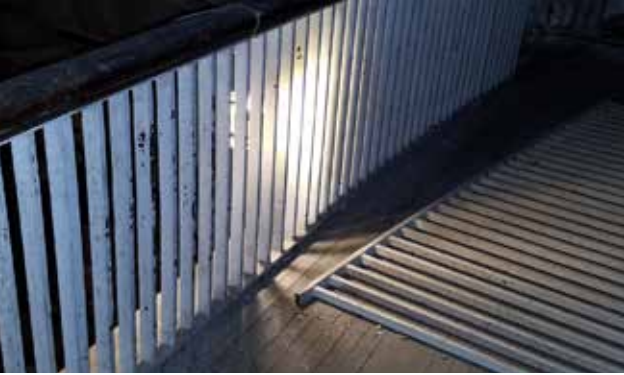
<b>R1-LC</b>  Balcony Railing at Mezzanine, Balcony and Auditorium Railing System	<b>Paint Loss</b> <ul style="list-style-type: none"><li>Loss of surface paint.</li></ul>	<b>Material Patching or Replacement</b> <ul style="list-style-type: none"><li>Determine reason for paint loss, correct problem and repaint.</li></ul>	Level 3

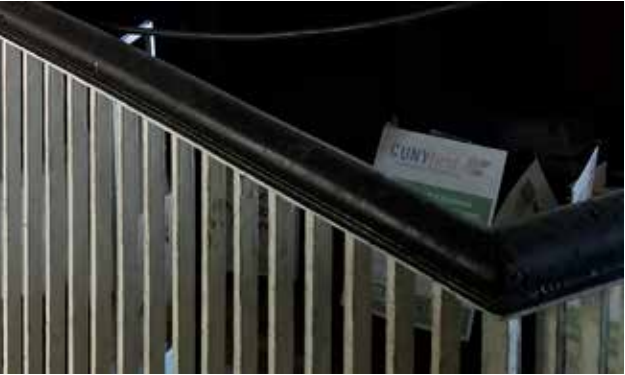
COMPONENT	CONDITION	TREATMENT	PRIORITY	REPRESENTATIVE PHOTO
<b>R1-OP</b>  Balcony Railing at Mezzanine, Balcony and Auditorium Railing System	<b>Overpainted</b> <ul style="list-style-type: none"><li>Multiple layers of paint.</li></ul>	<b>Material Patching or Replacement</b> <ul style="list-style-type: none"><li>Leave alone unless other forms of deterioration are present, then scrape to substrate and repaint.</li></ul>	Level 3

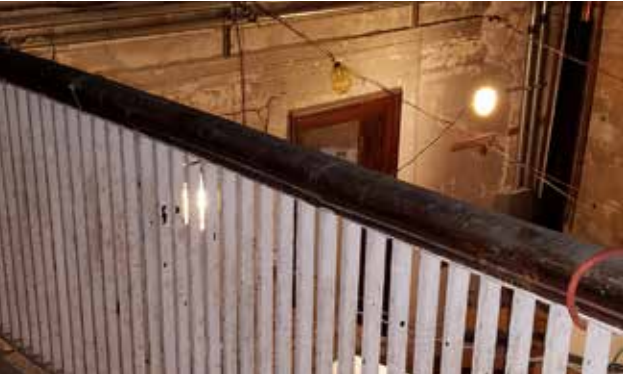
<b>R1-OJ</b>  Balcony Railing at Mezzanine, Balcony and Auditorium Railing System	<b>Open Joints</b> <ul style="list-style-type: none"><li>Open, unfilled joints between segments of wood handrail</li></ul>	<b>Material Patching or Replacement</b> <ul style="list-style-type: none"><li>Determine reason for open joint; fill or caulk joint.</li></ul>	Level 3

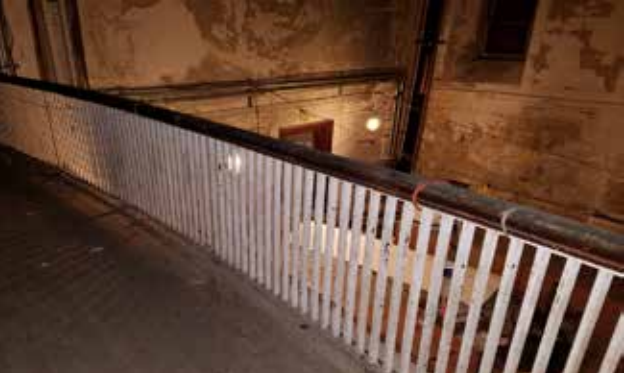
<b>R1-SD</b>  Balcony Railing at Mezzanine, Balcony and Auditorium Railing System	<b>Scratches / Dents</b> <ul style="list-style-type: none"><li>Damage to material caused by mechanical components or equipment</li></ul>	<b>Material Repair or Replacement</b> <ul style="list-style-type: none"><li>Patch areas of missing or damaged material, if feasible; remove and replace material, as required.</li></ul>	Level 3

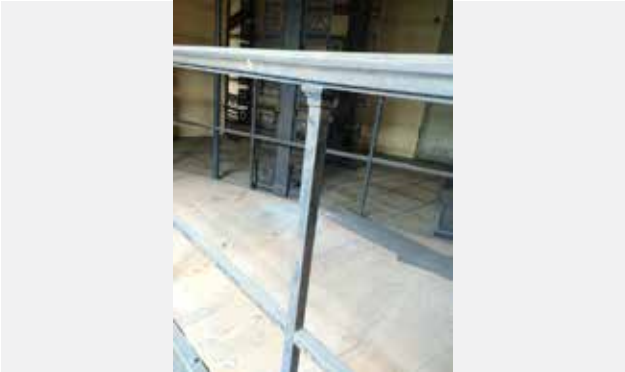
COMPONENT	CONDITION	TREATMENT	PRIORITY	REPRESENTATIVE PHOTO
<b>R2-ST</b>  Balcony Railing at Lightwell Railing System	<b>Staining</b> <ul style="list-style-type: none"><li>Surface problem caused by the build-up of pollutants, mineral deposits and water marks.</li></ul>	<b>Develop Cleaning Program</b> <ul style="list-style-type: none"><li>Develop a cleaning program if it can be implemented without damage to bulding system.</li></ul>	Level 3

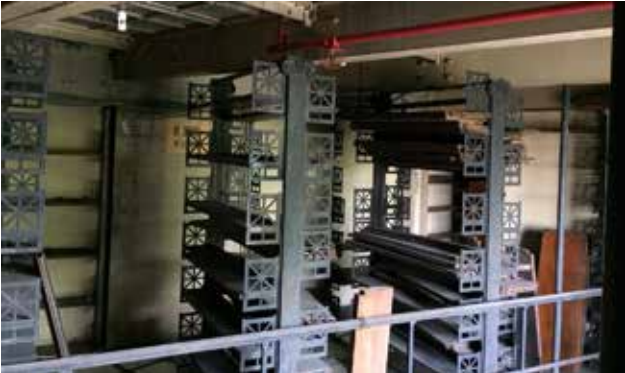
<b>R2-SA</b>  Balcony Railing at Lightwell Railing System	<b>Soiling</b> <ul style="list-style-type: none"><li>Surface staining caused by the build-up of pollutants.</li></ul>	<b>Develop Cleaning Program</b> <ul style="list-style-type: none"><li>Develop a cleaning program if it can be implemented without damage to bulding system.</li></ul>	Level 3
