# Conditions Assessment

## Gould Memorial Library & Hall of Fame

FINAL REPORT | 15 MARCH 2018

**BRONX**  
**COMMUNITY**  
COLLEGE

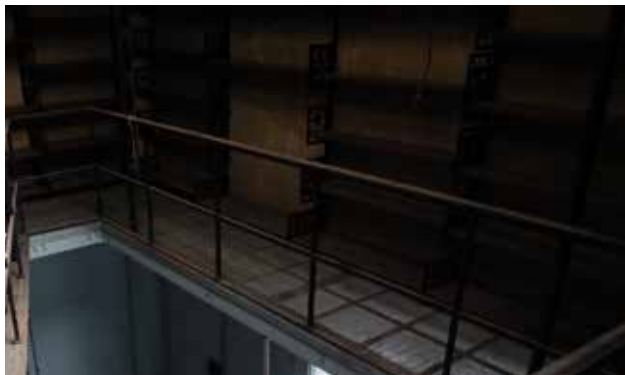
<b>R2-W</b>  Balcony Railing at Lightwell Railing System	<b>Wear</b> <ul style="list-style-type: none"><li>The gradual disintegration and erosion of materials caused by gradual use overtime.</li></ul>	<b>Material Patching or Replacement</b> <ul style="list-style-type: none"><li>Leave alone unless severe, then consider replacing.</li></ul>	Level 3

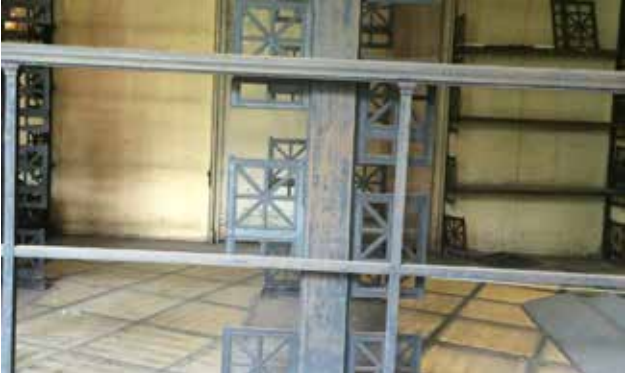
<b>R2-MC</b>  Steel Stair System	<b>Corrosion</b> <ul style="list-style-type: none"><li>Deterioration of material by a chemical reaction with its environment.</li></ul>	<b>Removal of Deteriorated Material</b> <ul style="list-style-type: none"><li>Remove corrosion and corrosive products; in severe cases, replace deteriorated members with new material to match existing.</li><li>Refer to assesment of structural engineer for details on replacement of select cast iron members.</li></ul>	Level 3

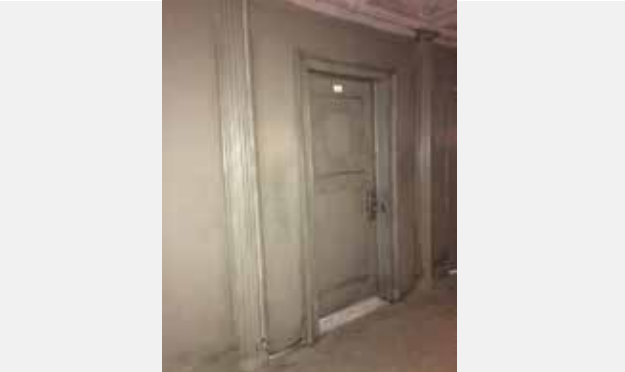
COMPONENT	CONDITION	TREATMENT	PRIORITY	REPRESENTATIVE PHOTO
<b>D1-MC</b>  Door Door System	<b>Corrosion</b> <ul style="list-style-type: none"><li>Deterioration of material by a chemical reaction with its environment.</li></ul>	<b>Removal of Deteriorated Material</b> <ul style="list-style-type: none"><li>Remove corrosion and corrosive products; in severe cases, replace deteriorated members with new material to match existing.</li><li>Refer to assesment of structural engineer for details on replacement of select cast iron members.</li></ul>	Level 3

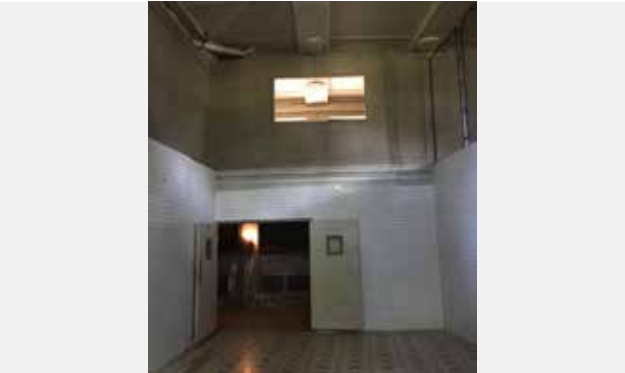
<b>D1-ST</b>  Door Door System	<b>Staining</b> <ul style="list-style-type: none"><li>Surface problem caused by the build-up of pollutants, mineral deposits and water marks.</li></ul>	<b>Develop Cleaning Program</b> <ul style="list-style-type: none"><li>Develop a cleaning program if it can be implemented without damage to bulding system.</li></ul>	Level 3

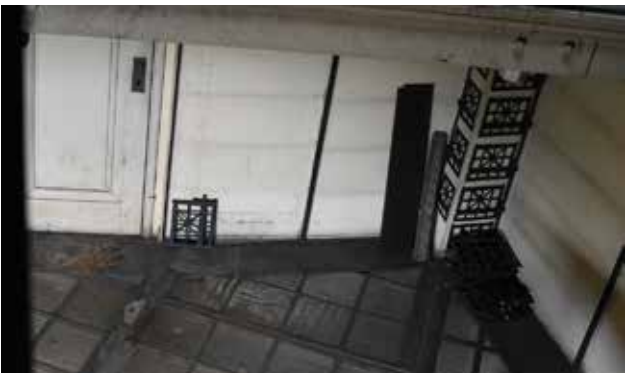
<b>D1-SA</b>  Door Door System	<b>Soiling</b> <ul style="list-style-type: none"><li>Surface staining caused by the build-up of pollutants.</li></ul>	<b>Develop Cleaning Program</b> <ul style="list-style-type: none"><li>Develop a cleaning program if it can be implemented without damage to bulding system.</li></ul>	Level 3

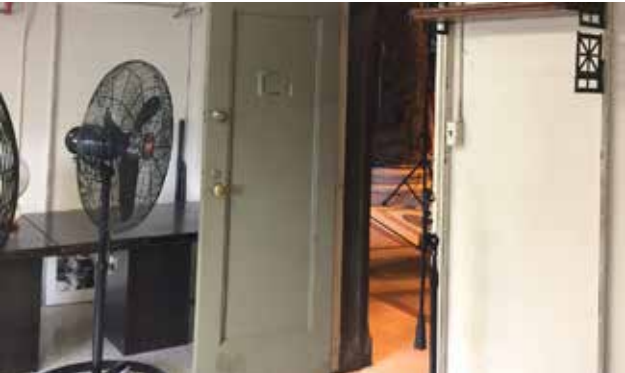
<b>D1-W</b>  Door Stair System	<b>Wear</b> <ul style="list-style-type: none"><li>The gradual disintegration and erosion of materials caused by gradual use overtime.</li></ul>	<b>Material Patching or Replacement</b> <ul style="list-style-type: none"><li>Leave alone unless severe, then consider replacing.</li></ul>	Level 3

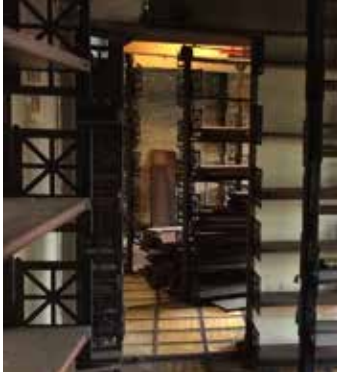
COMPONENT	CONDITION	TREATMENT	PRIORITY	REPRESENTATIVE PHOTO
<b>D1-D</b>  Door Door System	<b>Door Frame Only</b> <ul style="list-style-type: none"><li>Describes the existence of a door frame only, no door.</li></ul>	<b>Material Replacement</b> <ul style="list-style-type: none"><li>Replace missing door.</li></ul>	Level 3

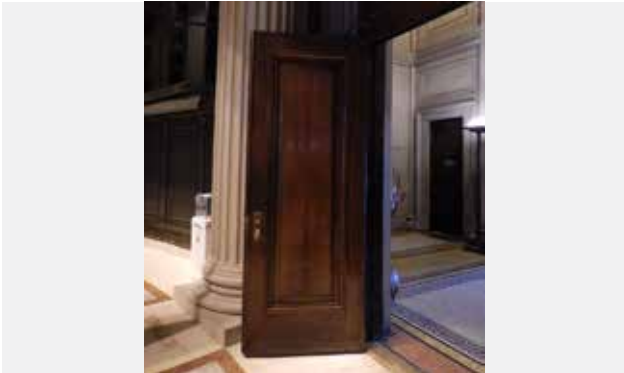
<b>D1-E/NE</b>  Door Door System	<b>Extant / Non-extant</b> <ul style="list-style-type: none"><li>Describes the existence or absence of a particular building system.</li></ul>	<b>Cyclical Maintenance / Material Replacement</b> <ul style="list-style-type: none"><li>Develop a cleaning program to extend life of building system / Replace missing element.</li></ul>	Level 3

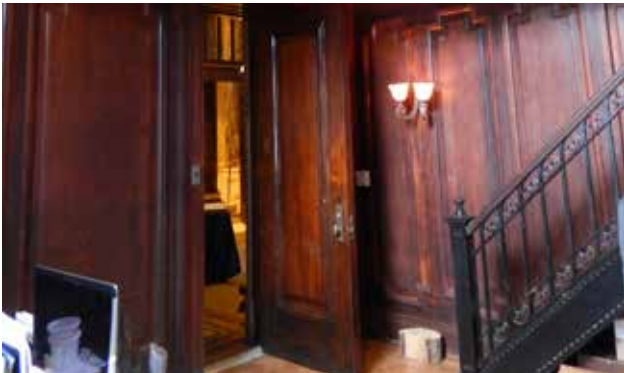
<b>D1-O/NO</b>  Door Door System	<b>Operable / Not Operable</b> <ul style="list-style-type: none"><li>Describes existing functionality of door.</li></ul>	<b>Cyclical Maintenance / Material Repair</b> <ul style="list-style-type: none"><li>Maintain operability of system / Repair system to make operable again.</li></ul>	Level 3

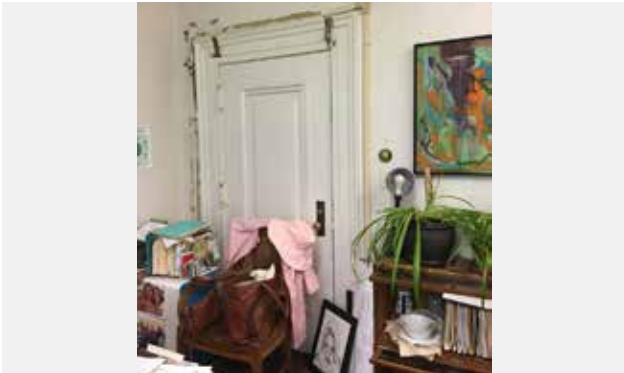
<b>D1-PR</b>  Door Stair System	<b>Previous Repair</b> <ul style="list-style-type: none"><li>Area where a previous repair was done, including repointing, patching and consolidation.</li></ul>	<b>Material Patching or Replacement</b> <ul style="list-style-type: none"><li>Replace inappropriate previous patches.</li></ul>	Level 3

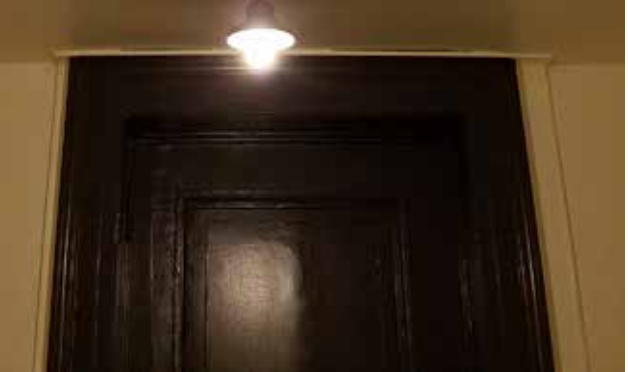
COMPONENT	CONDITION	TREATMENT	PRIORITY	REPRESENTATIVE PHOTO
<b>D1-BL</b>  Door Door System	<b>Blistering Paint</b> <ul style="list-style-type: none"><li>Swelling and rupturing of top layer, generally first stage of exfoliation.</li></ul>	<b>Material Patching or Replacement</b> <ul style="list-style-type: none"><li>Clean, identify source of water infiltration and remedy cause.</li></ul>	Level 3

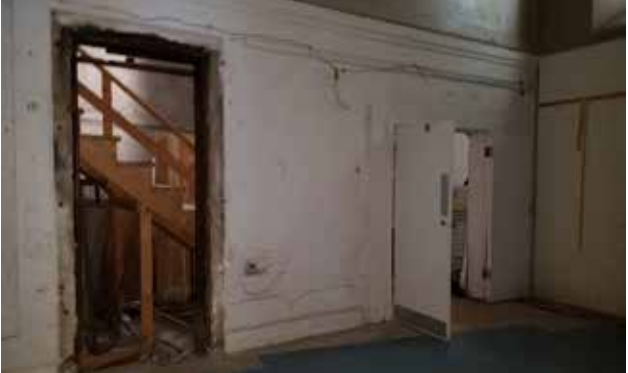
<b>D1-DS</b>  Door Door System	<b>Displacement</b> <ul style="list-style-type: none"><li>Movement of a building material or element from its original location.</li></ul>	<b>Removal of Deteriorated Material</b> <ul style="list-style-type: none"><li>Investigation to determine movement and then subsequent repair.</li></ul>	Level 3

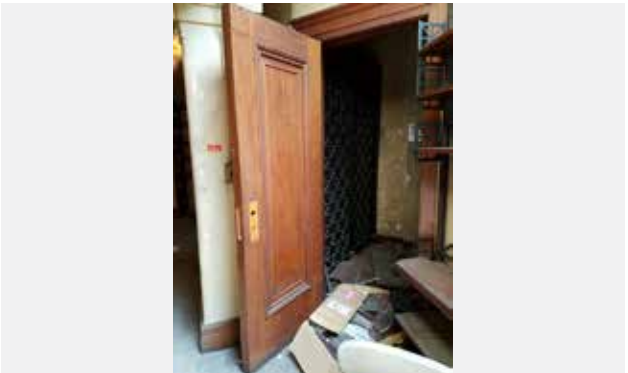
<b>D1-G</b>  Door Door System	<b>Graffiti</b> <ul style="list-style-type: none"><li>Paint sprayed on surface.</li></ul>	<b>Removal of Material</b> <ul style="list-style-type: none"><li>Investigate proper removal methods where appropriate without damaging material.</li></ul>	Level 3

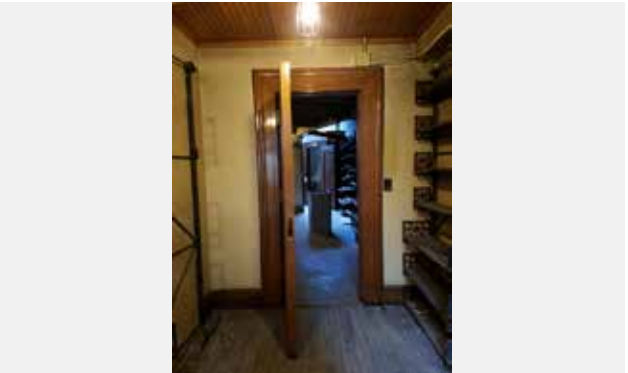
<b>D1-OJ</b>  Door Stair System	<b>Open Joints</b> <ul style="list-style-type: none"><li>Joints without caulking</li></ul>	<b>Material Patching or Replacement</b> <ul style="list-style-type: none"><li>Determine reason for missing caulk and reseal edges.</li></ul>	Level 3

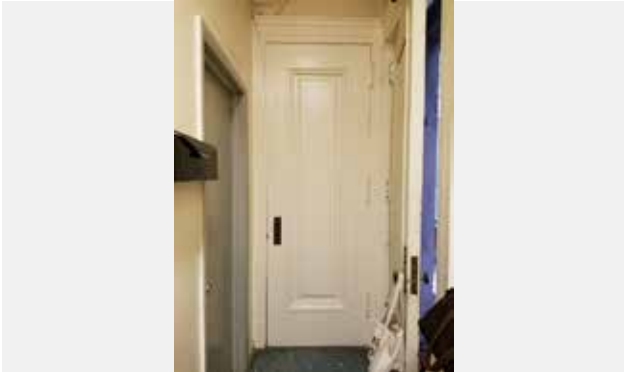
COMPONENT	CONDITION	TREATMENT	PRIORITY	REPRESENTATIVE PHOTO
<b>D1-W</b>  Door Door System	<b>Wear</b> <ul style="list-style-type: none"><li>The gradual disintegration and erosion of materials caused by gradual use overtime.</li></ul>	<b>Material Patching or Replacement</b> <ul style="list-style-type: none"><li>Leave alone unless severe, then consider replacing.</li></ul>	Level 3

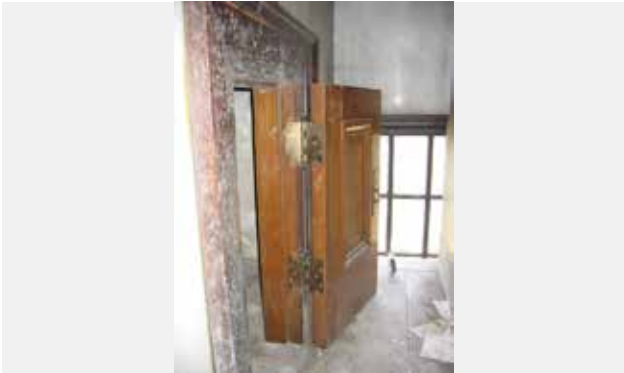
<b>D1-SW</b>  Door Door System	<b>Water Damage</b> <ul style="list-style-type: none"><li>Biological growth, blistering, efflorescence, wood rot or staining caused by the infiltration of water.</li></ul>	<b>Removal of Deteriorated Material</b> <ul style="list-style-type: none"><li>Clean, identify source of water infiltration and remedy cause.</li></ul>	Level 3

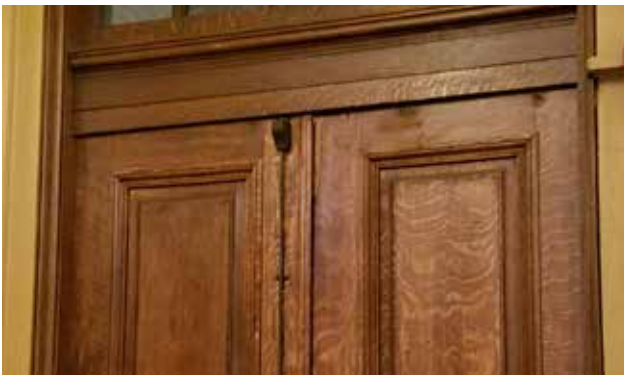
<b>D1-PR</b>  Door Door System	<b>Previous Repair</b> <ul style="list-style-type: none"><li>Area where a previous repair was done, including repointing, patching and consolidation.</li></ul>	<b>Material Patching or Replacement</b> <ul style="list-style-type: none"><li>Replace inappropriate previous patches.</li></ul>	Level 3

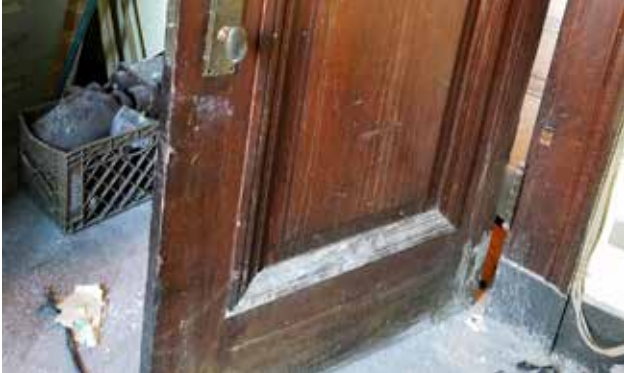
<b>D1-LM</b>  Door Stair System	<b>Material Loss</b> <ul style="list-style-type: none"><li>Loss of material leaving holes or exposing inner layers.</li></ul>	<b>Material Patching or Replacement</b> <ul style="list-style-type: none"><li>Patch areas of missing material, if feasible, or replace material to match existing.</li></ul>	Level 3

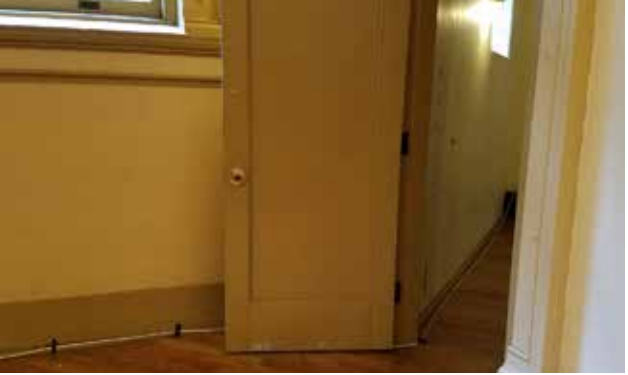
COMPONENT	CONDITION	TREATMENT	PRIORITY	REPRESENTATIVE PHOTO
<b>D1-LC</b>  Door Door System	<b>Paint Loss</b> <ul style="list-style-type: none"><li>Loss of surface paint.</li></ul>	<b>Material Patching or Replacement</b> <ul style="list-style-type: none"><li>Determine reason for paint loss, correct problem and repaint.</li></ul>	Level 3

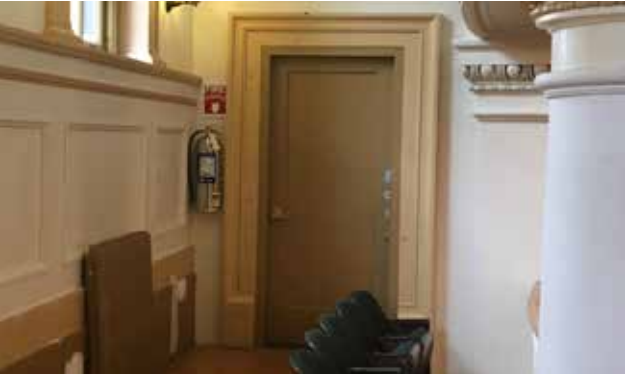
<b>D1-CR</b>  Door Door System	<b>Crack</b> <ul style="list-style-type: none"><li>1/16 to 1/2 inch wide visible fissure in a surface, possible penetrating through the surface.</li></ul>	<b>Material Patching or Replacement</b> <ul style="list-style-type: none"><li>Remove and replace damaged material.</li></ul>	Level 3

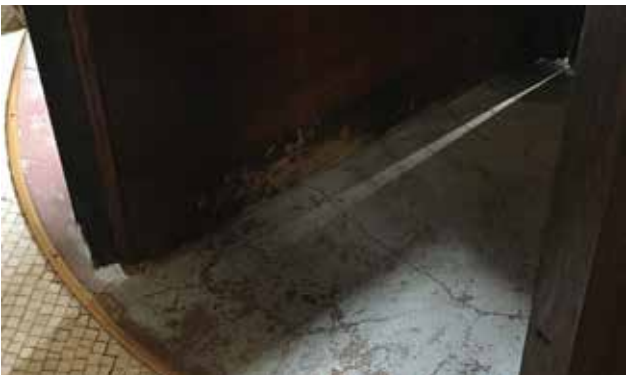
<b>D1-SL</b>  Door Door System	<b>Splintering</b> <ul style="list-style-type: none"><li>Caused by the process of swelling from moisture and drying from heat, or mechanical damage.</li></ul>	<b>Removal of Deteriorated Material</b> <ul style="list-style-type: none"><li>Repair by sanding or wood putty.</li></ul>	Level 3

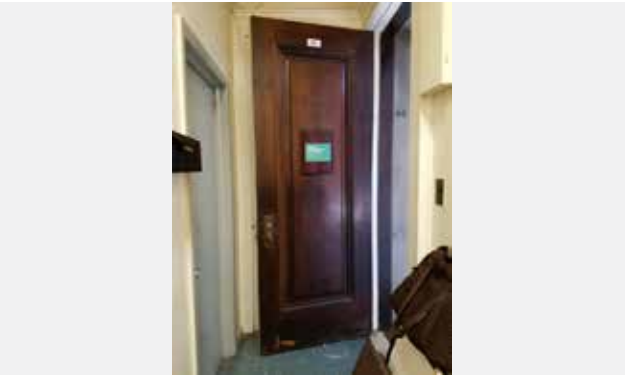
<b>D1-MD</b>  Door Stair System	<b>Mechanical Damage</b> <ul style="list-style-type: none"><li>Damage to material caused by mechanical components or equipment</li></ul>	<b>Material Repair or Replacement</b> <ul style="list-style-type: none"><li>Remove mechanical remnants and connections. Patch areas of missing or damaged material, if feasible; remove and replace material, as required.</li></ul>	Level 3

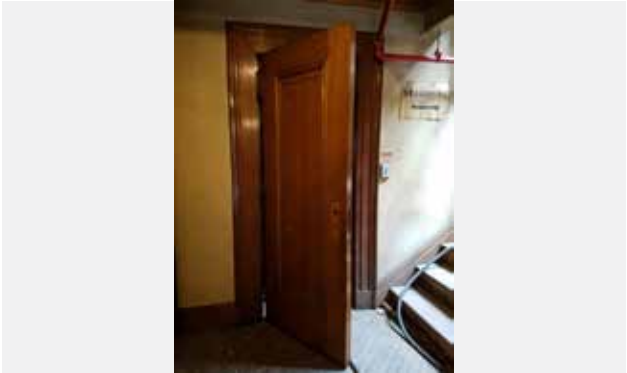
COMPONENT	CONDITION	TREATMENT	PRIORITY	REPRESENTATIVE PHOTO
<b>D1-SD</b>  Door Door System	<b>Scratches / Dents</b> <ul style="list-style-type: none"><li>Damage to material caused by mechanical components or equipment</li></ul>	<b>Material Repair or Replacement</b> <ul style="list-style-type: none"><li>Patch areas of missing or damaged material, if feasible; remove and replace material, as required.</li></ul>	Level 3

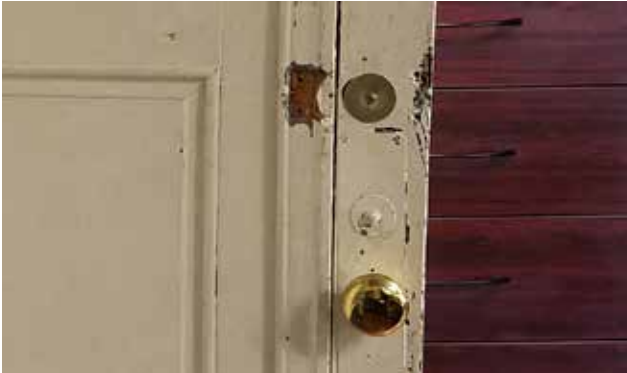
<b>D2-SD</b>  Door Hardware Door System	<b>Scratches / Dents</b> <ul style="list-style-type: none"><li>Damage to material caused by mechanical components or equipment</li></ul>	<b>Material Repair or Replacement</b> <ul style="list-style-type: none"><li>Patch areas of missing or damaged material, if feasible; remove and replace material, as required.</li></ul>	Level 3

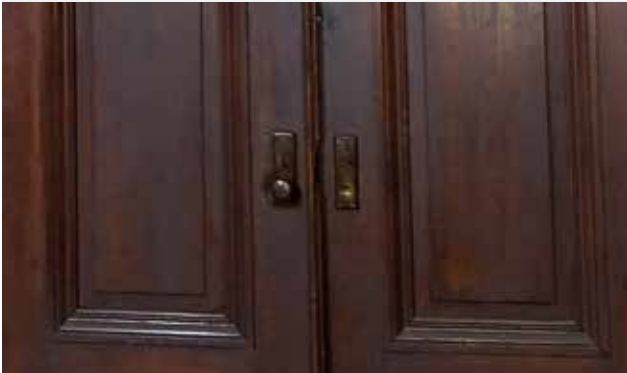
<b>D2-W</b>  Door Hardware Door System	<b>Wear</b> <ul style="list-style-type: none"><li>The gradual disintegration and erosion of materials caused by gradual use overtime.</li></ul>	<b>Material Patching or Replacement</b> <ul style="list-style-type: none"><li>Leave alone unless severe, then consider replacing.</li></ul>	Level 3

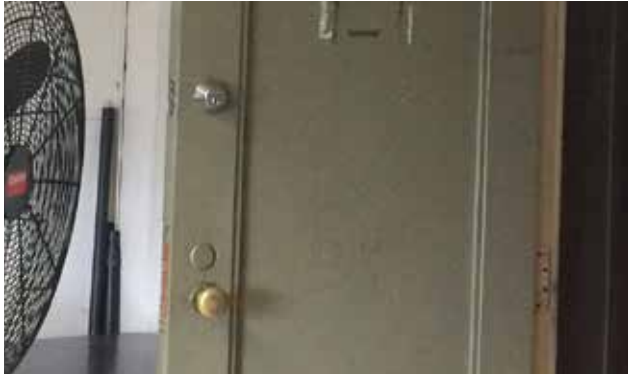
COMPONENT	CONDITION	TREATMENT	PRIORITY	REPRESENTATIVE PHOTO
<b>D2-E/NE</b> Door Hardware Door System	<b>Extant / Non-extant</b> <ul style="list-style-type: none"><li>Describes the existence or absence of a particular building system.</li></ul>	<b>Cyclical Maintenance / Material Replacement</b> <ul style="list-style-type: none"><li>Develop a cleaning program to extend life of building system / Replace missing element.</li></ul>	Level 3

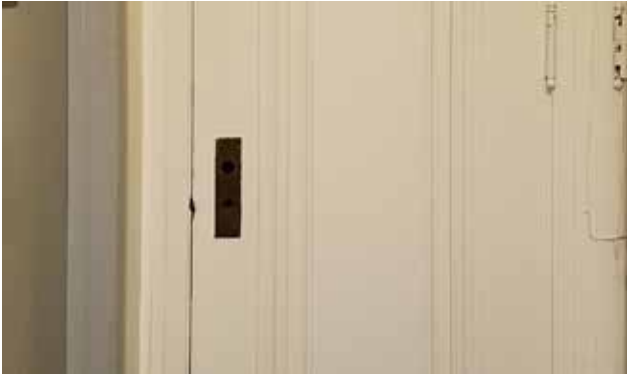
<b>D2-HM</b> Door Hardware Door System	<b>Missing Hardware</b> <ul style="list-style-type: none"><li>The absence of knobs, hinges, pulls, etc.</li></ul>	<b>Material Replacement</b> <ul style="list-style-type: none"><li>Replace missing hardware.</li></ul>	Level 3

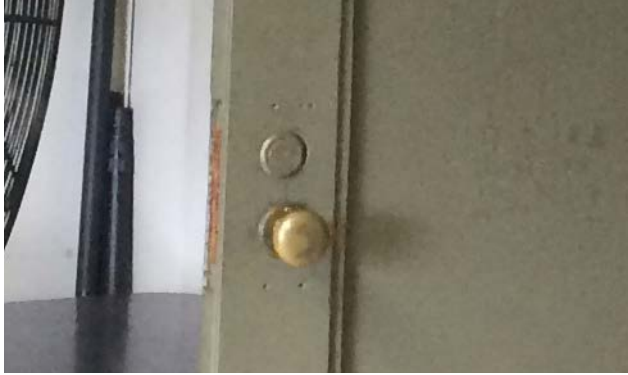
<b>D2-OP</b> Door Hardware Door System	<b>Overpainted</b> <ul style="list-style-type: none"><li>Multiple layers of paint.</li></ul>	<b>Material Patching or Replacement</b> <ul style="list-style-type: none"><li>Leave alone unless other forms of deterioration, then scrape to substrate and repaint.</li></ul>	Level 3

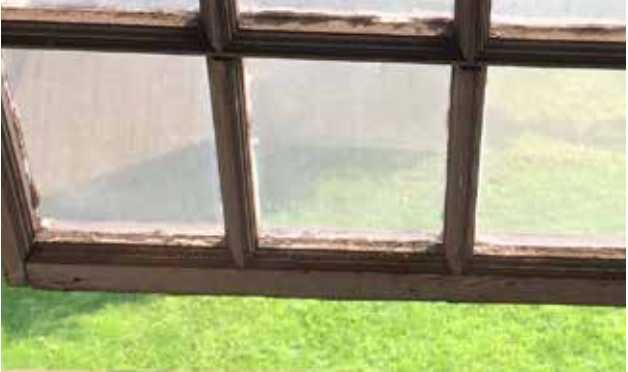
COMPONENT	CONDITION	TREATMENT	PRIORITY	REPRESENTATIVE PHOTO
<b>WD1-LC</b>  Wood and Glass Window System	<b>Paint Loss</b> <ul style="list-style-type: none"><li>Loss of surface paint.</li></ul>	<b>Material Patching or Replacement</b> <ul style="list-style-type: none"><li>Determine reason for paint loss, correct problem and repaint.</li></ul>	Level 3

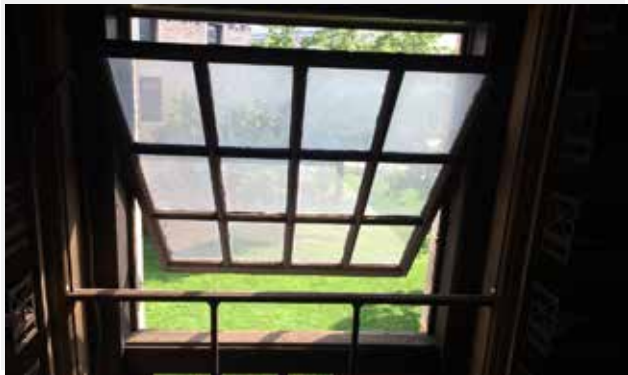
<b>WD1-DGC</b>  Wood and Glass Window System	<b>Deteriorated Glazing Putty</b> <ul style="list-style-type: none"><li>Minimal amounts of glazing putty at window remain.</li></ul>	<b>Material Repair or Replacement</b> <ul style="list-style-type: none"><li>Scrape remaining glazing putty away and replace with new glazing compound.</li></ul>	Level 3

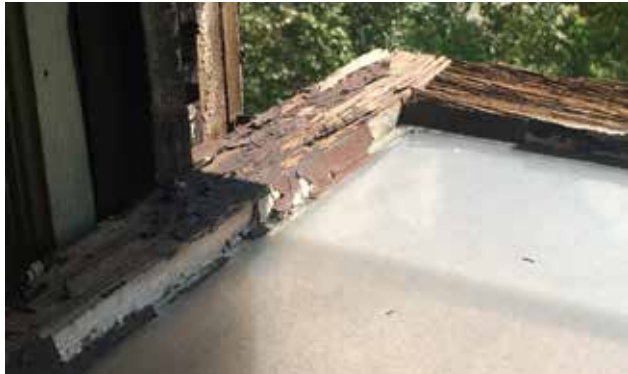
<b>WD1-NGC</b>  Wood and Glass Window System	<b>No Glazing Putty</b> <ul style="list-style-type: none"><li>Lack of glazing putty at window panes</li></ul>	<b>Material Patching or Replacement</b> <ul style="list-style-type: none"><li>Apply new glazing compound.</li></ul>	Level 3

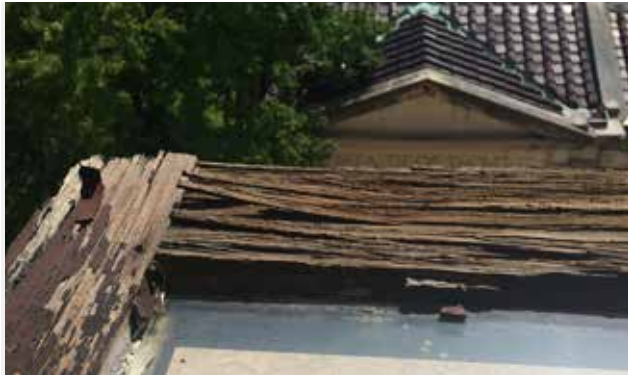
<b>WD1-SL</b>  Wood and Glass Window System	<b>Splintering</b> <ul style="list-style-type: none"><li>Caused by the process of swelling from moisture and drying from heat, or mechanical damage.</li></ul>	<b>Removal of Deteriorated Material</b> <ul style="list-style-type: none"><li>Repair by sanding or wood putty.</li></ul>	Level 3

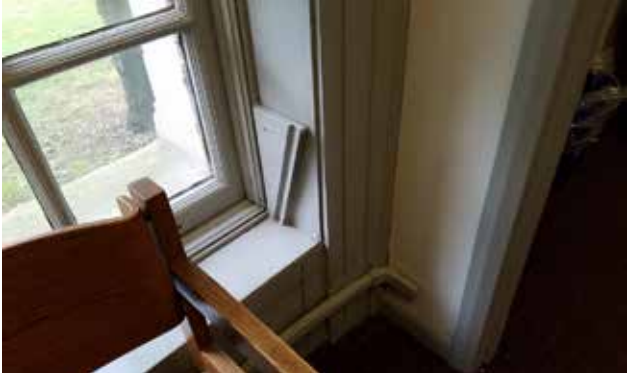
<b>WD1-OJ</b>  Wood and Glass Window System	<b>Open Joints</b> <ul style="list-style-type: none"><li>Joints without caulking</li></ul>	<b>Material Patching or Replacement</b> <ul style="list-style-type: none"><li>Determine reason for missing caulk and reseal edges.</li></ul>	Level 3

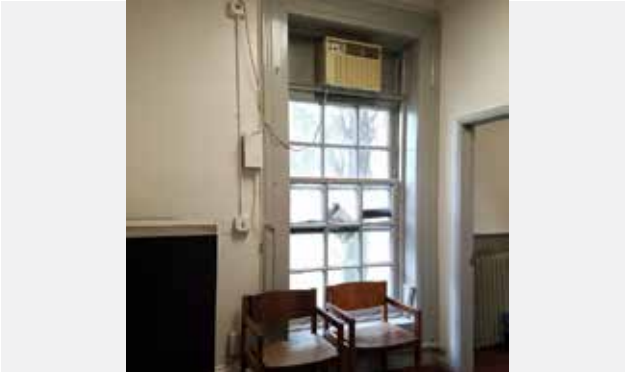
COMPONENT	CONDITION	TREATMENT	PRIORITY	REPRESENTATIVE PHOTO
<b>WD1-PR</b>  Wood and Glass Window System	<b>Previous Repair</b> <ul style="list-style-type: none"><li>Area where a previous repair was done, including repointing, patching and consolidation.</li></ul>	<b>Material Replacement</b> <ul style="list-style-type: none"><li>Replace inappropriate previous patches.</li></ul>	Level 3

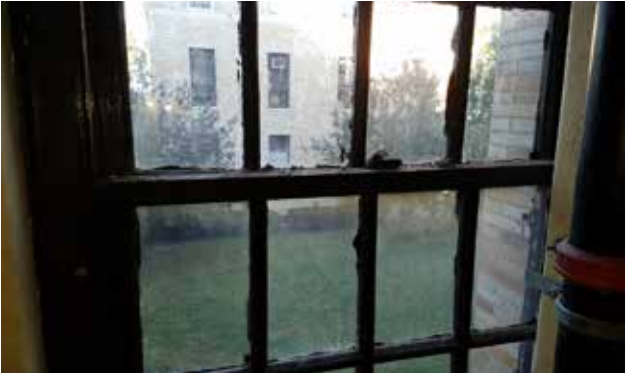
<b>WD1-OP</b>  Wood and Glass Window System	<b>Overpainted</b> <ul style="list-style-type: none"><li>Multiple layers of paint.</li></ul>	<b>Material Refinishing</b> <ul style="list-style-type: none"><li>Leave alone unless other forms of deterioration, then scrape to substrate and repaint.</li></ul>	Level 3

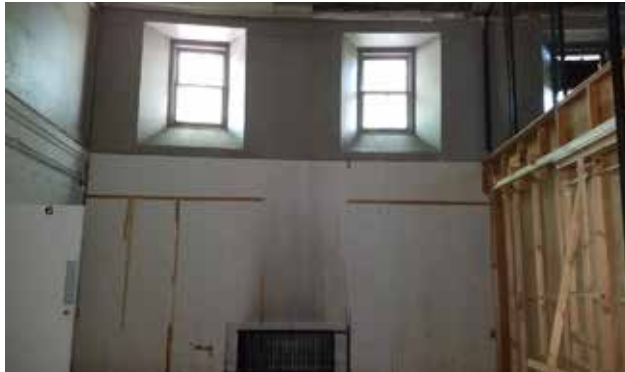
<b>WD1-NA</b>  Wood and Glass Window System	<b>Not Accessible</b> <ul style="list-style-type: none"><li>Window could not be reached during survey.</li></ul>	<b>Further Investigation</b> <ul style="list-style-type: none"><li>Further investigation required to assess operability and condition.</li></ul>	Level 3

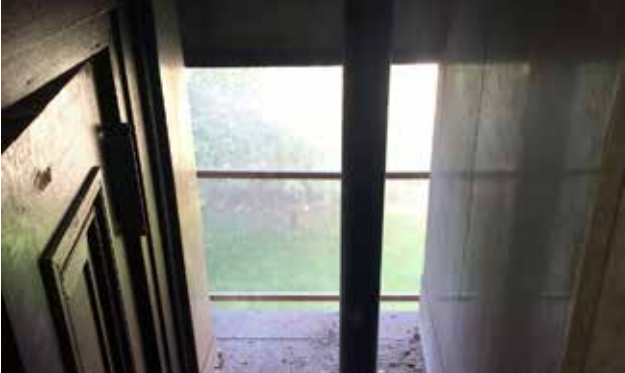
<b>WD1-E</b>  Wood and Glass Window System	<b>Extant</b> <ul style="list-style-type: none"><li>An existing building system in good condition.</li></ul>	<b>Cyclical Maintenance</b> <ul style="list-style-type: none"><li>Develop a cleaning program to extend life of building system.</li></ul>	Level 3

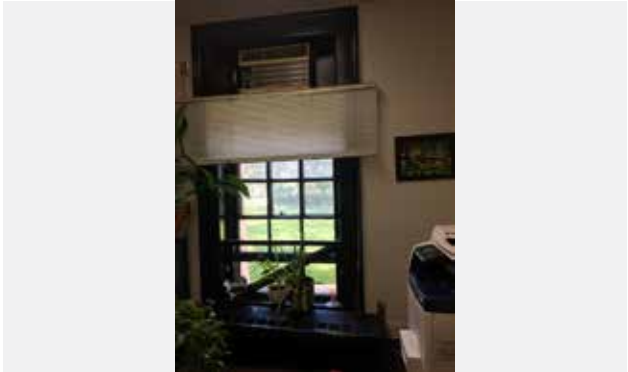
COMPONENT	CONDITION	TREATMENT	PRIORITY	REPRESENTATIVE PHOTO
<b>WD1-MD</b> Wood and Glass Window System	<b>Mechanical Damage</b> <ul style="list-style-type: none"><li>Damage to material caused by mechanical components or equipment</li></ul>	<b>Material Repair or Replacement</b> <ul style="list-style-type: none"><li>Remove mechanical remnants and connections. Patch areas of missing or damaged material, if feasible; remove and replace material, as required.</li></ul>	Level 3

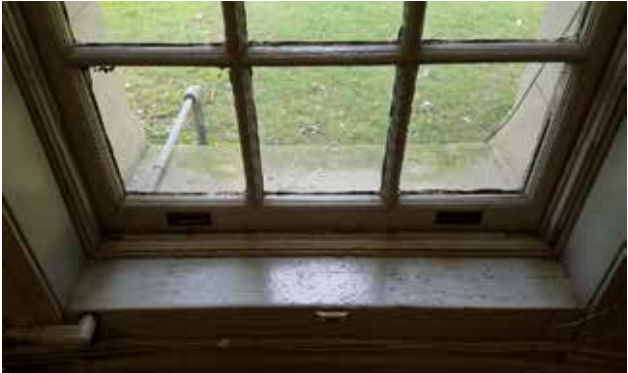
<b>WD1-CH</b> Wood and Glass Window System	<b>Hairline Cracking</b> <ul style="list-style-type: none"><li>Numerous shallow cracks across the outer layer of a surface.</li></ul>	<b>Material Patching or Replacement</b> <ul style="list-style-type: none"><li>Patch where appropriate.</li></ul>	Level 3

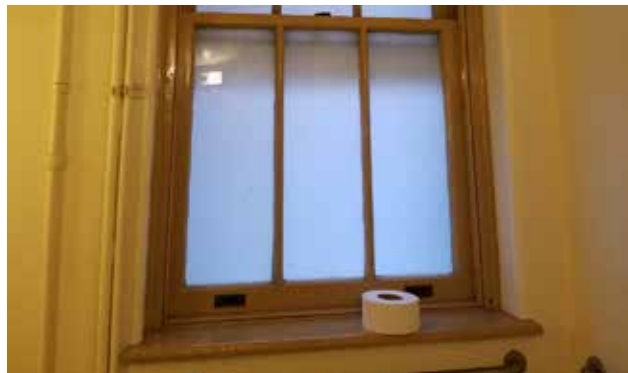
<b>WD1-BL</b> Wood and Glass Window System	<b>Blistering Paint</b> <ul style="list-style-type: none"><li>Swelling and rupturing of top layer, generally first stage of exfoliation.</li></ul>	<b>Material Patching or Replacement</b> <ul style="list-style-type: none"><li>Clean, identify source of water infiltration and remedy cause.</li></ul>	Level 3

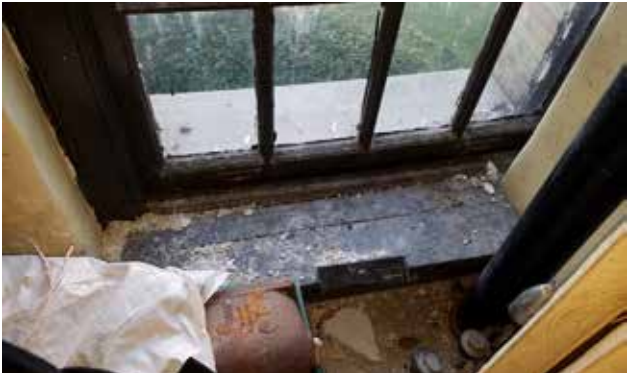
<b>WD1-RT</b> Wood and Glass Window System	<b>Wood Rot</b> <ul style="list-style-type: none"><li>The growth of fungi when oxygen, warmth and moisture are present in wood.</li></ul>	<b>Material Repair or Replacement</b> <ul style="list-style-type: none"><li>Replace rotted elements and treat new wood to repel agents that cause rotting.</li></ul>	Level 3

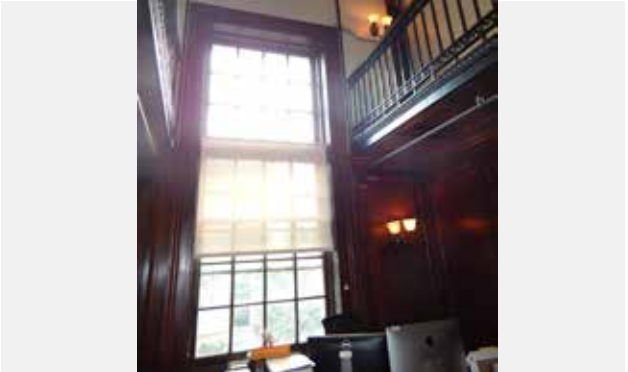
COMPONENT	CONDITION	TREATMENT	PRIORITY	REPRESENTATIVE PHOTO
<b>WD1-O/NO</b>  Wood and Glass Window System	<b>Operable / Not Operable</b> <ul style="list-style-type: none"><li>Describes existing functionality of window.</li></ul>	<b>Cyclical Maintenance / Material Repair</b> <ul style="list-style-type: none"><li>Maintain operability of system / Repair system to make operable again.</li></ul>	Level 3

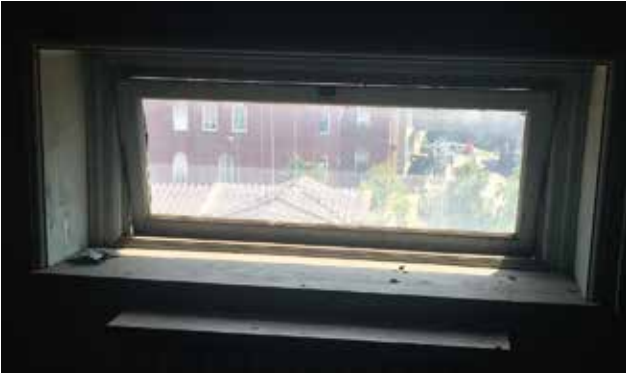
<b>WD1-SA</b>  Wood and Glass Window System	<b>Soiling</b> <ul style="list-style-type: none"><li>Surface staining caused by the build-up of pollutants.</li></ul>	<b>Develop Cleaning Program</b> <ul style="list-style-type: none"><li>Develop a cleaning program if it can be implemented without damage to bulding system.</li></ul>	Level 3

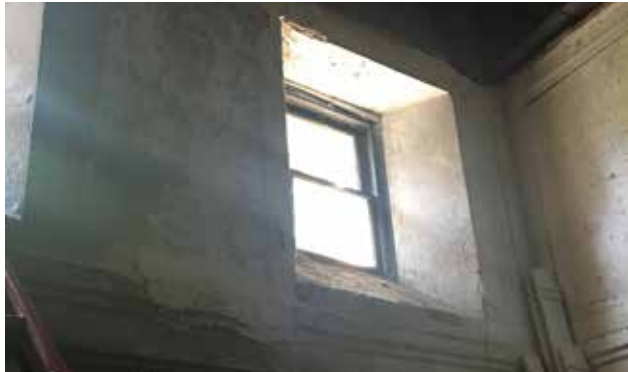
<b>WD1-ST</b>  Wood and Glass Window System	<b>Staining</b> <ul style="list-style-type: none"><li>Surface problem caused by the build-up of pollutants, mineral deposits and water marks.</li></ul>	<b>Develop Cleaning Program</b> <ul style="list-style-type: none"><li>Develop a cleaning program if it can be implemented without damage to bulding system.</li></ul>	Level 3

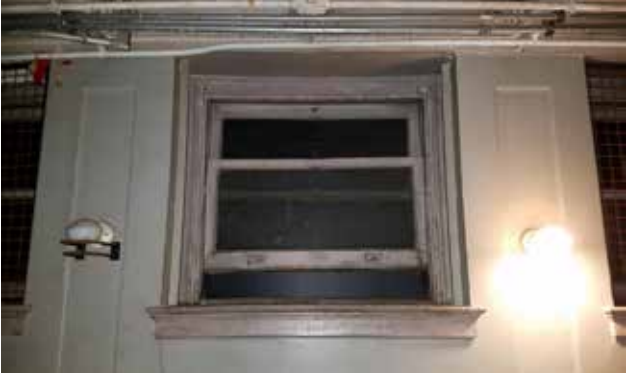
<b>WD1-SD</b>  Wood and Glass Window System	<b>Scratches / Dents</b> <ul style="list-style-type: none"><li>Damage to material caused by mechanical components or equipment</li></ul>	<b>Material Repair or Replacement</b> <ul style="list-style-type: none"><li>Patch areas of missing or damaged material, if feasible; remove and replace material, as required.</li></ul>	Level 3

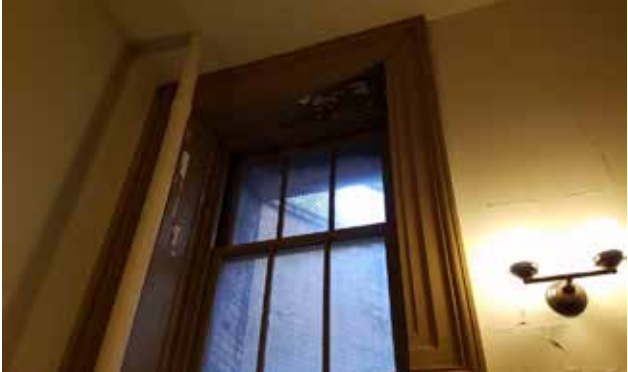
COMPONENT	CONDITION	TREATMENT	PRIORITY	REPRESENTATIVE PHOTO
<b>WD1-SW</b>  Wood and Glass Window System	<b>Water Damage</b> <ul style="list-style-type: none"><li>Biological growth, blistering, efflorescence, wood rot or staining caused by the infiltration of water.</li></ul>	<b>Removal of Deteriorated Material</b> <ul style="list-style-type: none"><li>Identify source of water infiltration and remedy cause. Replace deteriorated and damaged material.</li></ul>	Level 3

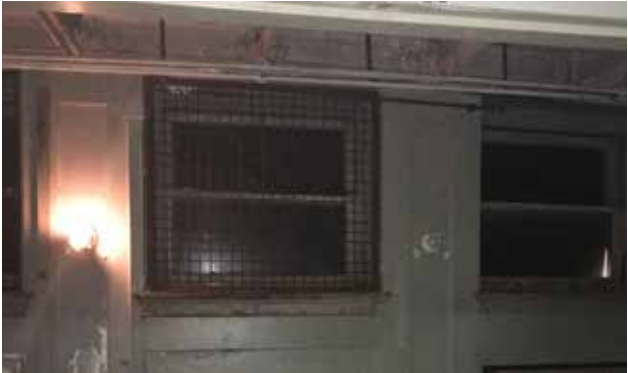
<b>WD2-O/NO</b>  Hardware Windows System	<b>Operable / Not Operable</b> <ul style="list-style-type: none"><li>Describes existing functionality of window hardware.</li></ul>	<b>Cyclical Maintenance / Material Repair</b> <ul style="list-style-type: none"><li>Maintain operability of system / Repair system to make operable again.</li></ul>	Level 3

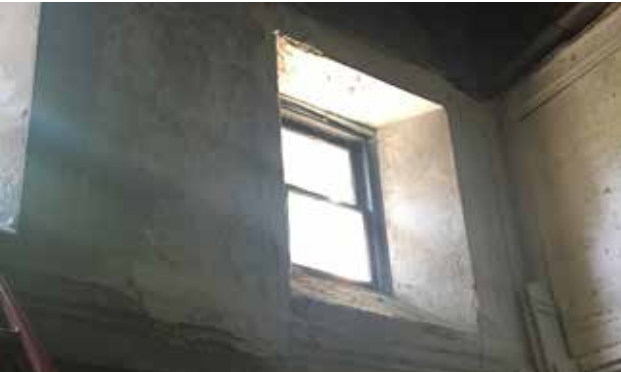
<b>WD2-HM</b>  Hardware Windows System	<b>Missing Hardware</b> <ul style="list-style-type: none"><li>The absence of knobs, hinges, pulls, etc.</li></ul>	<b>Material Replacement</b> <ul style="list-style-type: none"><li>Replace missing hardware.</li></ul>	Level 3

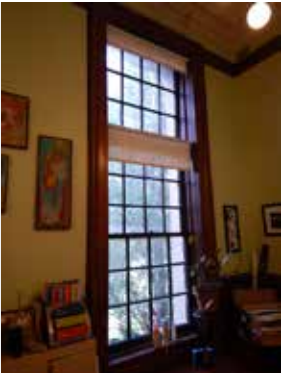
<b>WD2-E</b>  Hardware Windows System	<b>Extant</b> <ul style="list-style-type: none"><li>An existing building system in good condition.</li></ul>	<b>Cyclical Maintenance</b> <ul style="list-style-type: none"><li>Develop a cleaning program to extend life of building system.</li></ul>	Level 3

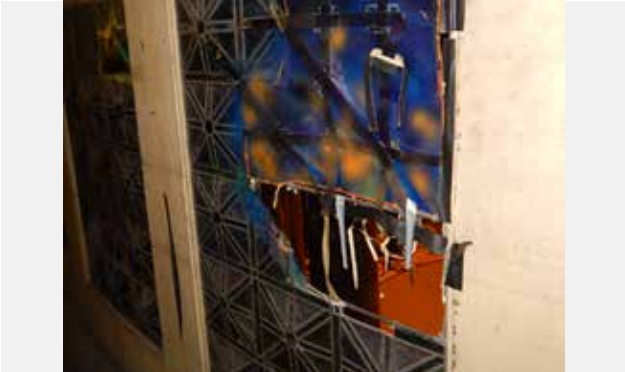
COMPONENT	CONDITION	TREATMENT	PRIORITY	REPRESENTATIVE PHOTO
<b>WD3-LM</b>  Tiffany Stained Glass Windows System	<b>Material Loss</b> <ul style="list-style-type: none"><li>Loss of material leaving holes or exposing inner layers.</li></ul>	<b>Material Patching or Replacement</b> <ul style="list-style-type: none"><li>Replace material to match existing/historic.</li></ul>	Level 3

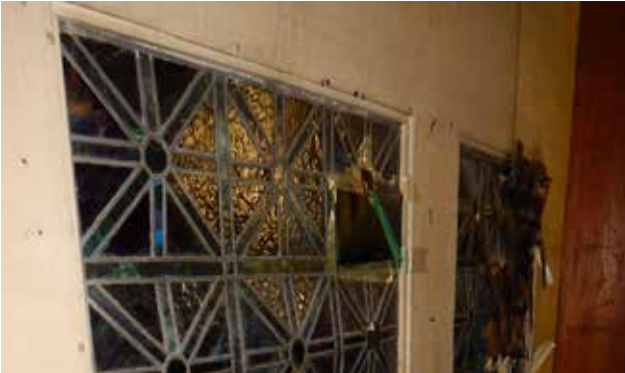
<b>WD3-PR</b>  Tiffany Stained Glass Windows System	<b>Previous Repair</b> <ul style="list-style-type: none"><li>Area where a previous repair was done.</li></ul>	<b>Material Patching or Replacement</b> <ul style="list-style-type: none"><li>Replace inappropriate previous patches.</li></ul>	Level 3

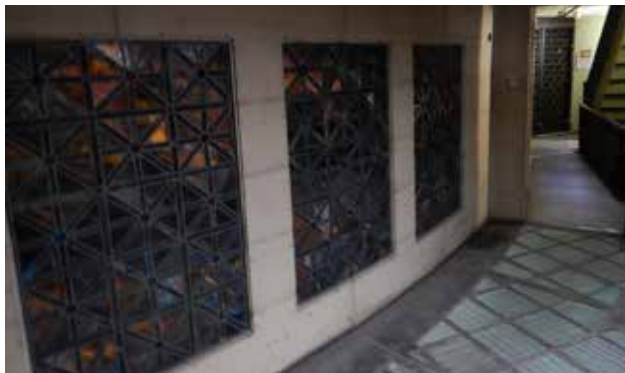
<b>WD3-SA</b>  Tiffany Stained Glass Windows System	<b>Soiling</b> <ul style="list-style-type: none"><li>Surface staining caused by the build-up of pollutants.</li></ul>	<b>Develop Cleaning Program</b> <ul style="list-style-type: none"><li>Develop a cleaning program if it can be implemented without damage to bulding system.</li></ul>	Level 3

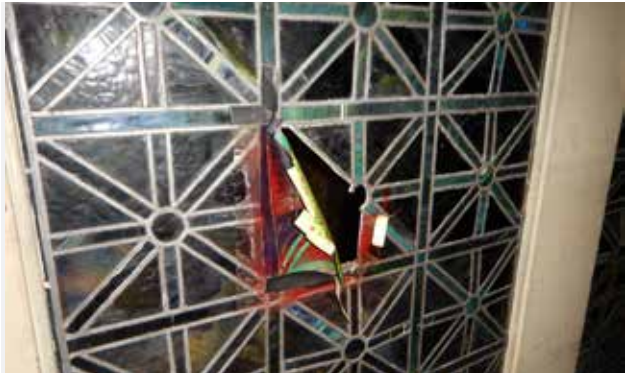
<b>WD3-MD</b>  Tiffany Stained Glass Windows System	<b>Mechanical Damage</b> <ul style="list-style-type: none"><li>Damage to material caused by mechanical components or equipment</li></ul>	<b>Material Repair or Replacement</b> <ul style="list-style-type: none"><li>Remove mechanical remnants and connections. Replace areas of missing or damaged material.</li></ul>	Level 3

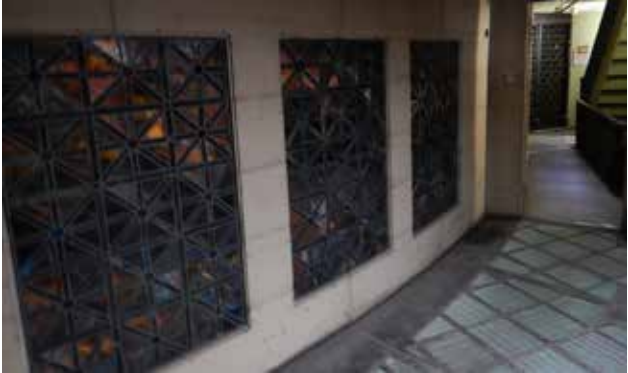
COMPONENT	CONDITION	TREATMENT	PRIORITY	REPRESENTATIVE PHOTO
<b>WD3-ST</b>  Tiffany Stained Glass Windows System	<b>Staining</b> <ul style="list-style-type: none"><li>Surface problem caused by the build-up of pollutants, mineral deposits and water marks.</li></ul>	<b>Develop Cleaning Program</b> <ul style="list-style-type: none"><li>Develop a cleaning program if it can be implemented without damage to building system.</li></ul>	Level 3

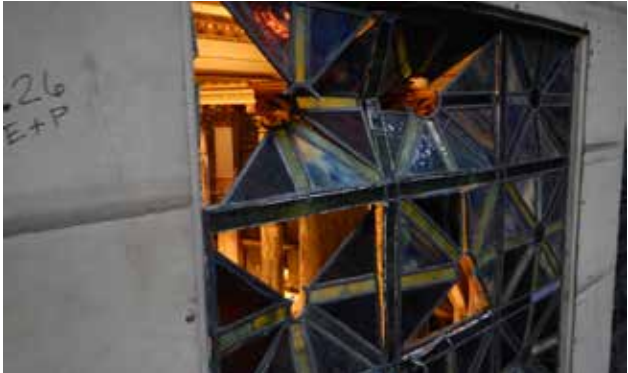
<b>WD3-CR</b>  Tiffany Stained Glass Windows System	<b>Cracking</b> <ul style="list-style-type: none"><li>1/16" to 1/2" wide visible fissures in glass surface, possibly penetrating through the material surface</li></ul>	<b>Material Patching or Replacement</b> <ul style="list-style-type: none"><li>Remove and replace damaged material.</li></ul>	Level 3

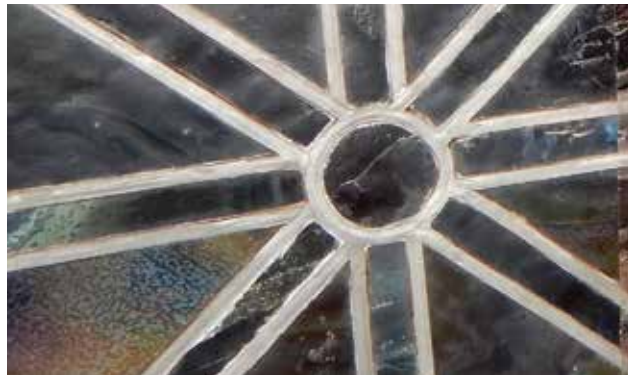
<b>WD3-MC</b>  Tiffany Stained Glass Windows System	<b>Corrosion</b> <ul style="list-style-type: none"><li>Deterioration of material by a chemical reaction with its environment.</li></ul>	<b>Removal of Deteriorated Material</b> <ul style="list-style-type: none"><li>Remove corrosion and corrosive products; in severe cases, replace deteriorated members with new material to match existing.</li></ul>	Level 3

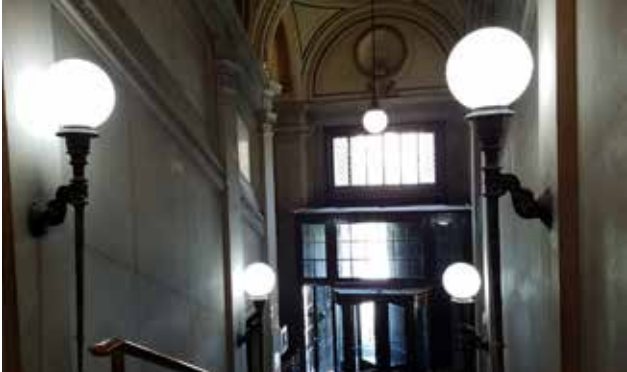
COMPONENT	CONDITION	TREATMENT	PRIORITY	REPRESENTATIVE PHOTO
<b>L1-SA</b>  Wall Sconce with Globes Lighting System	<b>Soiling</b> <ul style="list-style-type: none"><li>Surface staining caused by the build-up of pollutants.</li></ul>	<b>Develop Cleaning Program</b> <ul style="list-style-type: none"><li>Develop a cleaning program if it can be implemented without damage to building system.</li></ul>	Level 3

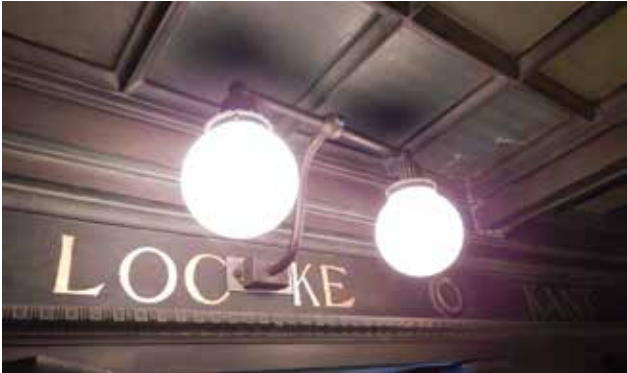
<b>L1-CR</b>  Wall Sconce with Globes Lighting System	<b>Cracking</b> <ul style="list-style-type: none"><li>1/16 to 1/2 inch wide visible fissure in a surface, possibly penetrating through the surface.</li></ul>	<b>Material Patching or Replacement</b> <ul style="list-style-type: none"><li>Remove and replace damaged material.</li></ul>	Level 3

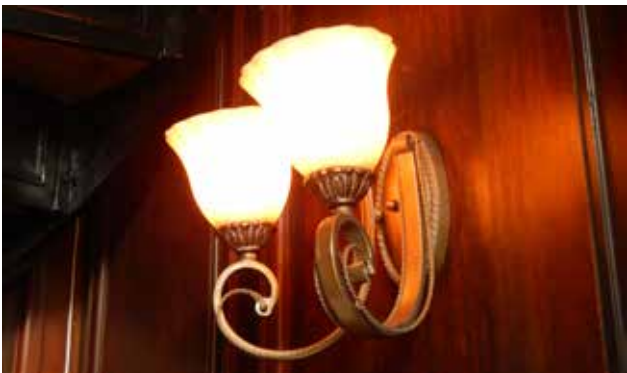
<b>L1-O/NO</b>  Wall Sconce with Globes Lighting System	<b>Operable / Not Operable</b> <ul style="list-style-type: none"><li>Describes existing functionality of fixture.</li></ul>	<b>Cyclical Maintenance / Material Repair</b> <ul style="list-style-type: none"><li>Maintain operability of system / Repair system to make operable again.</li></ul>	Level 3

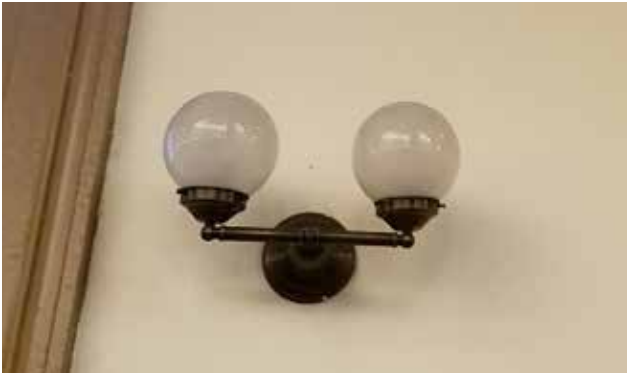
<b>L1-HM</b>  Wall Sconce with Globes Lighting System	<b>Missing Hardware</b> <ul style="list-style-type: none"><li>The absence of hardware associated with the light fixture.</li></ul>	<b>Material Replacement</b> <ul style="list-style-type: none"><li>Replace missing hardware.</li></ul>	Level 3

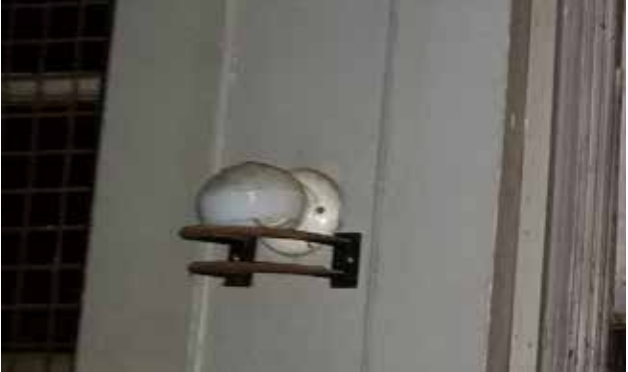
COMPONENT	CONDITION	TREATMENT	PRIORITY	REPRESENTATIVE PHOTO
<b>L1-OU</b>  Wall Sconce with Globes Lighting System	<b>Operation Unknown</b> <ul style="list-style-type: none"><li>Operability of light fixture was not determined.</li></ul>	<b>Further Investigation</b> <ul style="list-style-type: none"><li>Further investigation required to assess operability.</li></ul>	Level 3

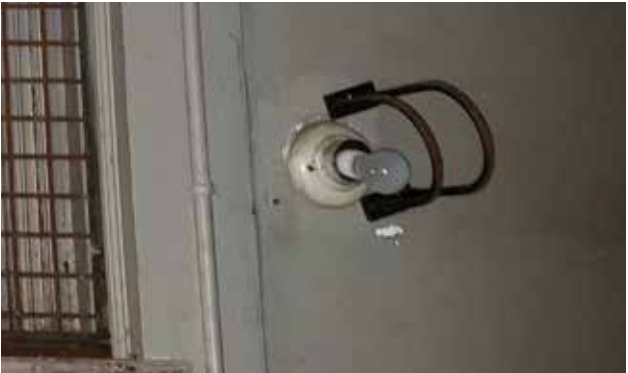
<b>L1-LM</b>  Wall Sconce with Globes Lighting System	<b>Material Loss</b> <ul style="list-style-type: none"><li>Loss of material or component of fixture</li></ul>	<b>Material Repair or Replacement</b> <ul style="list-style-type: none"><li>Repair or replace missing material.</li></ul>	Level 3

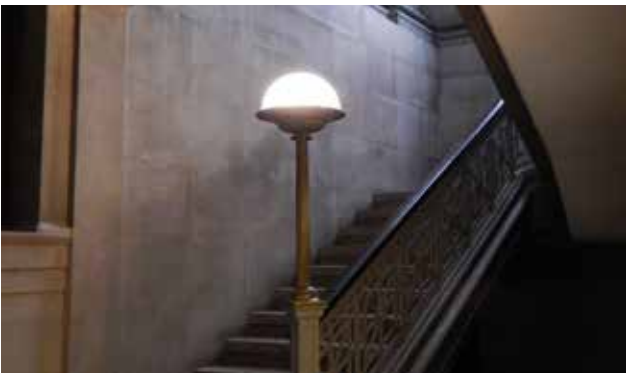
<b>L2-O/NO</b>  Railing Post Mounted Fixtures Lighting System	<b>Operable / Not Operable</b> <ul style="list-style-type: none"><li>Describes existing functionality of fixture.</li></ul>	<b>Cyclical Maintenance / Material Repair</b> <ul style="list-style-type: none"><li>Maintain operability of system / Repair system to make operable again.</li></ul>	Level 3

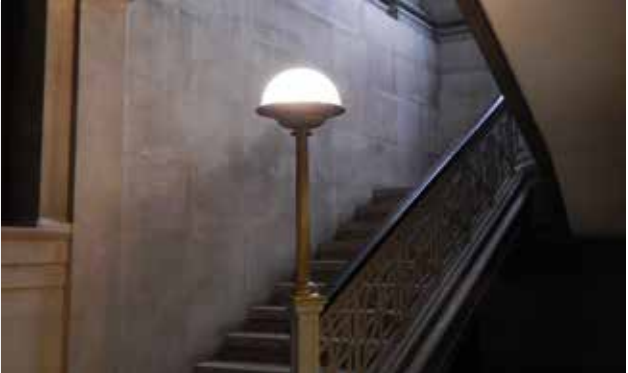
<b>L2-SA</b>  Railing Post Mounted Fixtures Lighting System	<b>Soiling</b> <ul style="list-style-type: none"><li>Surface staining caused by the build-up of pollutants.</li></ul>	<b>Develop Cleaning Program</b> <ul style="list-style-type: none"><li>Develop a cleaning program if it can be implemented without causing damage.</li></ul>	Level 3

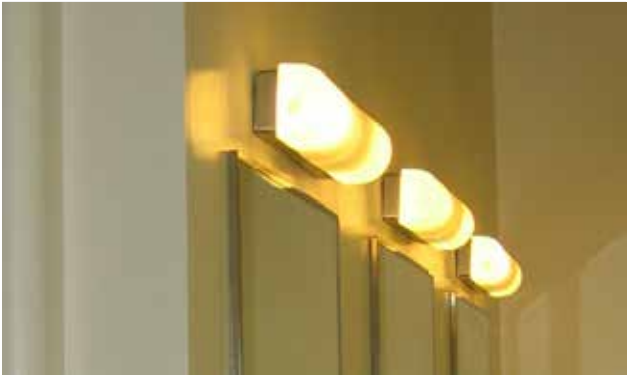
COMPONENT	CONDITION	TREATMENT	PRIORITY	REPRESENTATIVE PHOTO
<b>L3-OP</b>  Wall Mounted Flourescents Lighting System	<b>Overpainted</b> <ul style="list-style-type: none"><li>Multiple layers of paint.</li></ul>	<b>Clean Material</b> <ul style="list-style-type: none"><li>Leave alone unless other forms of deterioration are present, then scrape to substrate.</li></ul>

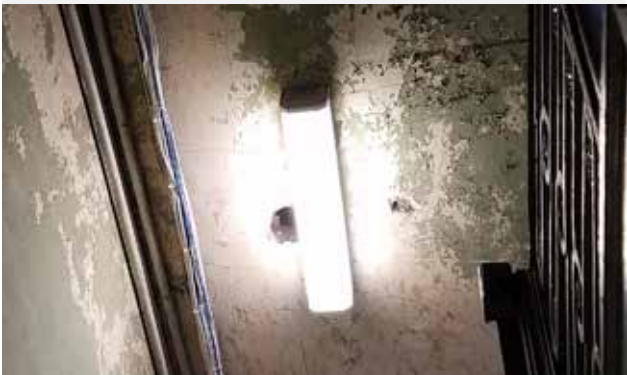
<b>L3-SA</b>  Wall Mounted Flourescents Lighting System	<b>Soiling</b> <ul style="list-style-type: none"><li>Surface staining caused by the build-up of pollutants.</li></ul>	<b>Develop Cleaning Program</b> <ul style="list-style-type: none"><li>Develop a cleaning program if it can be implemented without damage to bulding system.</li></ul>	Level 3

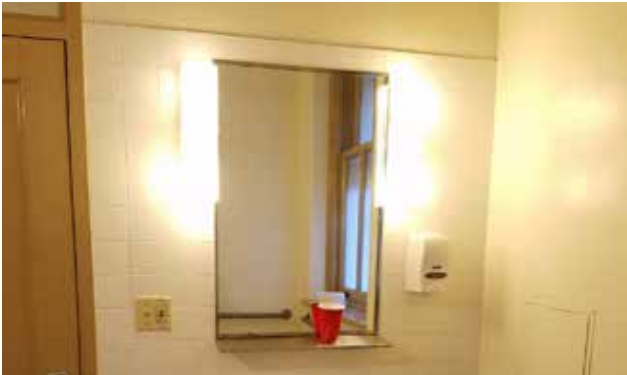
<b>L3-O/NO</b>  Wall Mounted Flourescents Lighting System	<b>Operable / Not Operable</b> <ul style="list-style-type: none"><li>Describes existing finctionality of fixture.</li></ul>	<b>Cyclical Maintenance / Material Repair</b> <ul style="list-style-type: none"><li>Maintain operability of system / Repair system to make operable again.</li></ul>	Level 3

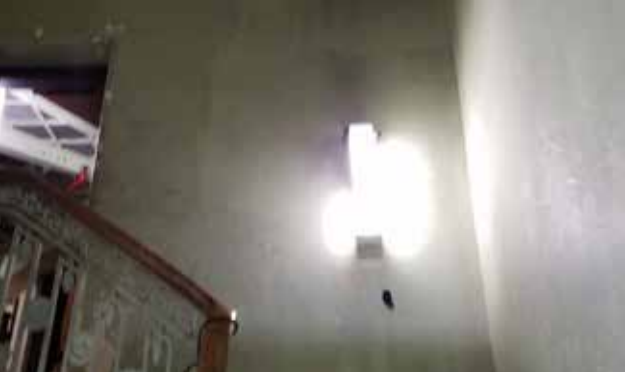
COMPONENT	CONDITION	TREATMENT	PRIORITY	REPRESENTATIVE PHOTO
<b>L3-MD</b>  Wall Mounted Flourescents Lighting System	<b>Mechanical Damage</b> <ul style="list-style-type: none"><li>Damage to material caused by mechanical components or equipment</li></ul>	<b>Material Repair or Replacement</b> <ul style="list-style-type: none"><li>Remove mechanical remnants and connections. Patch areas of missing or damaged material, if feasible; remove and replace material, as required.</li></ul>	Level 3
