# Conditions Assessment

## Gould Memorial Library & Hall of Fame

FINAL REPORT | 15 MARCH 2018

**BRONX**  
**COMMUNITY**  
COLLEGE

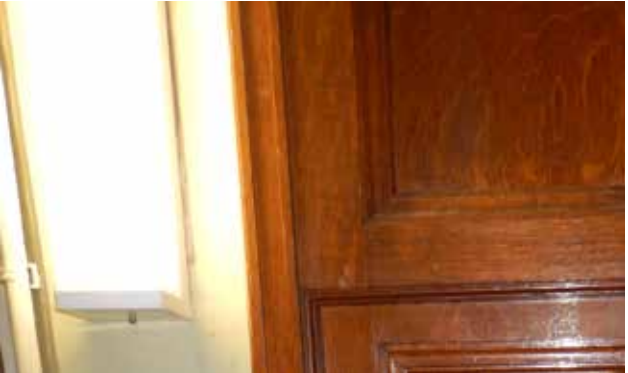
<b>L3-PR</b>  Wall Mounted Flourescents Lighting System	<b>Previous Repair</b> <ul style="list-style-type: none"><li>Area where a previous repair was done, including repointing, patching and consolidation.</li></ul>	<b>Material Patching or Replacement</b> <ul style="list-style-type: none"><li>Replace inappropriate previous patches.</li></ul>	Level 3

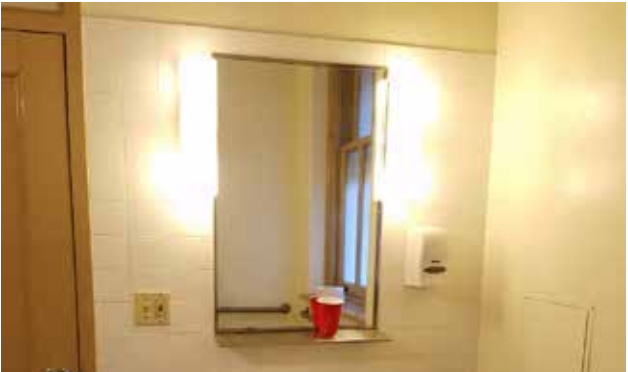
<b>L3-LM</b>  Wall Mounted Flourescents Lighting System	<b>Material Loss</b> <ul style="list-style-type: none"><li>Loss of material leaving holes or exposing inner layers.</li></ul>	<b>Material Repair or Replacement</b> <ul style="list-style-type: none"><li>Repair or replace missing material.</li></ul>	Level 3

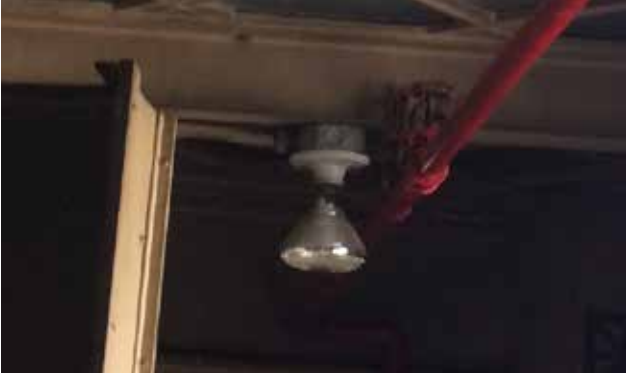
<b>L4-OU</b>  Ceiling Mounted Compact Flourescent Bulbs Lighting System	<b>Operation Unknown</b> <ul style="list-style-type: none"><li>Operability of light fixture was not determined.</li></ul>	<b>Further Investigation</b> <ul style="list-style-type: none"><li>Further investigation required to assess operability.</li></ul>	Level 3

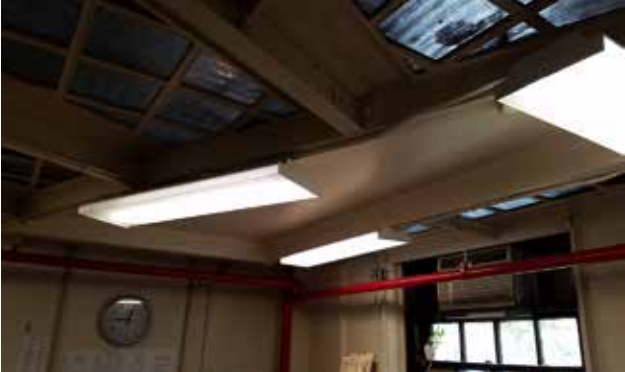
COMPONENT	CONDITION	TREATMENT	PRIORITY	REPRESENTATIVE PHOTO
<b>L4-SA</b>  Ceiling Mounted Compact Flourescent Bulbs Lighting System	<b>Soiling</b> <ul style="list-style-type: none"><li>Surface staining caused by the build-up of pollutants.</li></ul>	<b>Develop Cleaning Program</b> <ul style="list-style-type: none"><li>Develop a cleaning program if it can be implemented without damage to bulding system.</li></ul>	Level 3

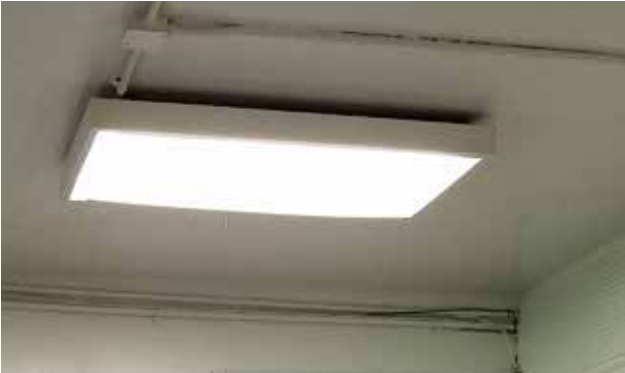
<b>L4-CR</b>  Ceiling Mounted Compact Flourescent Bulbs Lighting System	<b>Cracking</b> <ul style="list-style-type: none"><li>1/16 to 1/2 inch wide visible fissure in a surface, possibly penetrating through the surface.</li></ul>	<b>Material Patching or Replacement</b> <ul style="list-style-type: none"><li>Remove and replace damaged material.</li></ul>	Level 3

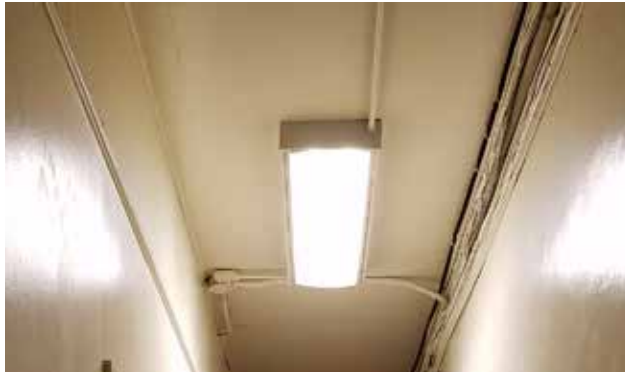
<b>L4-O/NO</b>  Ceiling Mounted Compact Flourescent Bulbs Lighting System	<b>Operable / Not Operable</b> <ul style="list-style-type: none"><li>Describes existing finctionality of fixture.</li></ul>	<b>Cyclical Maintenance / Material Repair</b> <ul style="list-style-type: none"><li>Maintain operability of system / Repair system to make operable again.</li></ul>	Level 3

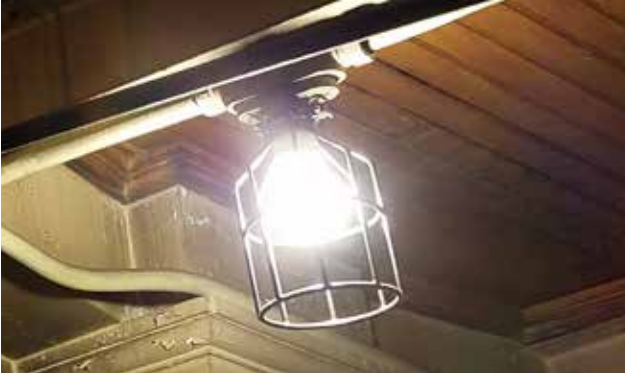
<b>L4-HM</b>  Ceiling Mounted Compact Flourescent Bulbs Lighting System	<b>Missing Hardware</b> <ul style="list-style-type: none"><li>The absence of hardware associated with the light fixture.</li></ul>	<b>Material Replacement</b> <ul style="list-style-type: none"><li>Replace missing hardware.</li></ul>	Level 3

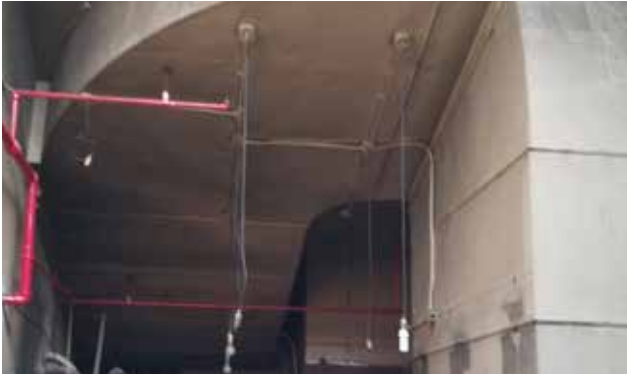
COMPONENT	CONDITION	TREATMENT	PRIORITY	REPRESENTATIVE PHOTO
<b>L5-LM</b>  Hanging Pendant Lighting System	<b>Material Loss</b> <ul style="list-style-type: none"><li>Loss of material leaving holes or exposing inner layers.</li></ul>	<b>Material Repair or Replacement</b> <ul style="list-style-type: none"><li>Repair or replace missing material.</li></ul>	Level 3

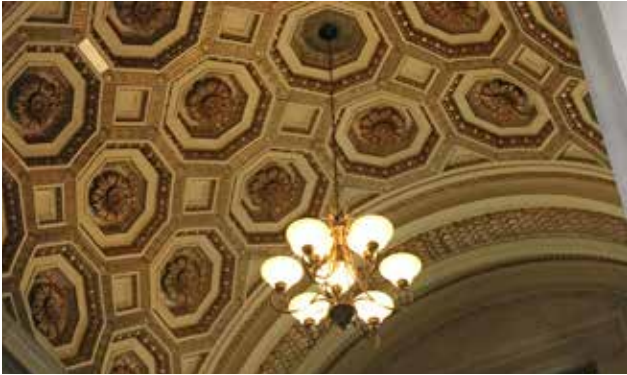
<b>L5-CR</b>  Hanging Pendant Lighting System	<b>Cracking</b> <ul style="list-style-type: none"><li>1/16 to 1/2 inch wide visible fissure in a surface, possibly penetrating through the surface.</li></ul>	<b>Material Patching or Replacement</b> <ul style="list-style-type: none"><li>Remove and replace damaged material.</li></ul>	Level 3

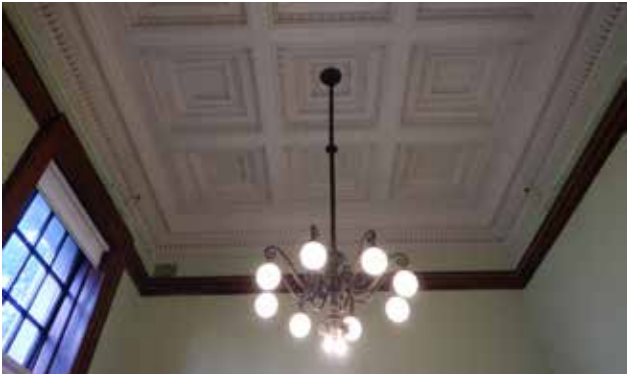
<b>L5-O/NO</b>  Hanging Pendant Lighting System	<b>Operable / Not Operable</b> <ul style="list-style-type: none"><li>Describes existing functionality of fixture.</li></ul>	<b>Cyclical Maintenance / Material Repair</b> <ul style="list-style-type: none"><li>Maintain operability of system / Repair system to make operable again.</li></ul>	Level 3

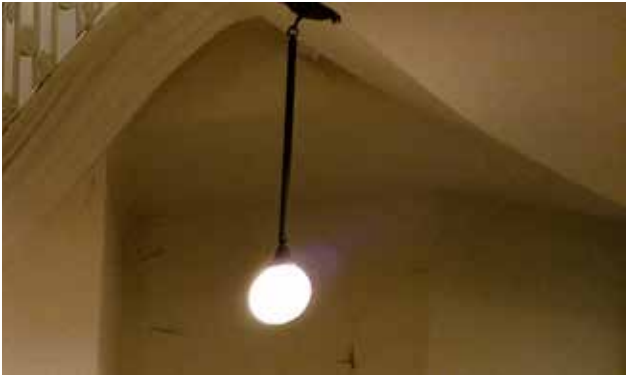
<b>L5-HM</b>  Hanging Pendant Lighting System	<b>Missing Hardware</b> <ul style="list-style-type: none"><li>The absence of hardware associated with the light fixture.</li></ul>	<b>Material Replacement</b> <ul style="list-style-type: none"><li>Replace missing hardware.</li></ul>	Level 3

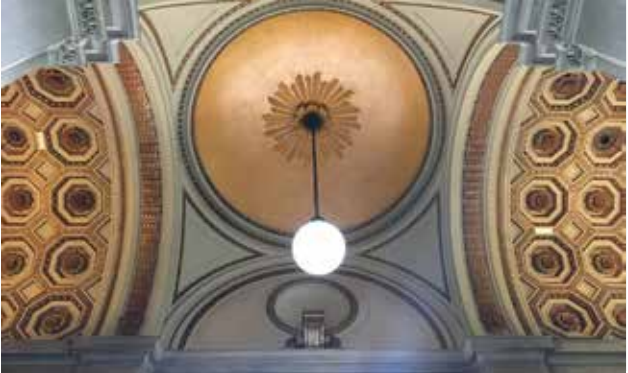
COMPONENT	CONDITION	TREATMENT	PRIORITY	REPRESENTATIVE PHOTO
<b>L5-SA</b>  Hanging Pendant Lighting System	<b>Soiling</b> <ul style="list-style-type: none"><li>Surface staining caused by the build-up of pollutants.</li></ul>	<b>Develop Cleaning Program</b> <ul style="list-style-type: none"><li>Develop a cleaning program if it can be implemented without damage to building system.</li></ul>	Level 3

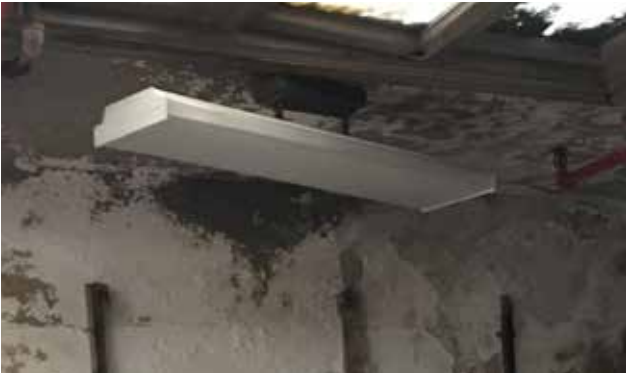
<b>L6-OU</b>  Suspended Flourescents Lighting System	<b>Operation Unknown</b> <ul style="list-style-type: none"><li>Operability of light fixture was not determined.</li></ul>	<b>Further Investigation</b> <ul style="list-style-type: none"><li>Further investigation required to assess operability.</li></ul>	Level 3

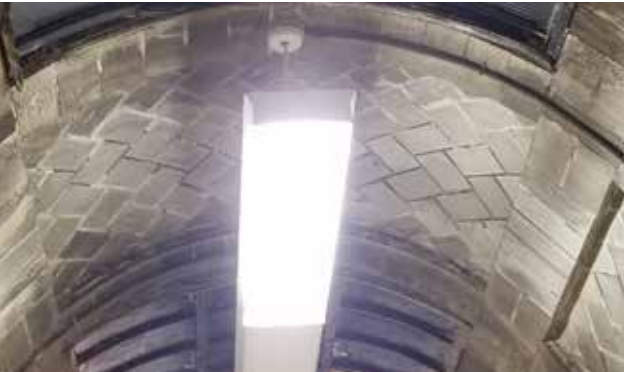
<b>L6-O/NO</b>  Suspended Flourescents Lighting System	<b>Operable / Not Operable</b> <ul style="list-style-type: none"><li>Describes existing finctionality of fixture.</li></ul>	<b>Cyclical Maintenance / Material Repair</b> <ul style="list-style-type: none"><li>Maintain operability of system / Repair system to make operable again.</li></ul>	Level 3

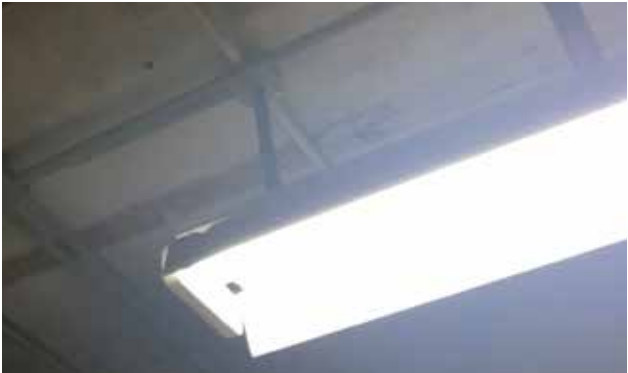
<b>L6-HM</b>  Suspended Flourescents Lighting System	<b>Missing Hardware</b> <ul style="list-style-type: none"><li>The absence of hardware associated with the light fixture.</li></ul>	<b>Material Replacement</b> <ul style="list-style-type: none"><li>Replace missing hardware.</li></ul>	Level 3

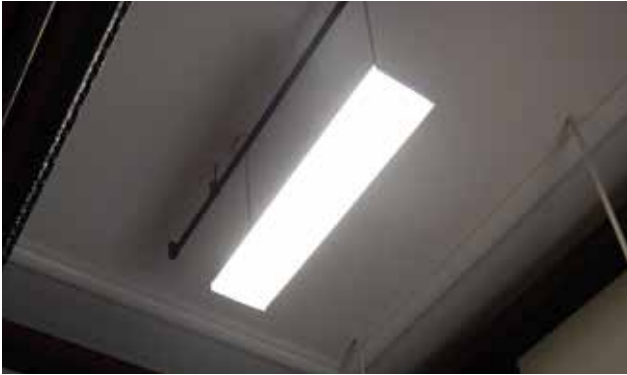
COMPONENT	CONDITION	TREATMENT	PRIORITY	REPRESENTATIVE PHOTO
<b>L6-SA</b>  Suspended Flourescents Lighting System	<b>Soiling</b> <ul style="list-style-type: none"><li>Surface staining caused by the build-up of pollutants.</li></ul>	<b>Develop Cleaning Program</b> <ul style="list-style-type: none"><li>Develop a cleaning program if it can be implemented without damage to bulding system.</li></ul>	Level 3

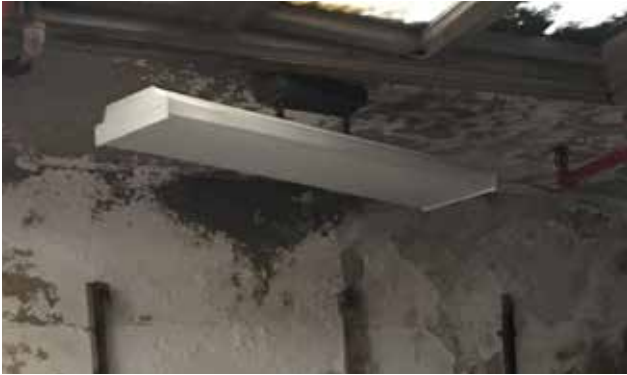
<b>L6-CR</b>  Suspended Flourescents Lighting System	<b>Cracking</b> <ul style="list-style-type: none"><li>1/16 to 1/2 inch wide visible fissure in a surface, possibly penetrating through the surface.</li></ul>	<b>Material Patching or Replacement</b> <ul style="list-style-type: none"><li>Remove and replace damaged material.</li></ul>	Level 3

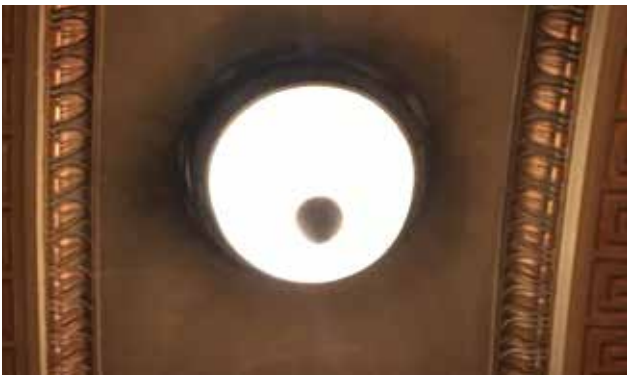
<b>L7-O/NO</b>  Ceiling Mounted Dome Lighting System	<b>Operable / Not Operable</b> <ul style="list-style-type: none"><li>Describes existing fnctionality of fixture.</li></ul>	<b>Cyclical Maintenance / Material Repair</b> <ul style="list-style-type: none"><li>Maintain operability of system / Repair system to make operable again.</li></ul>	Level 3

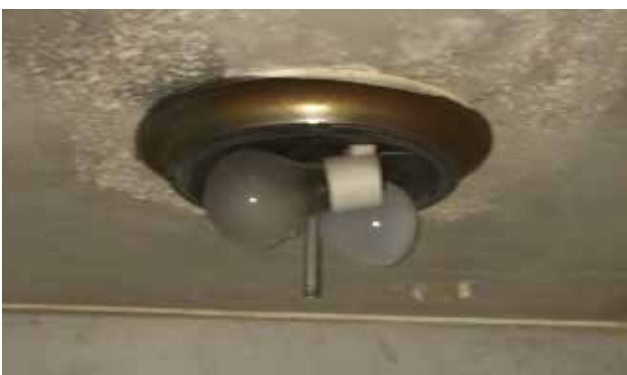
<b>L7-OU</b>  Ceiling Mounted Dome Lighting System	<b>Operation Unknown</b> <ul style="list-style-type: none"><li>Operability of light fixture was not determined.</li></ul>	<b>Further Investigation</b> <ul style="list-style-type: none"><li>Further investigation required to assess operability.</li></ul>	Level 3

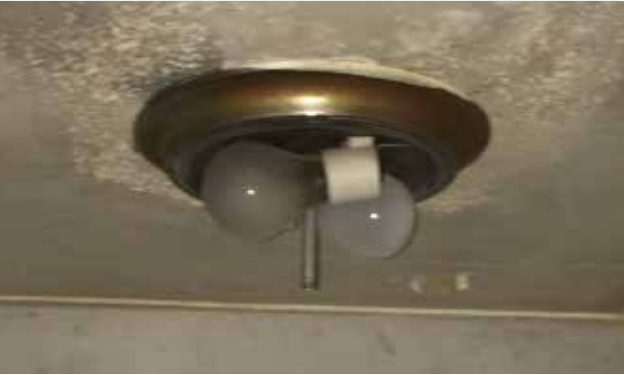
COMPONENT	CONDITION	TREATMENT	PRIORITY	REPRESENTATIVE PHOTO
<b>L7-HM</b>  Ceiling Mounted Dome Lighting System	<b>Missing Hardware</b> <ul style="list-style-type: none"><li>The absence of hardware associated with the light fixture.</li></ul>	<b>Material Replacement</b> <ul style="list-style-type: none"><li>Replace missing hardware.</li></ul>	Level 3

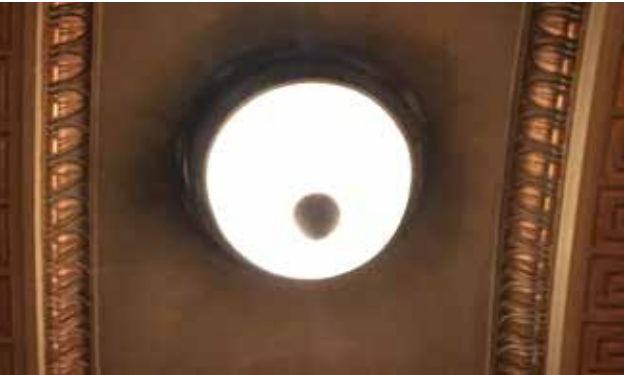
<b>L7-CR</b>  Ceiling Mounted Dome Lighting System	<b>Cracking</b> <ul style="list-style-type: none"><li>1/16 to 1/2 inch wide visible fissure in a surface, possible penetrating through the surface.</li></ul>	<b>Material Patching or Replacement</b> <ul style="list-style-type: none"><li>Remove and replace damaged material.</li></ul>	Level 3

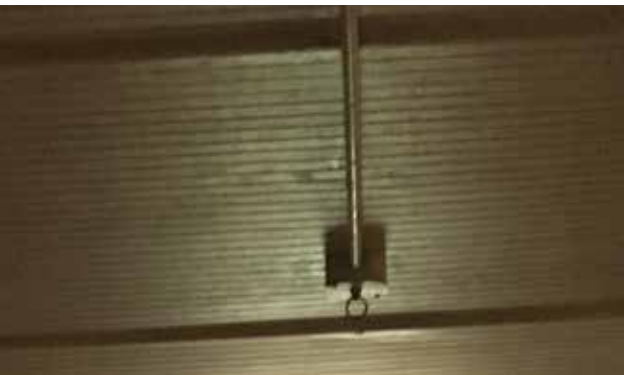
<b>L8-O/NO</b>  Empty J-box / Socket Lighting System	<b>Operable / Not Operable</b> <ul style="list-style-type: none"><li>Describes existing functionality of fixture.</li></ul>	<b>Cyclical Maintenance / Material Repair</b> <ul style="list-style-type: none"><li>Maintain operability of system / Repair system to make operable again.</li></ul>	Level 3

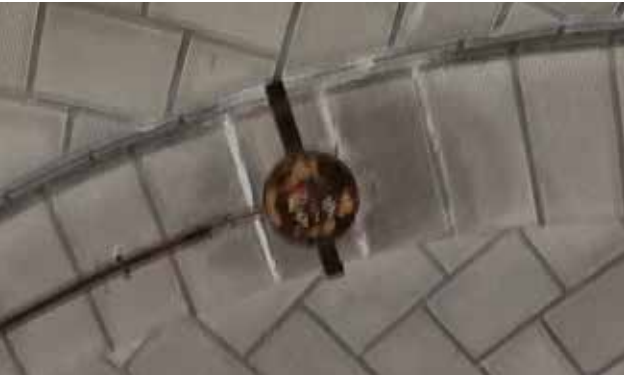
<b>L8-OU</b>  Empty J-box / Socket Lighting System	<b>Operation Unknown</b> <ul style="list-style-type: none"><li>Operability of light fixture was not determined.</li></ul>	<b>Further Investigation</b> <ul style="list-style-type: none"><li>Further investigation required to assess operability.</li></ul>	Level 3

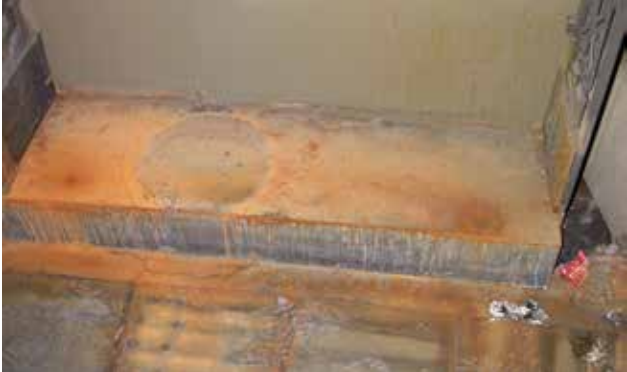
COMPONENT	CONDITION	TREATMENT	PRIORITY	REPRESENTATIVE PHOTO
<b>B1-MC</b>  Stack Panel Bookstacks System	<b>Corrosion</b> <ul style="list-style-type: none"><li>Deterioration of material by a chemical reaction with its environment.</li></ul>	<b>Removal of Deteriorated Material</b> <ul style="list-style-type: none"><li>Remove corrosion and corrosive products; in severe cases, replace deteriorated members with new material to match existing.</li><li>Refer to assesment of structural engineer for details on replacement of select cast iron members.</li></ul>	Level 3

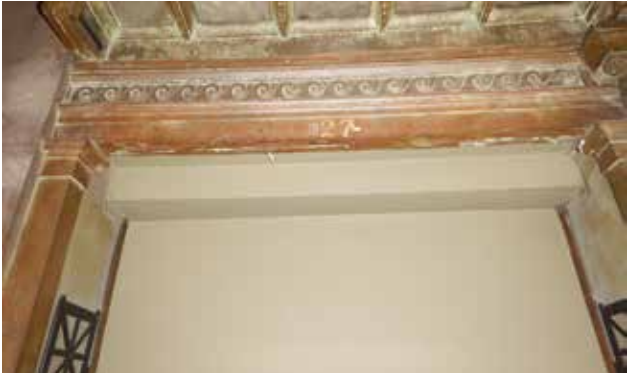
<b>B1-ST</b>  Stack Panel Bookstacks System	<b>Staining</b> <ul style="list-style-type: none"><li>Surface problem caused by the build-up of pollutants, mineral deposits and water marks.</li></ul>	<b>Develop Cleaning Program</b> <ul style="list-style-type: none"><li>Develop a cleaning program if it can be implemented without damage to bulding system.</li></ul>	Level 3

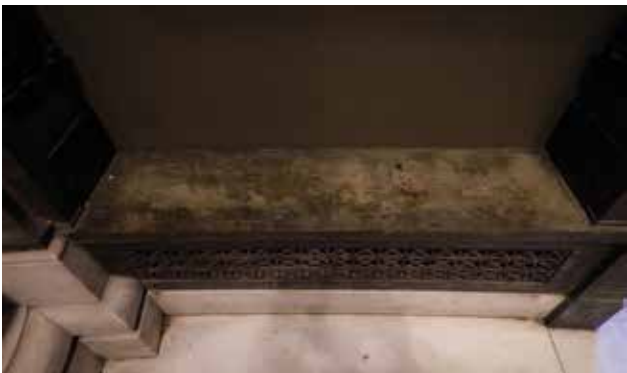
<b>B1-SA</b>  Stack Panel Bookstacks System	<b>Soiling</b> <ul style="list-style-type: none"><li>Surface staining caused by the build-up of pollutants.</li></ul>	<b>Develop Cleaning Program</b> <ul style="list-style-type: none"><li>Develop a cleaning program if it can be implemented without damage to bulding system.</li></ul>	Level 3

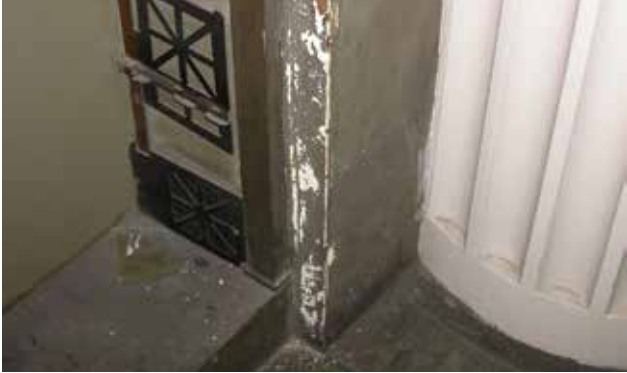
<b>B1-LC</b>  Stack Panel Bookstacks System	<b>Paint Loss</b> <ul style="list-style-type: none"><li>Loss of surface paint.</li></ul>	<b>Material Replacement</b> <ul style="list-style-type: none"><li>Determine reason for paint loss, correct problem and repaint.</li></ul>	Level 3

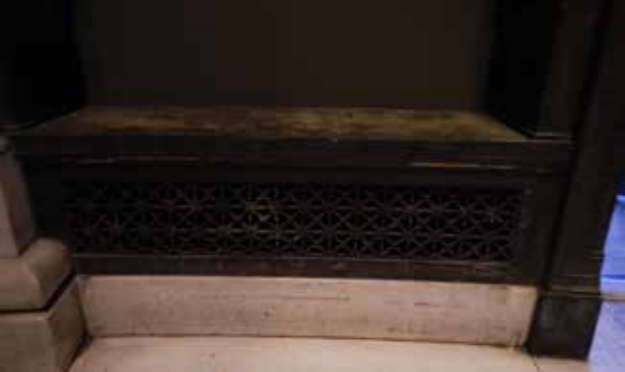
COMPONENT	CONDITION	TREATMENT	PRIORITY	REPRESENTATIVE PHOTO
<b>B1-MD</b>  Stack Panel Bookstacks System	<b>Mechanical Damage</b> <ul style="list-style-type: none"><li>Damage to material caused by mechanical components or equipment</li></ul>	<b>Material Repair or Replacement</b> <ul style="list-style-type: none"><li>Remove mechanical remnants and connections. Patch areas of missing or damaged material, if feasible; remove and replace material, as required.</li></ul>	Level 3

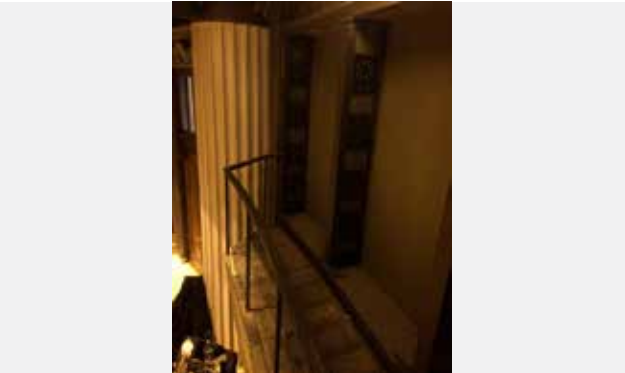
<b>B1-ED</b>  Stack Panel Bookstacks System	<b>Deformation</b> <ul style="list-style-type: none"><li>Distortion or changing in shape of a material, usually through the application of pressure.</li></ul>	<b>Material Repair or Replacement</b> <ul style="list-style-type: none"><li>Determine reason for deformation and repair or replace material if necessary.</li></ul>	Level 3

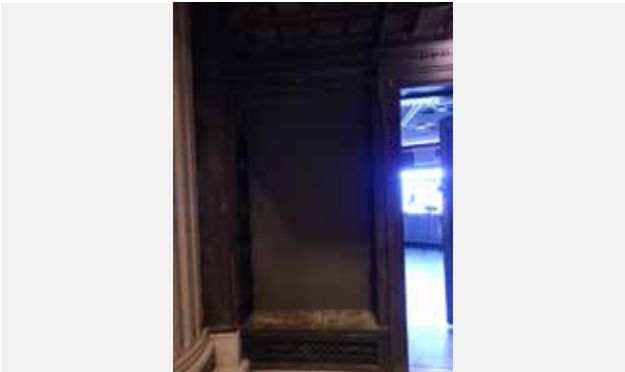
<b>B1-LM</b>  Stack Panel Bookstacks System	<b>Material Loss</b> <ul style="list-style-type: none"><li>Loss of material leaving holes or exposing inner layers.</li></ul>	<b>Material Patching or Replacement</b> <ul style="list-style-type: none"><li>Replace missing material to match existing.</li></ul>	Level 3

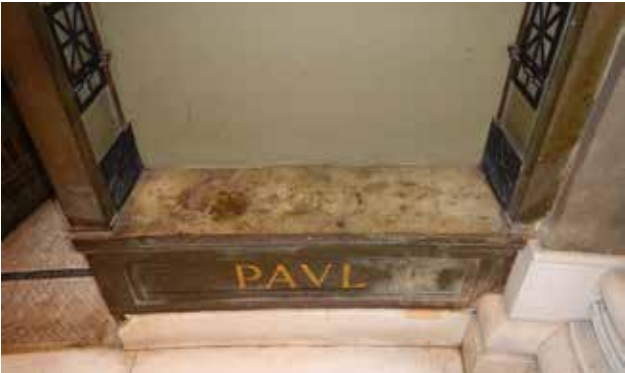
<b>B1-SD</b>  Stack Panel Bookstacks System	<b>Scratches / Dents</b> <ul style="list-style-type: none"><li>Damage to material caused by mechanical components or equipment</li></ul>	<b>Material Repair or Replacement</b> <ul style="list-style-type: none"><li>Patch areas of missing or damaged material, if feasible; remove and replace material, as required.</li></ul>	Level 3

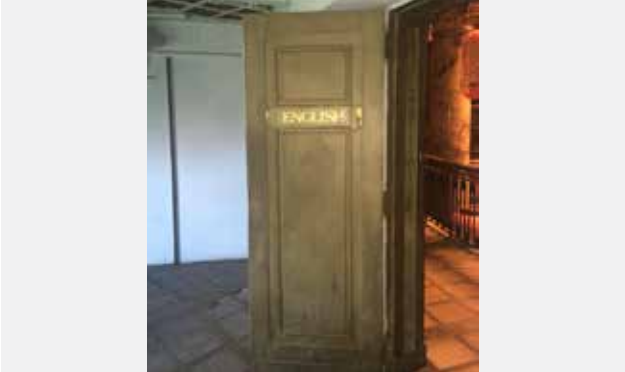
COMPONENT	CONDITION	TREATMENT	PRIORITY	REPRESENTATIVE PHOTO
<b>B2-HM</b>  Stack Panel Door Bookstacks System	<b>Missing Hardware</b> <ul style="list-style-type: none"><li>The absence of knobs, hinges, pulls, etc.</li></ul>	<b>Material Replacement</b> <ul style="list-style-type: none"><li>Replace missing hardware.</li></ul>	Level 3

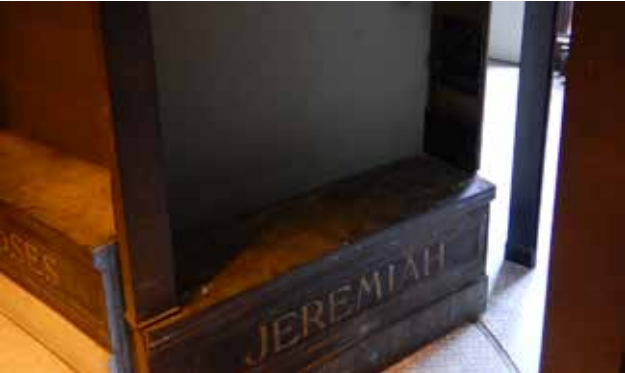
<b>B2-SW</b>  Stack Panel Door Bookstacks System	<b>Water Damage</b> <ul style="list-style-type: none"><li>Biological growth, blistering, efflorescence, wood rot or staining caused by the infiltration of water.</li></ul>	<b>Removal of Deteriorated Material</b> <ul style="list-style-type: none"><li>Identify source of water infiltration and remedy cause. Replace deteriorated and damaged material.</li></ul>	Level 3

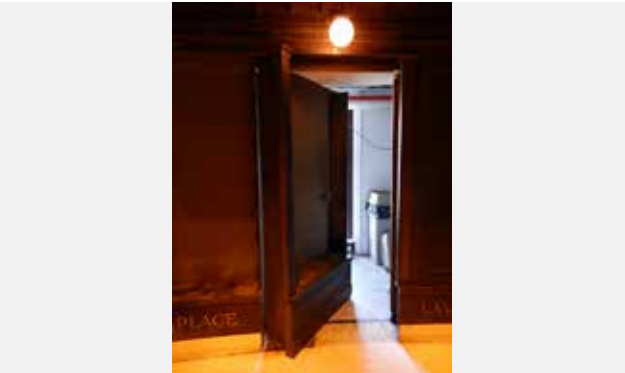
<b>B2-MC</b>  Stack Panel Door Bookstacks System	<b>Corrosion</b> <ul style="list-style-type: none"><li>Deterioration of material by a chemical reaction with its environment.</li></ul>	<b>Removal of Deteriorated Material</b> <ul style="list-style-type: none"><li>Remove corrosion and corrosive products; in severe cases, replace deteriorated members with new material to match existing.</li><li>Refer to assesment of structural engineer for details on replacement of select cast iron members.</li></ul>	Level 3

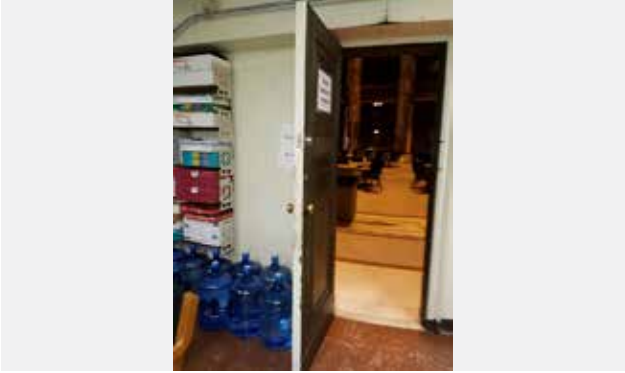
<b>B2-LC</b>  Stack Panel Door Bookstacks System	<b>Paint Loss</b> <ul style="list-style-type: none"><li>Loss of surface paint.</li></ul>	<b>Material Replacement</b> <ul style="list-style-type: none"><li>Determine reason for paint loss, correct problem and repaint.</li></ul>	Level 3

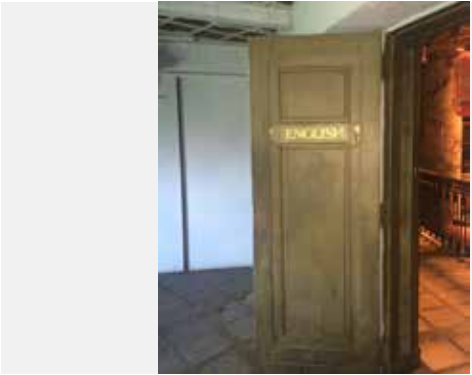
COMPONENT	CONDITION	TREATMENT	PRIORITY	REPRESENTATIVE PHOTO
<b>B2-MD</b>  Stack Panel Door Bookstacks System	<b>Mechanical Damage</b> <ul style="list-style-type: none"><li>Damage to material caused by mechanical components or equipment</li></ul>	<b>Material Repair or Replacement</b> <ul style="list-style-type: none"><li>Remove mechanical remnants and connections. Patch areas of missing or damaged material, if feasible; remove and replace material, as required.</li></ul>	Level 3

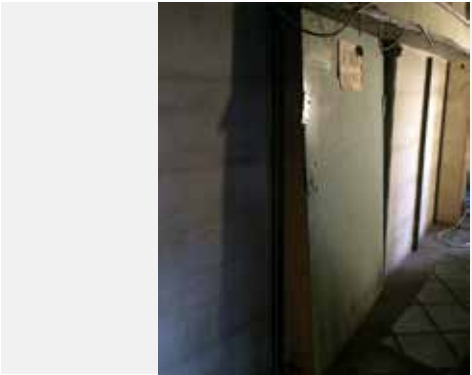
<b>B2-ED</b>  Stack Panel Door Bookstacks System	<b>Deformation</b> <ul style="list-style-type: none"><li>Distortion or changing in shape of a material, usually through the application of pressure.</li></ul>	<b>Material Repair or Replacement</b> <ul style="list-style-type: none"><li>Determine reason for deformation and repair or replace material if necessary.</li></ul>	Level 3

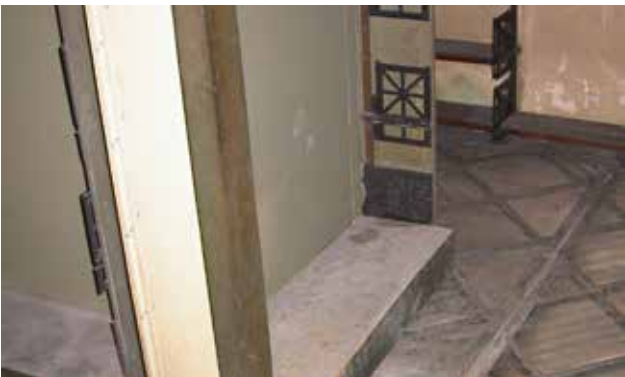
<b>B2-W</b>  Stack Panel Door Bookstacks System	<b>Wear</b> <ul style="list-style-type: none"><li>The gradual disintegration and erosion of materials caused by gradual use overtime.</li></ul>	<b>Material Patching or Replacement</b> <ul style="list-style-type: none"><li>Leave alone unless severe, then consider replacing.</li></ul>	Level 3

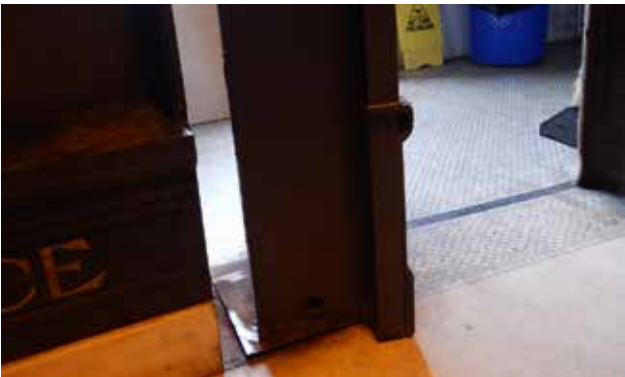
<b>B2-LM</b>  Stack Panel Door Bookstacks System	<b>Material Loss</b> <ul style="list-style-type: none"><li>Loss of material leaving holes or exposing inner layers.</li></ul>	<b>Material Patching or Replacement</b> <ul style="list-style-type: none"><li>Patch areas of missing material, if feasible, or replace material to match existing.</li></ul>	Level 3

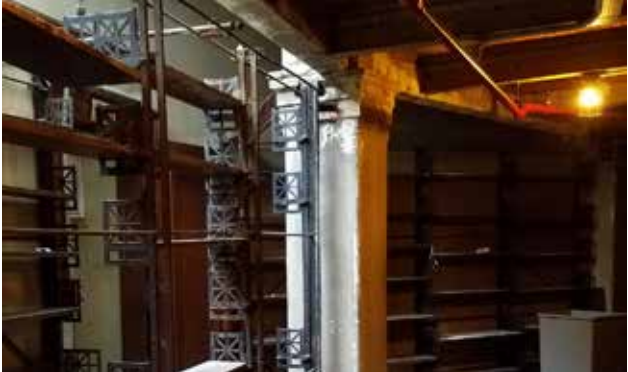
COMPONENT	CONDITION	TREATMENT	PRIORITY	REPRESENTATIVE PHOTO
<b>B3-SB</b>  Free Standing Bookstacks System	<b>Biological Growth</b> <ul style="list-style-type: none"><li>• Surface growth having biological origins, typically found in damp locations.</li></ul>	<b>Develop Cleaning Program</b> <ul style="list-style-type: none"><li>• Clean, identify source of water infiltration and remedy cause. If severe, replace deteriorated material.</li></ul>	Level 3

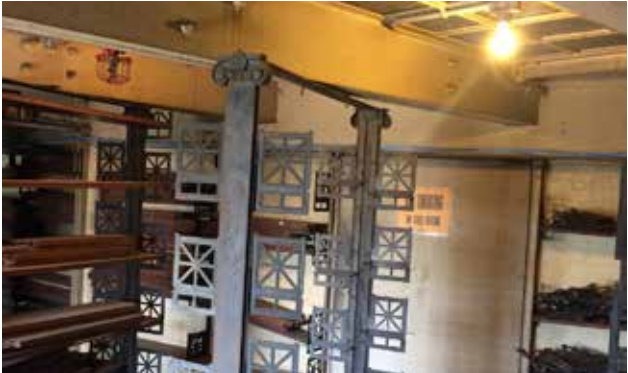
<b>B3-ST</b>  Free Standing Bookstacks System	<b>Staining</b> <ul style="list-style-type: none"><li>• Surface problem caused by the build-up of pollutants, mineral deposits and water marks.</li></ul>	<b>Develop Cleaning Program</b> <ul style="list-style-type: none"><li>• Develop a cleaning program if it can be implemented without damage to bulding system.</li></ul>	Level 3

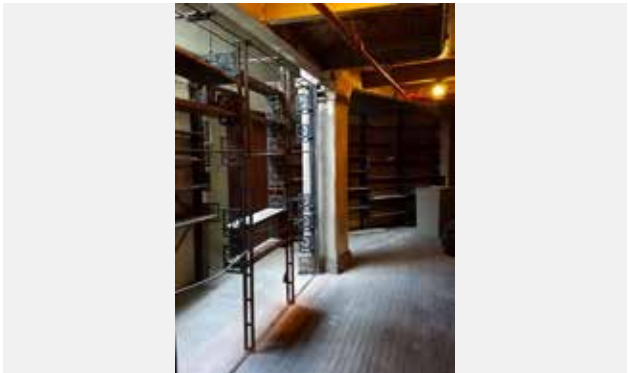
<b>B3-SA</b>  Free Standing Bookstacks System	<b>Soiling</b> <ul style="list-style-type: none"><li>• Surface staining caused by the build-up of pollutants.</li></ul>	<b>Develop Cleaning Program</b> <ul style="list-style-type: none"><li>• Develop a cleaning program if it can be implemented without damage to bulding system.</li></ul>	Level 3

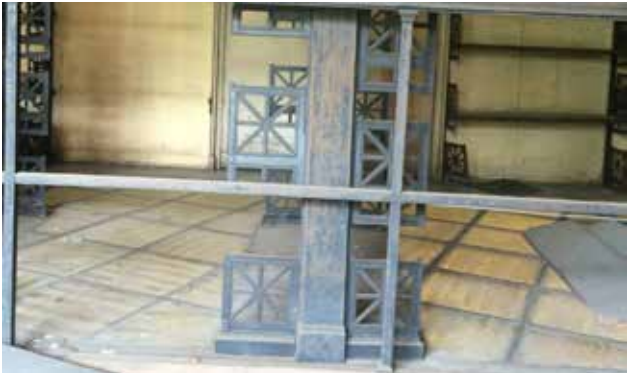
<b>B3-MC</b>  Free Standing Bookstacks System	<b>Corrosion</b> <ul style="list-style-type: none"><li>• Deterioration of material by a chemical reaction with its environment.</li></ul>	<b>Removal of Deteriorated Material</b> <ul style="list-style-type: none"><li>• Remove corrosion and corrosive products; in severe cases, replace deteriorated members with new material to match existing.</li><li>• Refer to assesment of structural engineer for details on replacement of select cast iron members.</li></ul>	Level 3

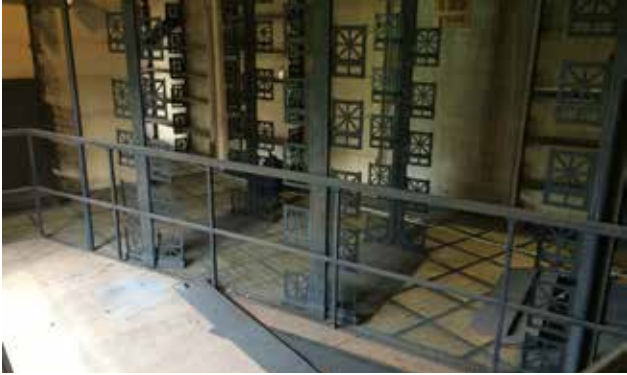
COMPONENT	CONDITION	TREATMENT	PRIORITY	REPRESENTATIVE PHOTO
<b>B3-E</b>  Free Standing Bookstacks System	<b>Extant</b> <ul style="list-style-type: none"><li>An existing building system in good condition.</li></ul>	<b>Cyclical Maintenance</b> <ul style="list-style-type: none"><li>Develop a cleaning program to extend life of building system.</li></ul>	Level 3

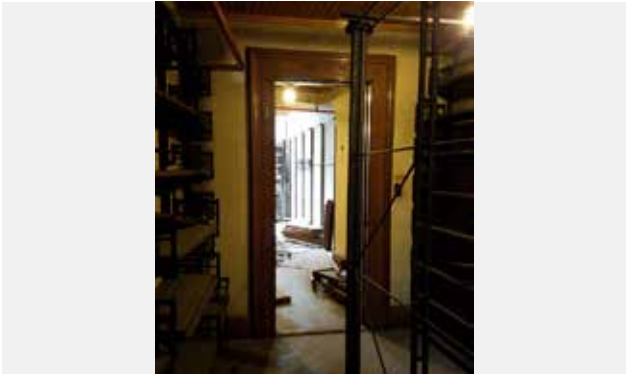
<b>B3-MD</b>  Free Standing Bookstacks System	<b>Mechanical Damage</b> <ul style="list-style-type: none"><li>Damage to material caused by mechanical components or equipment</li></ul>	<b>Material Repair or Replacement</b> <ul style="list-style-type: none"><li>Remove mechanical remnants and connections. Patch areas of missing or damaged material, if feasible; remove and replace material, as required.</li></ul>	Level 3

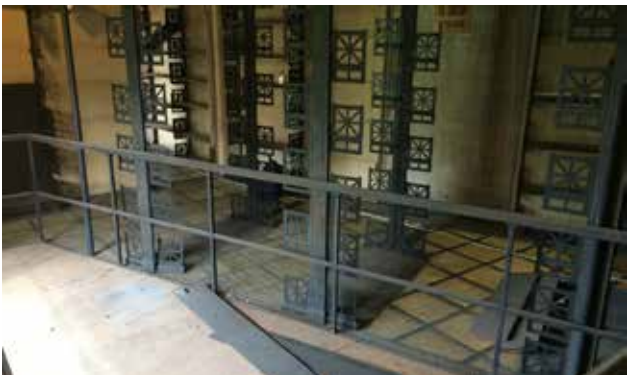
<b>B3-LM</b>  Free Standing Bookstacks System	<b>Material Loss</b> <ul style="list-style-type: none"><li>Loss of material leaving holes or exposing inner layers.</li></ul>	<b>Material Replacement</b> <ul style="list-style-type: none"><li>Patch areas of missing material, if feasible, or replace material to match existing.</li></ul>	Level 3

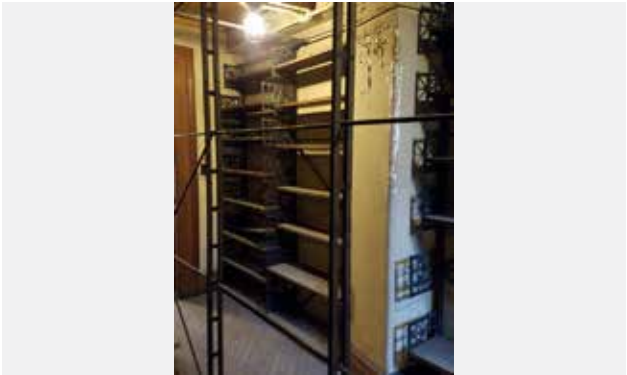
<b>B3-CR</b>  Free Standing Bookstacks System	<b>Crack</b> <ul style="list-style-type: none"><li>1/16 to 1/2 inch wide visible fissure in a surface, possibly penetrating through the surface.</li></ul>	<b>Material Patching or Replacement</b> <ul style="list-style-type: none"><li>Remove and replace damaged material.</li></ul>	Level 3

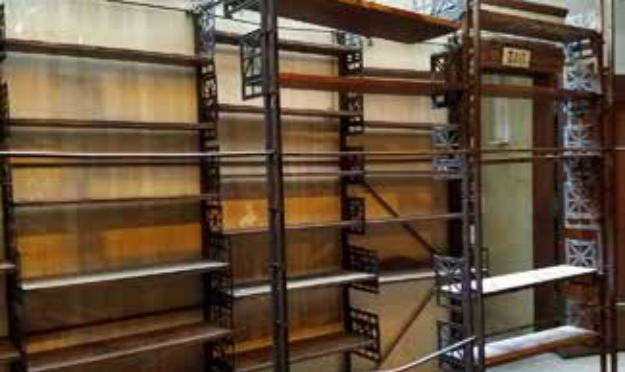
COMPONENT	CONDITION	TREATMENT	PRIORITY	REPRESENTATIVE PHOTO
<b>B3-SL</b>  Free Standing Bookstacks System	<b>Splintering</b> <ul style="list-style-type: none"><li>Caused by the process of swelling from moisture and drying from heat, or mechanical damage.</li></ul>	<b>Removal of Deteriorated Material</b> <ul style="list-style-type: none"><li>Repair by sanding or wood putty.</li></ul>	Level 3

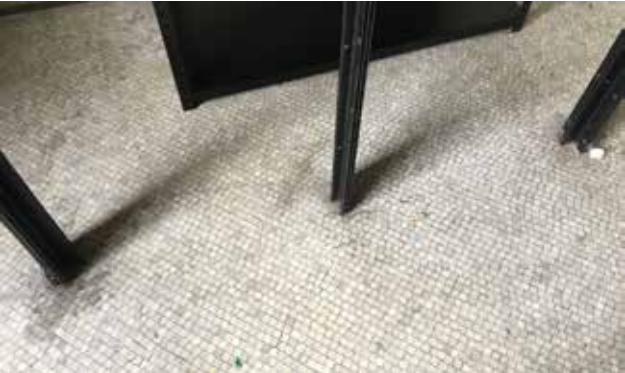
<b>B3-LC</b>  Free Standing Bookstacks System	<b>Paint Loss</b> <ul style="list-style-type: none"><li>Loss of surface paint.</li></ul>	<b>Material Replacement</b> <ul style="list-style-type: none"><li>Determine reason for paint loss, correct problem and repaint.</li></ul>	Level 3

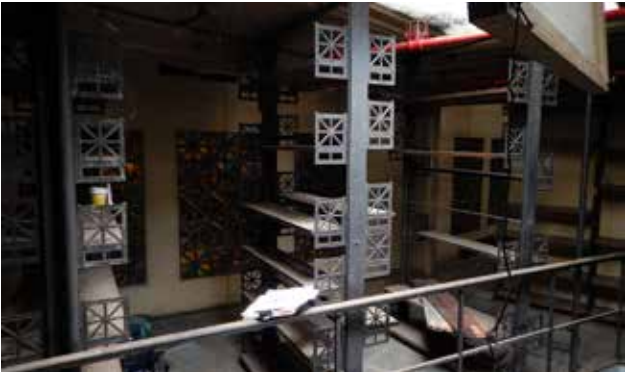
<b>B3-OJ</b>  Free Standing Bookstacks System	<b>Open Joints</b> <ul style="list-style-type: none"><li>Joints without caulking</li></ul>	<b>Material Patching or Replacement</b> <ul style="list-style-type: none"><li>Determine reason for missing caulk and reseal edges.</li></ul>	Level 3

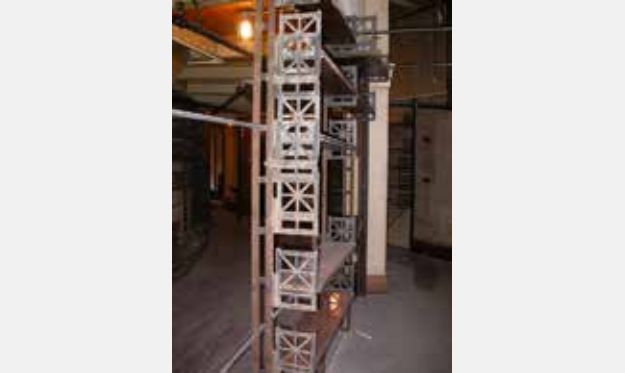
<b>B3-SW</b>  Free Standing Bookstacks System	<b>Water Damage</b> <ul style="list-style-type: none"><li>Biological growth, blistering, efflorescence, wood rot or staining caused by the infiltration of water.</li></ul>	<b>Removal of Deteriorated Material</b> <ul style="list-style-type: none"><li>Identify source of water infiltration and remedy cause. Replace deteriorated and damaged material.</li></ul>	Level 3

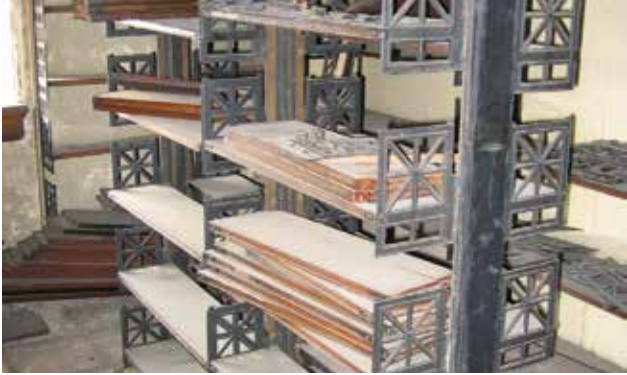
COMPONENT	CONDITION	TREATMENT	PRIORITY	REPRESENTATIVE PHOTO
<b>B3-W</b>  Free Standing Bookstacks System	<b>Wear</b> <ul style="list-style-type: none"><li>The gradual disintegration and erosion of materials caused by gradual use overtime.</li></ul>	<b>Material Patching or Replacement</b> <ul style="list-style-type: none"><li>Leave alone unless severe, then consider replacing.</li></ul>	Level 3

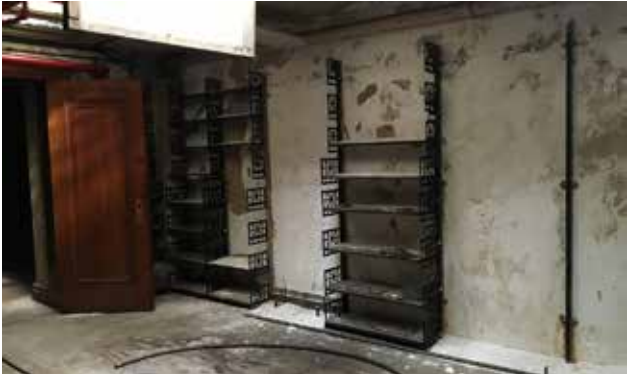
<b>B4-MD</b>  Wall Mounted Bookstacks System	<b>Mechanical Damage</b> <ul style="list-style-type: none"><li>Damage to material caused by mechanical components or equipment</li></ul>	<b>Material Repair or Replacement</b> <ul style="list-style-type: none"><li>Remove mechanical remnants and connections. Patch areas of missing or damaged material, if feasible; remove and replace material, as required.</li></ul>	Level 3

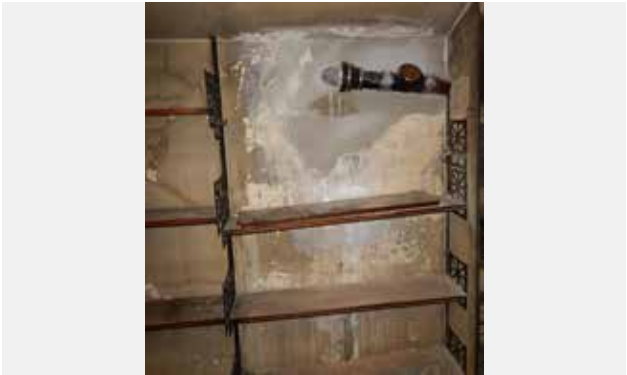
<b>B4-SW</b>  Wall Mounted Bookstacks System	<b>Water Damage</b> <ul style="list-style-type: none"><li>Biological growth, blistering, efflorescence, wood rot or staining caused by the infiltration of water.</li></ul>	<b>Removal of Deteriorated Material</b> <ul style="list-style-type: none"><li>Identify source of water infiltration and remedy cause. Replace deteriorated and damaged material.</li></ul>	Level 3

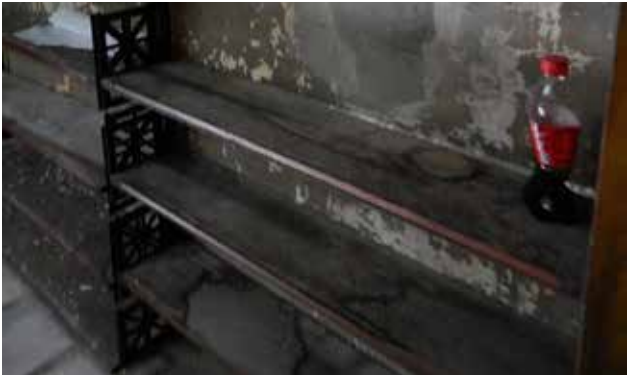
<b>B4-RT</b>  Wall Mounted Bookstacks System	<b>Wood Rot</b> <ul style="list-style-type: none"><li>The growth of fungi when oxygen, warmth and moisture are present in wood.</li></ul>	<b>Material Repair or Replacement</b> <ul style="list-style-type: none"><li>Replace rotted elements and treat new wood to repel agents that cause rotting.</li></ul>	Level 3

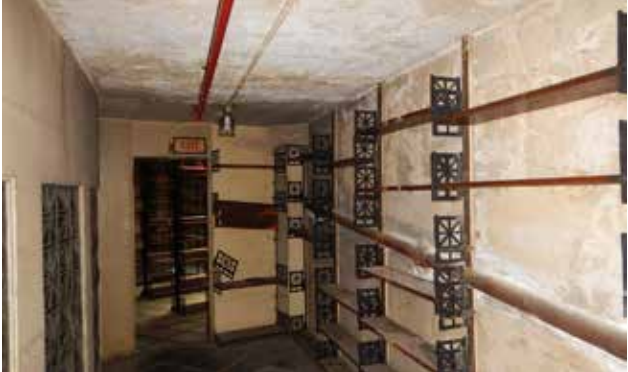
COMPONENT	CONDITION	TREATMENT	PRIORITY	REPRESENTATIVE PHOTO
<b>B4-MC</b>  Wall Mounted Bookstacks System	<b>Corrosion</b> <ul style="list-style-type: none"><li>Deterioration of material by a chemical reaction with its environment.</li></ul>	<b>Removal of Deteriorated Material</b> <ul style="list-style-type: none"><li>Remove corrosion and corrosive products; in severe cases, replace deteriorated members with new material to match existing.</li><li>Refer to assesment of structural engineer for details on replacement of select cast iron members.</li></ul>	Level 3

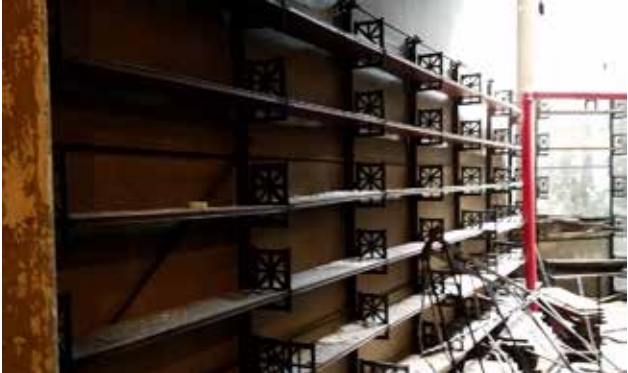
<b>B4-ST</b>  Wall Mounted Bookstacks System	<b>Staining</b> <ul style="list-style-type: none"><li>Surface problem caused by the build-up of pollutants, mineral deposits and water marks.</li></ul>	<b>Develop Cleaning Program</b> <ul style="list-style-type: none"><li>Develop a cleaning program if it can be implemented without damage to bulding system.</li></ul>	Level 3

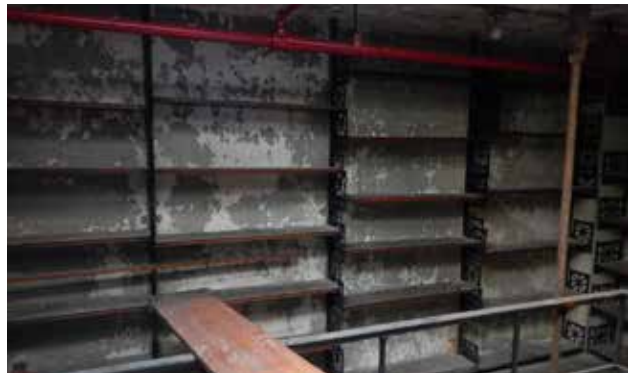
<b>B4-SA</b>  Wall Mounted Bookstacks System	<b>Soiling</b> <ul style="list-style-type: none"><li>Surface staining caused by the build-up of pollutants.</li></ul>	<b>Develop Cleaning Program</b> <ul style="list-style-type: none"><li>Develop a cleaning program if it can be implemented without damage to bulding system.</li></ul>	Level 3

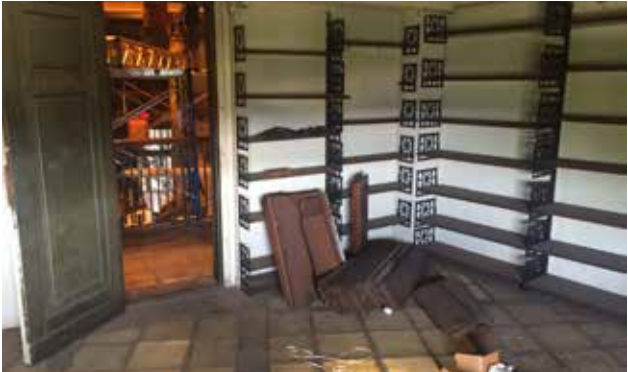
<b>B4-E</b>  Wall Mounted Bookstacks System	<b>Extant</b> <ul style="list-style-type: none"><li>An existing building system in good condition.</li></ul>	<b>Cyclical Maintenance</b> <ul style="list-style-type: none"><li>Develop a cleaning program to extend life of building system.</li></ul>	Level 3

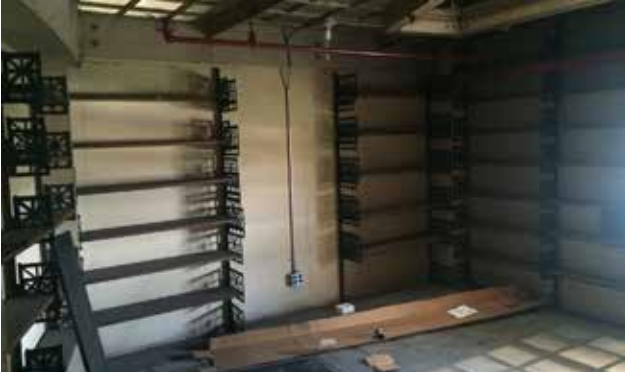
COMPONENT	CONDITION	TREATMENT	PRIORITY	REPRESENTATIVE PHOTO
<b>B4-W</b>  Wall Mounted Bookstacks System	<b>Wear</b> <ul style="list-style-type: none"><li>The gradual disintegration and erosion of materials caused by gradual use overtime.</li></ul>	<b>Material Patching or Replacement</b> <ul style="list-style-type: none"><li>Leave alone unless severe, then consider replacing.</li></ul>	Level 3

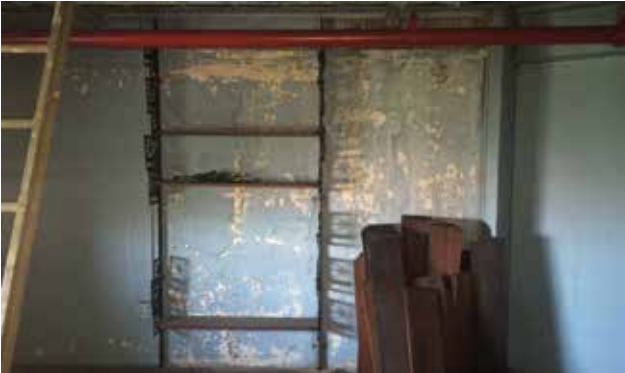
<b>B4-LM</b>  Wall Mounted Bookstacks System	<b>Material Loss</b> <ul style="list-style-type: none"><li>Loss of material leaving holes or exposing inner layers.</li></ul>	<b>Material Patching or Replacement</b> <ul style="list-style-type: none"><li>Patch areas of missing material, if feasible, or replace material to match existing.</li></ul>	Level 3

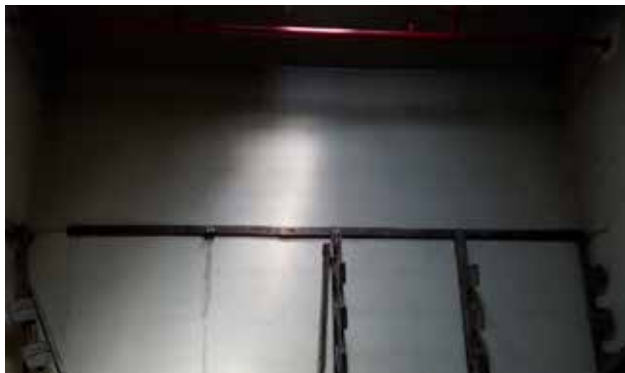
<b>B4-CR</b>  Wall Mounted Bookstacks System	<b>Crack</b> <ul style="list-style-type: none"><li>1/16 to 1/2 inch wide visible fissure in a surface, possibly penetrating through the surface.</li></ul>	<b>Material Patching or Replacement</b> <ul style="list-style-type: none"><li>Remove and replace damaged material.</li></ul>	Level 3

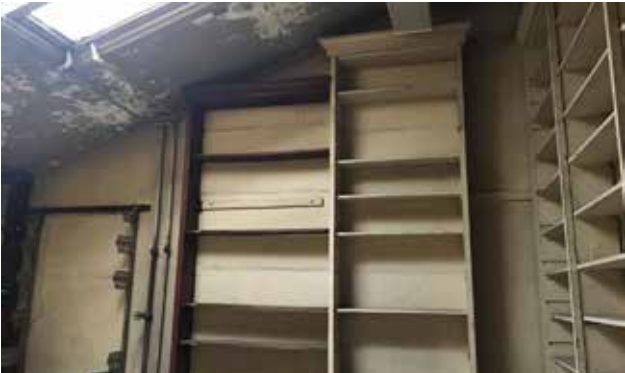
<b>B4-BL</b>  Wall Mounted Bookstacks System	<b>Blistering Paint</b> <ul style="list-style-type: none"><li>Swelling and rupturing of top layer, generally first stage of exfoliation.</li></ul>	<b>Material Patching or Replacement</b> <ul style="list-style-type: none"><li>Identify cause of blistering and remedy. Remove deteriorated paint and repaint.</li></ul>	Level 3

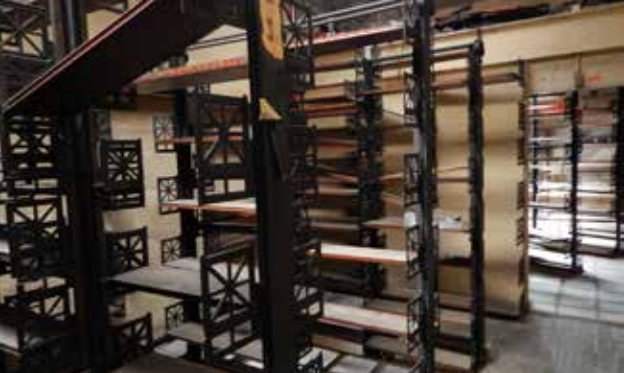
COMPONENT	CONDITION	TREATMENT	PRIORITY	REPRESENTATIVE PHOTO
<b>B5-SW</b>  By-Pass (Through Floor) Bookstacks System	<b>Water Damage</b> <ul style="list-style-type: none"><li>Biological growth, blistering, efflorescence, wood rot or staining caused by the infiltration of water.</li></ul>	<b>Removal of Deteriorated Material</b> <ul style="list-style-type: none"><li>Identify source of water infiltration and remedy cause. Replace deteriorated and damaged material.</li></ul>	Level 3

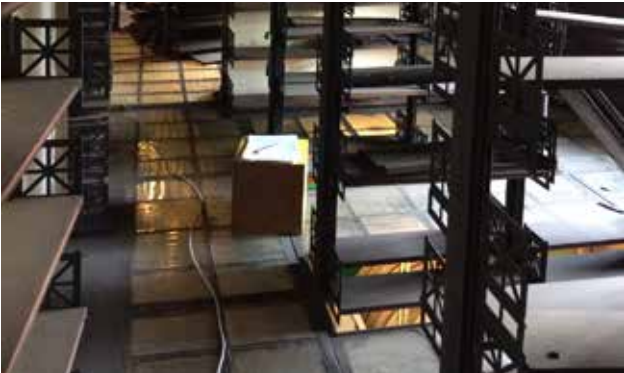
<b>B5-ST</b>  By-Pass (Through Floor) Bookstacks System	<b>Staining</b> <ul style="list-style-type: none"><li>Surface problem caused by the build-up of pollutants, mineral deposits and water marks.</li></ul>	<b>Develop Cleaning Program</b> <ul style="list-style-type: none"><li>Develop a cleaning program if it can be implemented without damage to bulding system.</li></ul>	Level 3

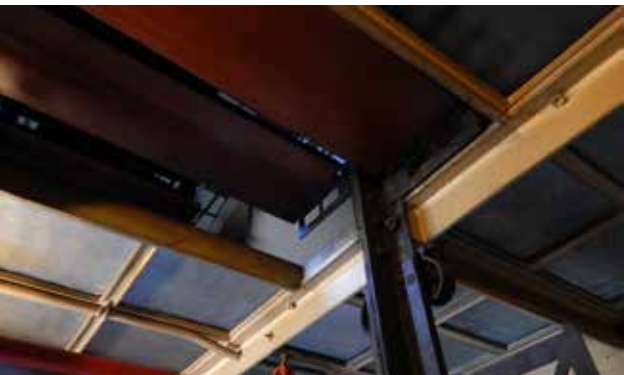
<b>B5-SA</b>  By-Pass (Through Floor) Bookstacks System	<b>Soiling</b> <ul style="list-style-type: none"><li>Surface staining caused by the build-up of pollutants.</li></ul>	<b>Develop Cleaning Program</b> <ul style="list-style-type: none"><li>Develop a cleaning program if it can be implemented without damage to bulding system.</li></ul>	Level 3

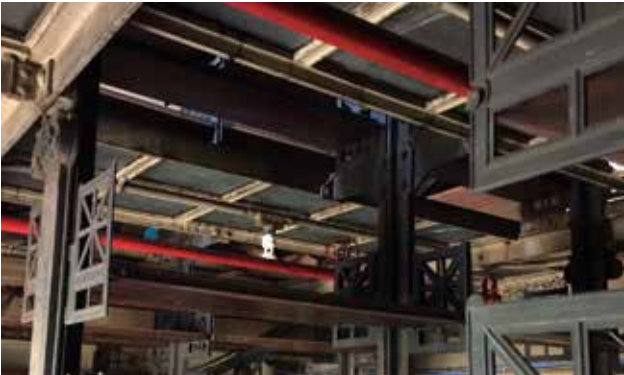
<b>B5-E</b>  By-Pass (Through Floor) Bookstacks System	<b>Extant</b> <ul style="list-style-type: none"><li>An existing building system in good condition.</li></ul>	<b>Cyclical Maintenance</b> <ul style="list-style-type: none"><li>Develop a cleaning program to extend life of building system.</li></ul>	Level 3
