# Conditions Assessment

## Gould Memorial Library & Hall of Fame

FINAL REPORT | 15 MARCH 2018

**BRONX**  
**COMMUNITY**  
COLLEGE

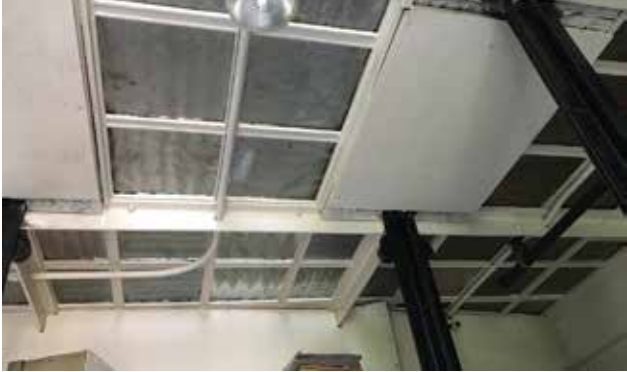
COMPONENT	CONDITION	TREATMENT	PRIORITY	REPRESENTATIVE PHOTO
<b>B5-MD</b>  By-Pass (Through Floor) Bookstacks System	<b>Mechanical Damage</b> <ul style="list-style-type: none"><li>Damage to material caused by mechanical components or equipment</li></ul>	<b>Material Repair or Replacement</b> <ul style="list-style-type: none"><li>Remove mechanical remnants and connections. Patch areas of missing or damaged material, if feasible; remove and replace material, as required.</li></ul>	Level 3

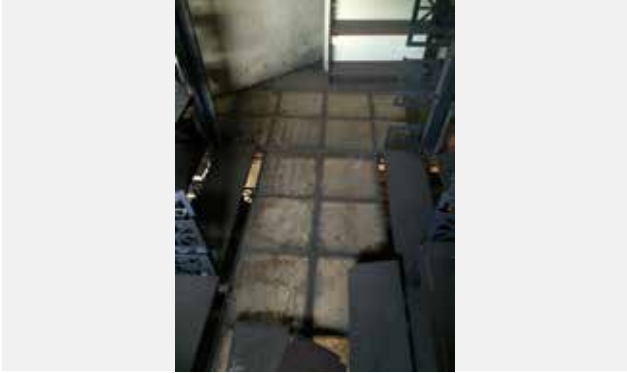
<b>B5-SD</b>  By-Pass (Through Floor) Bookstacks System	<b>Scratches / Dents</b> <ul style="list-style-type: none"><li>Damage to material caused by mechanical components or equipment</li></ul>	<b>Material Repair or Replacement</b> <ul style="list-style-type: none"><li>Patch areas of missing or damaged material, if feasible; remove and replace material, as required.</li></ul>	Level 3

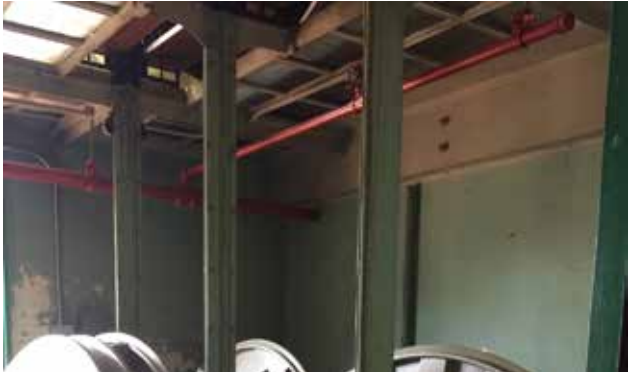
<b>B5-LM</b>  By-Pass (Through Floor) Bookstacks System	<b>Material Loss</b> <ul style="list-style-type: none"><li>Loss of material leaving holes or exposing inner layers.</li></ul>	<b>Material Patching or Replacement</b> <ul style="list-style-type: none"><li>Patch areas of missing material, if feasible, or replace material to match existing.</li></ul>	Level 3

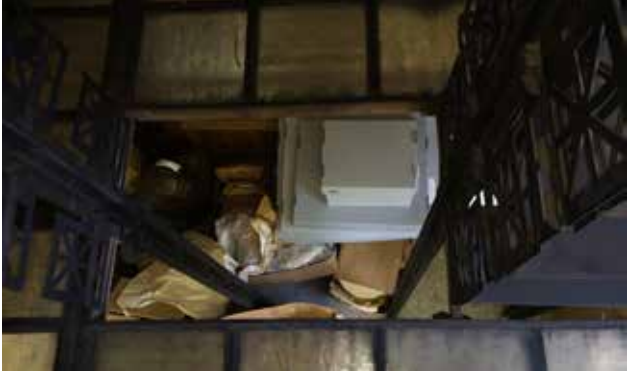
<b>B5-MC</b>  By-Pass (Through Floor) Bookstacks System	<b>Corrosion</b> <ul style="list-style-type: none"><li>Deterioration of material by a chemical reaction with its environment.</li></ul>	<b>Removal of Deteriorated Material</b> <ul style="list-style-type: none"><li>Remove corrosion and corrosive products; in severe cases, replace deteriorated members with new material to match existing.</li><li>Refer to assesment of structural engineer for details on replacement of select cast iron members.</li></ul>	Level 3

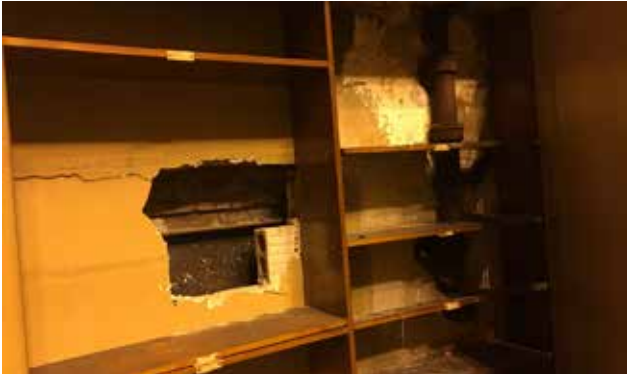
COMPONENT	CONDITION	TREATMENT	PRIORITY	REPRESENTATIVE PHOTO
<b>B6-SA</b>  Dome Level Shelves Bookstacks System	<b>Soiling</b> <ul style="list-style-type: none"><li>Surface staining caused by the build-up of pollutants.</li></ul>	<b>Develop Cleaning Program</b> <ul style="list-style-type: none"><li>Develop a cleaning program if it can be implemented without damage to building system.</li></ul>	Level 3

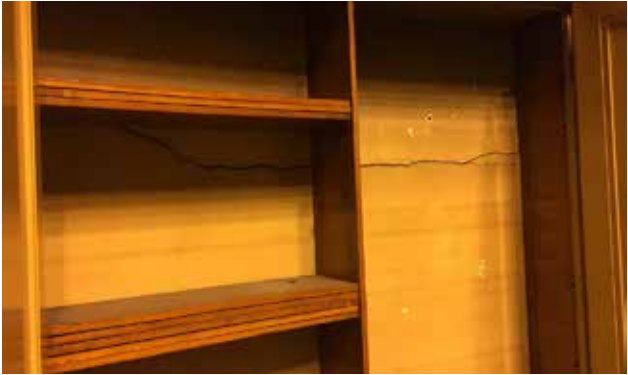
<b>B6-E</b>  Dome Level Shelves Bookstacks System	<b>Extant</b> <ul style="list-style-type: none"><li>An existing building system in good condition.</li></ul>	<b>Cyclical Maintenance</b> <ul style="list-style-type: none"><li>Develop a cleaning program to extend life of building system.</li></ul>	Level 3

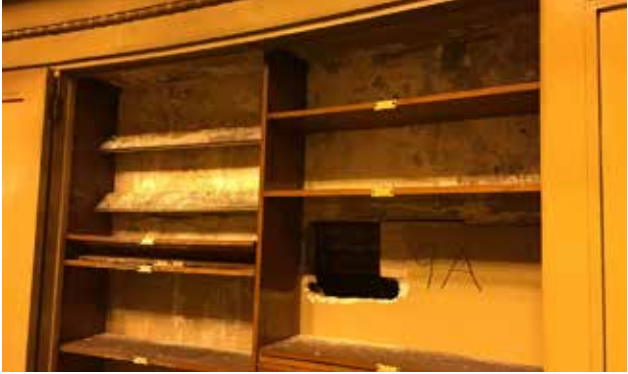
<b>B6-ST</b>  Dome Level Shelves Bookstacks System	<b>Staining</b> <ul style="list-style-type: none"><li>Surface problem caused by the build-up of pollutants, mineral deposits and water marks.</li></ul>	<b>Develop Cleaning Program</b> <ul style="list-style-type: none"><li>Develop a cleaning program if it can be implemented without damage to building system.</li></ul>	Level 3

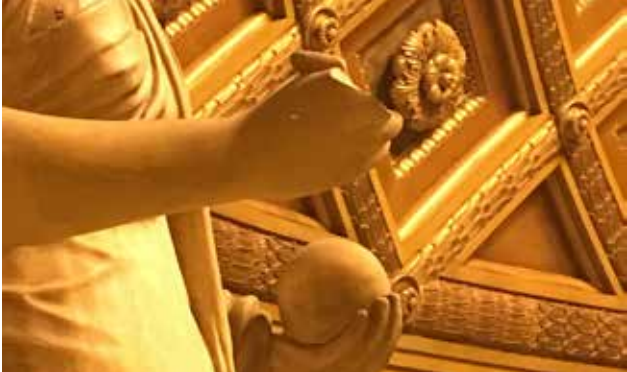
COMPONENT	CONDITION	TREATMENT	PRIORITY	REPRESENTATIVE PHOTO
<b>PS-LM</b>  Plaster Statue	<b>Material Loss</b> <ul style="list-style-type: none"><li>Loss of material leaving holes or exposing inner layers.</li></ul>	<b>Material Patching or Replacement</b> <ul style="list-style-type: none"><li>Patch areas of missing material, if feasible, or replace material to match existing.</li></ul>	Level 3

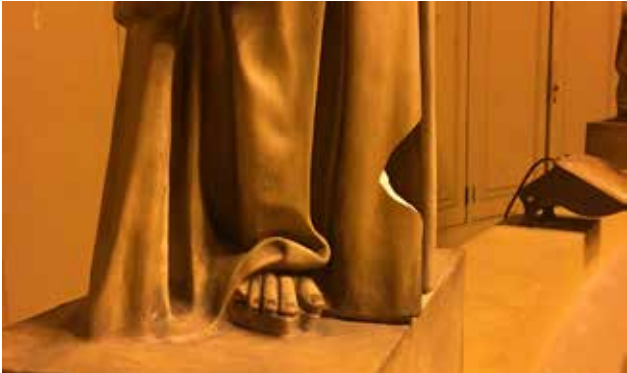
<b>PS-SA</b>  Plaster Statue	<b>Soiling</b> <ul style="list-style-type: none"><li>Surface staining caused by the build-up of pollutants.</li></ul>	<b>Develop Cleaning Program</b> <ul style="list-style-type: none"><li>Develop a cleaning program if it can be implemented without damage to bulding system.</li></ul>	Level 3

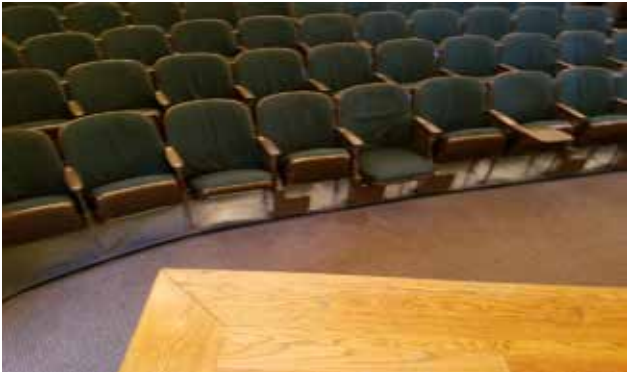
<b>AS-W</b>  Auditorium Seating	<b>Wear</b> <ul style="list-style-type: none"><li>The gradual disintegration and erosion of materials caused by gradual use overtime.</li></ul>	<b>Material Patching or Replacement</b> <ul style="list-style-type: none"><li>Leave alone unless severe, then consider replacing.</li></ul>	Level 3

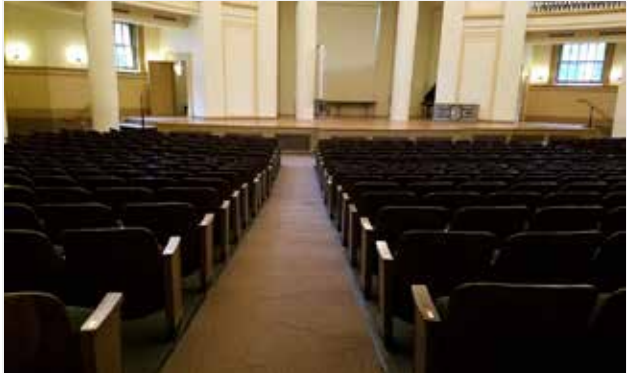
<b>AS-ST</b>  Auditorium Seating	<b>Staining</b> <ul style="list-style-type: none"><li>Surface problem caused by the build-up of pollutants, mineral deposits and water marks.</li></ul>	<b>Develop Cleaning Program</b> <ul style="list-style-type: none"><li>Develop a cleaning program if it can be implemented without damage to bulding system.</li></ul>	Level 3

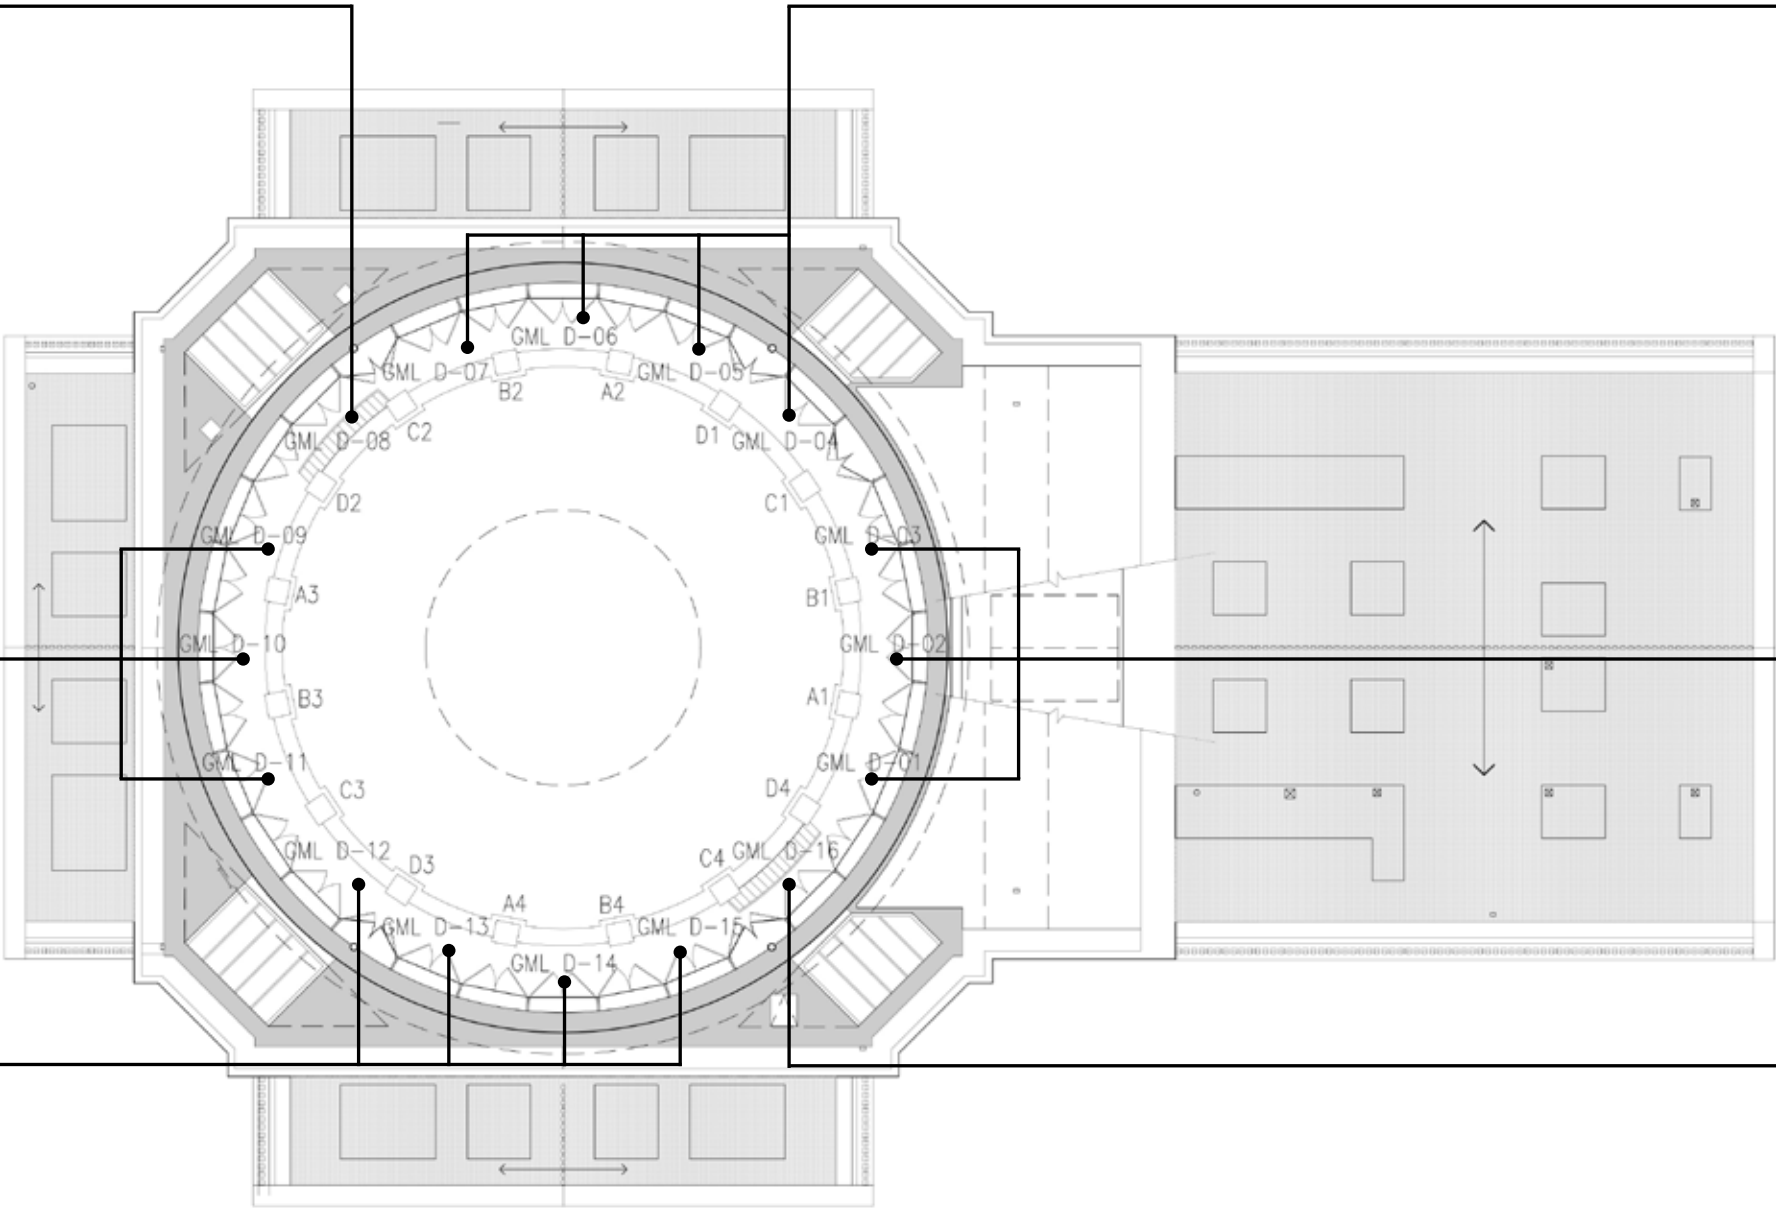
# Interior Plan o8 - Dome Room Level

GML-D-08	
F2:	W, SA, OJ, ST
W2:	CR, ST, SW, LC, SA
W12:	SA, W, LC
C2:	CR, SA
S1:	ST, SA
S3:	SA, W, PR
S6:	SA, W
D1:	SA, W, CR
B6:	SA, ST
PS:	SA, LM

GML-D-12/13/14/15	
F2:	W, SA, OJ, ST
W2:	CR, SW, LM, LC, ST, SA
W12:	SA, W, MD, LC
C2:	CR, SA
D1:	SA, W, ST, LM, CR, LC
B6:	SA, ST
PS:	SA, LM

GML-D-16	
F2:	W, SA, OJ, ST
W2:	CR, MD, SW, LC
W12:	SA, W, LC
C2:	CR, SA
S1:	ST, SA
S3:	SG, ST, SA, LC
S6:	SA, SD, OP
D1:	SA, W
B6:	SA, ST
PS:	SA, LM

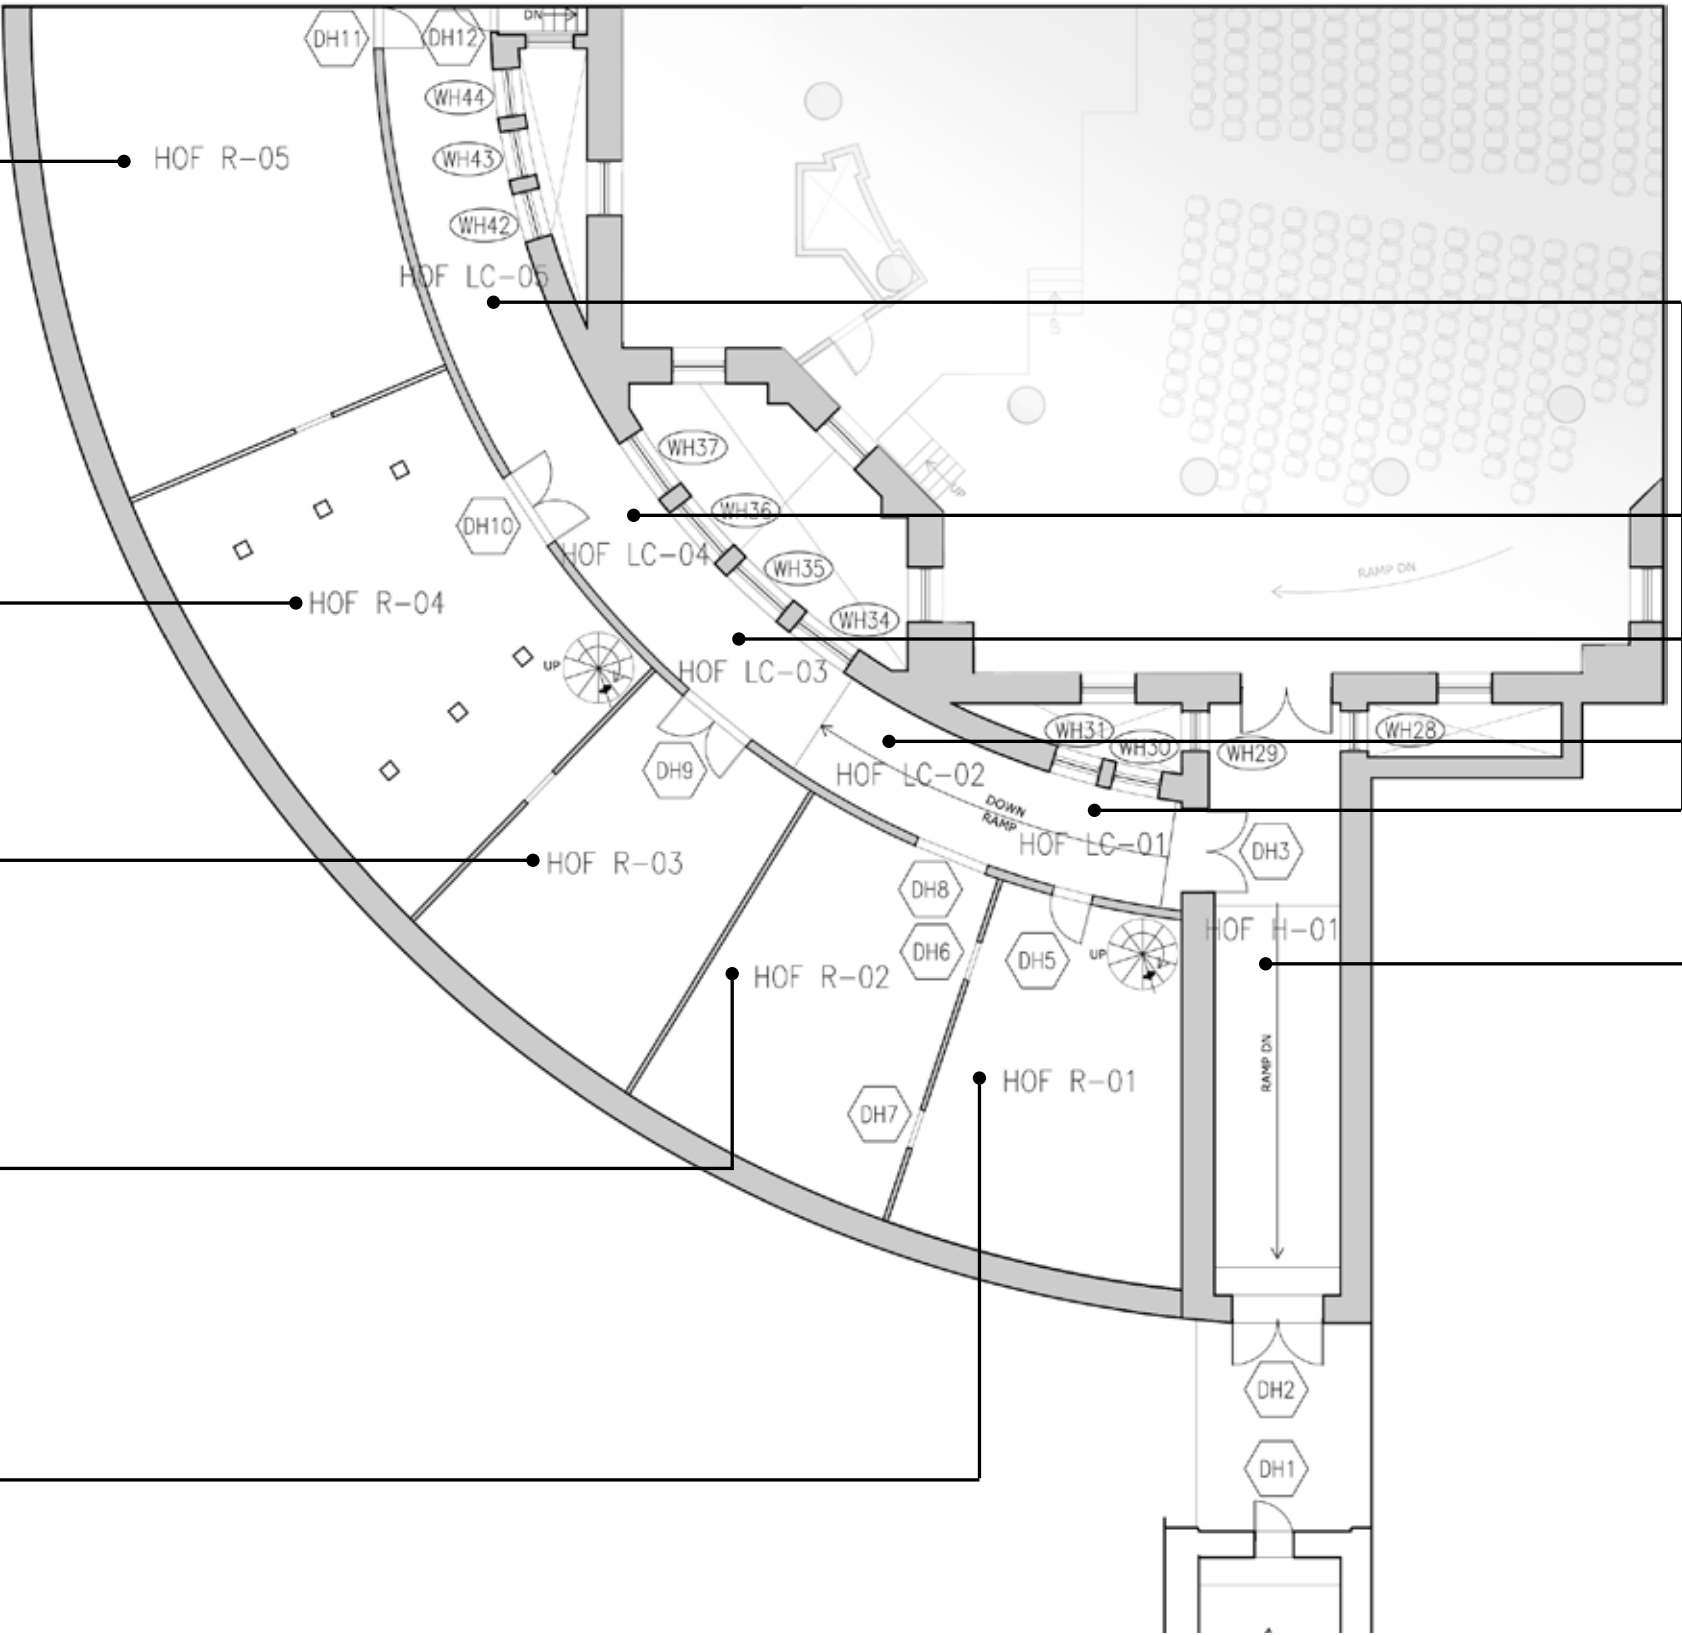
Interior Plan o1 Part B - Auditorium Level HOF South

HOF-R-05	
F4:	PR, CR, SA
W2:	MD, SP, LC, SD
W5:	LM
C9:	LM, SA, MD
D1:	W, SD, SA
WD1:	RT, LM, ST, LC, CR, NGC
L8:	(6) OU

HOF-R-02	
F5:	W, SA, MD
F8:	W, SA, MD
W2:	SP, LM, MD, LC
W5:	LM
W6:	LC, W, ST, LM, RT
W7:	SA
CM1:	MC, LC, CR, ST
C9:	MD, CR
D1:	(DH6) D, MC, LM, MD
WD1:	LM, W, DGC, ST
L8:	(4) NO

HOF-R-01	
F5:	ST, W, MD, LM, CR
W2:	CR, LC, EF, SA, SP, LM
W5:	LC, OJ
W6:	ST, LC, MD
CM1:	MC, LC
C7:	MC
D1:	(D7) W, LM, DS
D2:	HM
WD1:	NGC, LC, LM, MD, SL
WD2:	HM
S1:	MC, LC
S4:	SA, W
S6:	W, MC, LC

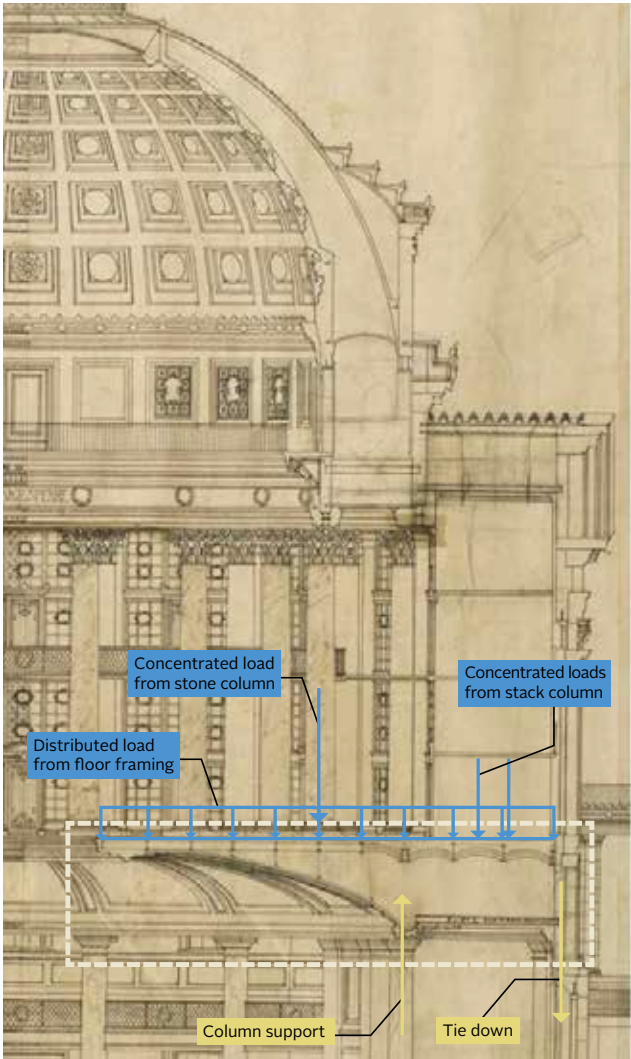
Section - Tapered cantilever shown in dashed box

Library stacks exist on the north, south, and west sides of the building. Each wing of the stack is divided into three areas on plan. The outer portions of each wing is symmetrical with Levels 04 and 06 being hung from the floor structure of Levels 05 and 07, respectively. In the middle portion of each wing the vertical stack structure travel between all of the stack levels and are integrated into overall floor structure. The floor and stack loads in these middle portion bear on the floor structure of Level 03. The described load path is depicted in the axonometric drawing.

Level 03 consists of tapered built up cantilevers as shown in the section drawing above. The elevation drawing shows the tie down detail within the building's

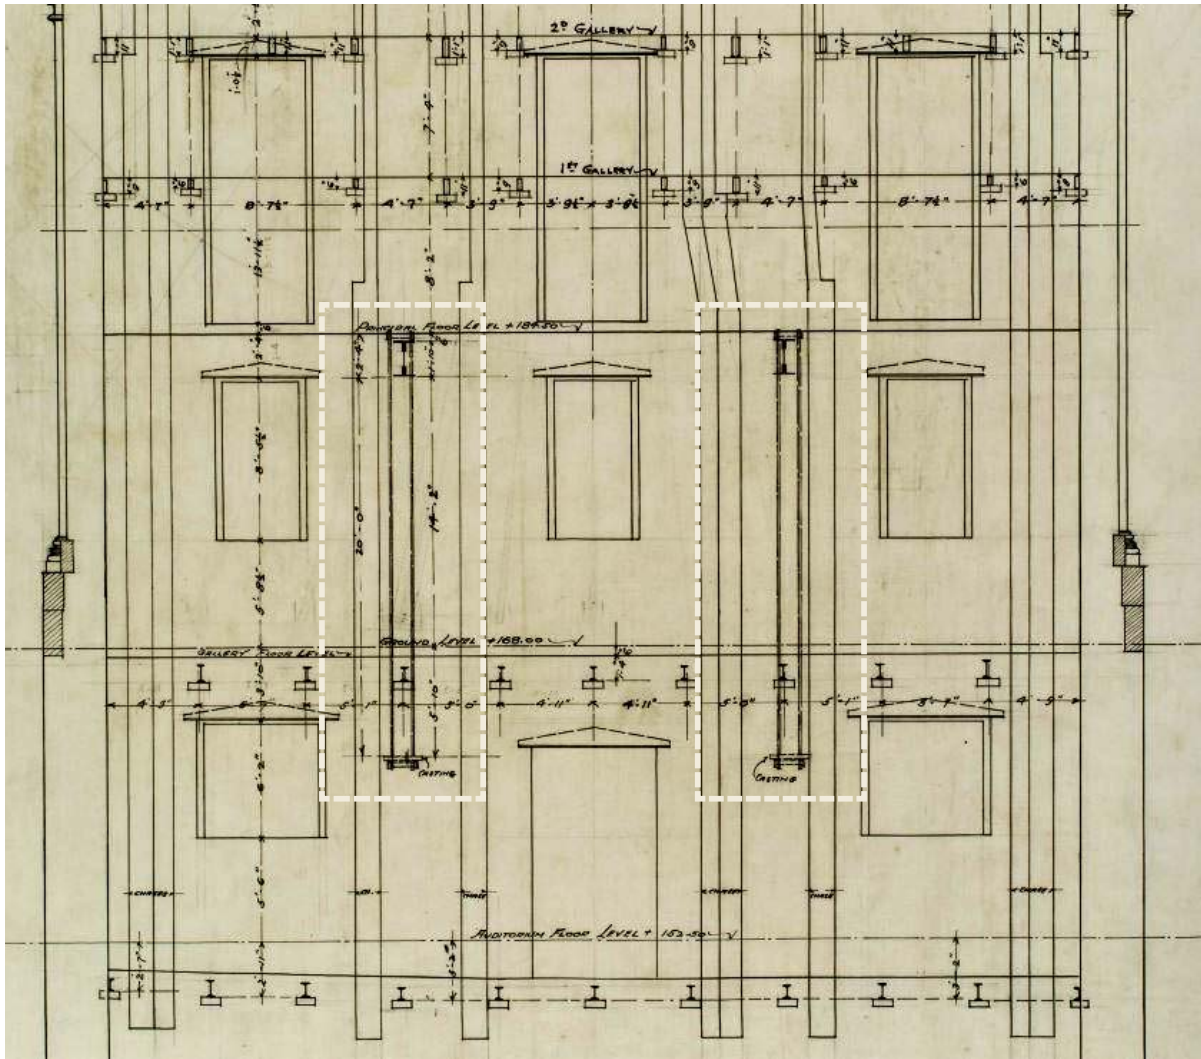
Elevation - Tie downs shown in dashed box

masonry walls that resist the uplift at the end of the cantilever's back span. It was initially assumed that modification to the middle portion of the stack may have a detrimental effect on the framing of Level 03 if the cantilever was depending on the weight of the stacks to load it's back span. Based on preliminary analysis this does not seem to be the case. Further investigation and analysis should be carried out to determine potential changes in deflections of the structure of Level 03 if the stacks are modified. Changes in deflections could cause additional cracking of the floor and ceiling finishes and repairs should be considered.

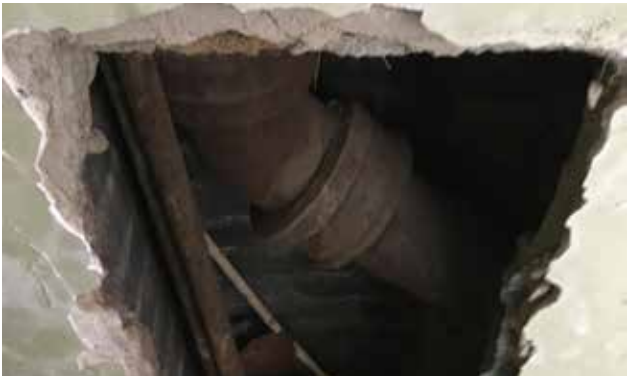
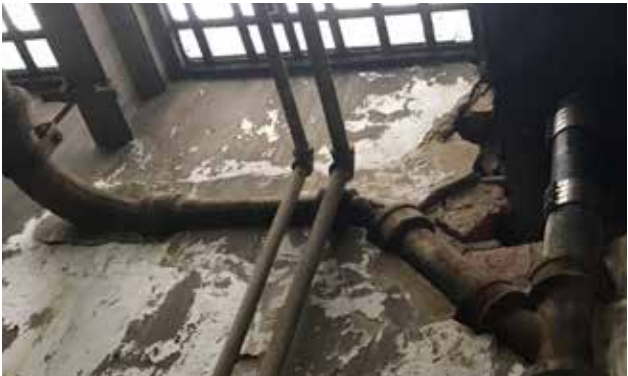
COMPONENT	CONDITION	TREATMENT	PRIORITY	REPRESENTATIVE PHOTO	
Stormwater	<b>Uninsulated Stormwater Piping</b> Summer condensation can cause interior damage.	<b>Insulate Piping</b> Cut walls to expose for access to re-insulate in areas of secondary and tertiary historic character. Apply pipe insulation and restore interior finishes.	Level 2

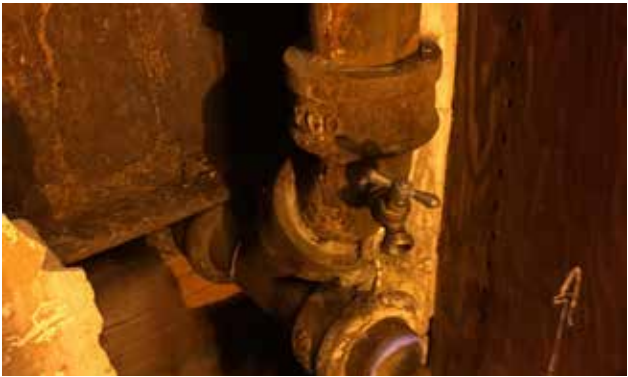
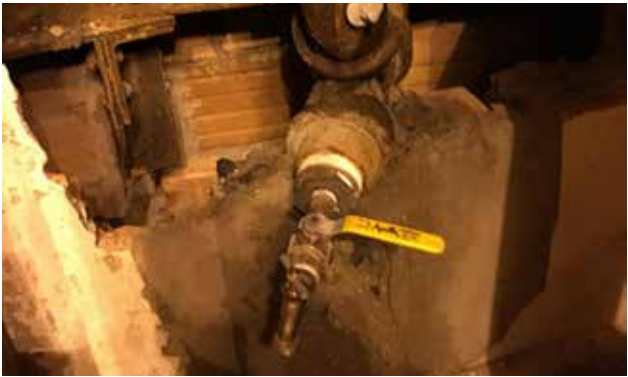
Stormwater	<b>Piping in Poor Condition</b> Leaders at Dome Room have temporary taps installed to remedy clogged drainage.	<b>Replace Piping</b> Correction in progress by college staff. Replacement scoped as part of previously designed “Critical Roof Repair” project.	Level 3

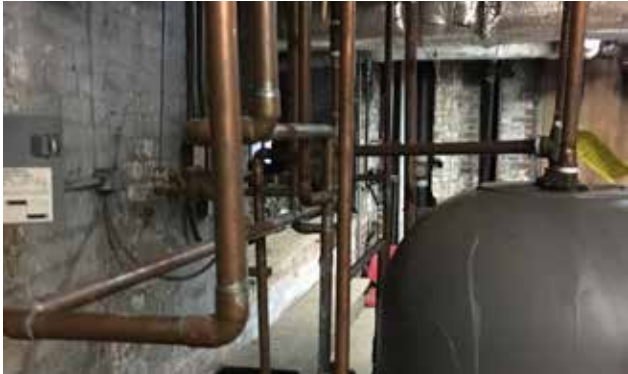
COMPONENT	CONDITION	TREATMENT	PRIORITY	REPRESENTATIVE PHOTO	
Domestic Water	Domestic water service does not have water meter or backflow preventer.	Upgrade Provide water meter and backflow preventer	Level 2

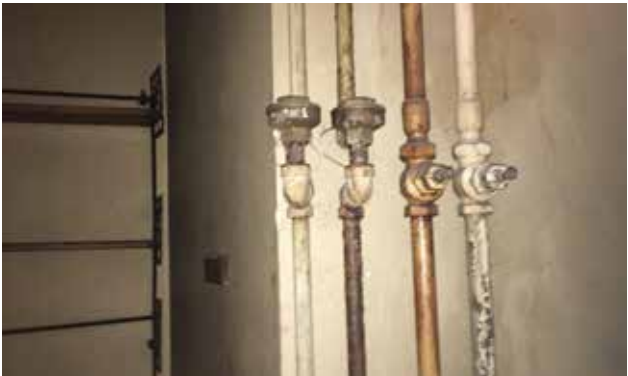
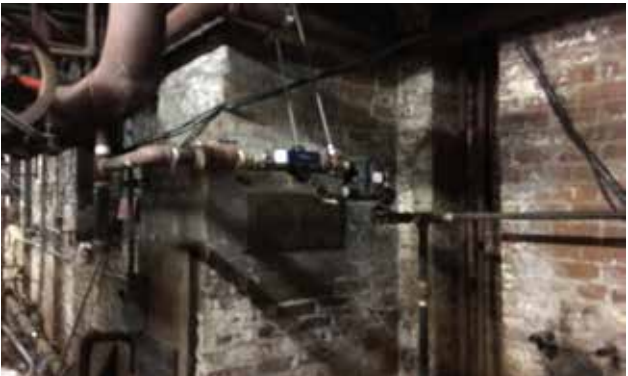
COMPONENT	CONDITION	TREATMENT	PRIORITY	REPRESENTATIVE PHOTO	
Heating	<b>Uninsulated Piping</b> Not all steam and condensate piping insulated.	<b>Insulate Piping</b> Cut walls to expose for access to re-insulate in areas of secondary and tertiary historic character. Apply pipe insulation and restore interior finishes.	Level 3

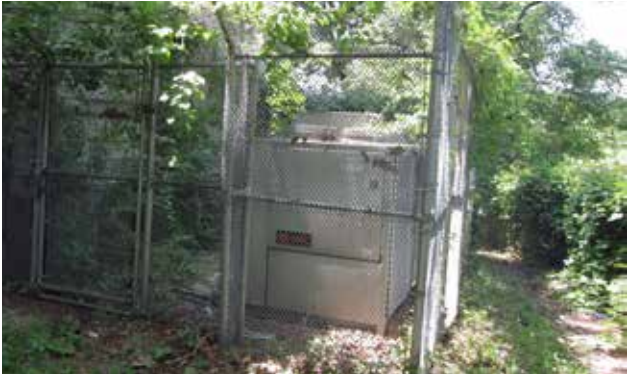
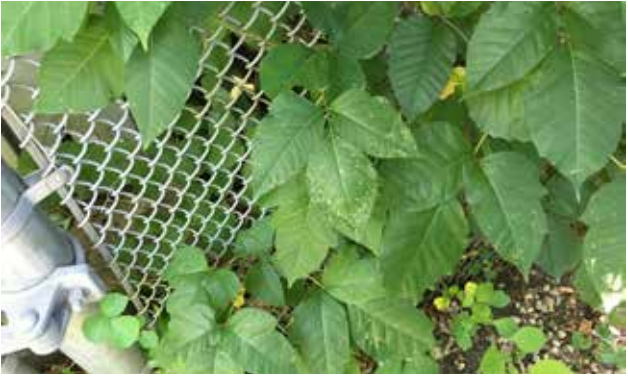
Heating/Air Conditioning	<b>Overgrowth</b> Auditorium's exterior condensers have considerable amount of poison ivy around them.	<b>Abate Poison Ivy</b> Obviate exterior condensers by connecting to campus chilled water system.	Level 3

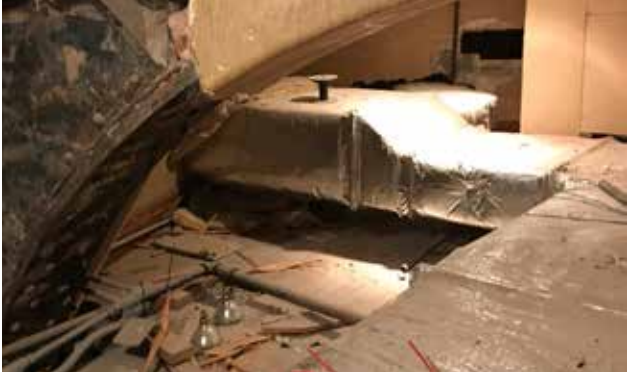
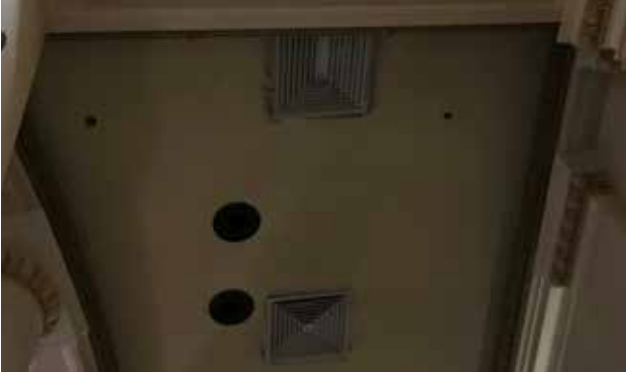
Heating/Air Conditioning	<b>Poor Acoustical Performance</b> Auditorium's interior air handlers do not perform according to accepted acoustical standards and may diminish quality of sound in the space.	<b>Provide Acoustical Controls</b> Analyze space for acoustical needs and provide duct silencers to suit.	Level 5

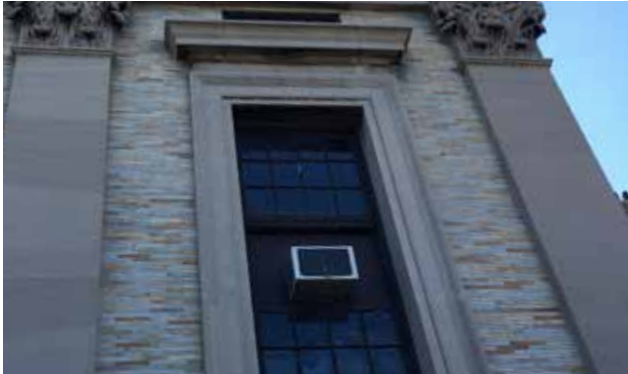
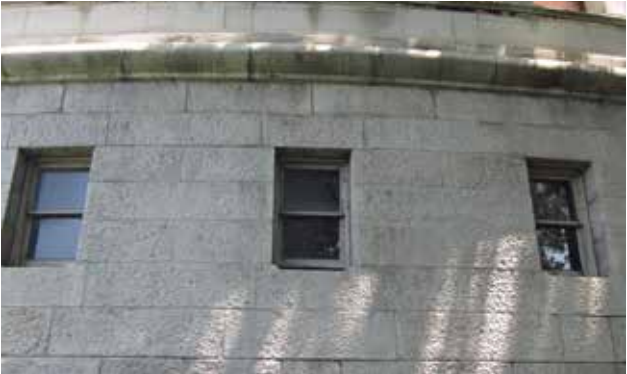
COMPONENT	CONDITION	TREATMENT	PRIORITY	REPRESENTATIVE PHOTO	
Ventilation	<p><b>Insufficient Fresh Air Supply</b> With the exception of the Auditorium, most GML and HOF spaces do not have proper ventilation. During the hot and cold seasons, the operating windows is not an effective strategy.</p> <p>Mechanical ventilation should be provided. This has significant implications to heating and cooling the spaces as the fresh air needs to conditioned as well.</p>	<p><b>Provide Code-Minimum Ventilation</b> Install heating and cooling systems that allow for proper ventilation. Coordination with campus systems to be necessary. Space for equipment can be difficult. Integration into building fabric to be difficult.</p>	Level 5

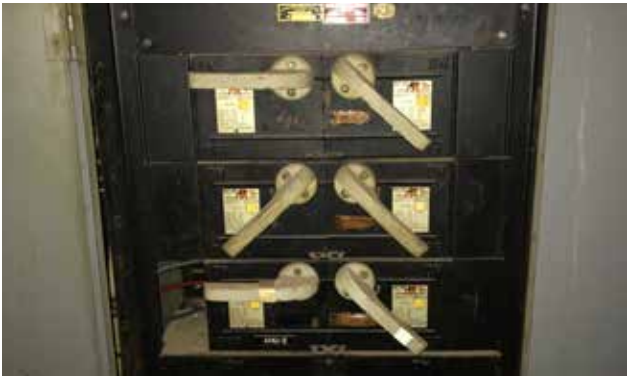
COMPONENT	CONDITION	TREATMENT	PRIORITY	REPRESENTATIVE PHOTO	
Switchboards	<b>Outdated System</b> Switchboard MDP-12 is old and in poor condition.	<b>Upgrade</b> Replace with new switchboard	Level 3

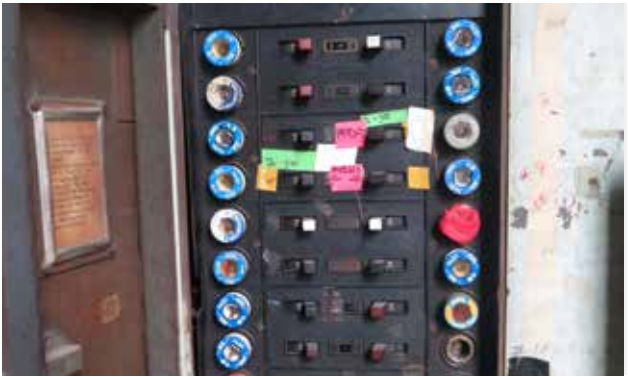
Distribution Panels	<b>Outdated System</b> Many of the older distribution panels are beyond their useful life and require replacement.	<b>Upgrade</b> Replace distribution panel with new.	Level 3

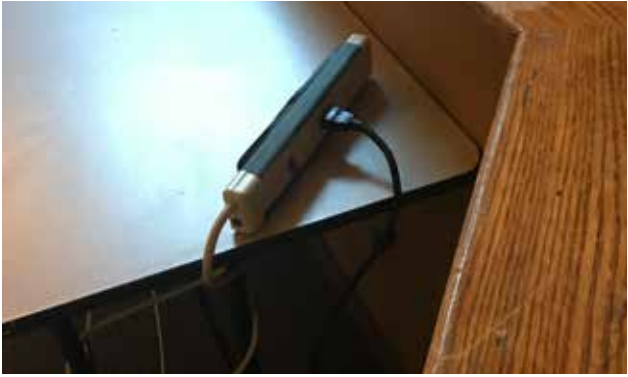
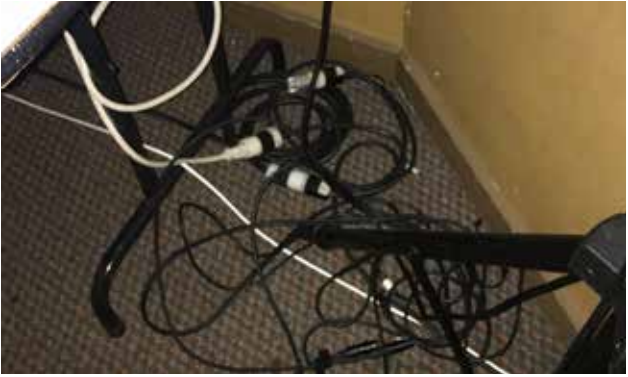
Receptacles	<b>Outdated System</b> In all areas of GML there are a lack of sufficient electrical receptacles. Although not a code violation, this leads to overuse of flexible cord sets and power strip devices. Offices do not have enough outlet receptacles to support modern office functions and often have power strips to compensate. There are areas in the former stacks which have no receptacles.	<b>Upgrade Plug Load System</b> Add more receptacles and distribution panels to support them.	Level 4

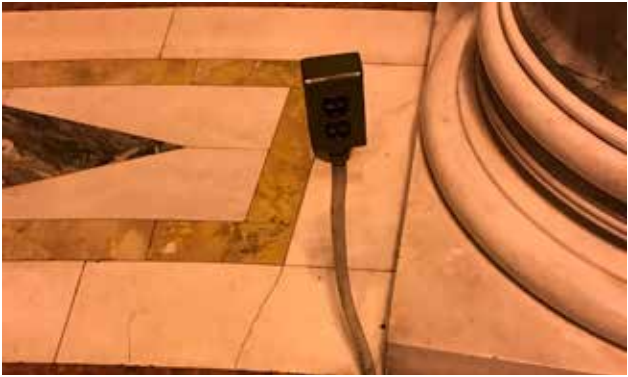
Receptacles	<b>Outdated System</b> Receptacle in the Rotunda is not supported properly and is supported only by a conduit.	<b>Upgrade Plug Load System</b> Provide properly supported receptacles to the Rotunda in a historically sensitive manner.	Level 2

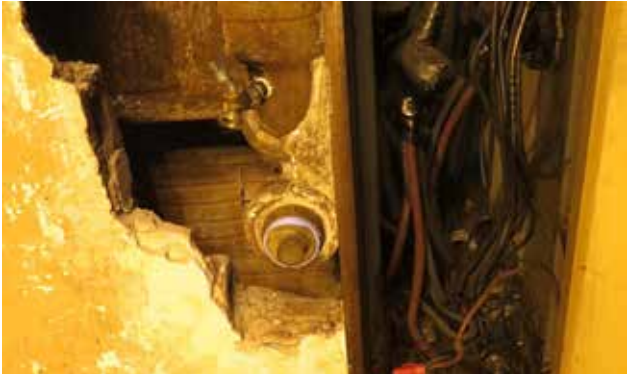
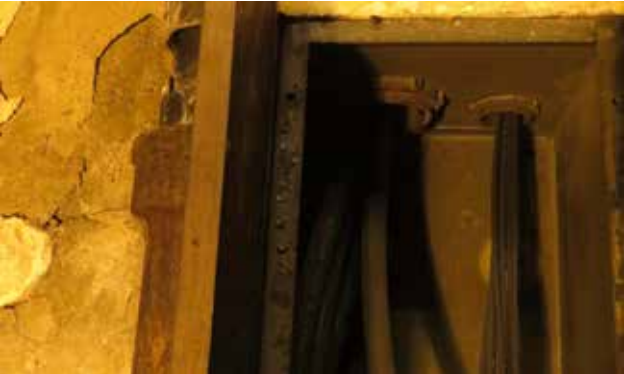
COMPONENT	CONDITION	TREATMENT	PRIORITY	REPRESENTATIVE PHOTO	
Junction Boxes	<b>Outdated System</b> Wall-mounted junction boxes in balcony area have exposed wiring.	<b>Upgrade</b> Install code-compliant cover of wiring.	Level 2

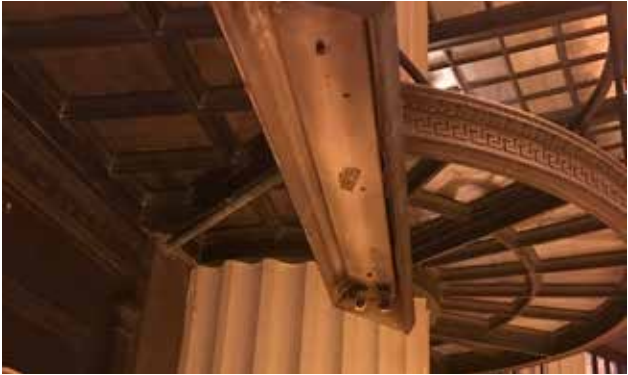
Abandoned Equipment	<b>Outdated System</b> Abandoned electrical fixtures exist in the building.  List locations	<b>Upgrade</b> Remove abandoned fixtures.	Level 4

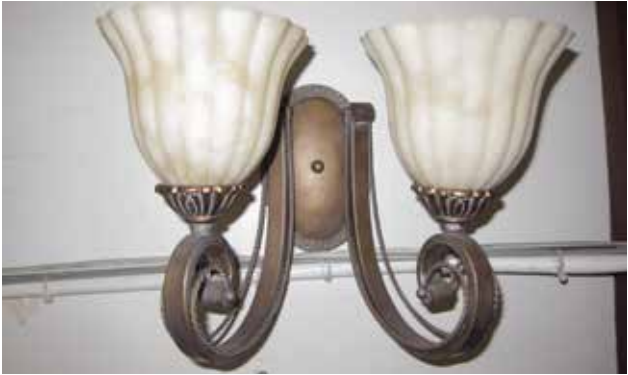
Lighting in GML	<b>Outdated System</b> Light fixtures in office areas are generally in poor condition. Period fixtures originally intended to utilize incandescent lamps that have been replaced with compact fluorescent lamps.  Lighting in the stack areas is in poor condition. In many areas lighting is by means of incandescent light bulbs suspended by flexible pendants. These pendants are dangerously unprotected from physical damage.	<b>Upgrade</b> Replace office lighting with new modern energy efficient LED lighting fixtures Period fixtures should be custom upgraded to LED lamps.  Replace lighting in stacks with LED fixtures to meet codes and to suit luminosity required by type of use.	GML Offices Level 4  GML Stacks Level 2

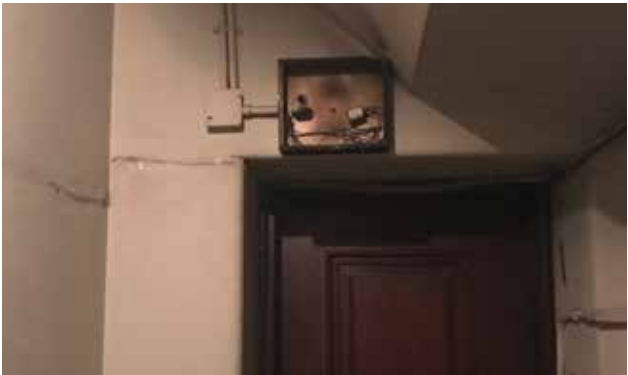
Emergency Lighting	<b>Outdated System</b> Emergency lighting is provided by selected fixtures connected to the generator service. It is not clear if exterior lighting at exit doors are connected to the emergency system.	<b>Upgrade</b> Connect exterior exit lighting to the emergency system.	Level 2

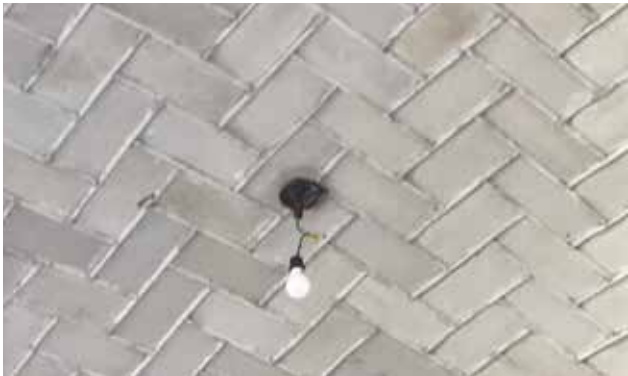
COMPONENT	CONDITION	TREATMENT	PRIORITY	REPRESENTATIVE PHOTO	
HOF Lighting	<b>Outdated System</b> Several of the lighting fixtures in the ambulatory are completely missing. Others were replaced with historically inappropriate fixtures.	<b>Refurbish &amp; Upgrade</b> Replace the missing fixtures with reproductions of the existing original fixtures and convert all fixtures to LED lighting.	Level 4

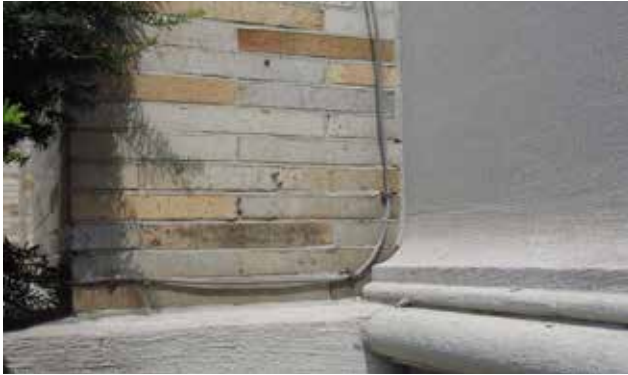
Low Voltage	<b>Inappropriate Elements</b> Conduit associated with the security cameras was exposed along the surface of the Hall of Fame ceiling and walls.	<b>Install Historically Sensitive Upgrades</b> Conceal security camera wiring within structure and remove the conduit.	Level 4

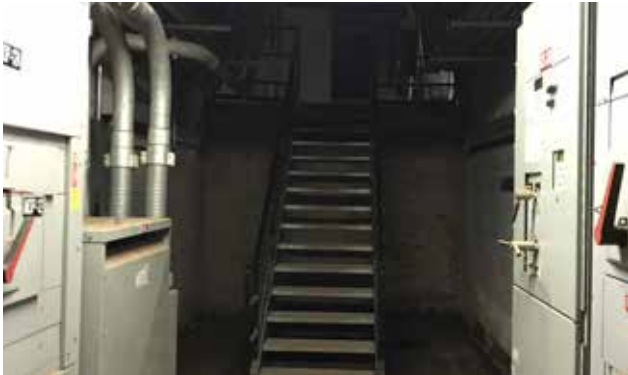
Switchboard	<b>Outdated System</b> The 800 amp capacity of this switchboard is insufficient for the future use of the buildings.	<b>Upgrade</b> For future use bring 480 volt service from the campus wide network. Install new switchboard at 480/277 volts, 800 amps to power new equipment.	Level 5

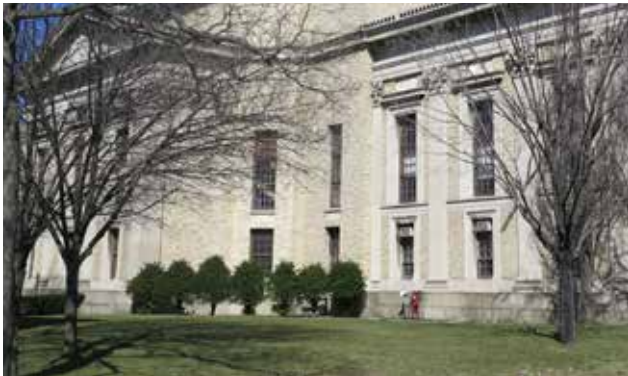
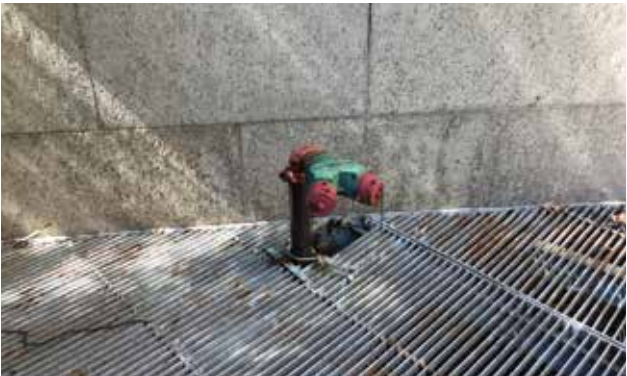
COMPONENT	CONDITION	TREATMENT	PRIORITY	REPRESENTATIVE PHOTO	
Standpipe	<b>Obstructed Access</b> Fire department connection visible and physically obstructed by landscaping.	<b>Reconfigure Landscaping</b>	Level 2

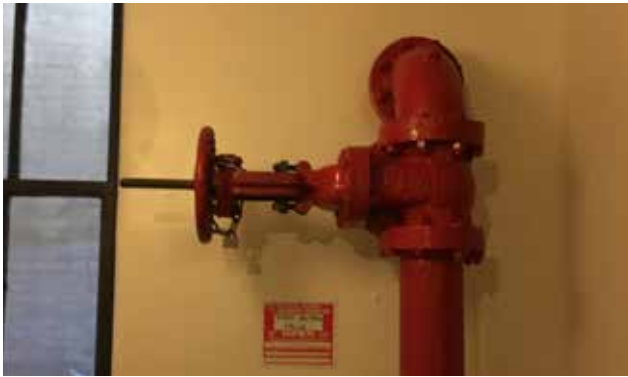
Standpipe	<b>Missing Components</b> Fire water service does not have water meter or backflow preventer.	<b>Upgrade</b> Provide water meter and backflow preventer.	Level 2

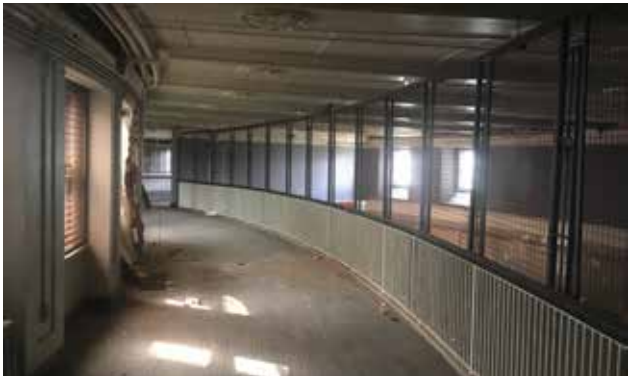
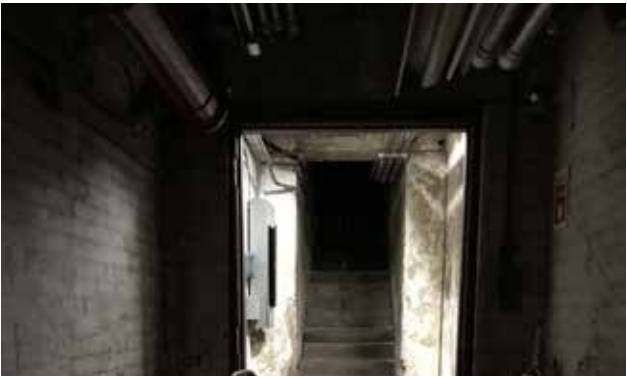
Sprinklers	<b>Missing Components</b> Sub-basement and HOF rooms are not protected by a sprinkler system.	<b>Upgrade</b> Provide sprinkler system in sub-basement and HOF rooms.	Level 2

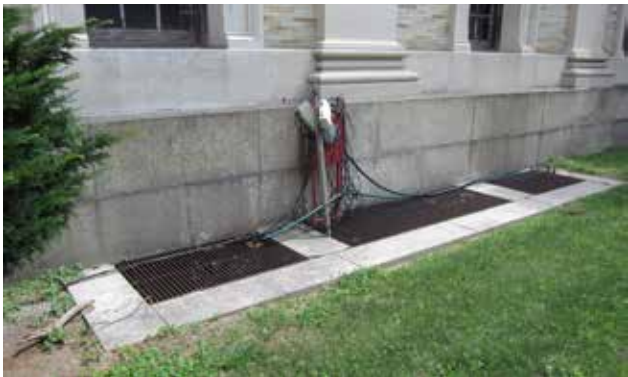
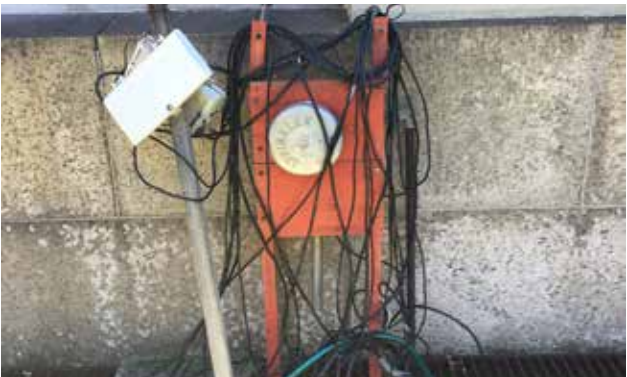
Fire Alarm	<b>Non-Functional System</b> The existing fire alarm system is completely nonfunctional.	<b>Upgrade</b> Provide an entirely new fire alarm system as part of campus work scheduled for 2018.	Level 1
