# Conditions Assessment

## Gould Memorial Library & Hall of Fame

FINAL REPORT | 15 MARCH 2018

**BRONX**  
**COMMUNITY**  
COLLEGE

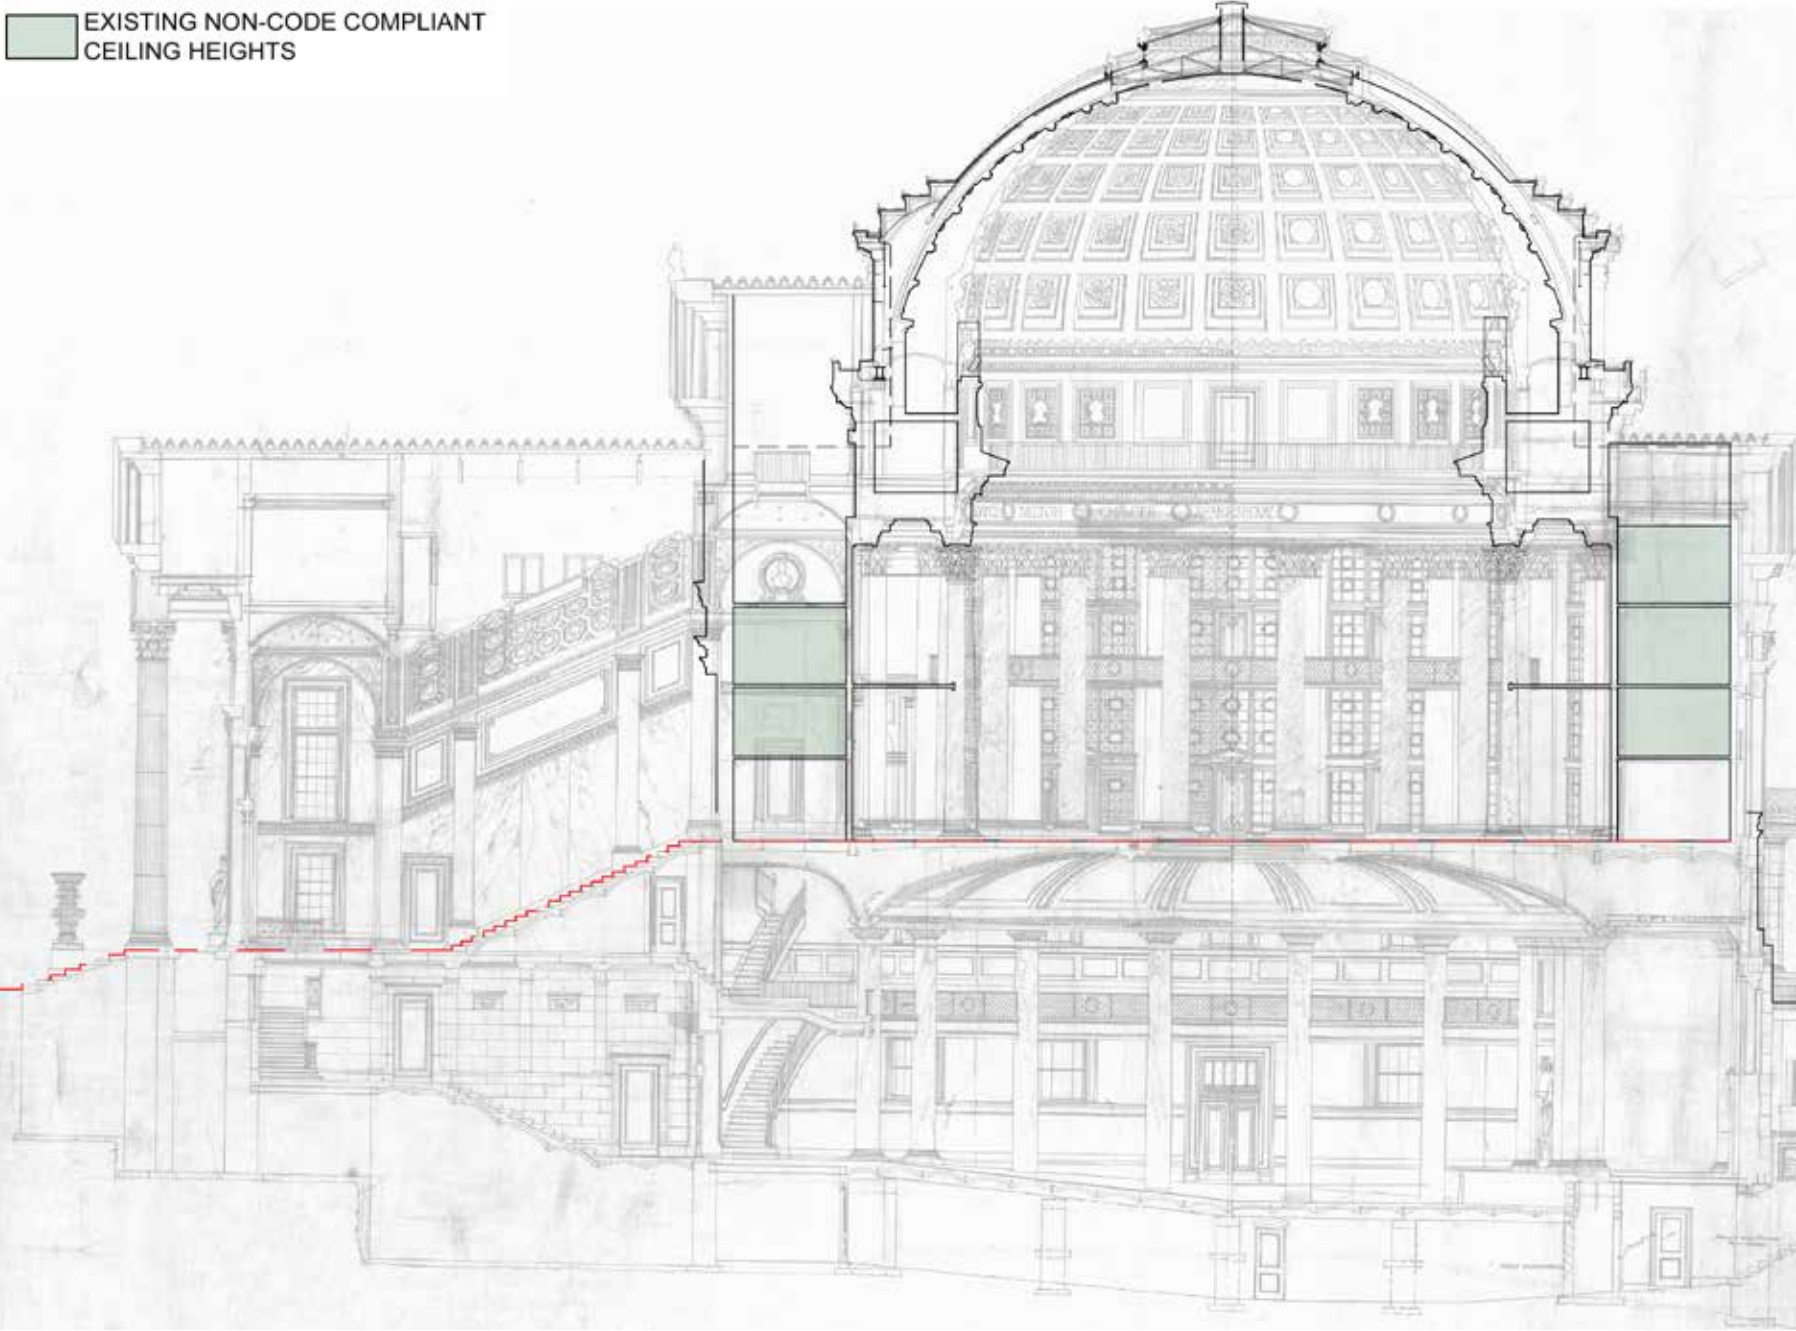
CODE IMPLICATIONS - SECTION

(See section diagram color green.)

**Note: A variance will be required from the Bronx DOB for select areas.**

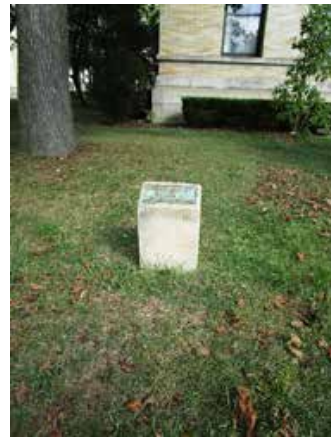
- LE4 The concrete and bronze tree memorial is out of place with removal of other memorial plaques on the campus green.

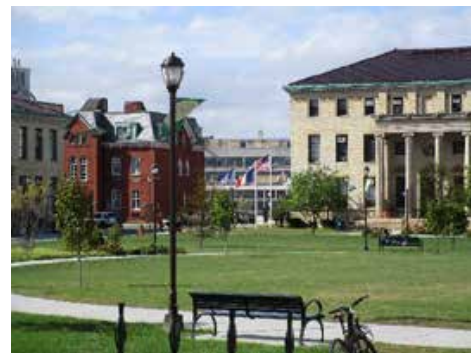
- LE5 Three flagpoles aside of the Hall of Language are added to the historic landscape. They appear to be slightly out of scale with the architectural mass of the buildings.

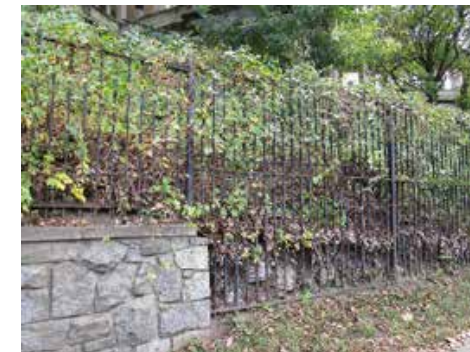
- LE7 Iron fencing along Sedgwick Avenue is in fair to poor condition. Many of the historic acorn finials are missing and the base is rusting from having soil and debris pile up against the post and pickets over several decades. Some minor sections of fence have bent or dislodged pickets. The stone wall base at the intersection of the Hall of Fame Terrace and Sedgwick avenue is in fair to good condition.

LE6-LE7 Iron fencing along Sedgwick Avenue is a contributing element of the historic landscape. Repair/rehabilitation of the fencing to reflect its historic character. Deteriorated site conditions, collected debris, elevated grades and proposed vegetation renewal, need to be addressed as part of the perimeter fence work. Remnant elements of fence posts attached to the HOF and Hall of Philosophy

appear to have no function and should be removed and the anchor holes repaired.

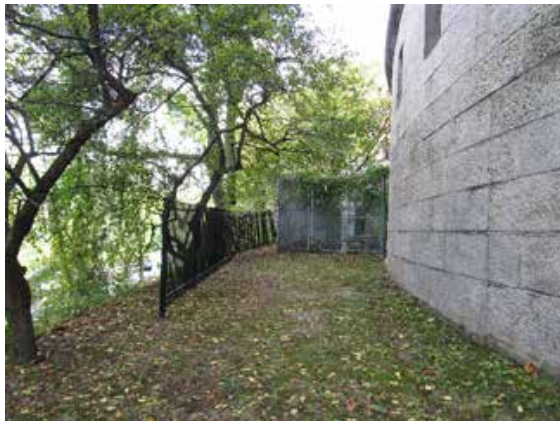
- LE8 The concrete walk at the northwest auditorium exit is cracked and failing, the walk is blocked off from the corner of Sedgwick Avenue and Hall of Fame Terrace drive by the 8-foot high black aluminum fencing.
- LE9 Remnant concrete walk segments alongside the HOF colonnade are not functional and do not connect with the adjacent walks.

LE8-LE10 The concrete walks are part of the historic circulation system of the building and west slope that no longer have a purpose as part of the overall campus pedestrian circulation system. Walks atop the west slope need to be removed to deter student access to this area of the campus and the lower set of steps that were not visible at the time of the field inspection should not be replaced. Re-grading of their location to illustrate the historic circulation pattern and replacement with a secure yet operational gate at the intersection of Sedgewick Avenue and Hall of Fame Terrace will serve as a maintenance access for this area. Contemporary pedestrian, handicapped access and emergency exit needs for the GML auditorium will direct the preferred treatment options in this location.

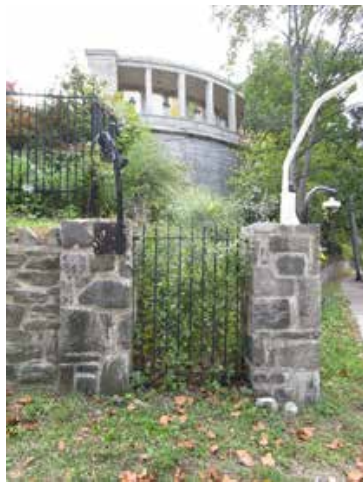
- LE10 The historic steps to the gate at the corner of Sedgwick Avenue and Hall of Fame Terrace Drive are not visible and assumed to have been removed. There is no operational gate at the bottom.
- LE11 The stone wall north of Community Hall Plaza is deteriorated with large areas of mortar cracked and missing. Several stones at the end of the wall have become dislodged and are on the ground.
- LE12 The stepped retaining wall with stone finials upslope of the historic walk and steps is a character feature of the historic landscape and still functions to retain the slope. It is in fair to poor condition.

LE11 The stone veneer retaining wall that is part of the Community Hall and Colston Tower complex forms the edge of the drive to the GML auditorium and west landscape. Stones have fallen from the inner concrete structural wall in many locations and mortar is failing. The wall is in need of repair and repointing to stop further deterioration and water infiltration

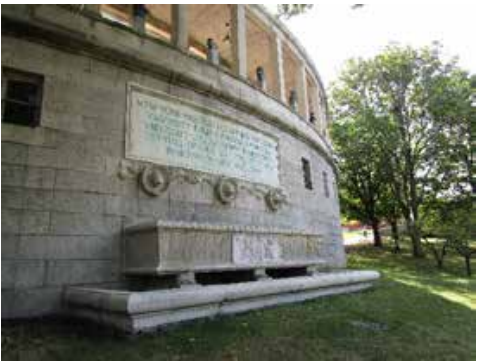
- LE14 The stone fountain structure is in fair condition with all ornamental elements retained. Plumbing and mechanical water systems are not operational.

LE14 The historic fountain (water trough) at the west face of the GML auditorium and is an integral component of the building architecture and a contributing feature to the landscape in the historic core. The fountain masonry is in good condition but no longer operational. The stone work is in need of modest cleaning repair for repointing and sealing any locations where water may infiltrate. Plumbing and electrical service need to be replaced and a fountain operation mechanical system put in place. Fountain operation will require a concealed housing for mechanical equipment and a water storage vault below grade for water storage and operational supply.

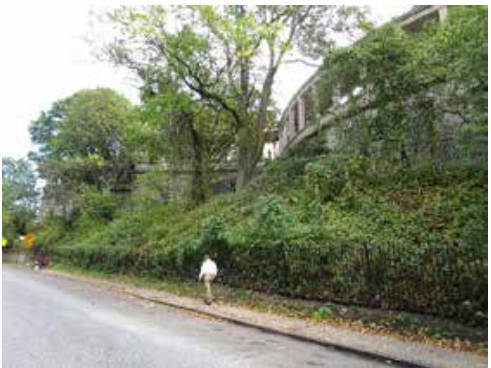
- LP1 The west sloping bank is covered with invasive vines, brambles, woody shrubs and tree species. Select areas appear managed keeping vegetation at a low height, however the majority of the slope along Sedgwick Avenue looks untended and unkempt.
- LP2 Area just outside of the gate is compacted from foot traffic and void of lawn. Note there is a four to six inch drop from the granite threshold to finish turf grade.

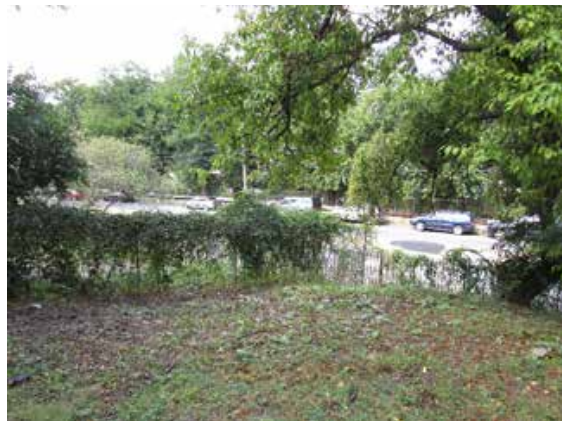
- LP4 Invasive vines engulf the chain link fencing at the south west perimeter of the GML & HOF west lawn. The vine covered fence is visually unsightly from all vantage points.
- LP5 The east façade of the GML is partially covered by flanking columnar English oak trees to either side. Of the eight originally planted oaks, five remain, three to the north and two to the south.

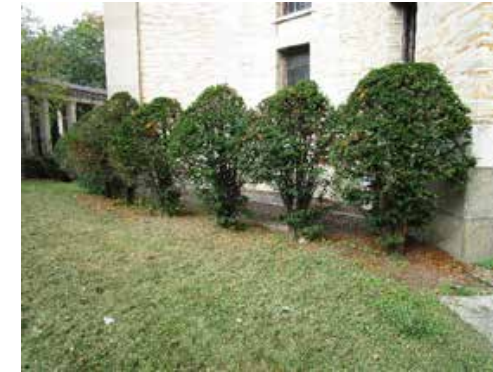
- LP6 Yews planted in a line along the area way grate at the south wall of GML are overgrown, misshaped and with lost bottom foliage. This planting is unrelated and not symmetrical with plantings opposite at the north side of GML.

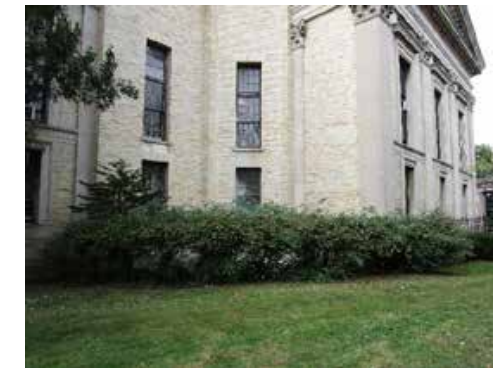
- LP7 Shrub massing to the north of GML is unsightly, the flowering abelia having poor form with heavy top massing and thinned out bases, and the end yew is overgrown contributing to an overall unkempt appearance.

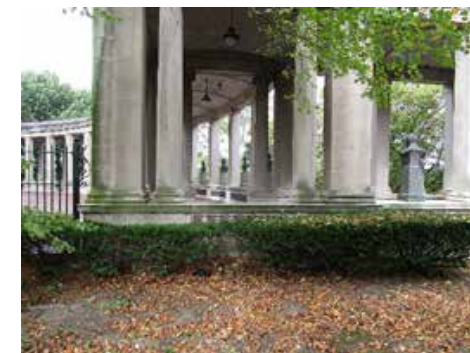
- LP8 Yew hedging at the end walls of the HOF Colonnade is to the base of the columns and block the balustrade below when viewed from the east or Quad.

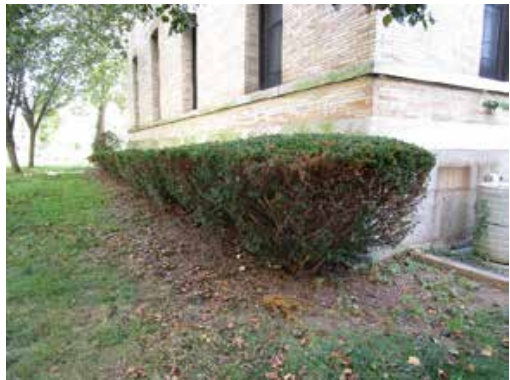
- LP9 Yew hedges along the base of the GML, Halls of Language and Hall of Philosophy and generally maintained below the limestone coursing on the buildings. The “v” form however presents the appearance of being un-managed with narrow vegetation at the base and wider at the top. Properly managed hedging is directed toward vertical sides or slight inward canted shapes toward the top to achieve ideal appearance and full foliage.
- LP10 The planting bed is comprised of a mix of ornamental shrub materials unrelated to the historic landscape.

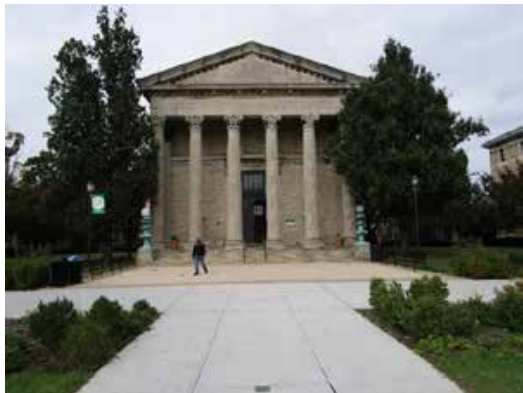
- LV1 The view of the GML front façade and pediment is partially blocked buy vegetation from the central and crossing walkways.

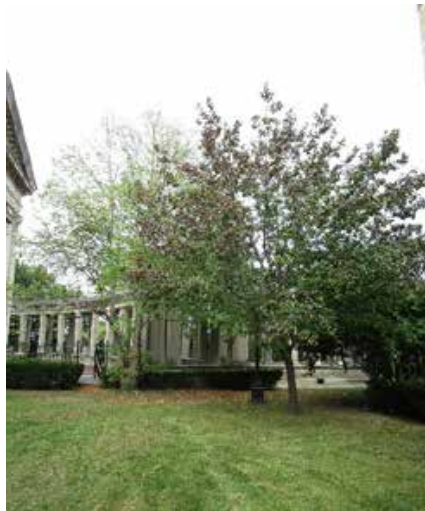
- LV2 View of the HOF end roof gable is blocked by a Bradford Pear tree, altering the historic view of the colonnade from the Quad to the east.

- LV2 Bradford Pear trees blocking the views of the HOF colonnade and roof should be removed. Restructure tree and shrub planting to reinforce the historic setting of the White complex while addressing contemporary uses of the immediate buildings surrounds. The process will involve review of historic images, selective removal and appropriate replacement materials.

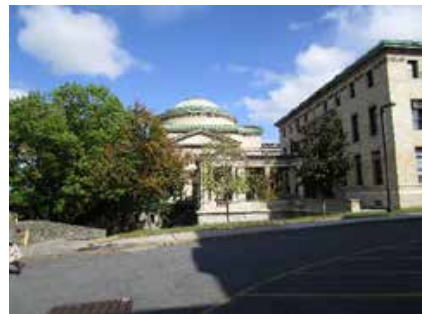
- LV3 Recently planted trees intended to enhance the campus landscape will mature and block historic views of the of the HOF colonnade and GML south facing end wall and dome structure from the campus walks and drive.

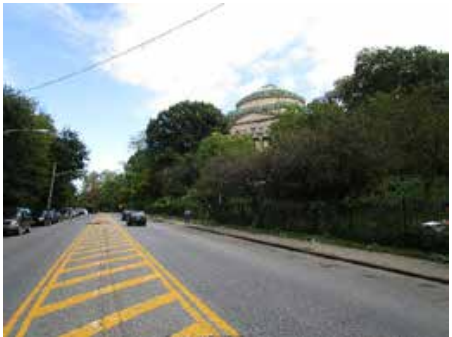
- LV4 The historic view toward the HOF and GML and fountain basin is blocked from Sedgwick Avenue by heavy tree and woody material volunteer growth, including the vine covered chain link fence at the Colston Hall service area drive

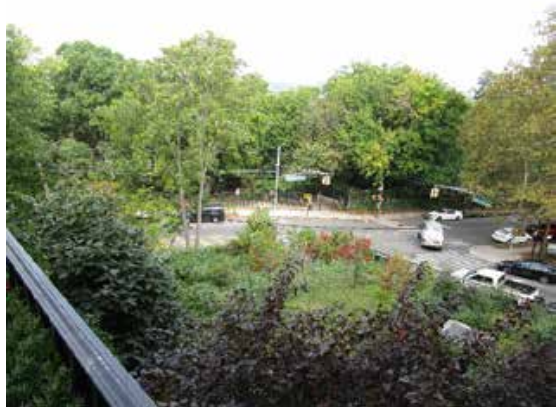
LV5 Views outward from the north end of the HOF toward the Harlem River, palisades and across the north tip of Manhattan are in part obscured in by a mixed tree canopy that includes invasive species at the edge of University Woods along Sedgwick Avenue.

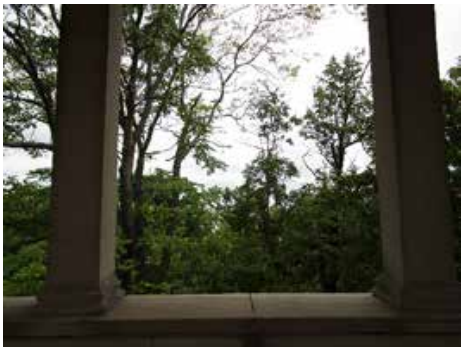
LV6 Views west from the HOF terrace toward the Harlem River, Manhattan and the beyond are blocked by a mix of trees that include mature oaks and maples as well as several species considered to be invasive, ailanthus, black cherry and Norway maple.

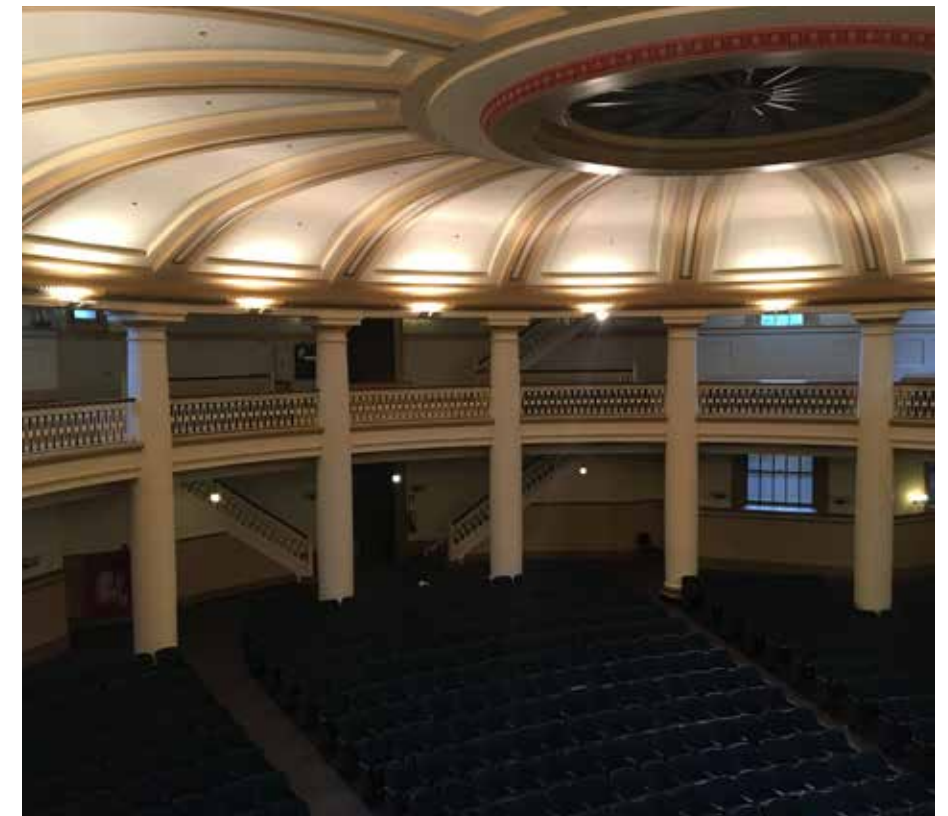
Gould Memorial Library, Interior of Auditorium
